Memorandum

Assignment and Scope of Work

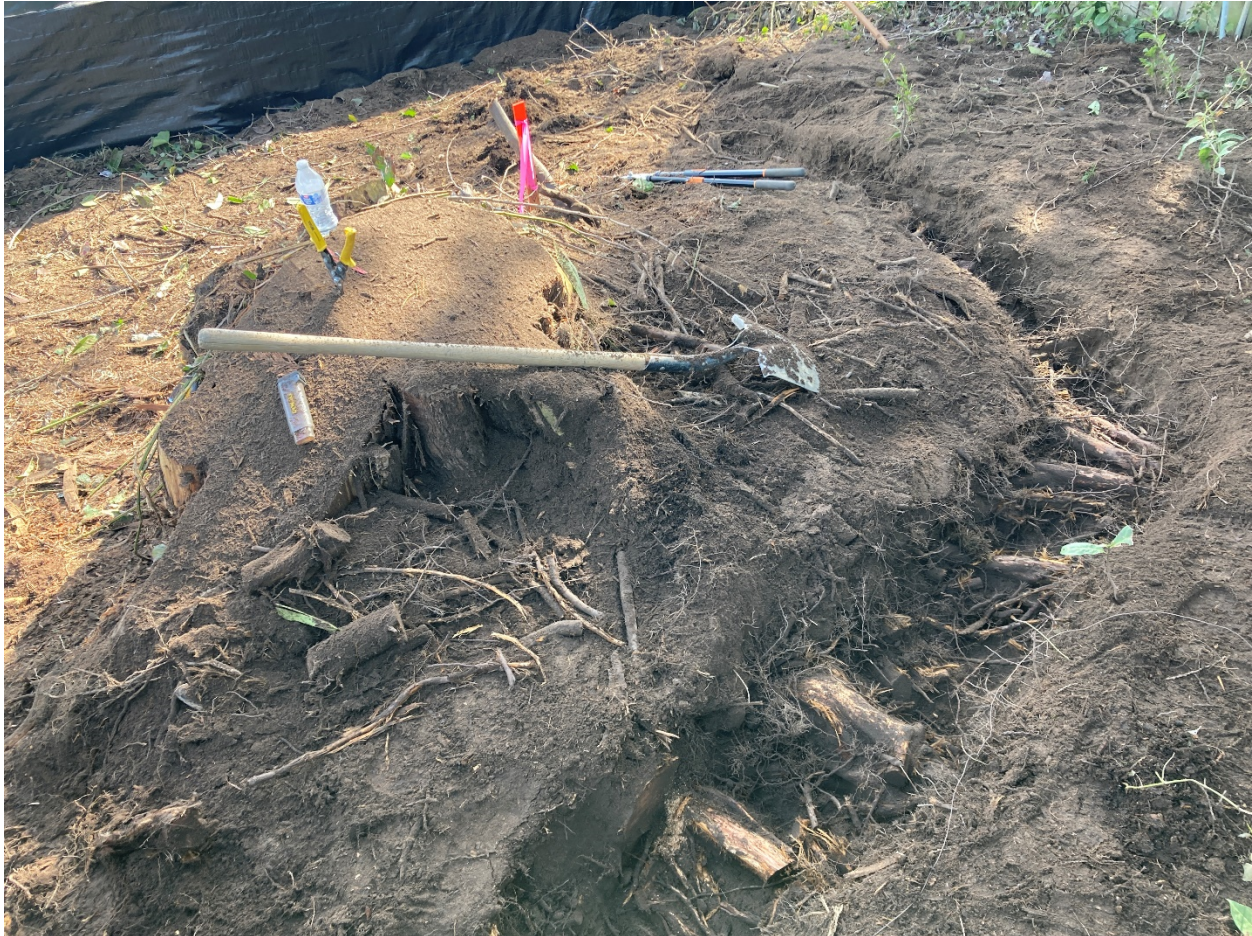
Photograph 2. The stump of “Dead tree 1” with roots partially exposed on March 7, 2023. A mix of hand excavation and pneumatic excavation was used to expose this tree’s roots so that they could be cut cleanly as to avoid collateral root damage to tree 576 when this stump was removed.

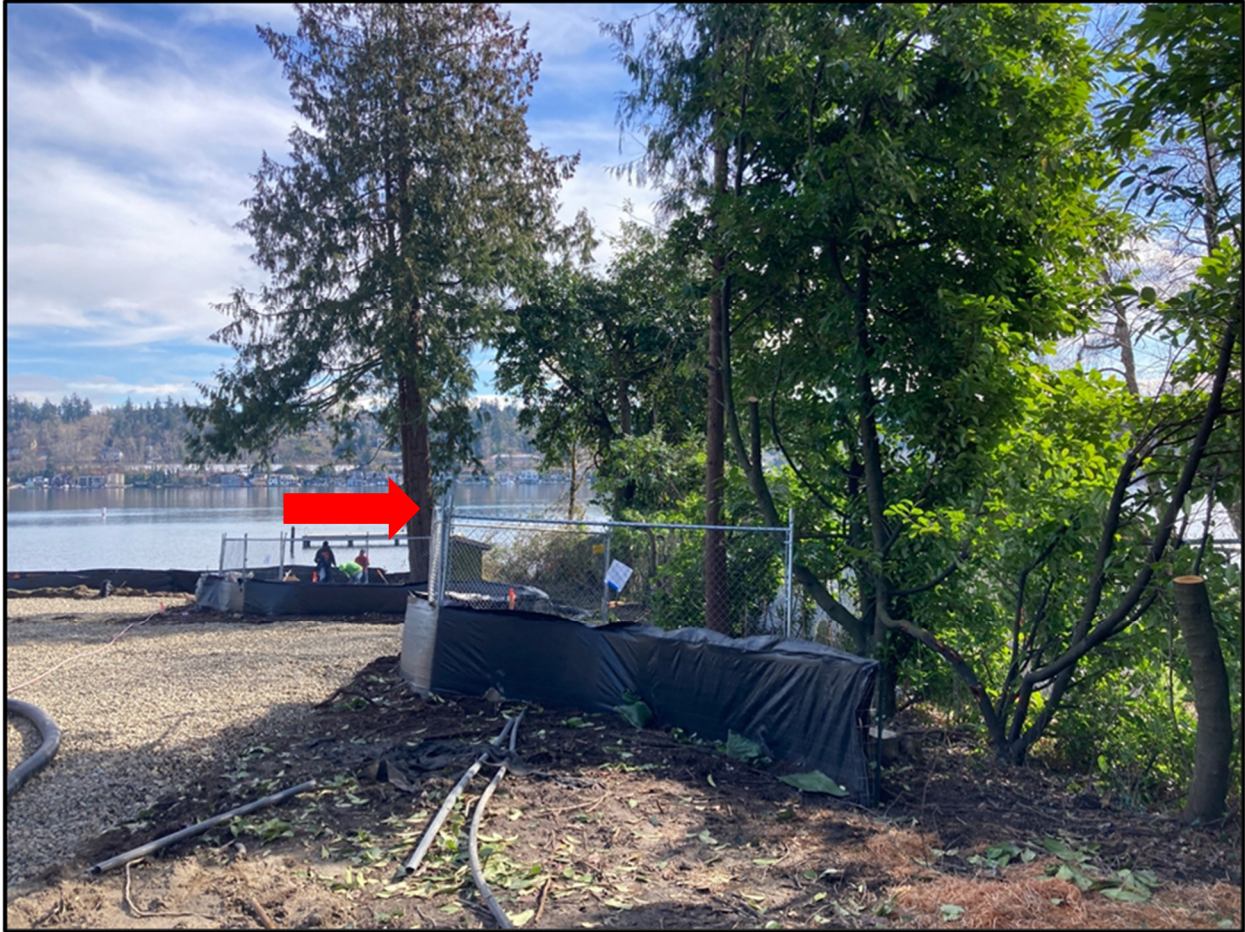
Photograph 3. Tree 576 (red arrow) as it appeared during my site visit on March 7, 2023. Thinning foliage is visible in the upper crown

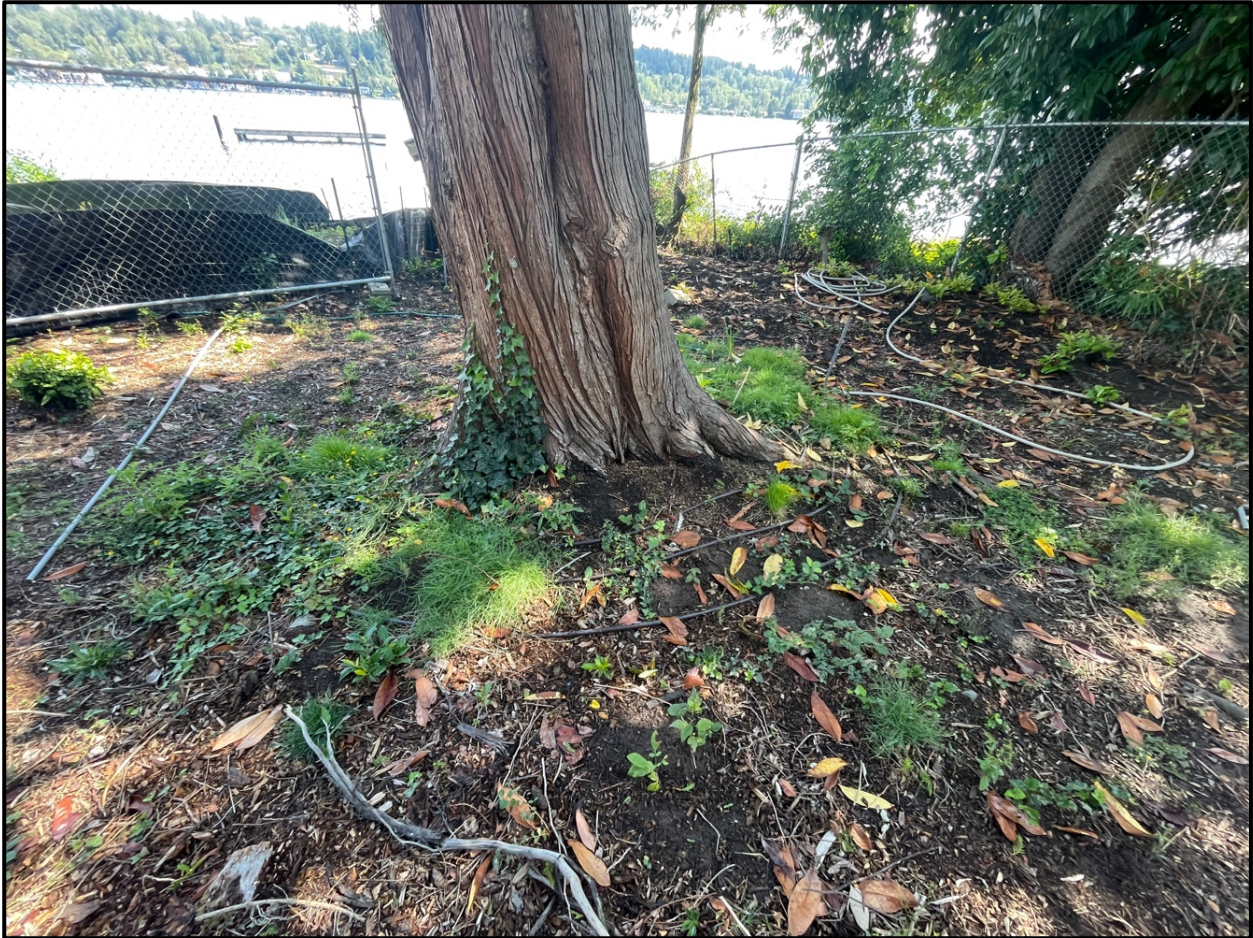
Photograph 5. Drip irrigation installed at the base of tree 576 as it appeared during my August 2024 site visit. I recommend adding additional mulch and augmenting the drip irrigation to cover more of the root zone during this site visit.

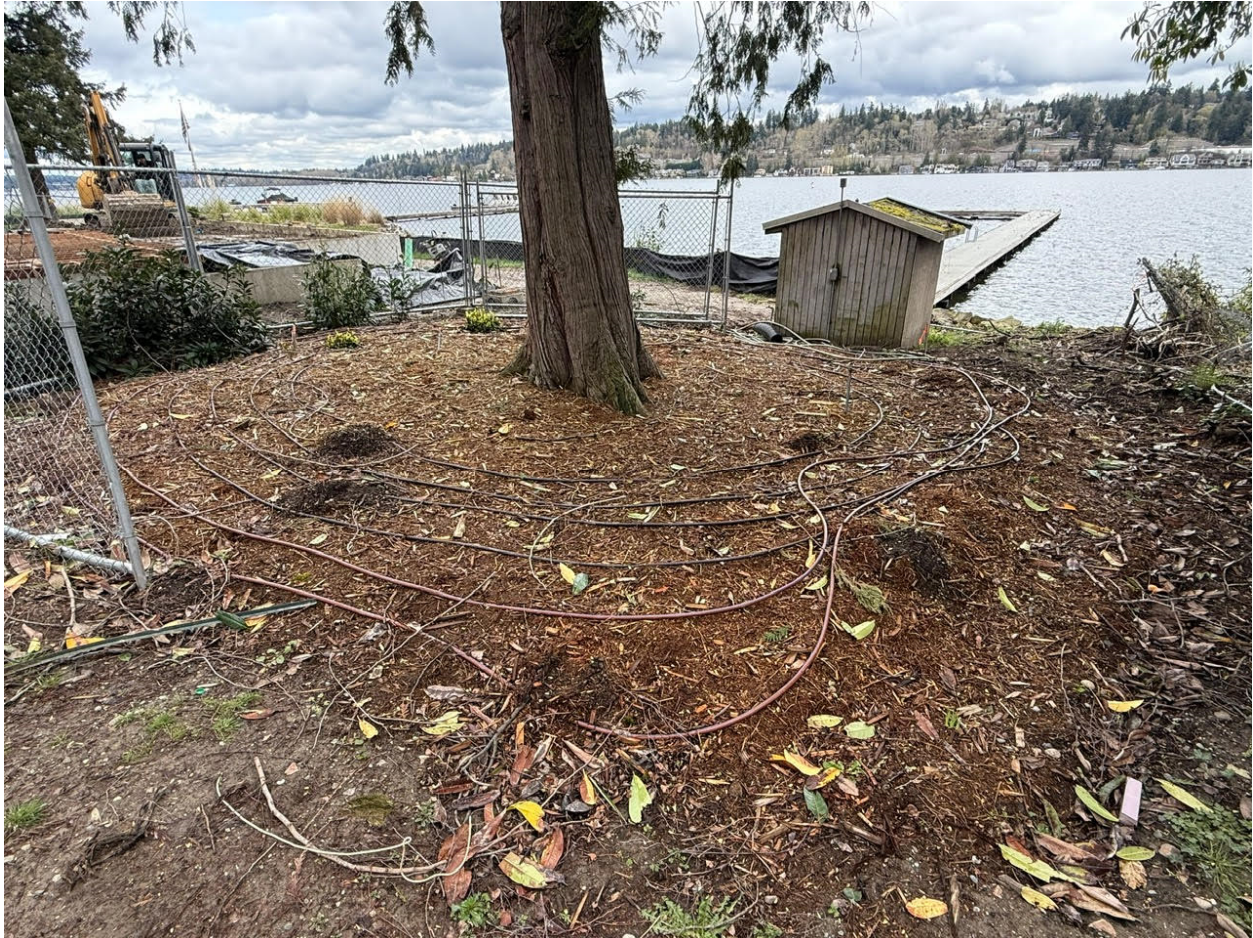
Photograph 6. Provided photograph of the additional mulch and requested adjustments to the drip irrigation following my 2024 site assessment.

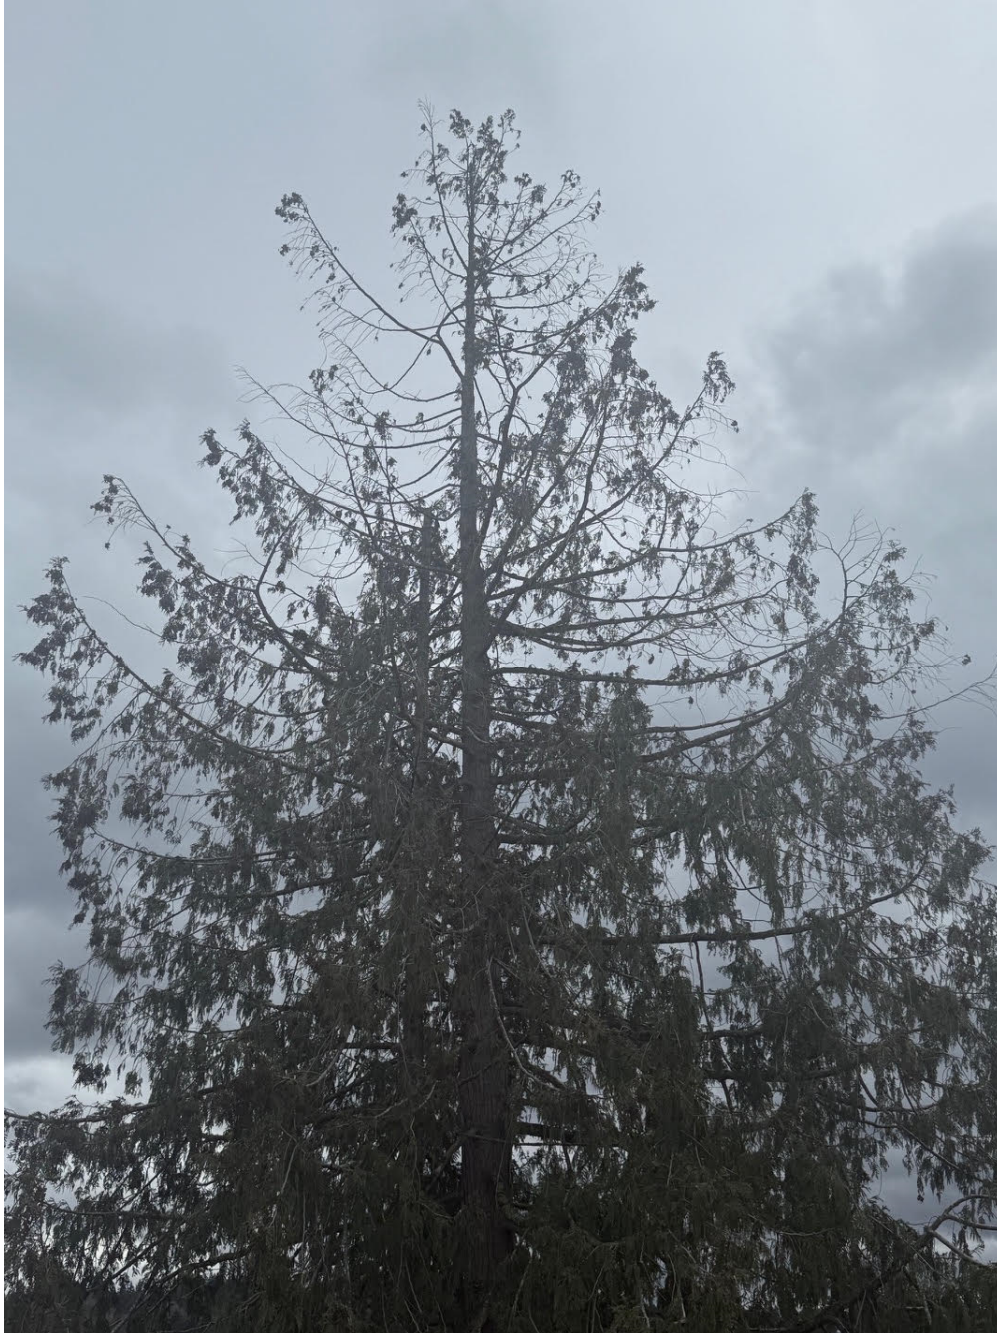
Photograph 7. A provided photograph showing dieback in the upper crown of tree 576 as it appeared on March 31, 2024.
