Level 1 Downstream Analysis

Adams Residence

8035 SE 45th St.

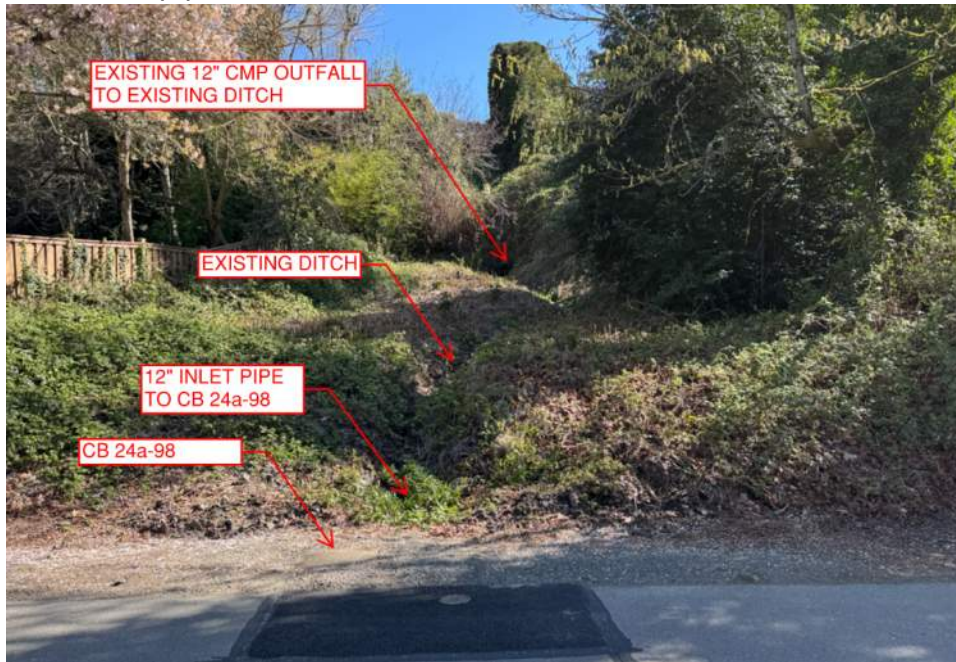
Standing on Forest Ave SE looking east towards project site. Existing 12" outfall, existing ditch, inlet pipe, and CB 24a-98.

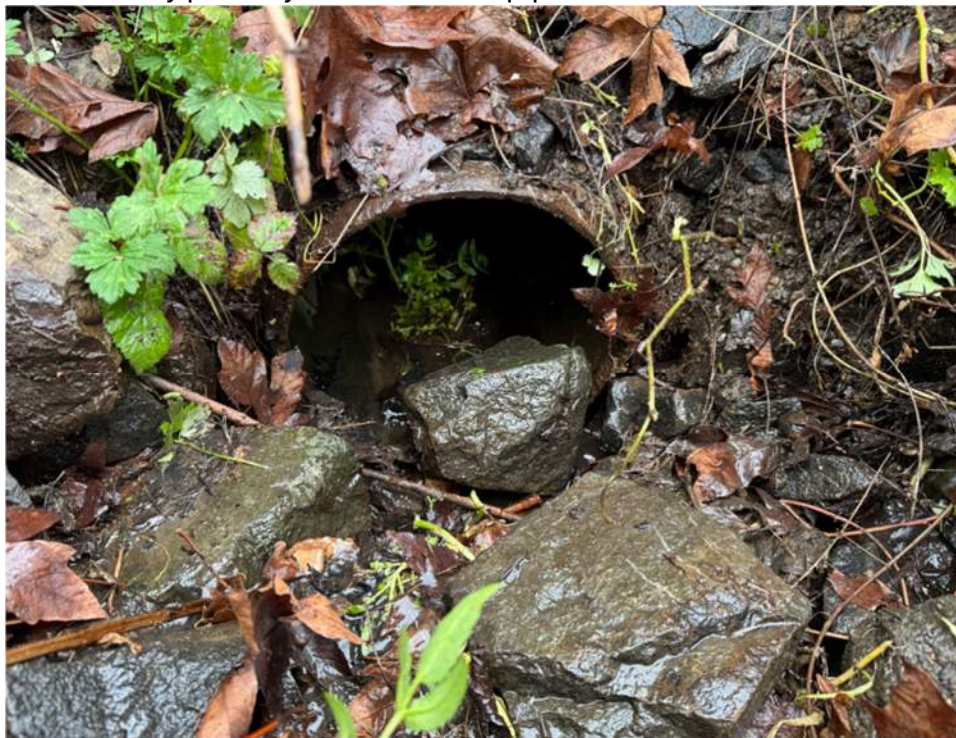
Standing in ditch looking at inlet pipe to CB 24a-98. Note that rocks and vegetation occasionally partially block the inlet pipe.

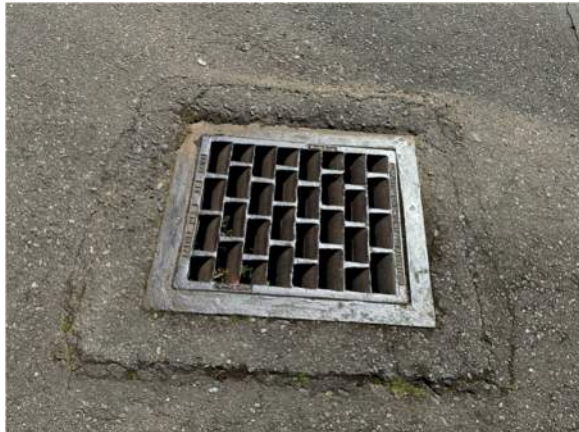
CB 25a-44 (unable to open for inside picture)

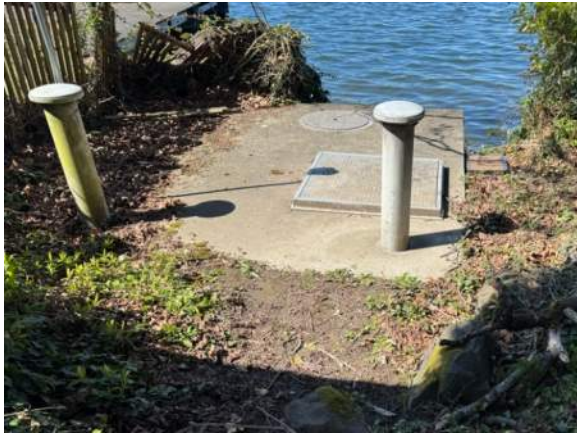
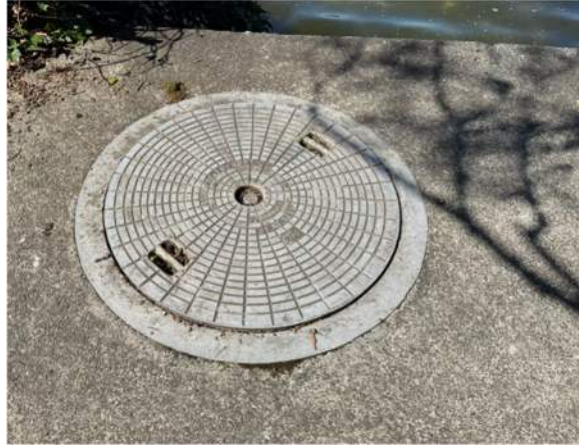
Outfall to Lake Washington (unable to open for inside picture)
