## Arborist Report

To: Yazan Aldehayyat  
Site: 2969 74<sup>th</sup> Ave SE, Mercer Island, WA 98040  
Re: Tree inventory  
Date: March 24, 2025  
Project Arborist: George White,  
ISA Certified Arborist PN-8908A  
ISA Qualified Tree Risk Assessor  
Reviewed By: Tyler Bunton  
ISA Certified Arborist PN-8715A  
ISA Qualified Tree Risk Assessor  
Referenced Documents: Site Plan A2 - Permit Set (Lane Williams Architects, 1.16.2025)  
Attached: Table of Trees  
Tree Site Map  
Statement of Objectivity

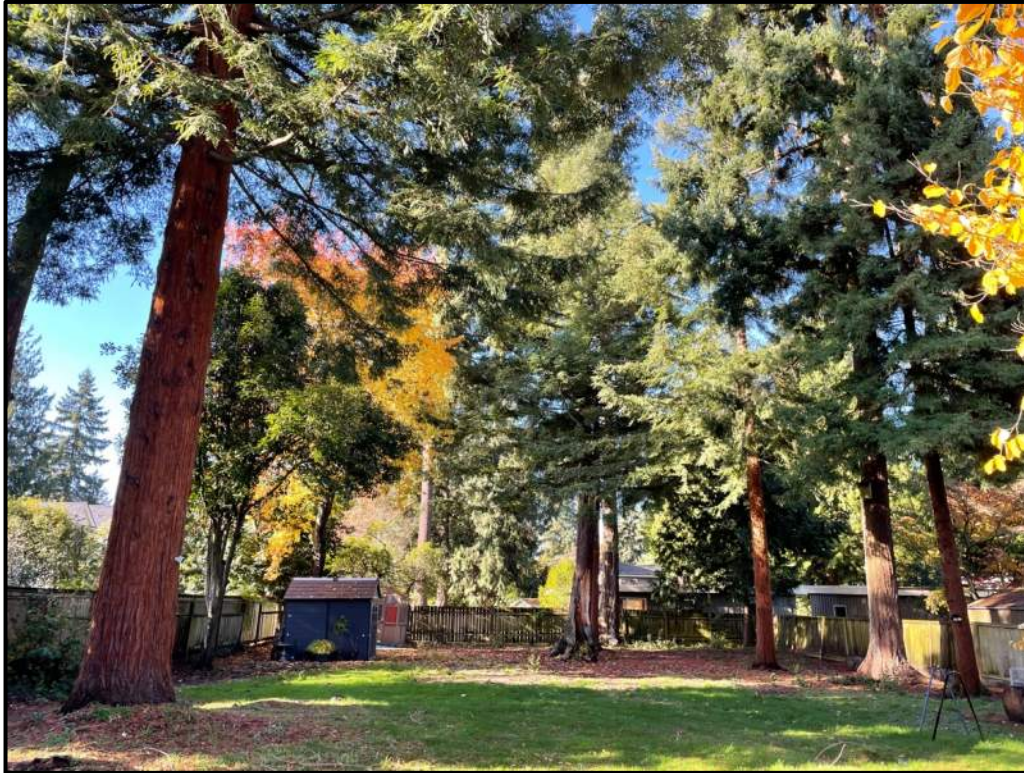
**Photograph 1.** The western half of the site, an undeveloped area with several mature trees that comprise a tree grove.

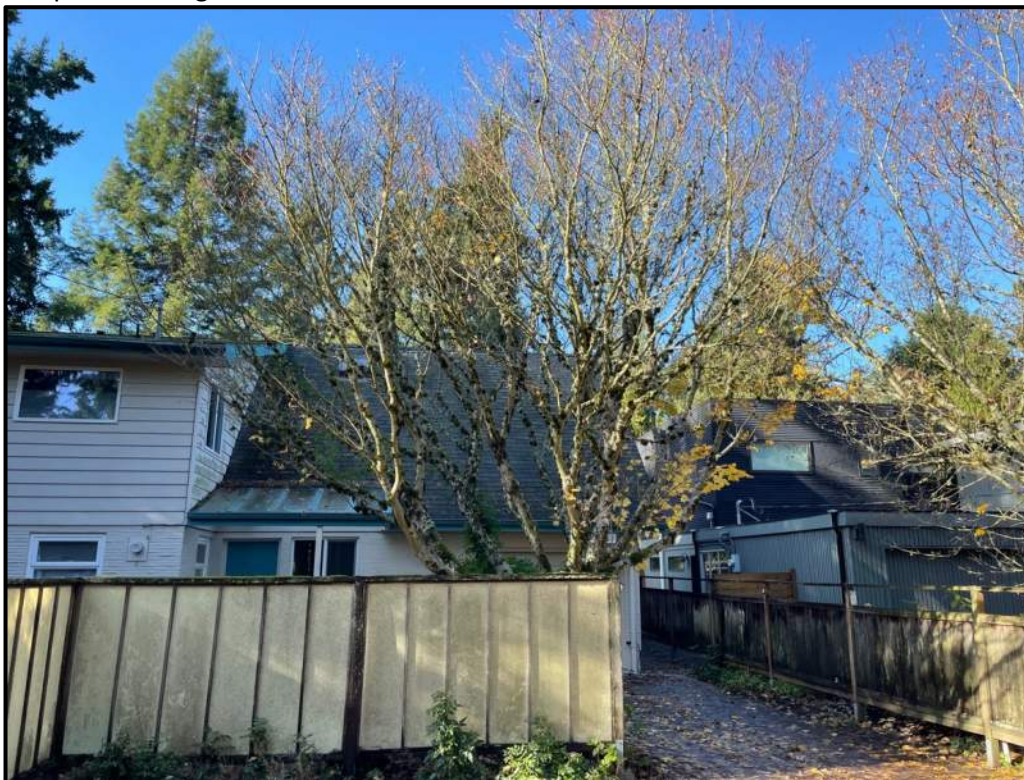
Tree 80 is a vine maple located in the northeast corner of the site. This tree is in good health, exhibits excellent structural condition, and is large for the species.

**Photograph 2.** Tree 80, an exceptional vine maple east of the existing house.

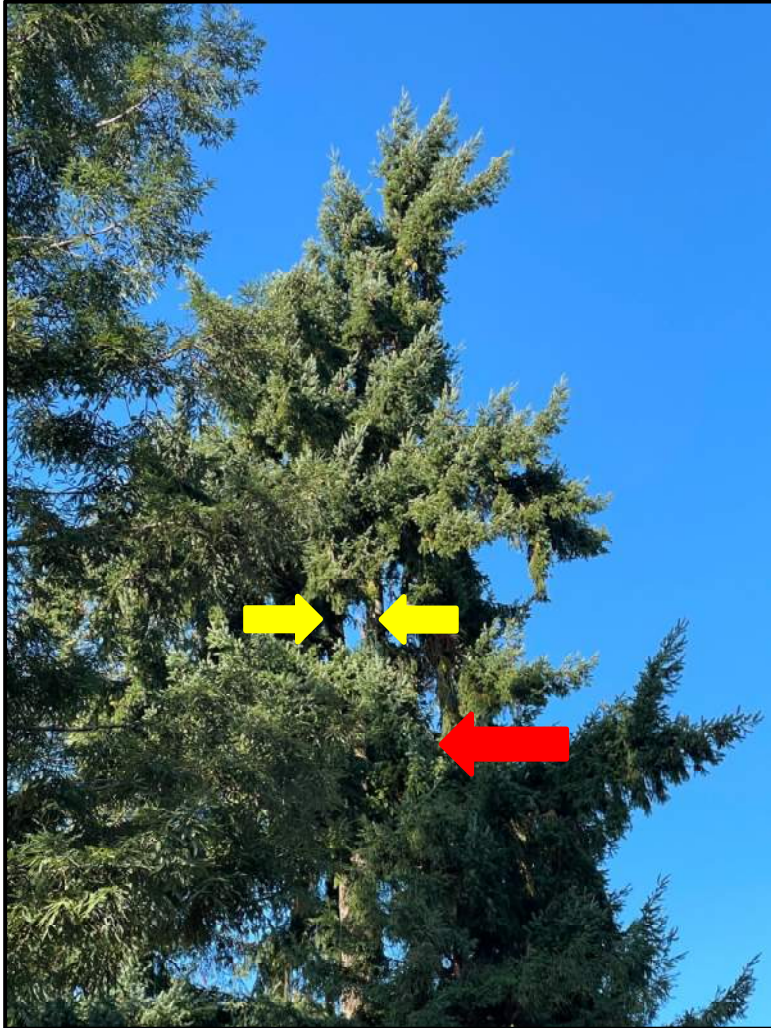
Tree 590 is a 33-inch Douglas-fir in good health but fair structural condition located adjacent to the north property line. This tree appears to have been topped historically at approximately 65 feet above grade and has two, codominant reiterations growing above the old topping site. I recommend hiring a climbing arborist to inspect the site of the old topping wound for decay and to perform structural pruning on the reiterations. The reiteration found to have a better attachment should remain intact and the other reiteration should be subordinated by 10-15 feet with a reduction cut. This will encourage the tree to reassume a single-trunk form and reduce the future likelihood of part failure.

**Photograph 3.** The crown of tree 590. This tree has been topped historically at the approximate location indicated with the red arrow. Two, codominant reiterations are growing above the old topping site. Structural pruning and evaluation of the old topping site is recommended.

- Consider structural pruning and aerial assessment of tree 590.
- Consider conducting an advanced assessment of tree 593 to determine the cause of the extensive pitch flows.

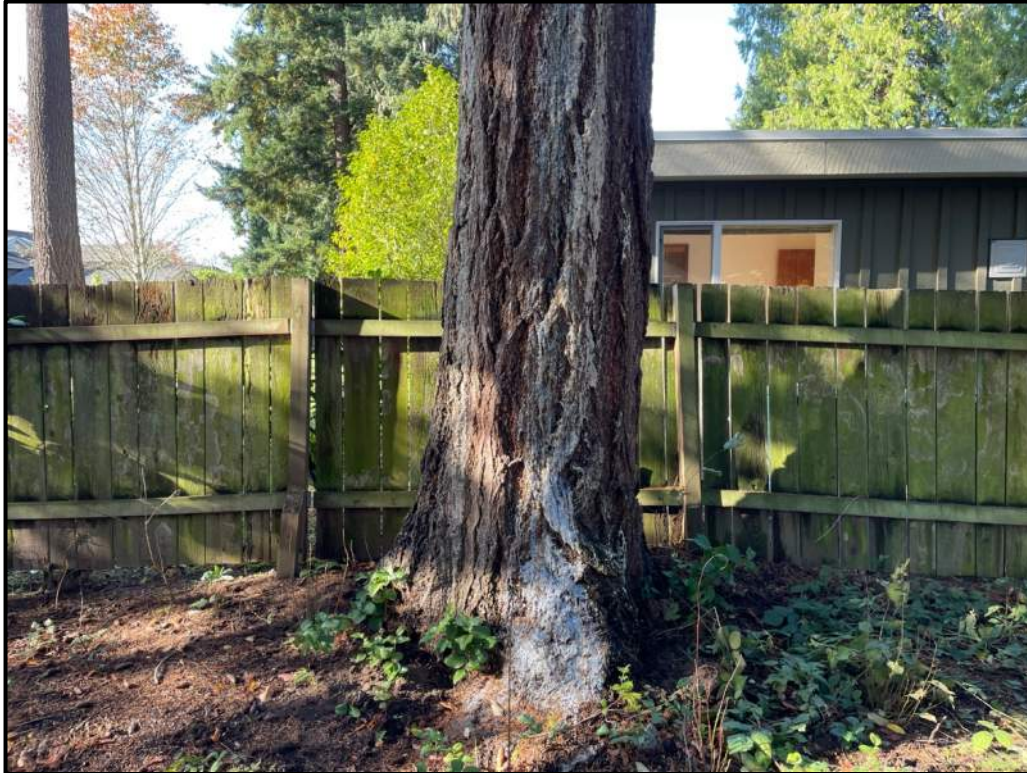
Tree 593 is a 34.4-inch Douglas-fir located adjacent to the west property line. I observed significant pitch flows on the east aspect of the trunk which appeared to originate from two distinct points. I also observed older (dry) pitch flows on other aspects of the trunk which appeared to originate from old pruning cuts.

While basal pitch flow can be an indication *Armillaria* infection, I do not believe this to be the case. A brief root crown excavation did not reveal any characteristic rhizomorphs and I did not observe any signs of reduced vigor in the crown of the tree. This pitch is more likely related to an internal defect, such as an internal crack, that is re-injured following high wind events.

**Photograph 4.** Heavy pitch flow at the base of tree 593. This pitch is likely associated with an internal crack.

An advanced assessment using micro-resistance drilling or sonic tomography could help determine the cause of pitch flows and evaluate the extent of any internal defect that may exist.

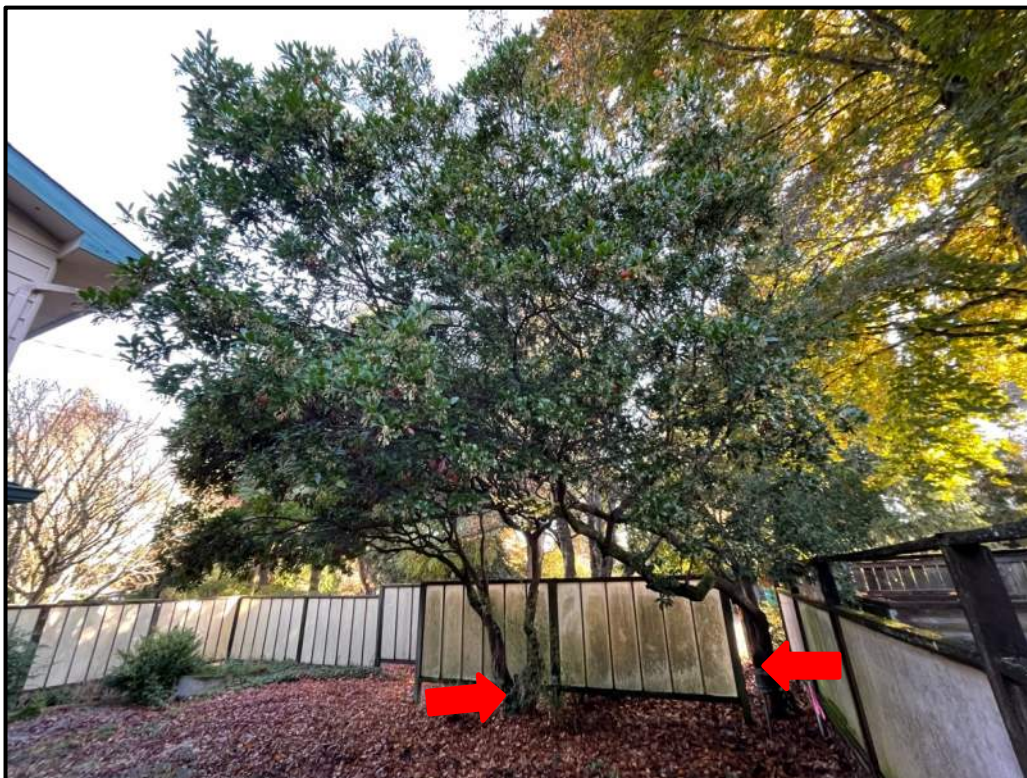
Trees 598 and C (existing tag no. 599) are mature Japanese pieris (*Pieris japonica*) shrubs located on either side of the west property line. These woody plants are not considered to be trees based on the definition listed in the MICC. Mercer Island defines a tree as “Any living woody plant species... that is known to reach a **typical mature height of at least 15 feet**”. Typical mature height for this species is listed as 9-12 feet in Washington State University’s plant database and Oregon State University’s landscape plants list.

**Photograph 5.** "Trees" 598 and C (599) (Red arrows). These woody shrubs (*Pieris japonica*) do not meet the definition of a tree as described in MICC.
