Arborist Report

Site: 4525 Forest Ave SE, Mercer Island, WA

Re: Tree Inventory and Assessment

Date: February 26, 2024

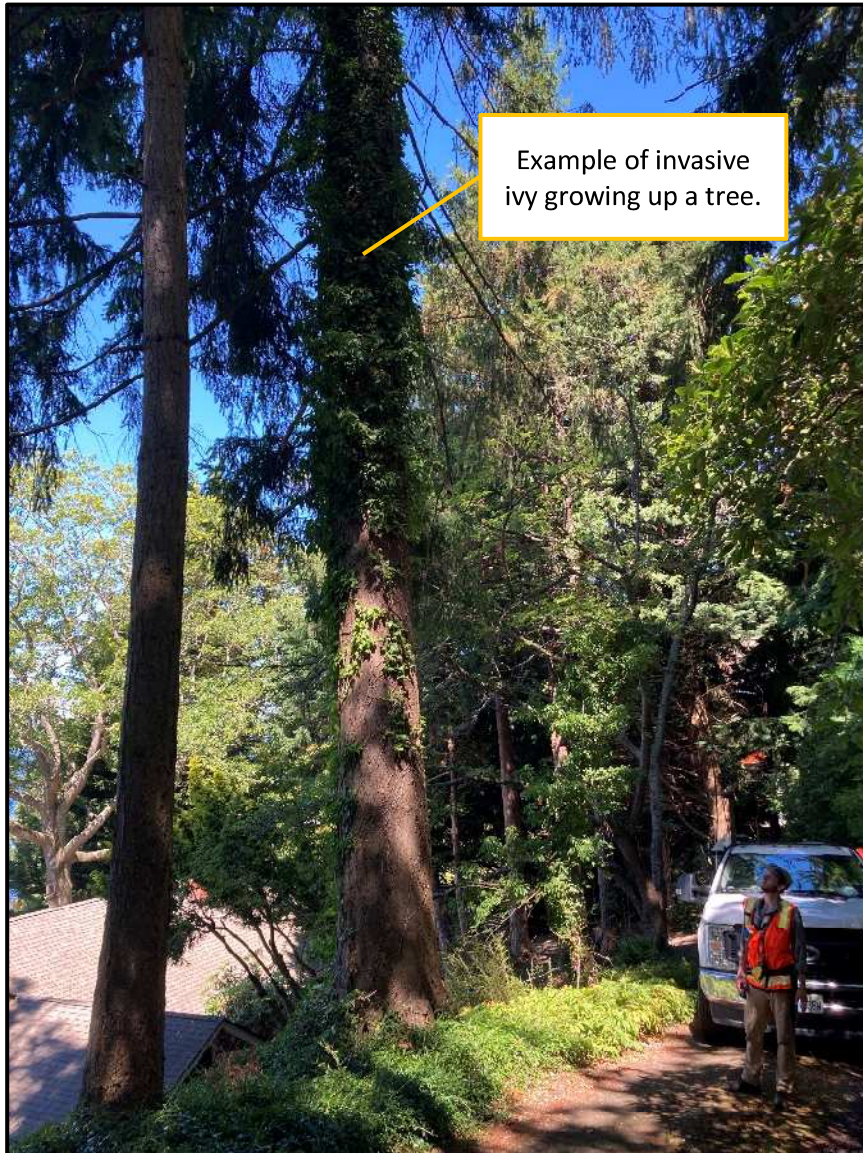
We noted the presence of multiple invasive plant species on site including English ivy (*Hedera* sp.) (Photo 1), holly (*Ilex* spp.), Saint John's wort (*Hypericum* spp.), and black locust (*Robinia pseudoacacia*). Invasive plants should be managed prior to development.

Photo 1. Tree 130 is an exceptional tree with significant vines growing up the main stem. Management of invasive species is easier prior to construction.

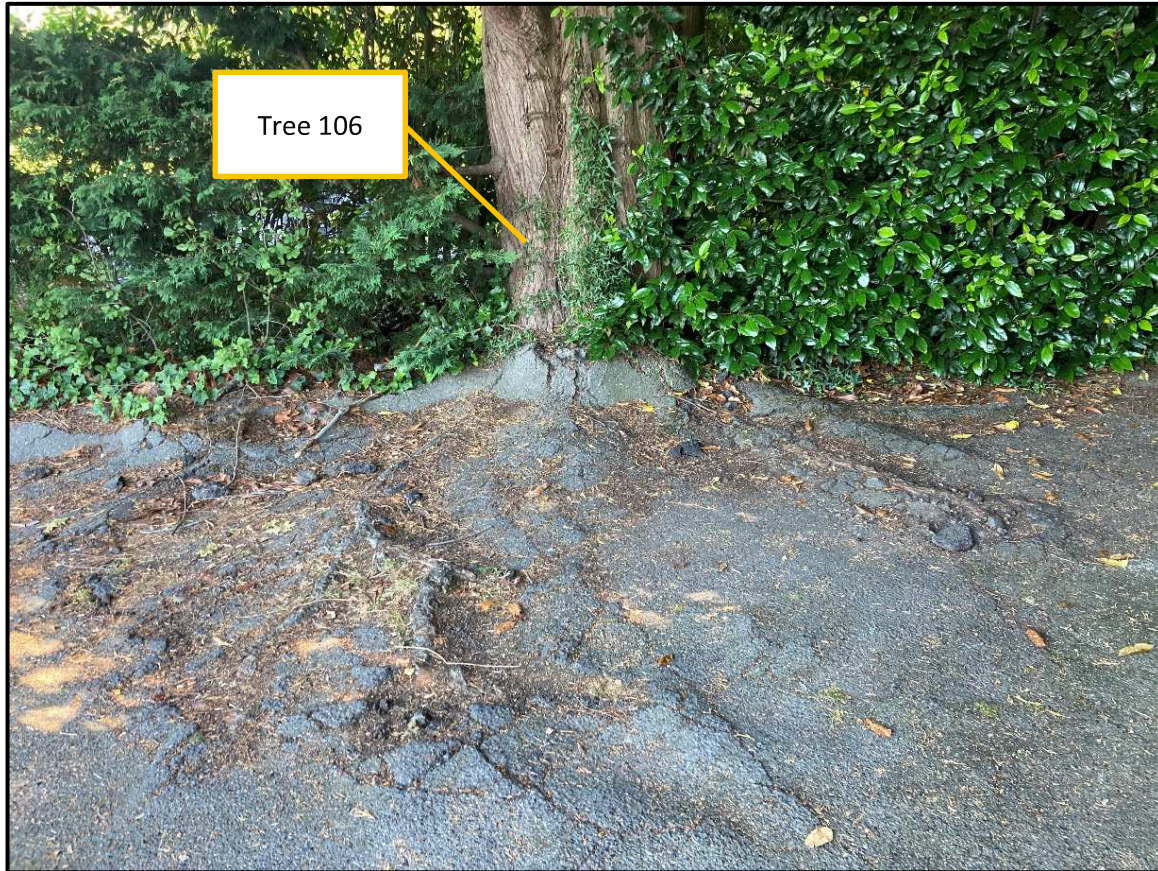
Tree 106 is an exceptional Leyland cypress located north of the existing home. The roots of this tree have significant conflict with the existing driveway (Photo 2). Leyland cypress trees grow rapidly and often outgrow their location.

Photo 2. Tree 106 is causing significant damage to the existing driveway.

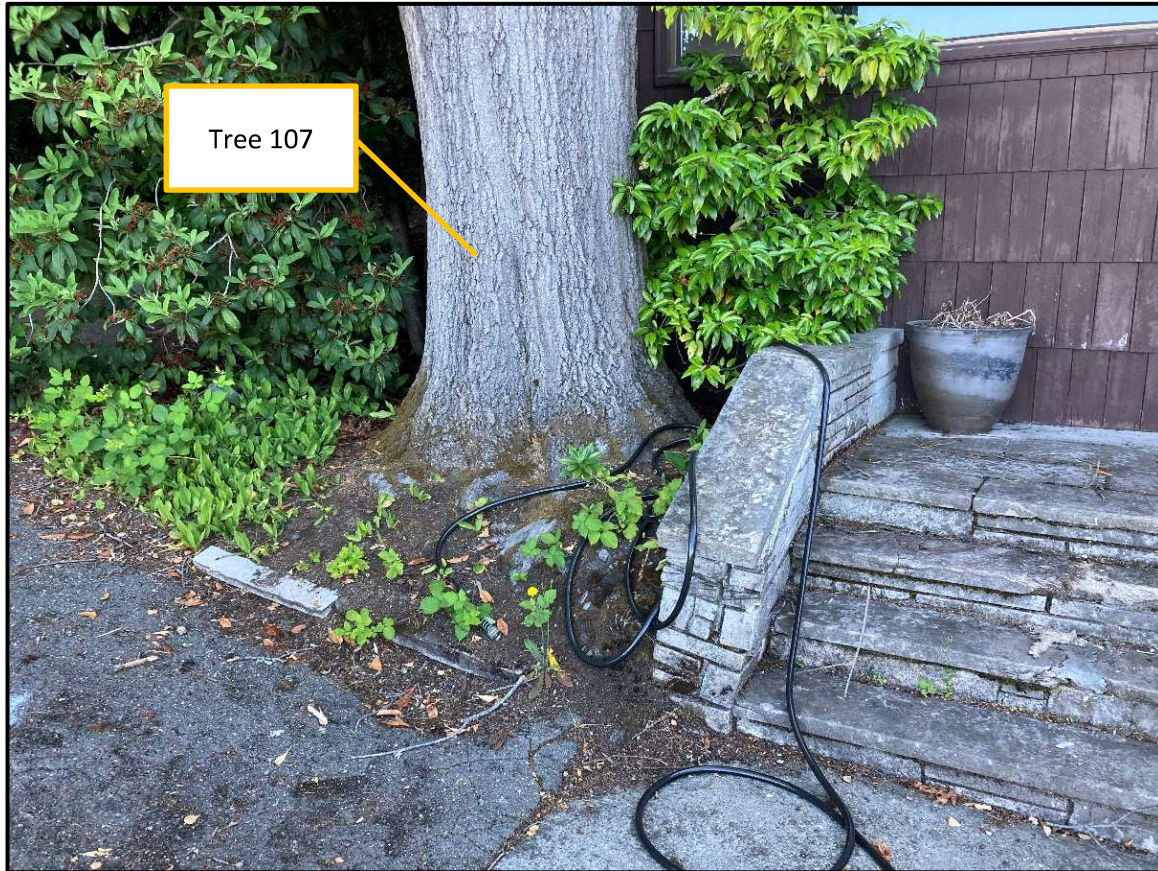
Tree 107 is an exceptional 36.6-inch eastern black oak that is currently proposed for removal. Retention is not possible due to the impacts of the proposed demolition of the existing foundation which is located within inches of the trunk (Photo 4).

Photo 4. Oak tree near existing building and hardscape.

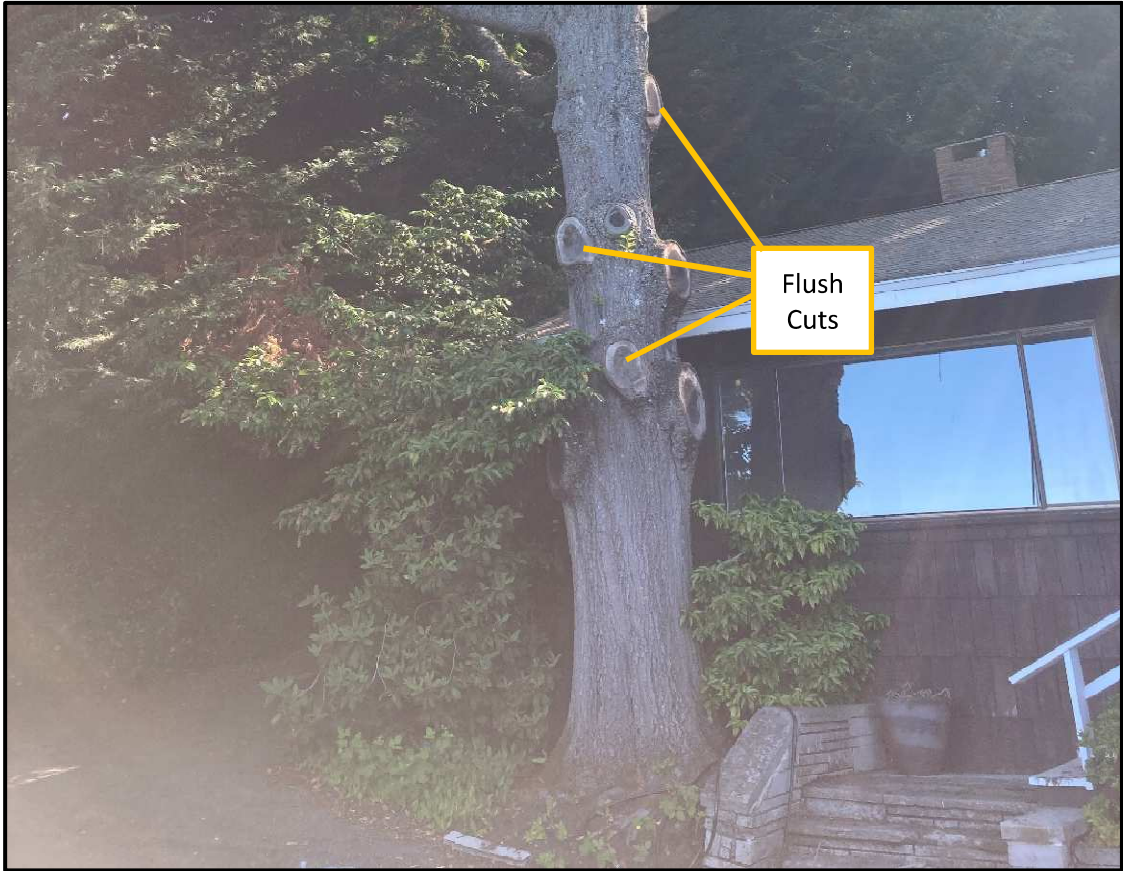
Tree 107 is an exceptional black oak located immediately adjacent to the existing building (Photo 3). This tree was malpruned by the previous property owner. Several large scaffold limbs were removed, with some pruning cuts in excess of 13 inches in diameter. A few of the cuts were made flush to the trunk and did not leave the branch collar intact (Photo 4). Even though oaks are generally strong-wooded trees which compartmentalize decay well, the severity of these wounds and the expected root impacts during demolition make it unlikely to be viable over the long term.

Photo 5. Improper pruning on tree 107.

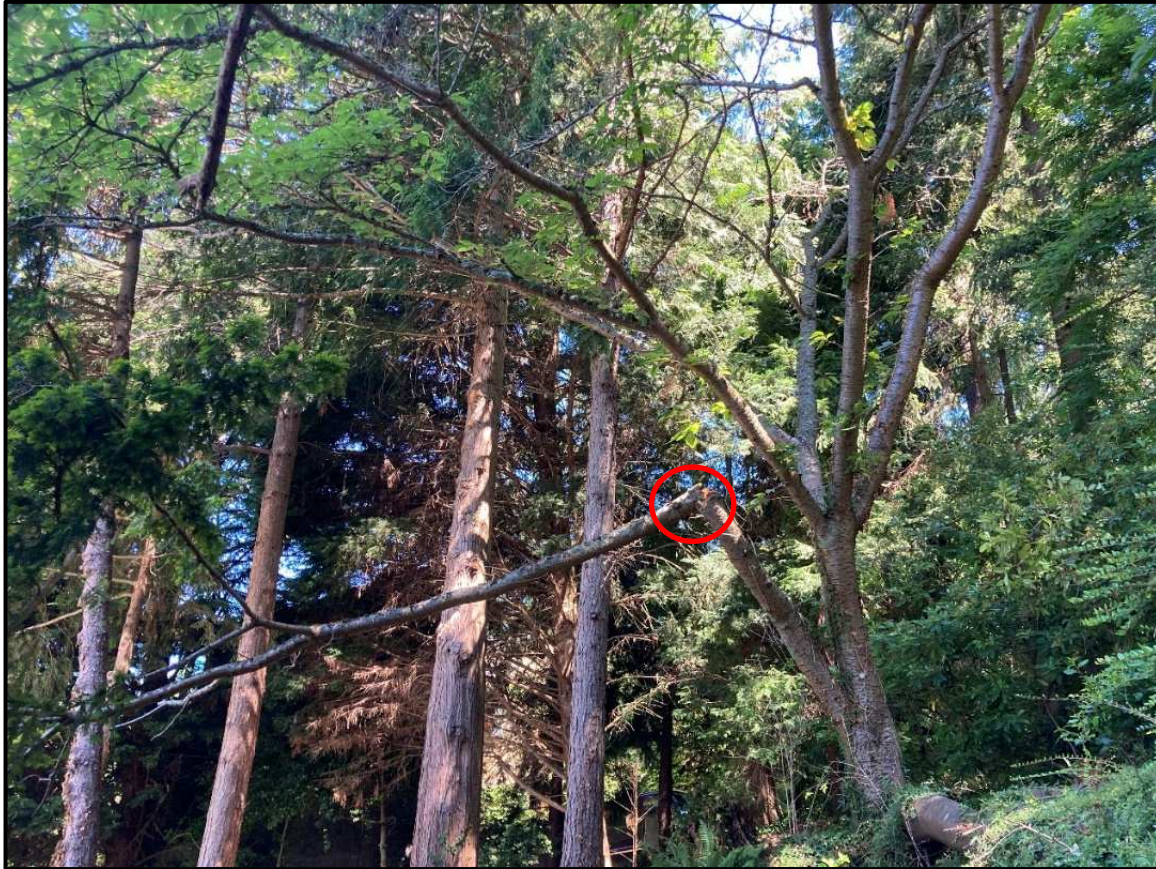
Tree 119 is a flowering cherry located east of the existing house. This tree is in poor health and has a failed limb overhanging the house (Photo 6). In our opinion, this tree should not be prioritized for retention. The broken limb should be removed as soon as possible.

Photo 6. Major damage to tree 119. The tree overall is in poor condition and is not recommended for retention.

| Tree ID | Scientific Name | Common Name | DSH (inches) | DSH Multistem | Health Condition | Structural Condition | Exceptional Threshold | Exceptional | 24-Inch DSH or Greater | MLOD (feet) | RLOD (feet) | Proposed Action | Replacement Trees | Notes |
|---|---|---|---|---|---|---|---|---|---|---|---|---|---|--|
| 119 | <i>Prunus spp. (serrula, serrulata)</i> | Flowering Cherry | 17.0 | 7.3,11.6,10.1 | Poor | Poor | 23.0 | | - | 7 | 11 | Remove | 2 | Very little live foliage, large stem broken, east stem mostly dead |
