# Arborist Report

*Tree Inventory - March 2023*

Davey Resource Group (DRG) was contracted by Chung Ling (Vicky) Ou to inspect and provide an arborist report and tree protection plan for the property 3804 E Mercer Way in Mercer Island, Washington (PIN: 210700-0100). The client intends to develop the property.

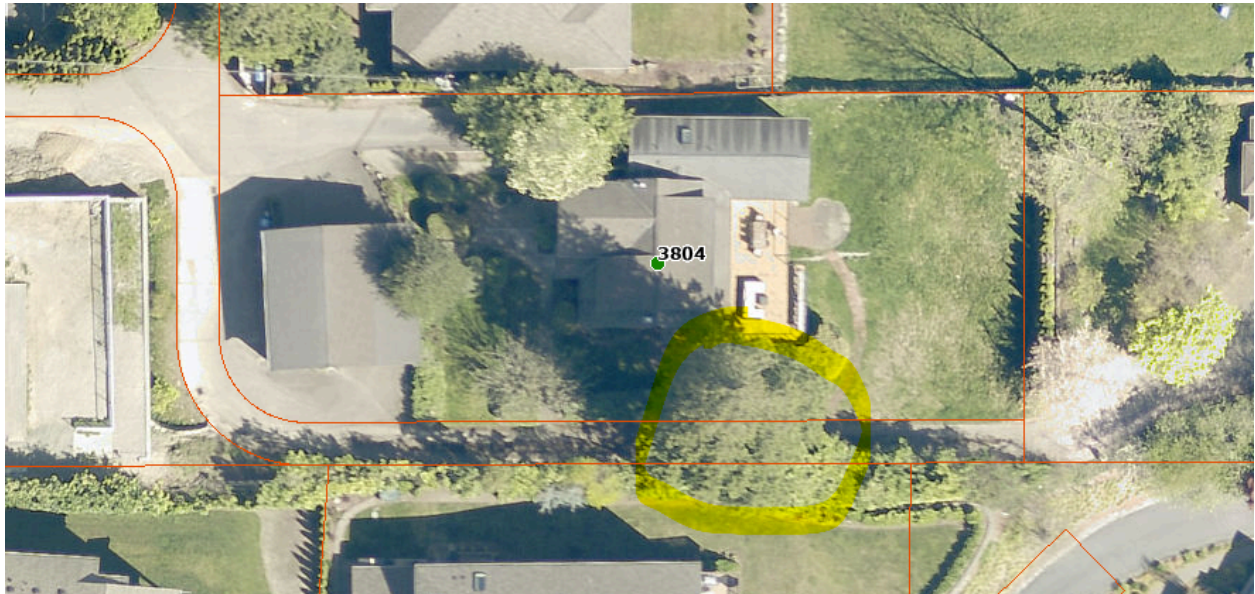
The City of Mercer Island has requested that all previously removed trees from the past five years be accounted for in this report. One tree was possibly removed from the subject property within this timeframe. The tree has been identified and circled in yellow from an image captured on the King County Parcel Map, however, it's unclear when the tree was removed.

**Image 2. An overview of the subject parcel with the previously removed tree circled in yellow.**

No stump or visible remnants of the trees remained on-site during the field inspection. Google Maps Streetview tool was used in order to determine the approximate size of the tree prior to its removal. The imagery was captured in August 2011. The tree appears to have been a tall-statured Western red cedar (*Thuja plicata*). Using other site objects and features as a reference, the estimated size (DSH) of the tree prior to its removal ranges from 26-30 inches. The image of the tree is included on the next page of the report.

- Tree #8450 (12" DSH) is an exceptional tree and will require 6 replacement trees.
- A western red cedar (Estimated 26" DSH) had been removed from the site at some time in the recent past. This tree will require 3 replacement trees (see addendum).

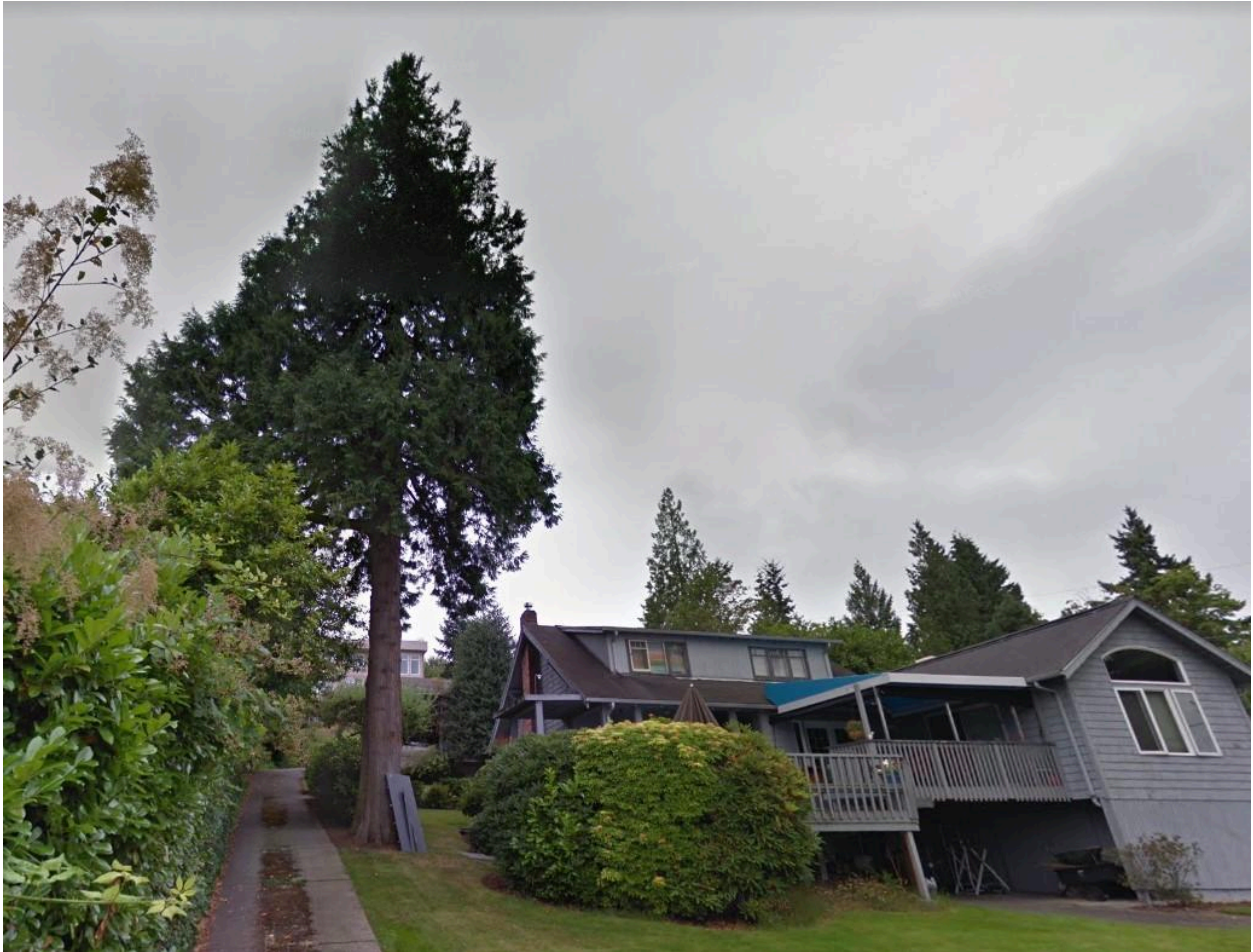
***Image 3. Google Maps Streetview imagery of the removed tree dated August 2011.***
