Client: Lund
 Assignment: Tree Protection Plan

TO: Renee Lund
SITE: 8520 SE 82nd Street Mercer Island 98040 Parcel #362550-0210
RE: Tree Protection Plan
DATE: March 23, 2025
PROJECT ARBORIST: Scott Selby
ASCA Registered Consulting Arborist #749
ISA Board Certified Master Arborist #PN-1775B
ISA Qualified Tree Risk Assessor

This project involves restoration of a fire-damaged single-family residence. Tree retention requirements apply.

Home Restoration: 8520 SE 82nd Street Mercer Island 98040 Parcel #362550-0210

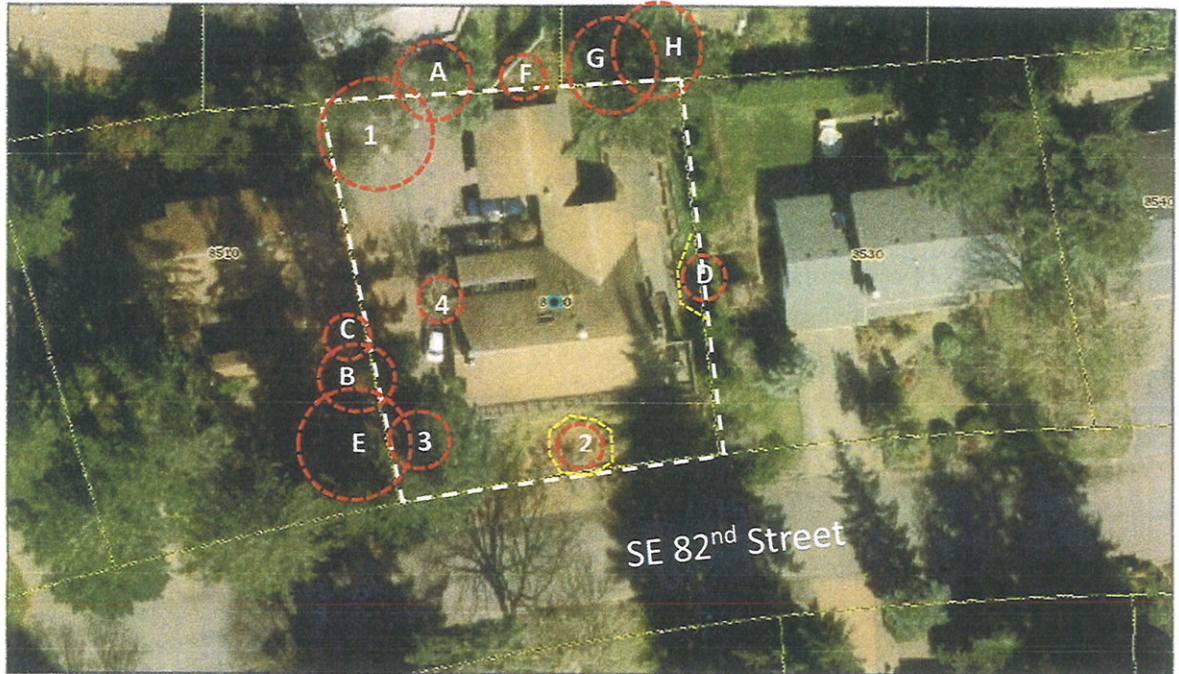
Site Map

Mercer Island GIS map showing property outline, tree locations and identifiers, street name. The two tree protection zones needed are shown in yellow. Refer to Tree Table for tree ID.

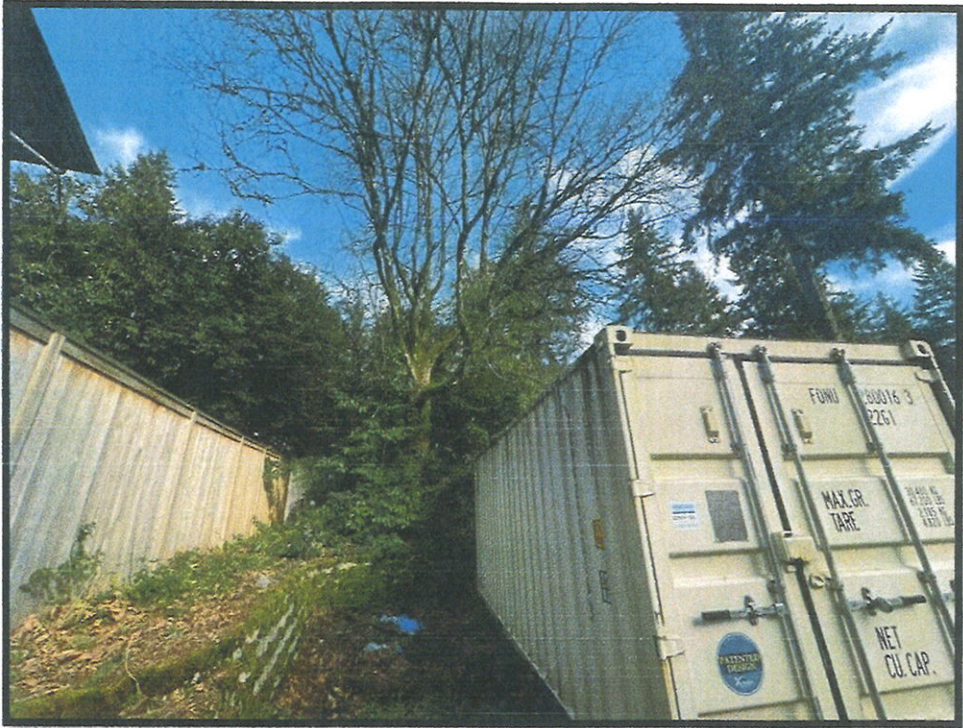
Tree #	Common Name	Scientific Name	*DSH (inches)	N	E	S	W	**RLOD (feet)	Condition	Comments	Proposal	Exceptional
1	Pacific dogwood	<i>Cornus nuttallii</i>	24	18	18	16	12	10	poor	trunk damage	retain	yes
2	Flowering cherry	<i>Prunus serrulata</i> spp.	15	6	8	8	8	6	fair		retain	no
3	Strawberry tree	<i>Arbutus unedo</i>	13.5	10	10	10	3	8	good	multi-stem:8,8,5,5,5	retain	no
4	Korean dogwood	<i>Cornus kousa</i>	11.3	10	5	10	13	8	good	multi-stem:5,5,6,7	retain	no
A	Sweet osmanthus	<i>Osmanthus fragrans</i>	9.8			8		6	fair	multi-stem: 6 x 4"	n/a	no
B	Douglas-fir	<i>Pseudotsuga menziesii</i>	20		12			10	good		n/a	no
C	Scots pine	<i>Pinus sylvestris</i>	10		10			8	good		n/a	no
D	Hollywood juniper	<i>Juniperus chinensis</i> 'Torulosa'	10				7	5	fair		n/a	no
E	Douglas-fir	<i>Pseudotsuga menziesii</i>	32		22			12	good		n/a	yes
F	Flowering cherry	<i>Prunus serrulata</i> spp.	12			4		4	poor	topped	n/a	no
G	Douglas-fir	<i>Pseudotsuga menziesii</i>	24			18		12	good		n/a	no

Photo 1. Tree 1, Pacific dogwood, in NW corner of property.

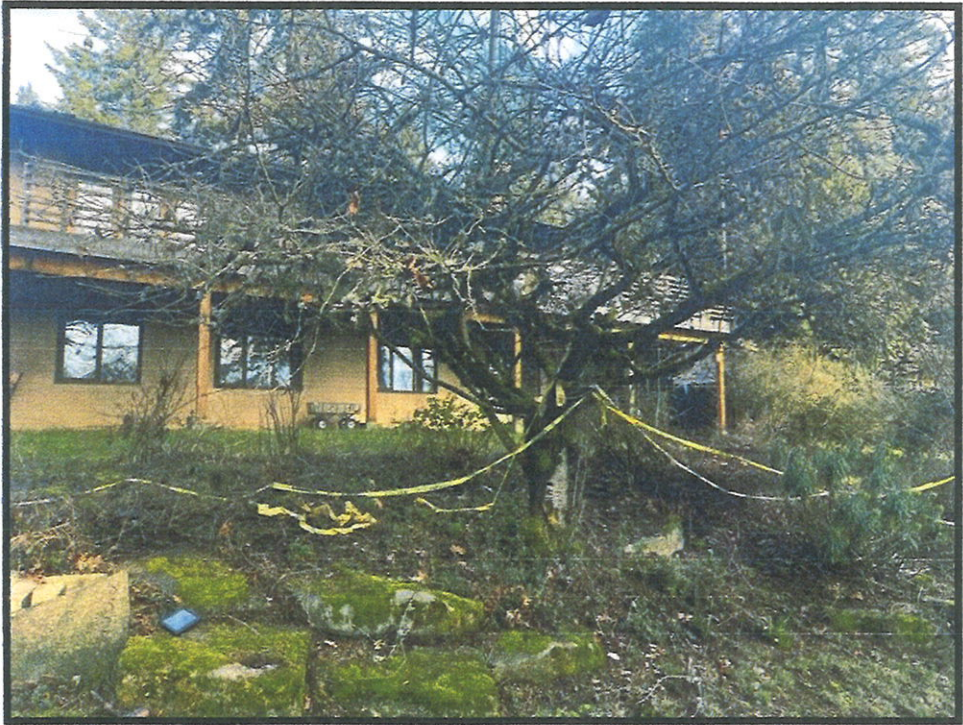
Photo 2. Tree 2, Flowering cherry, in front yard.

Impacts to retained trees should be minimal and well within guidelines outlined in ISA Best Management Practices, Managing Trees During Construction. *Only trees 2 and D require protection; all other trees are located within planters, elevated and behind retaining walls, set back sufficiently from an existing fence (off-site trees), or have their roots covered by pavement*. The trees shall be protected with tree protection fencing at the RLOD outlined in the *Table of Trees* to the specifications outlined in the *Tree Protection Specifications* page. No excavation, grading, parking, machine access or materials storage is permitted within the RLOD without arborist coordination.

- Prior to the beginning of any work, tree protection consisting of chain-link fencing should be installed at the Limits of Disturbance listed in the *Table of Trees*. Refer to *Tree Protection Specifications* page for further protection specifications.

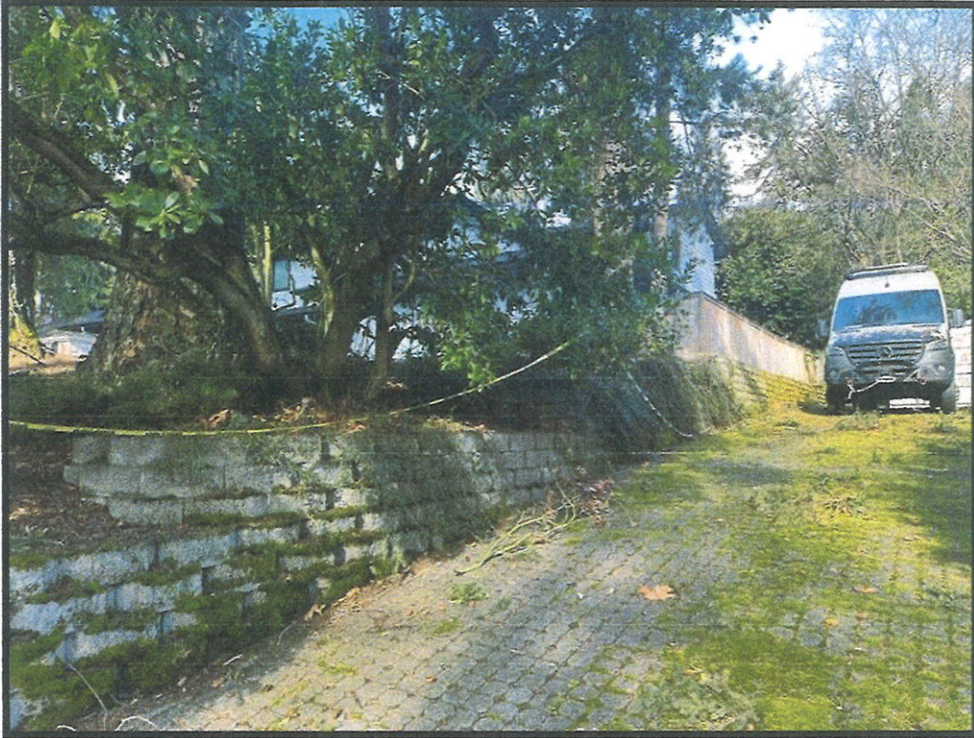
Photo 3. Tree 3, Strawberry tree, along west side of driveway in front.

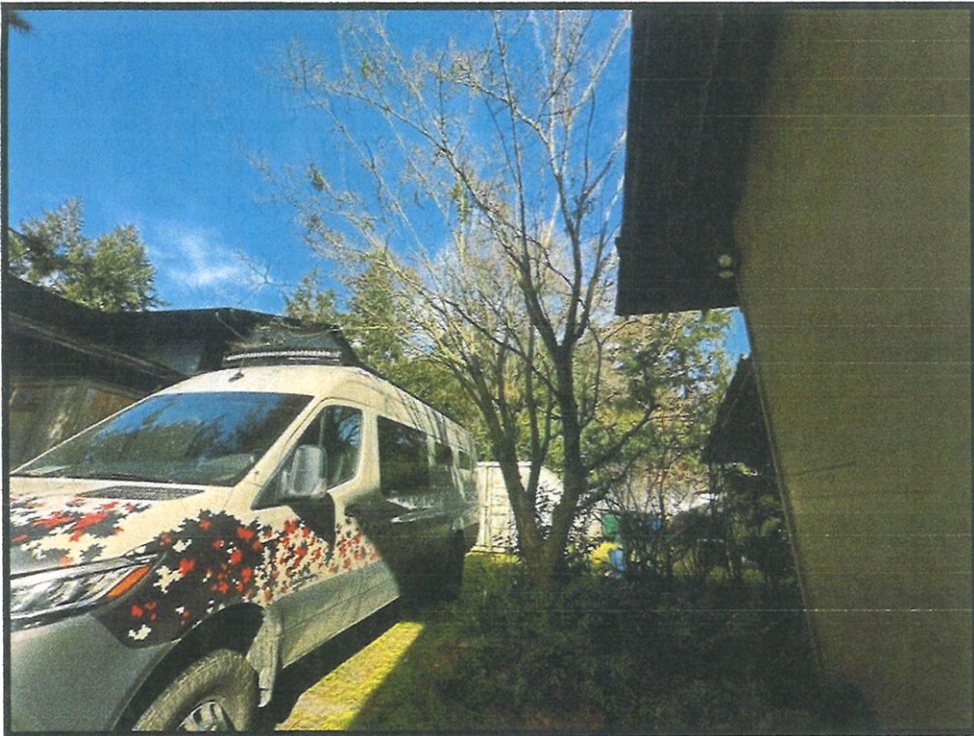
Photo 4. Tree 4, Korean dogwood, at left rear house corner.

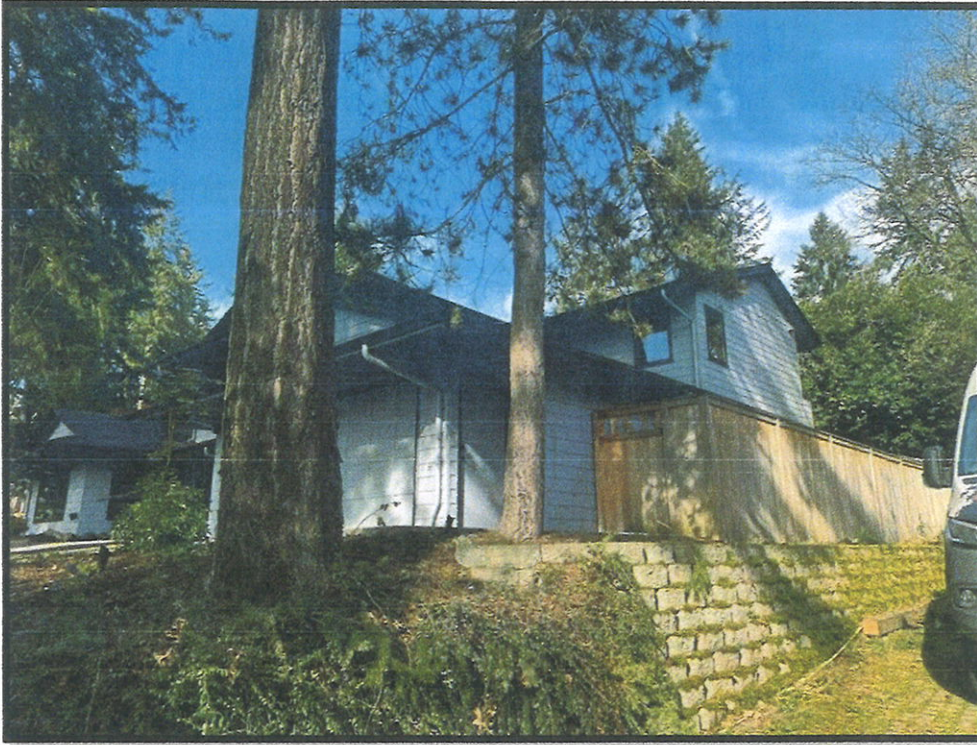
Photo 5. Trees B and C, Douglas fir and Scots pine, along west side of driveway in front.
