ARBOR INFO LLC

**Tree Assessment
For
Sturman Architects
At
8413 SE 82nd St.
Mercer Island, Washington**

**Date
6/13/2024(rev 8/22/2024)**

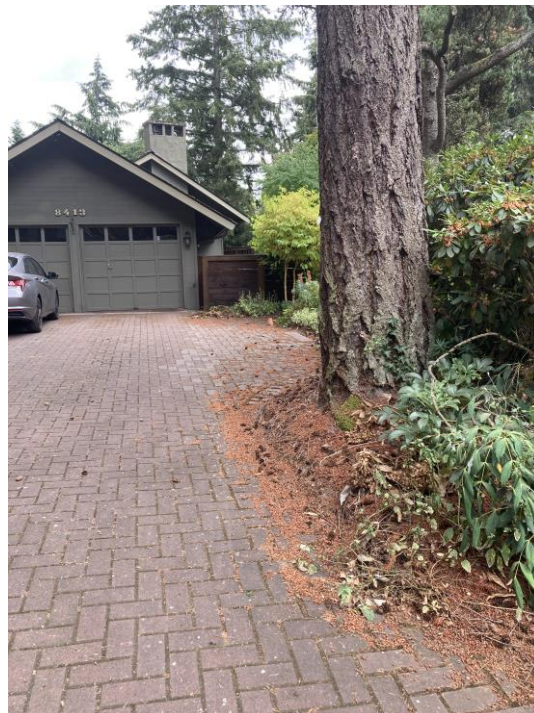
Tree 2:

The existing 30.5" Douglas Fir canopy and root zone overlap the existing driveway. There will be a new driveway installed and the concern is that the root system will crack the new concrete. We will not be expanding the driveway but will be following the existing footprint for the new concrete.

Tree No. 2 with existing driveway at the base.

<u>Tree No.</u>	<u>Species</u>	<u>Diameter (in)</u>	<u>Classification</u>	<u>Purpose</u>
2	Douglas-fir	30.5	Exceptional	Driveway uplift potential hazard for new driveway concrete
3	Douglas-fir	30.4	Exceptional	Potential Hazard due to potential retaining wall failure
4	Douglas-fir	32.5	Exceptional	Within House foot print
8	Flowering cherry	9.5	Not Regulated	Within House foot print
9	Douglas-fir	36.5	Exceptional	W/in Building footprint-lower floor excavation

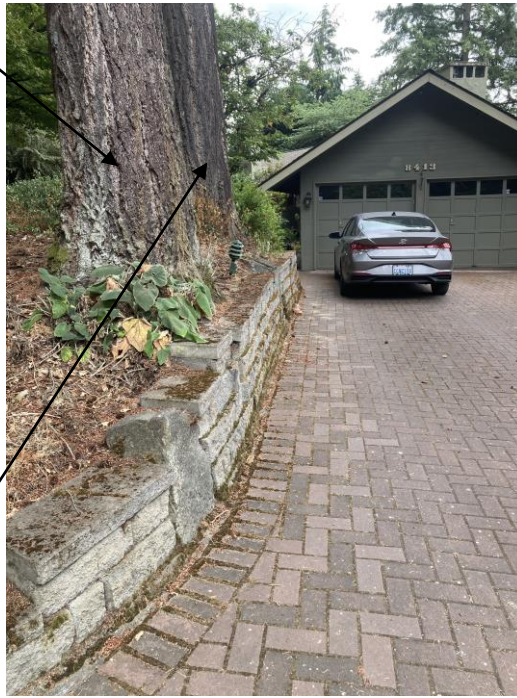
Tree 3: The 32.5" Douglas Fir is substantially growing into an existing retaining wall. The trunk of the tree is within inches of the existing retaining wall which is showing signs of structural failure. The tree is proposed to be removed to ensure the stability of the wall.

Tree No. 3 and 4 growing atop block retaining wall

Tree 4: The 30.4" Douglas Fir is substantially growing into an existing retaining wall. The trunk of the tree is within inches of the existing retaining wall which is showing signs of structural failure. The tree is proposed to be removed to ensure the stability of the wall. The tree canopy and root zone will also be overlapping the new garage foundation.

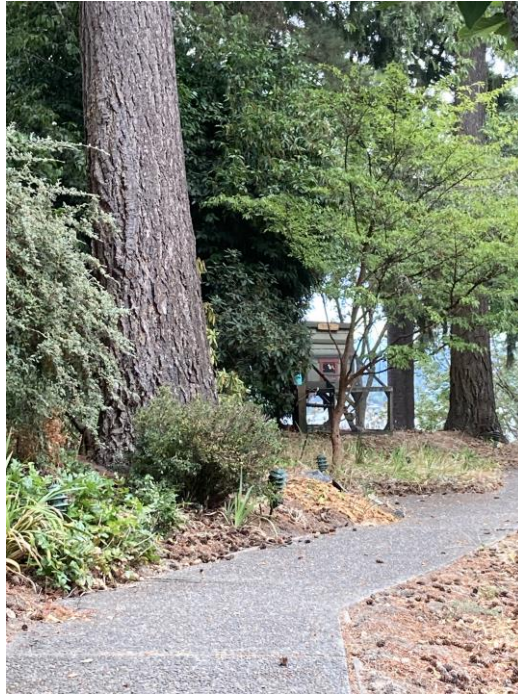
Tree 9: The 36.5" Douglas-fir will sustain significant root zone loss due to excavation for the lower floor.

Tree No. 9 to have substantial root loss due to excavation
