ARBOR INFO LLC

**Tree Assessment  
For  
Sturman Architects  
At  
8413 SE 82<sup>nd</sup> St.  
Mercer Island, Washington**

**Date  
6/13/2024(rev 10/29/2024)**

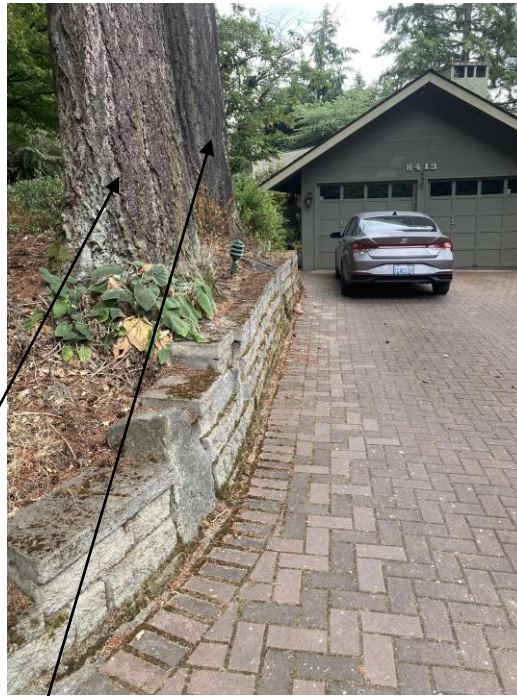
“Roots of two trees near the block walls are causing structural damage and movement of the wall system. These trees may be removed without adversely affecting geologic hazards in the area or adjacent areas provided surfaces are surfaced with topsoil/mulch and new low-lying vegetation.”

Tree No. 3 and 4 growing atop block retaining wall

Tree 3 the 30.4" and Tree 4 the 32.5" Douglas Fir is substantially growing into an existing retaining wall. The trunk of the tree is within inches of the existing retaining wall which is showing signs of structural failure. The tree is proposed to be removed to ensure the stability of the wall. The tree canopy and root zone will also be overlapping the new garage foundation.

<u>Tree No.</u>	<u>Species</u>	<u>Diameter (in)</u>	<u>Classification</u>	<u>Purpose</u>
3	Douglas-fir	30.4	Exceptional	Potential Hazard due to potential retaining wall failure
4	Douglas-fir	32.5	Exceptional	Potential Hazard due to potential retaining wall failure
8	Flowering cherry	9.5	Not Regulated	Within House foot print

Once removed, it appears that some minor wall mitigation will be necessary (block replacement/realignment). We can provide additional input upon request.

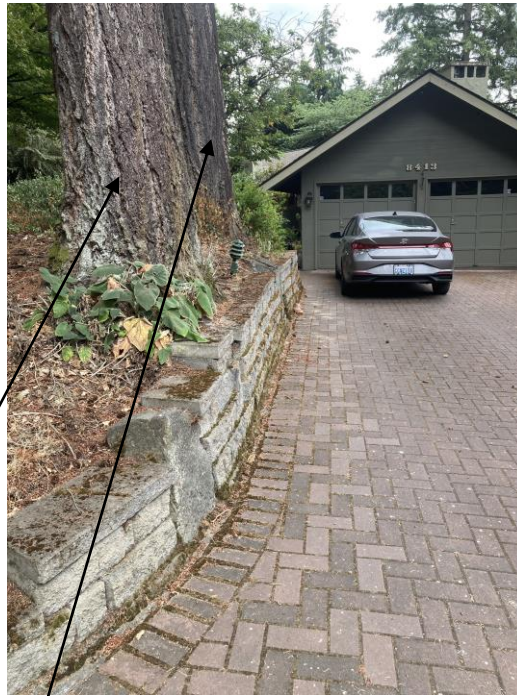
“Roots of two trees near the block walls are causing structural damage and movement of the wall system. These trees may be removed without adversely affecting geologic hazards in the area or adjacent areas provided surfaces are surfaced with topsoil/mulch and new low-lying vegetation.”

Tree No. 3 and 4 growing atop block retaining wall

Tree 3 the 30.4" and Tree 4 the 32.5" Douglas Fir is substantially growing into an existing retaining wall. The trunk of the tree is within inches of the existing retaining wall which is showing signs of structural failure. The tree is proposed to be removed to ensure the stability of the wall. The tree canopy and root zone will also be overlapping the new garage foundation.

<u>Tree No.</u>	<u>Species</u>	<u>Diameter (in)</u>	<u>Classification</u>	<u>Purpose</u>
3	Douglas-fir	30.4	Exceptional	Potential Hazard due to potential retaining wall failure
4	Douglas-fir	32.5	Exceptional	Potential Hazard due to potential retaining wall failure
8	Flowering cherry	9.5	Not Regulated	Within House foot print
