DOWNSTREAM ANALYSIS
FOR
SINGLE FAMILY RESIDENCE
3008 70TH AVENEU SE
MERCER ISLAND, WA 98040

March 10, 2024

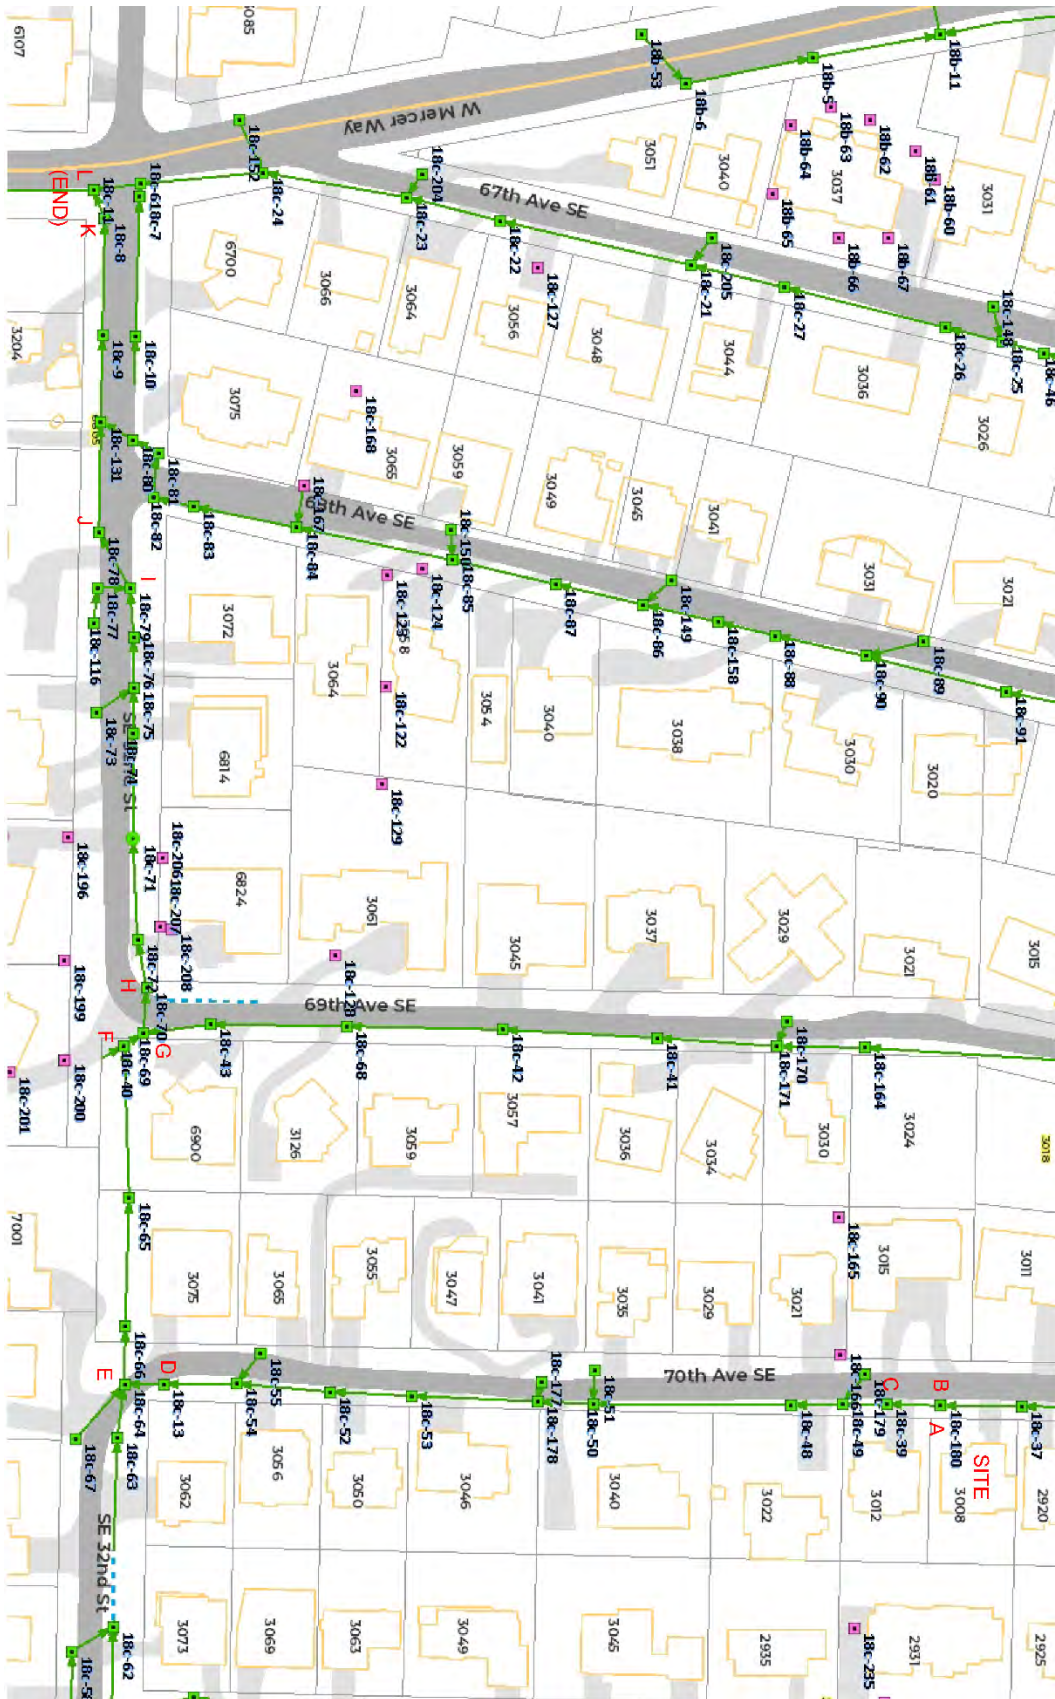
FIGURE 5: DOWNSTREAM MAP (NTS) ↻

- Presently, site runoff discharges at the west property line (**A**) to the street drainage system. Surface flow enters a CB (**B**) approximately 8 l.f. from the property line (See Figure 5, Downstream Map). It continues in a 12" DI pipe on the east edge of the street approximately 38 l.f. under the driveway to another CB (**C**). Then, it continues travels southerly through multiple catch basins at the same street side approximately 495 L.F. in the 12" pipes to another Type 1 CB (point **D**) with vaned grate located at the northeast corner of 70th Avenue SE and SE 32nd Street intersection. From here, it crosses under the street to the south west side to another Type 1 CB (**E**) at the edge of pavement , approximately 27 L.F. at the top of the trail. It then continues westerly along a trail through 2 more catch basins but are not visible on site approximately 230 l.f. to another Type 1 CB (**F**) located at the each of private driveway, end of trail. At this point, it flows northwesterly for approximately 15 l.f. to yet another catch basin (**G**) located at the east edge of 69th Avenue SE and SE 32nd Street intersection. Then, it travels in the 12" pipe crossing 69th Avenue SE approximately 30 l.f. to a catch basin (**H**) located on the west side of the street or northwest corner of the intersection. From here, it continues on the north side of SE 32nd Street through 5 more catch basins approximately 275 l.f. in the 12" pipe to another Type 1 CB (**I**). It then continues down slope crossing under the concrete pavement southwesterly direction approximately 45 l.f. to another Type 1 CB (**J**) located

on the south side of the same street. Runoff continues westerly on the same side of the street approximately 215 l.f. through 2 more catch basins to another Type 1 CB (**K**) located at the south side of SE 32nd Street near the intersection of W Mercer Way. From here it continues for another 22 l.f. to another Type 1 CB (**L**) located at the southeast intersection of W Mercer Way where the analysis is terminated for a total approximately distance of 1,400 l.f. During the downstream drainage field visit, no drainage issues were observed and no areas of any existing or potential major drainage problems were apparent.

The down stream drainage system as described above is not prone to stream bank erosion, siltation, and slide and does not threaten destruction of aquatic habitats. Catch basins as observed are mostly clean and sediment in the catch basins are below the invert of the outlet pipes. No open ditch existed along the route. Due to the fairly steep slope of the analysis route, the conveyance pipes system does not appear to have a capacity problem or show any sign of overtopping in any of the structure.

No off-site mitigation is necessary as there are no observed major drainage issues during the analysis for the downstream portion and runoff discharges from this site will be very minimal to downstream system.

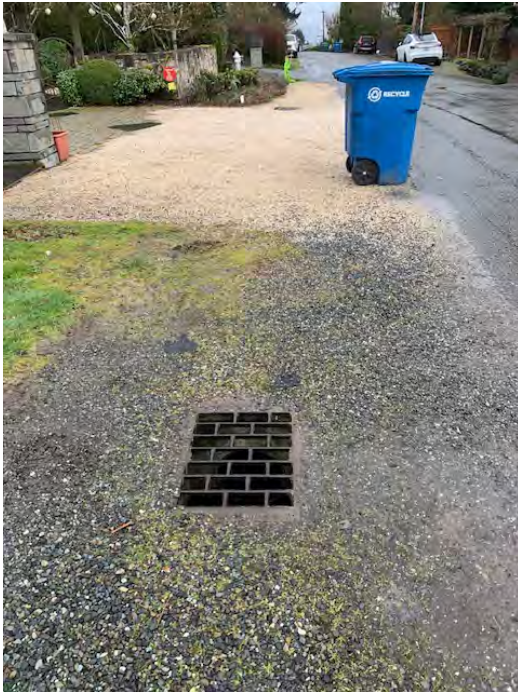
Catch Basin – At point B, Looking Downstream

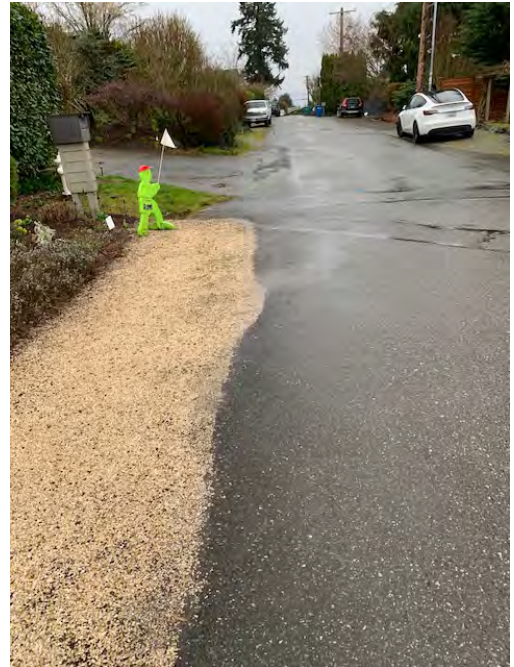
Looking Downstream from Catch Basin – At Point C

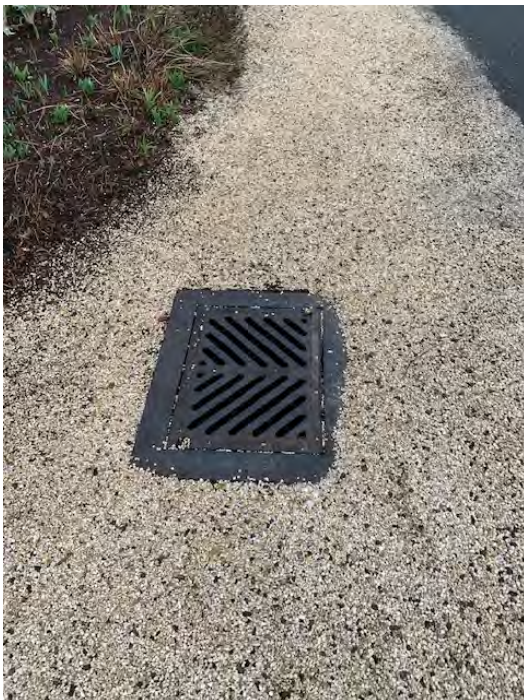
Catch Basin – At Point C

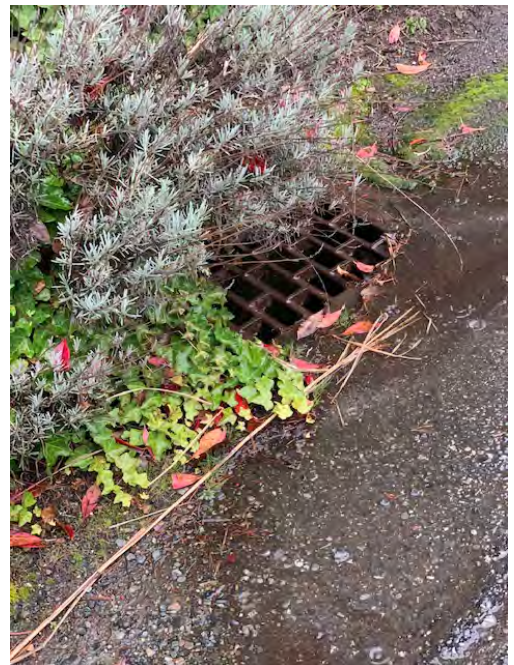
Near intersection East Edge Catch Basin – Point D

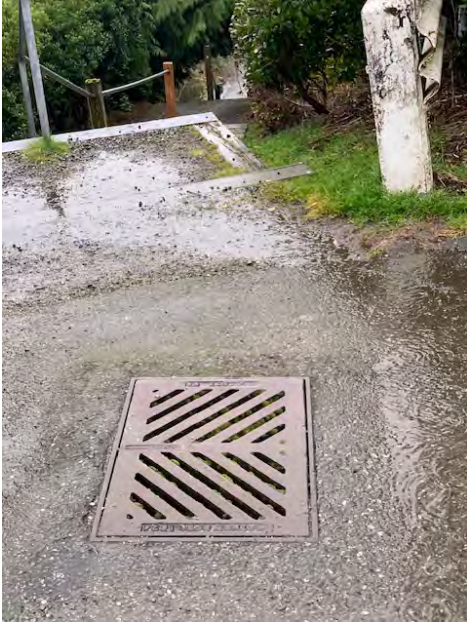
Catch Basin – Point E Top of Trail

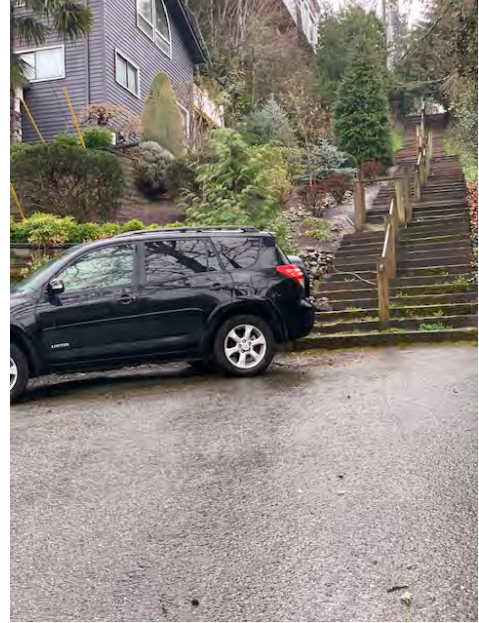
Catch Basin under Car at Point F at end of trail

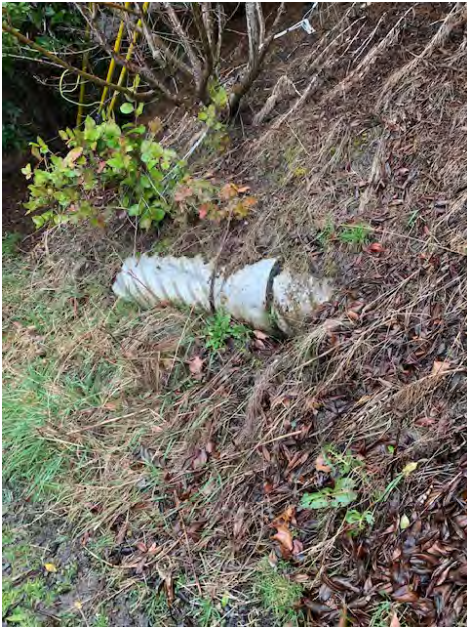
Exposed pipe next to trail near top of trail Point E, no joint leaking

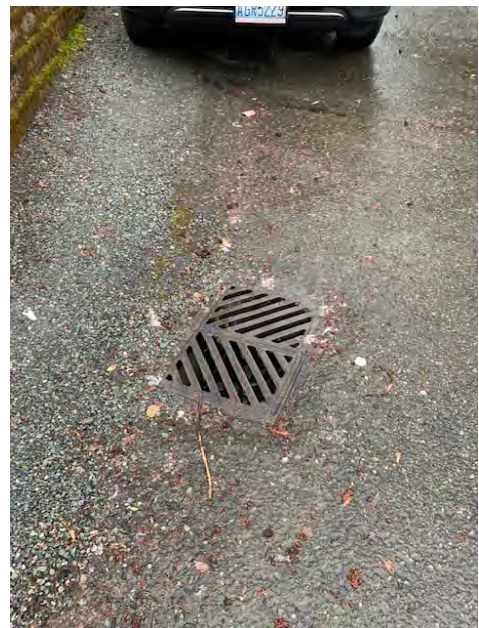
Cath Basin at Point G near end of trail

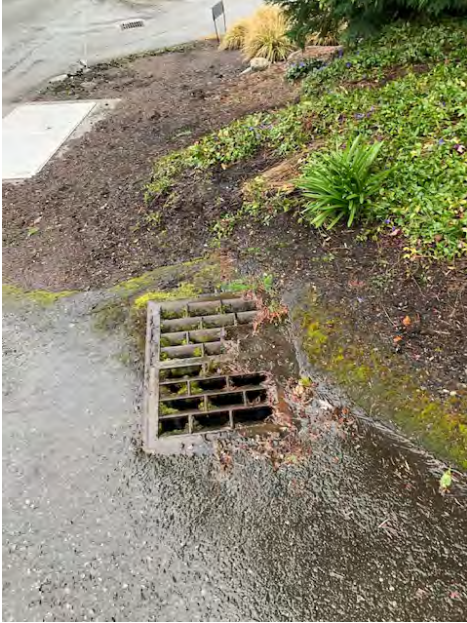
Catch Basin Point H - West of 69th Ave
SE at intersection - Looking West

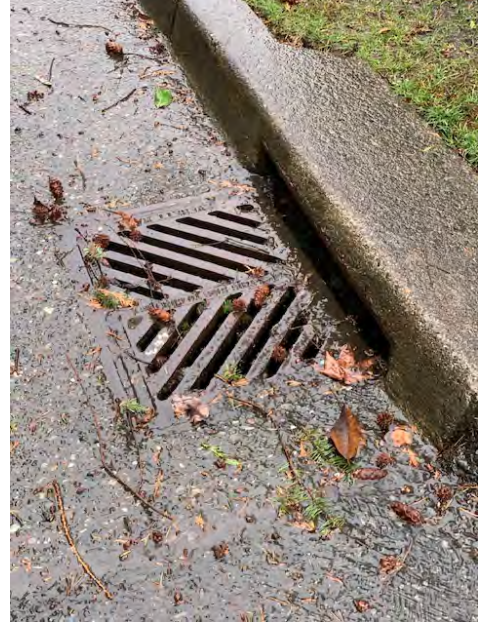
Catch Basin along Noth side of SE 32nd
Street, At Point I

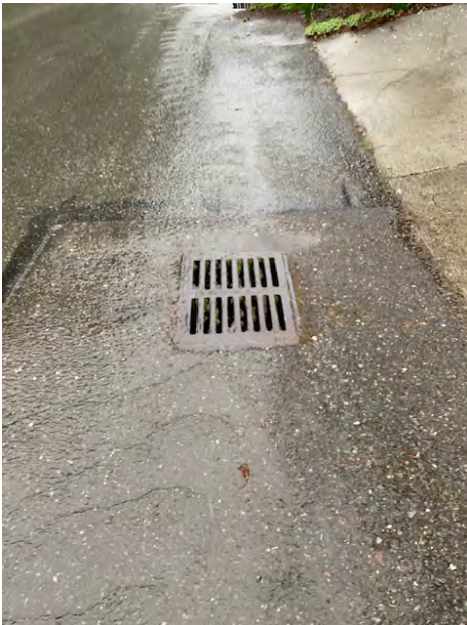
Catch Basin along Noth side of SE 32nd
Street, Downstream of Point H

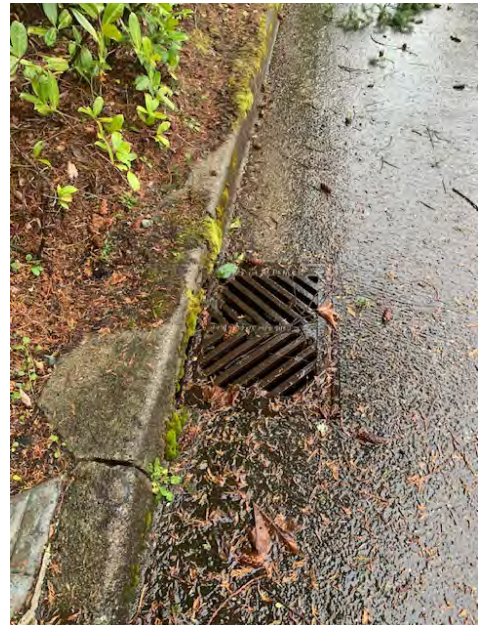
Catch Basin along Noth side of SE 32nd
Street, At Point J

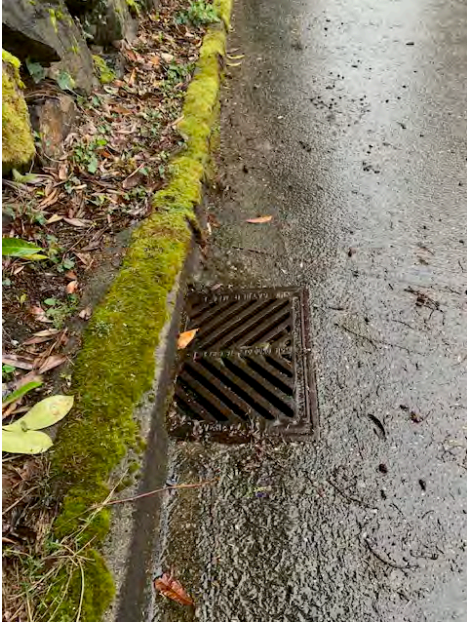
Catch Basin along South Side of SE 32nd Street, Downstream of Point J

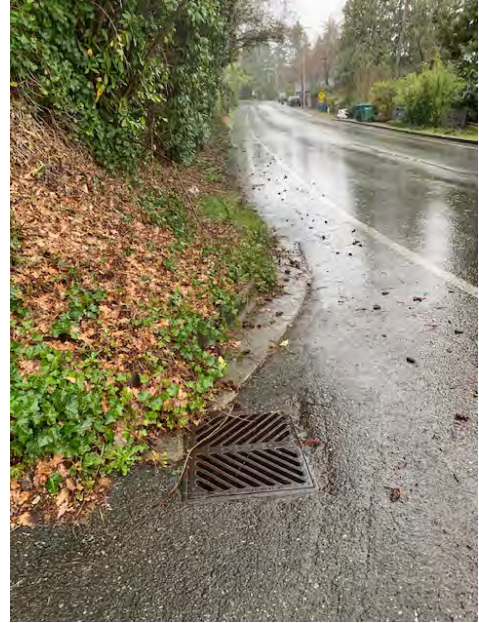
Catch Basin At East side of W Mercer Way, At Point L. End of Analysis Looking Downstream

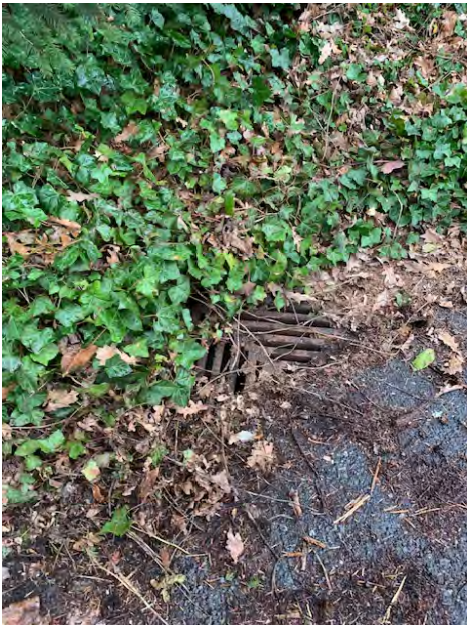
Catch Basin at South Side of SE 32nd Street, At Point K
