Arborist Report

*Tree Protection Plan 8020 SE 57th St, Mercer Island
August 25, 2023*

Davey Resource Group (DRG) was contracted by Vann Lanz from LNL Builds to inspect and provide an arborist report and tree protection plan for the property 8020 SE 57th St, Mercer Island, WA (parcel #2948900082). The client intends to develop the property.

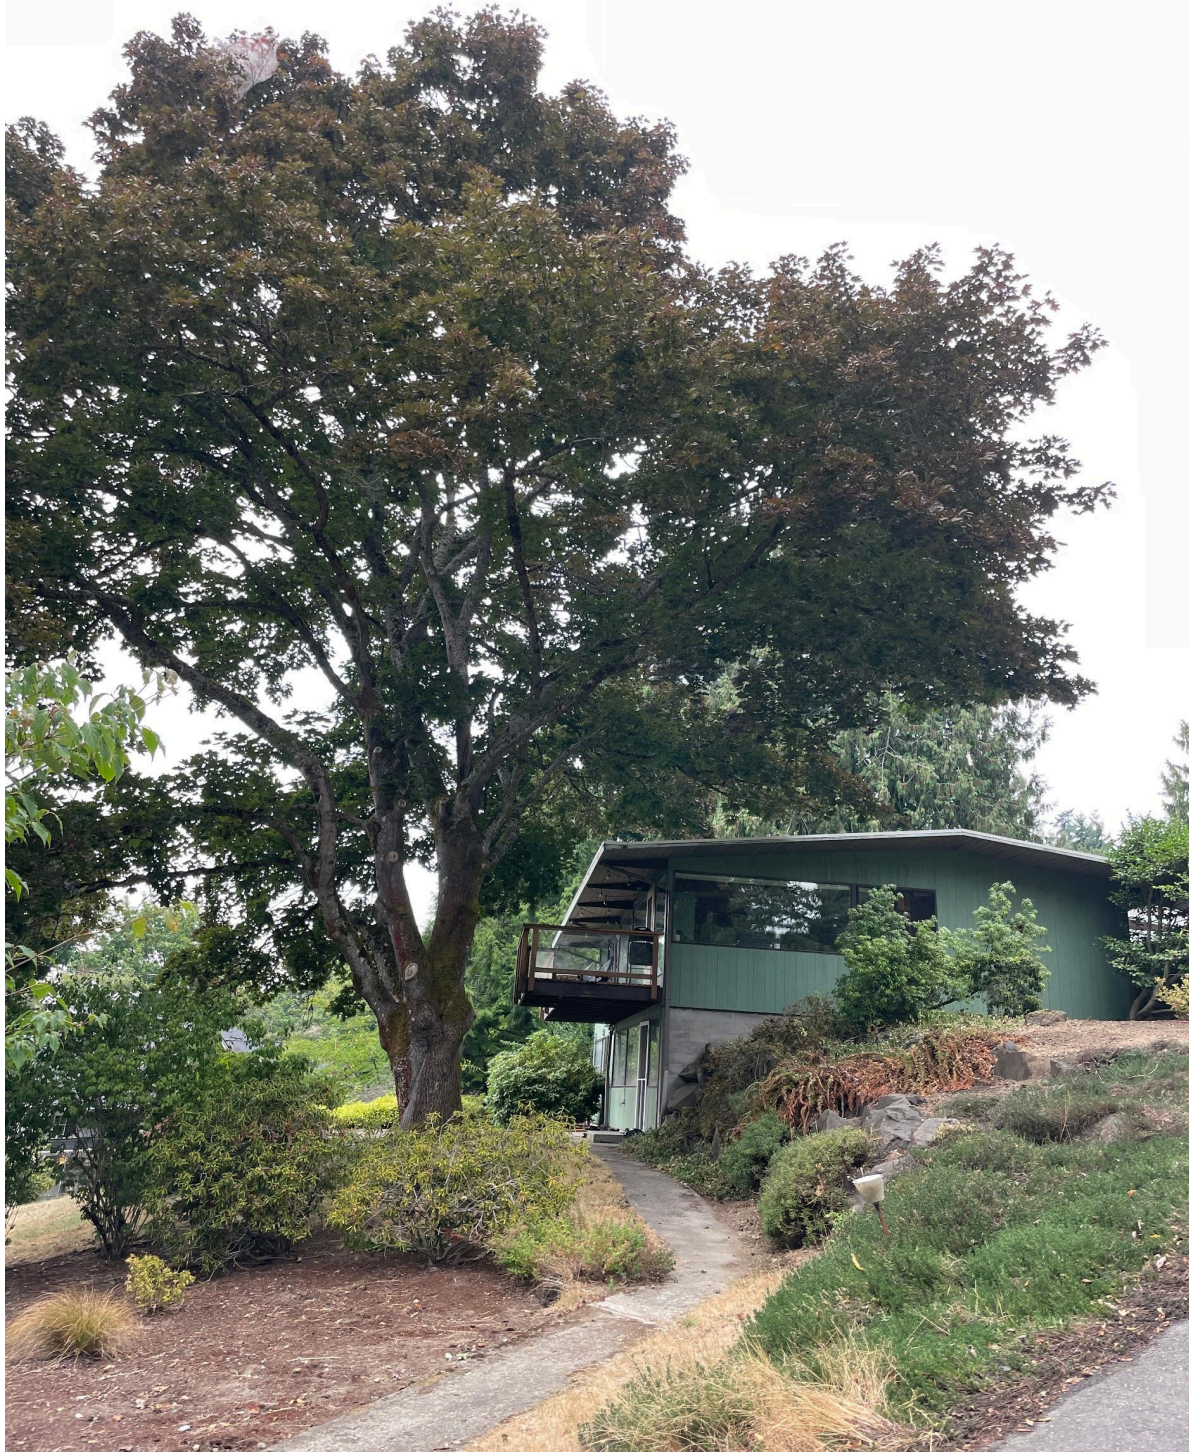
Image 2: Tree # 8037 next to the home

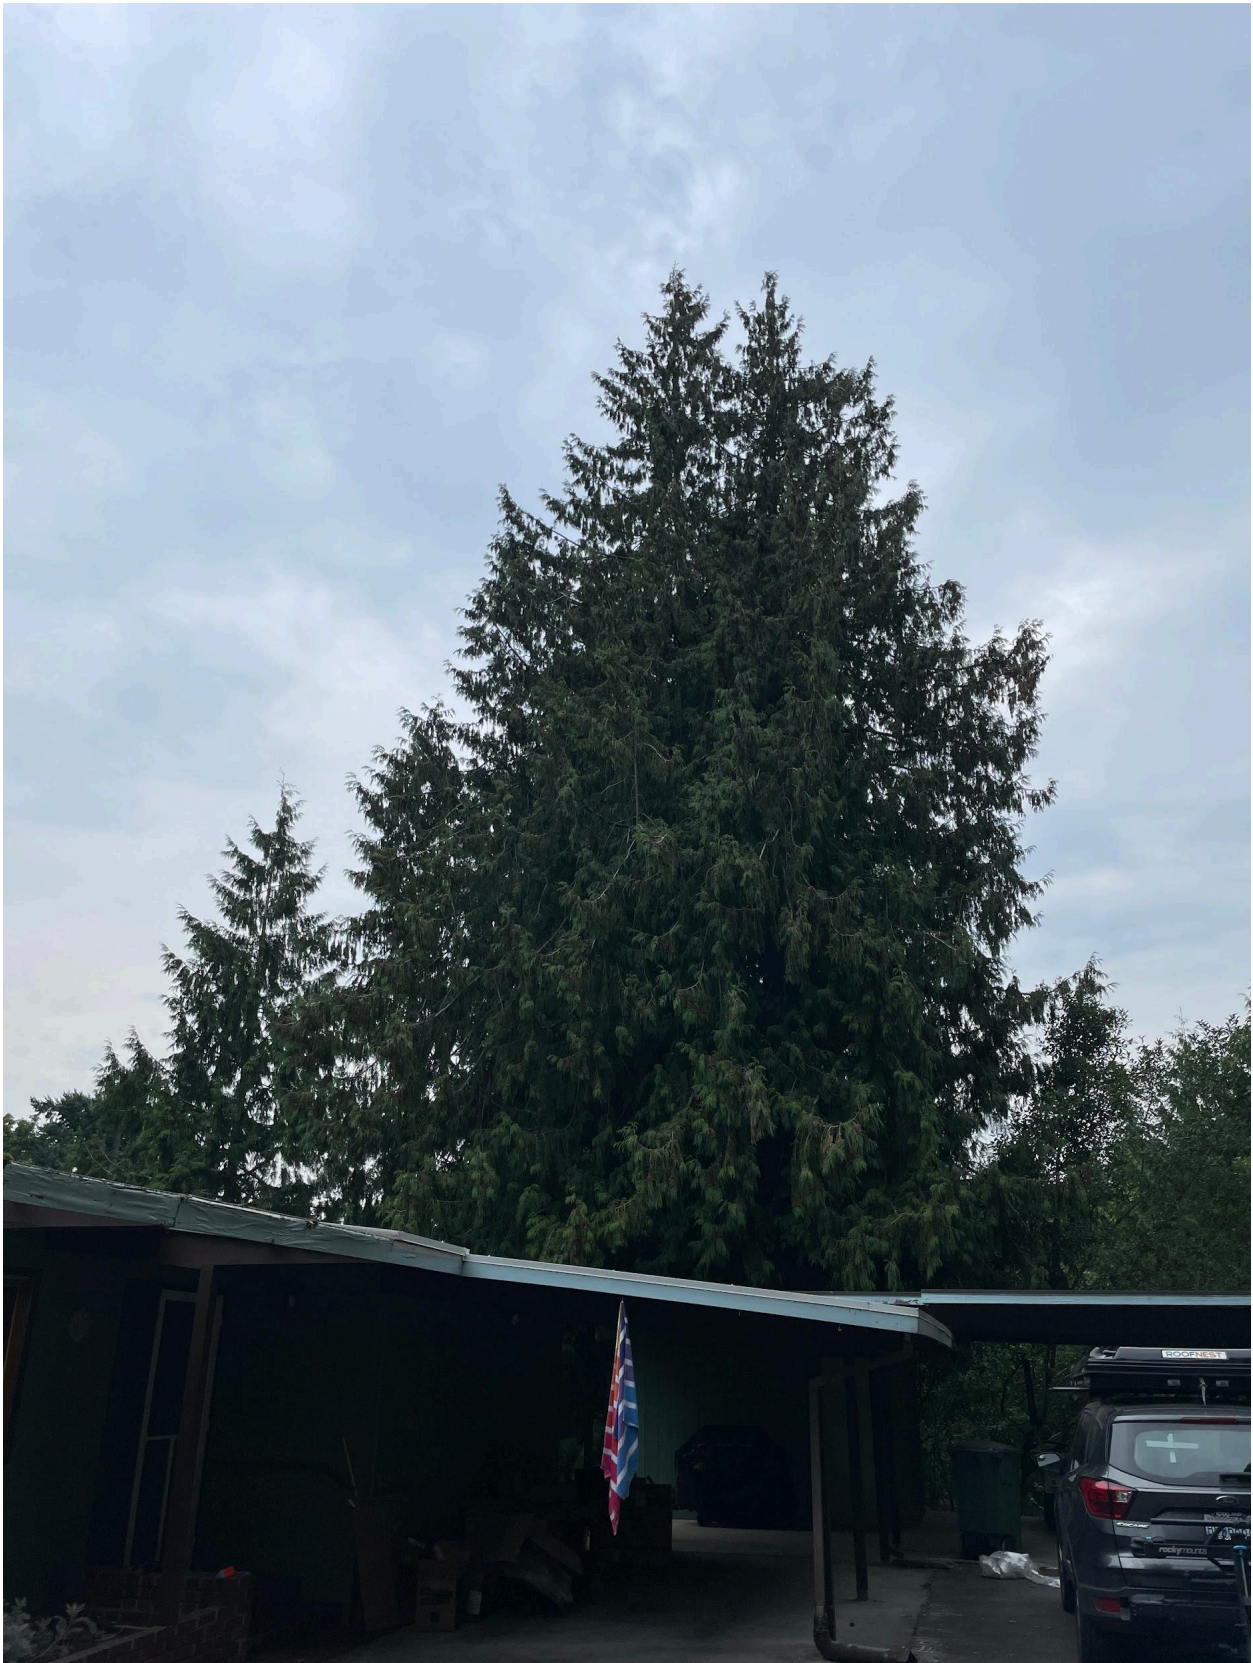
Image 3: Tree #8039 and 8040

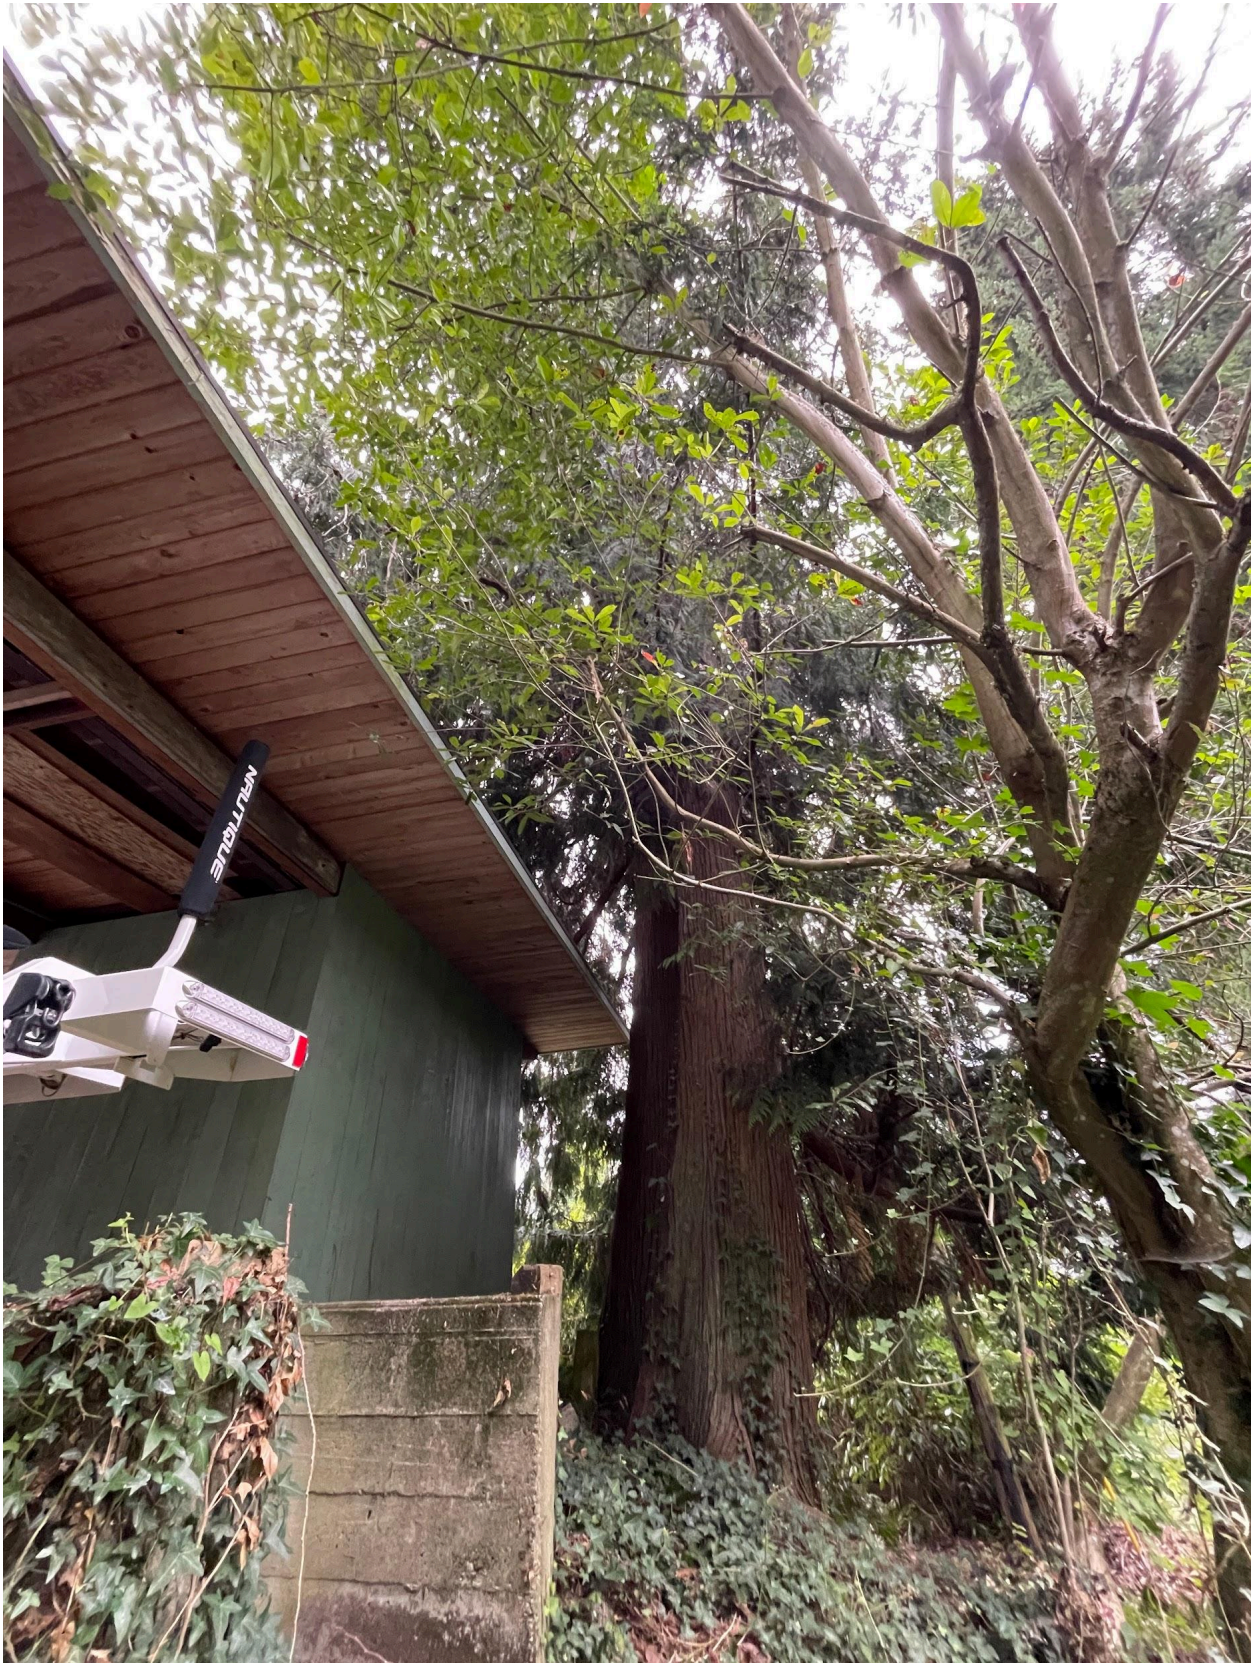
Image 4: Trees 8039 and 8040 showing the proximity to the garage/shed

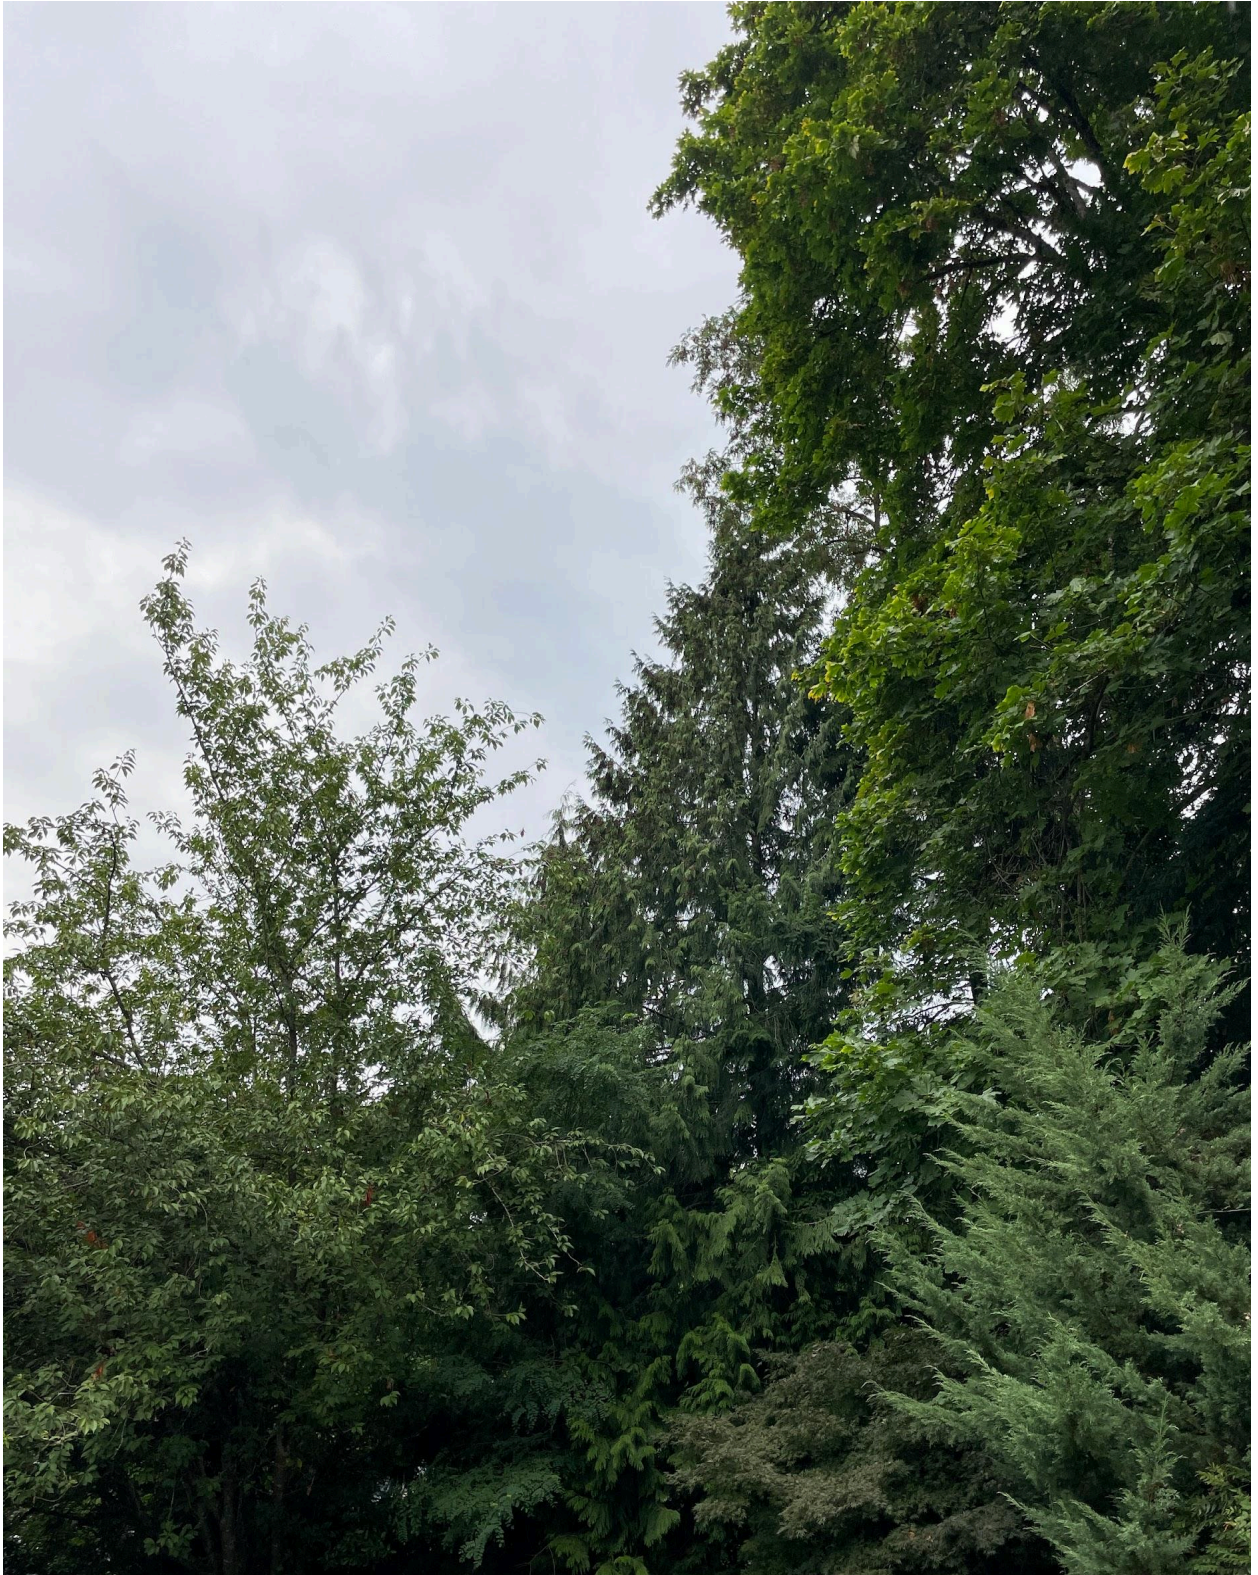
Image 5: Trees within a Grove
