## **ARBORIST REPORT**

April 6, 2024 (revised 8/26/24)

8440 SE 82nd St Mercer Island, WA 98040 / Lot # 3625600120

Kim Ettari - ISA Certified Arborist PN1301A / TRAQ

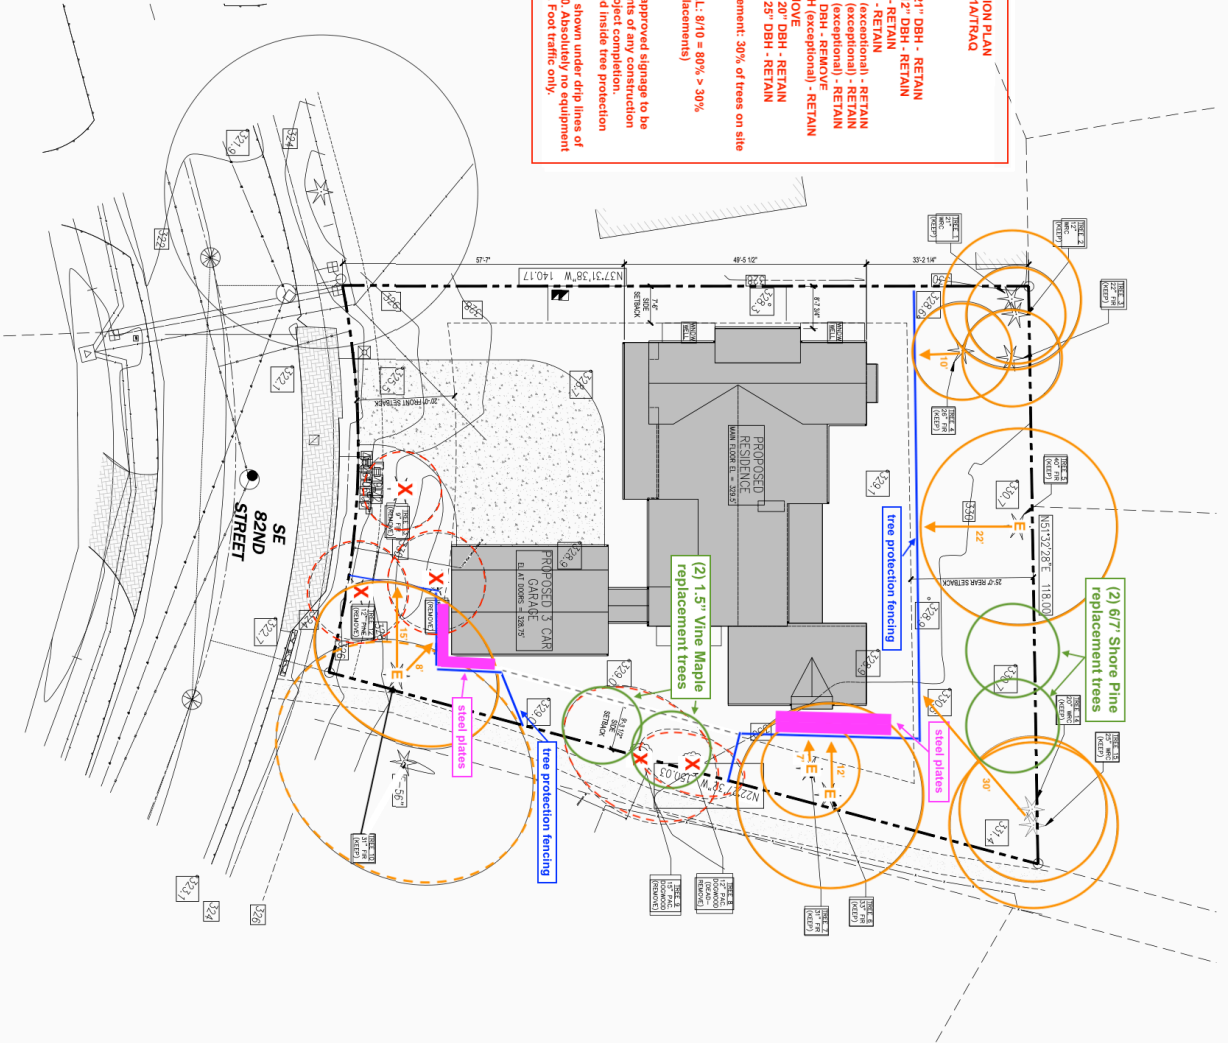
1 SITE PLAN  
 SCALE: 1" = 10'

- Tree #1 - Western Red Cedar - 21" DBH - RETAIN
- Tree #2 - Western Red Cedar - 12" DBH - RETAIN
- Tree #3 - Douglas Fir - 26" DBH - RETAIN
- Tree #4 - Douglas Fir - 26" DBH - RETAIN
- Tree #5 - Douglas Fir - 40" DBH (exceptional) - RETAIN
- Tree #6 - Douglas Fir - 33" DBH (exceptional) - RETAIN
- Tree #7 - Douglas Fir - 31" DBH (exceptional) - RETAIN
- Tree #8 - Pacific Dogwood - 15" DBH - REMOVE
- Tree #9 - Douglas Fir - 31" DBH (exceptional) - RETAIN
- Tree #10 - Douglas Fir - 31" DBH (exceptional) - RETAIN
- Tree #11 - Douglas Fir - 20" DBH - RETAIN
- Tree #12 - Douglas Fir - 20" DBH - RETAIN
- Tree #13 - Douglas Fir - 20" DBH - RETAIN
- Tree #14 - Western Red Cedar - 25" DBH - RETAIN
- Tree #15 - Western Red Cedar - 25" DBH - RETAIN

Mercer Island Retention Requirement: 30% of trees on site  
 Trees to be retained: 2  
 Trees to be removed: 2  
 Tree Removal: 8/10 = 80% > 30%  
 (meets requirement with no replacements)

1. Tree protection fencing with approved signage to be installed prior to commencement of any construction activities and to remain until project completion.
2. Steel plates to be installed inside tree protection areas.
3. Steel plates to be installed as shown under drip lines of exceptional Trees #6, #7 and #10. Absolutely no equipment traffic permitted on steel plates. Foot traffic only.
