**Arborist Report and Inventory-Addendum on Pages 18-19
March 19th, 2024**

Sino Yeganeh
Aspen Homes

3029 62nd Ave SE
Mercer Island, Wa

Arborist notes for Aspen homes at 3029 62nd Ave. SE., Mercer Island Washington. Time of site visit: Thursday, March 14, 2024. 1:30 PM.

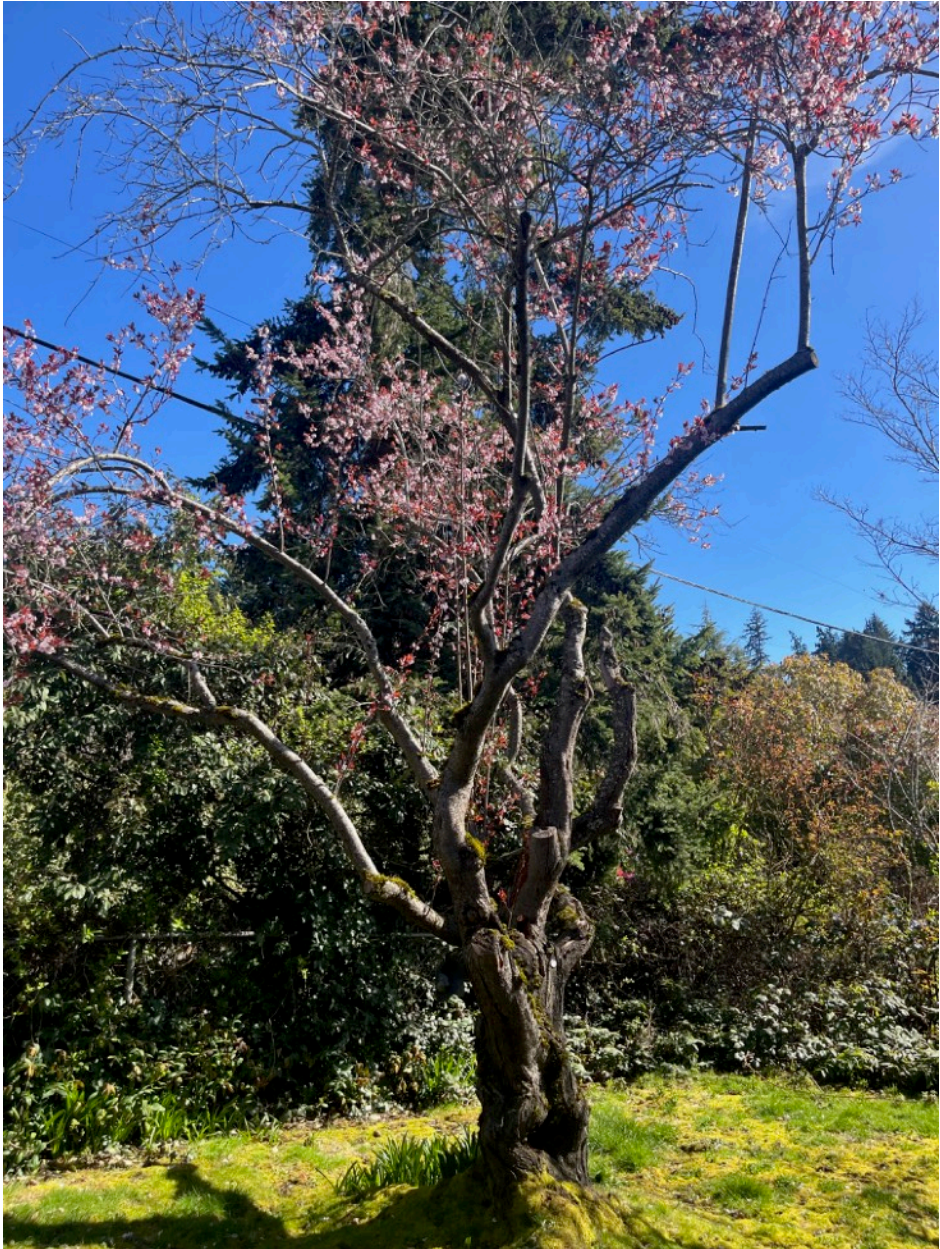
Tree #2476 There is a Flowering Plum (*Prunus* sp.) tree in the front yard, east of the existing single-family residence at this site. This tree appears to have been heavily pruned throughout its existence and during the site visit I thought that this tree was in poor condition and close to the end of its life curve. There's quite a bit of apparent decay in the pedestal region of the tree and very few live limbs left in the upper canopy.

2476 Looking East

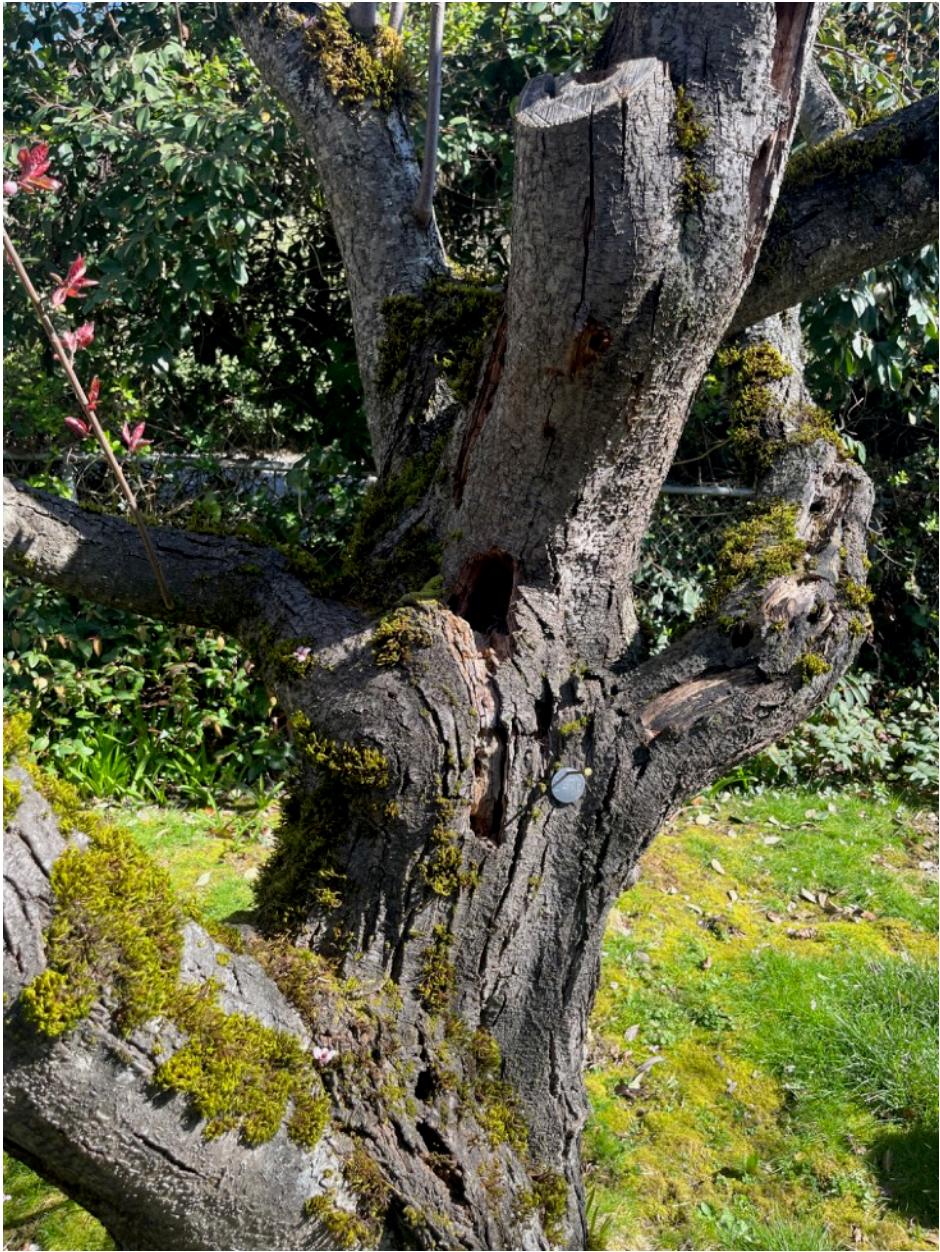
Looking north at the decaying 2476

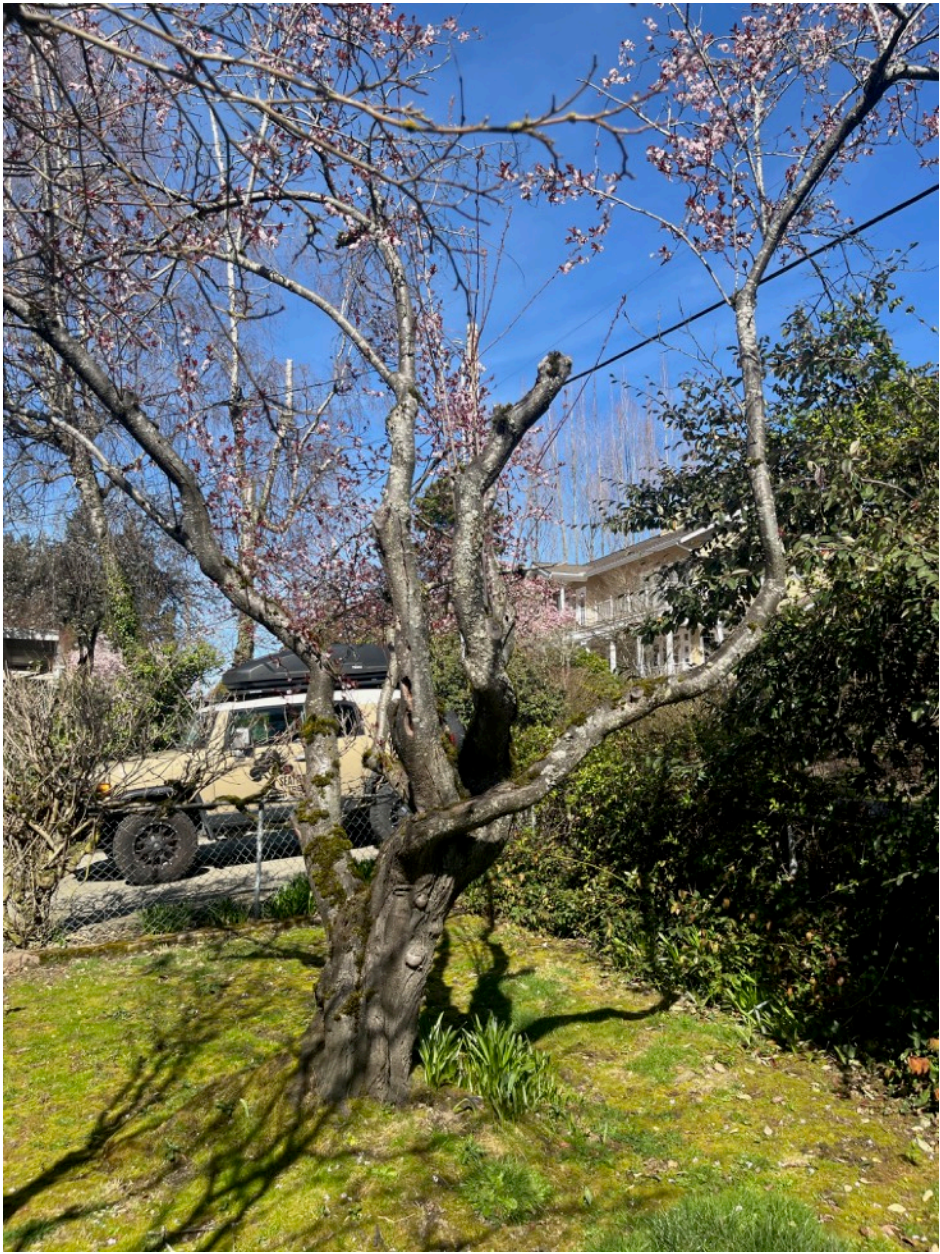
Looking west at 2476

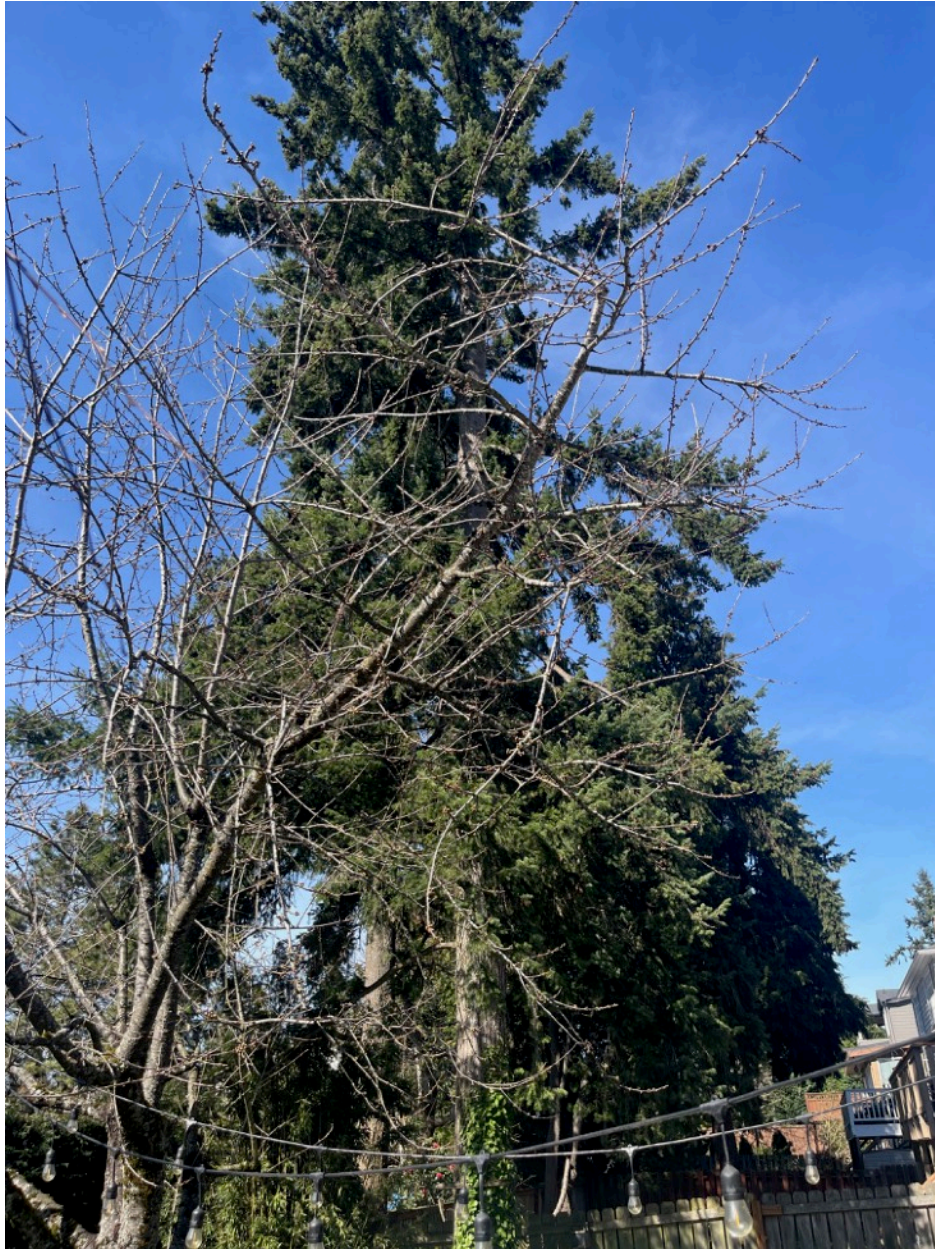
Tree #2477 On the north property line in the backyard there is a Douglas Fir (*Pseudotsuga mensiezii*) tree with excurrent structure and which is in good condition. This tree has a live crown ratio of approximately 80% and is not presenting any hazards, nor does it seem to be in need of any pruning at this time.

Looking north at 2477 (fir in the background)

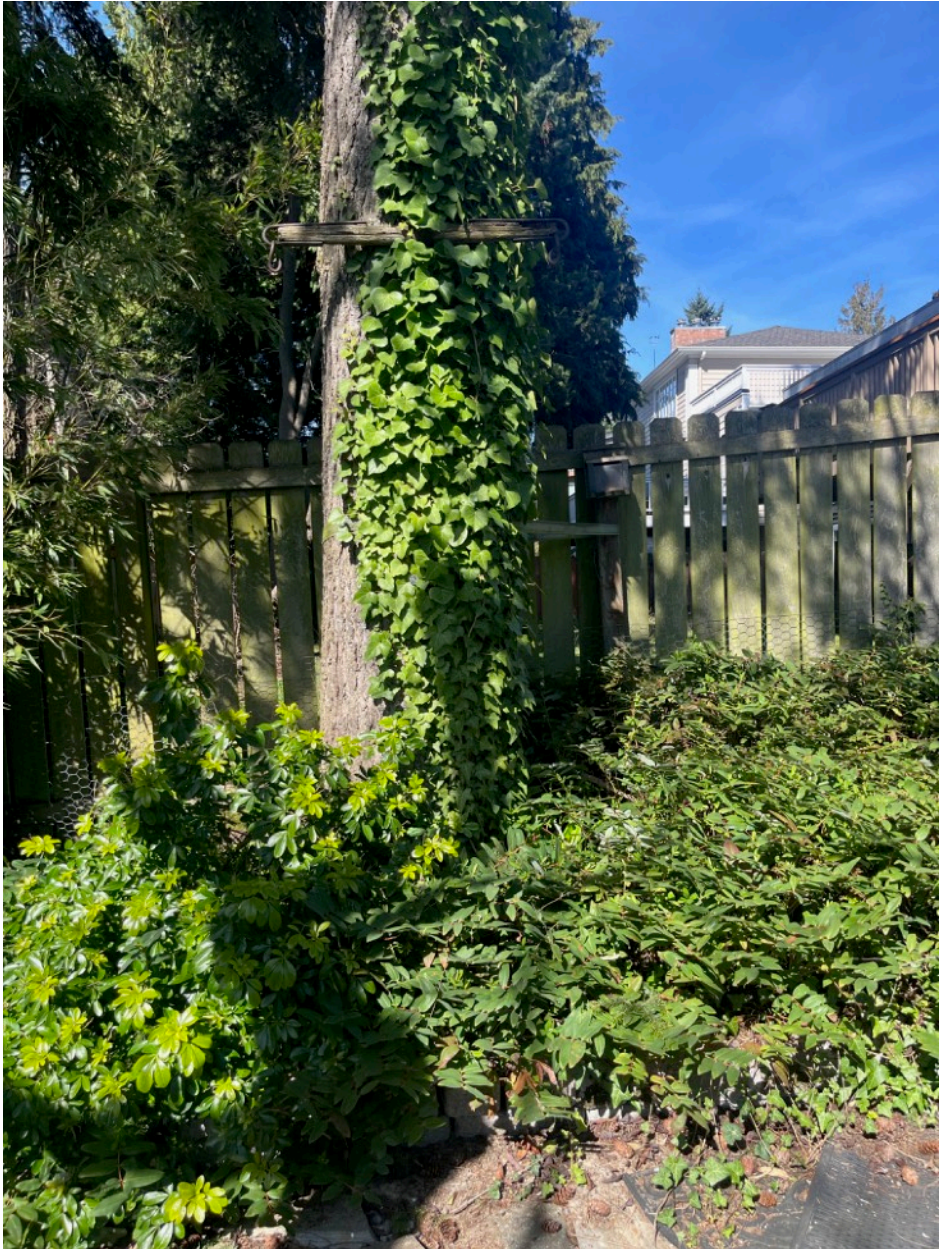
Looking north at the trunk of 2477

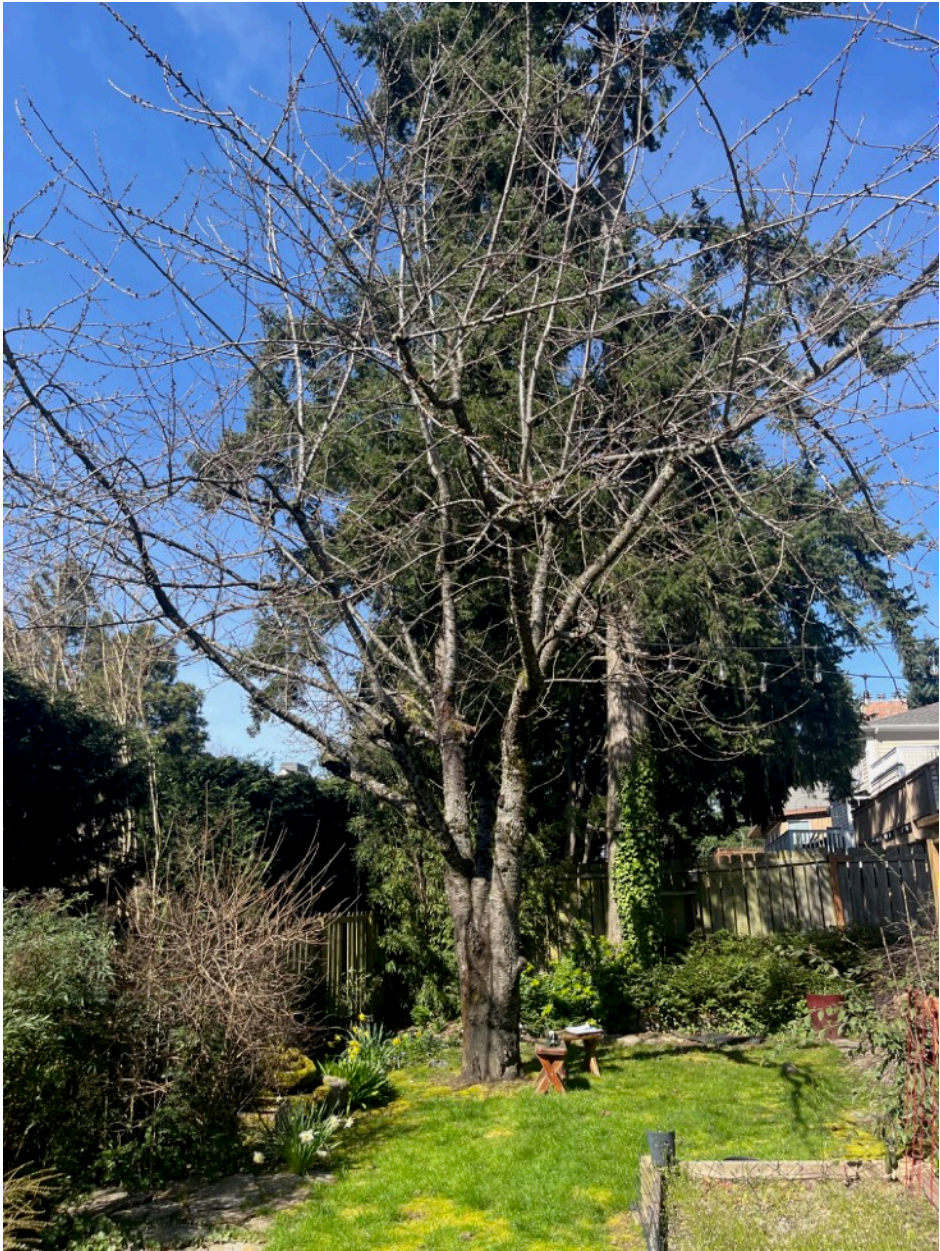
Tree #2478 Just to the south of the Douglas Fir tree is a decurrent (spread out canopy) specimen of Flowering Cherry (*Prunus* sp.) that is in fair condition. This tree seems to have been height reduced several times throughout its existence and there is apparent decay in the pedestal region as well as in the upper canopy of this tree. This tree is large enough to be considered Exceptional on Mercer Island and despite some of its defects, it is not presenting any hazards.

Looking north at the Exceptional Cherry 2478

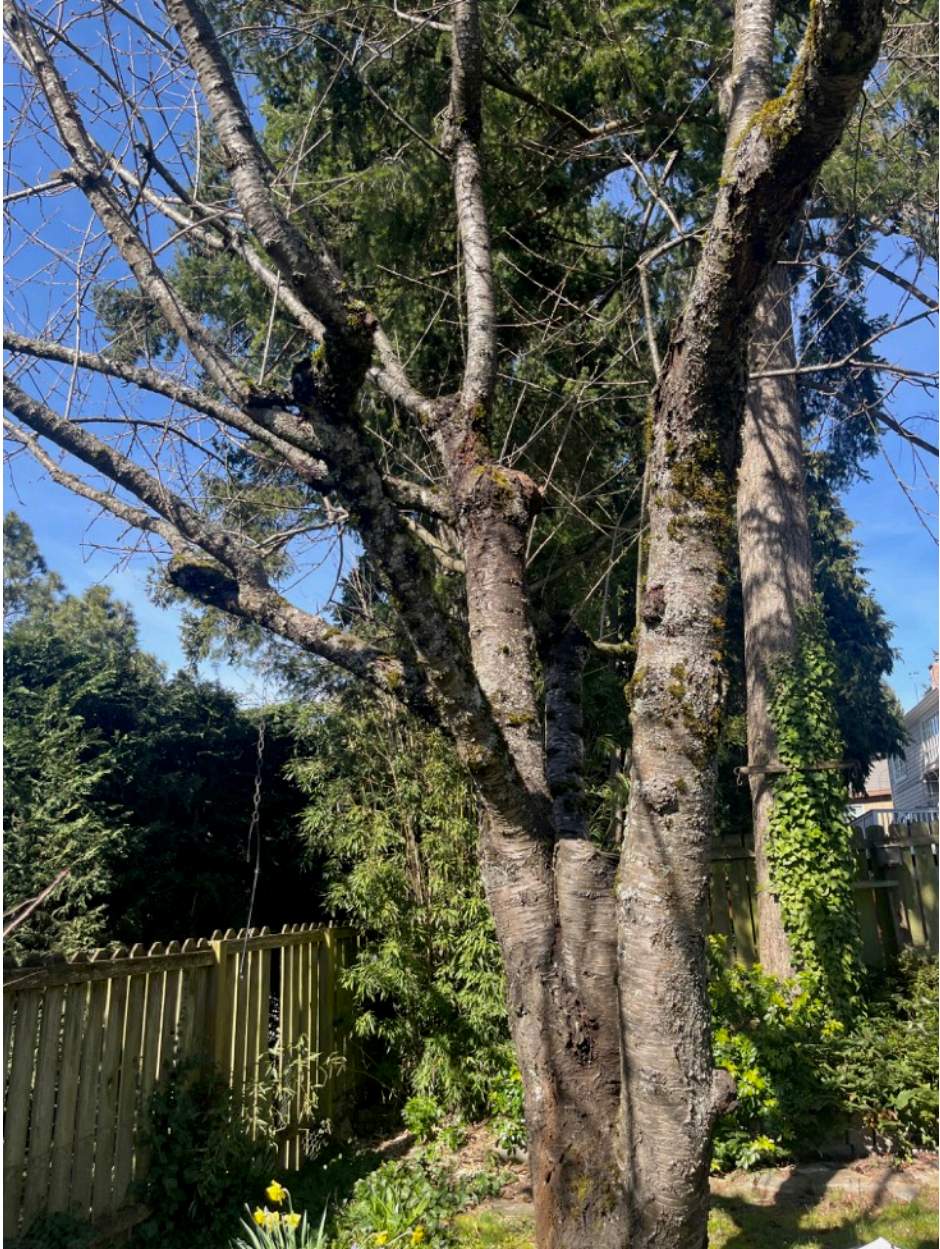
Looking north at the pedestal and structure of 2478

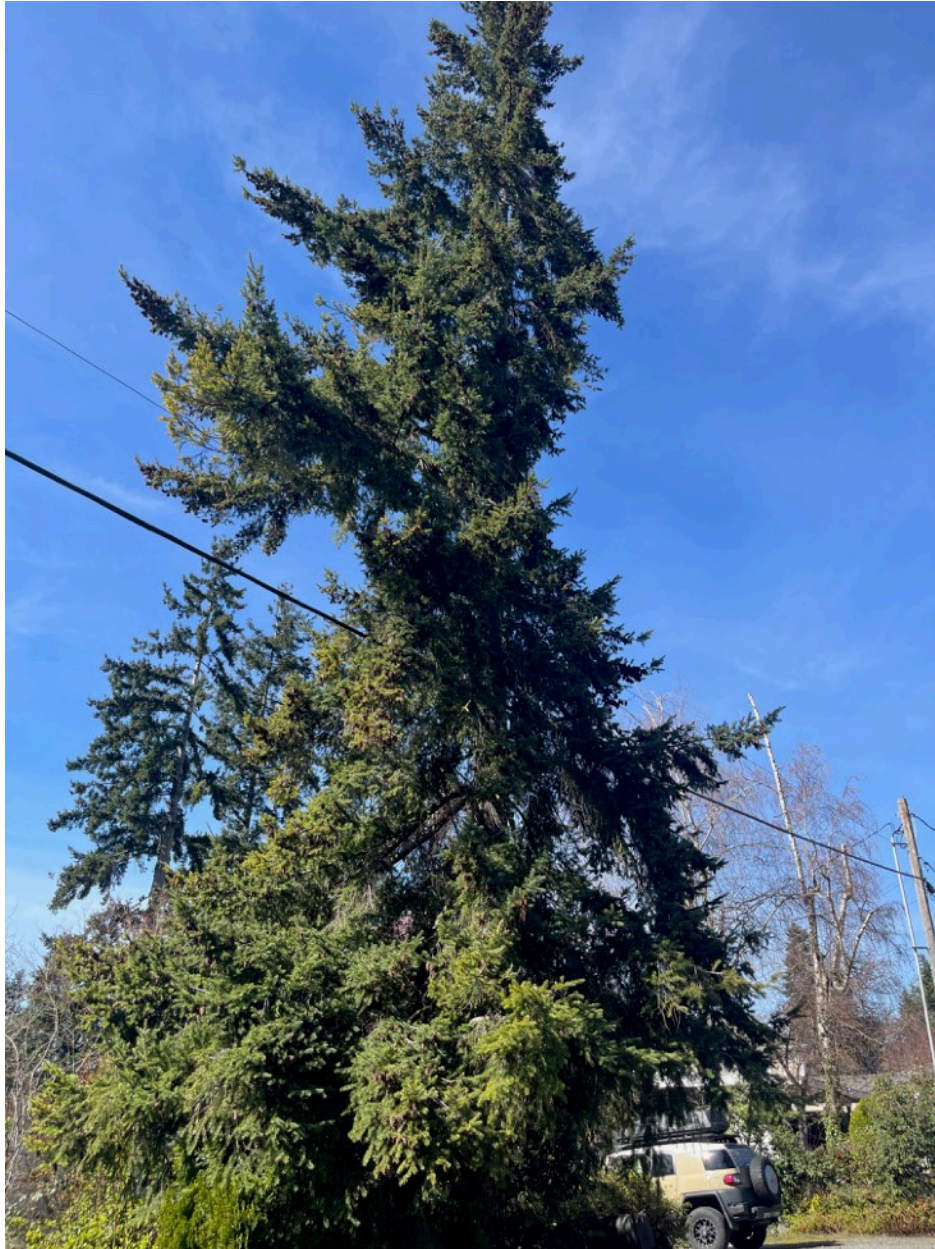
Tree #2479 Close to the southeast corner of this lot, on the east side of the fence that protects the front yard, is a specimen of Douglas Fir with an 18 inch diameter standard height. This tree also has excurrent structure and is in good condition. There are some communication and power lines that run through the low canopy of this tree. This tree is exposed to the prevailing winds and there are some areas on the trunk where it is apparent that limbs of broken off in the upper canopy.

Looking north at 2479 with the power lines running along the east side of the tree

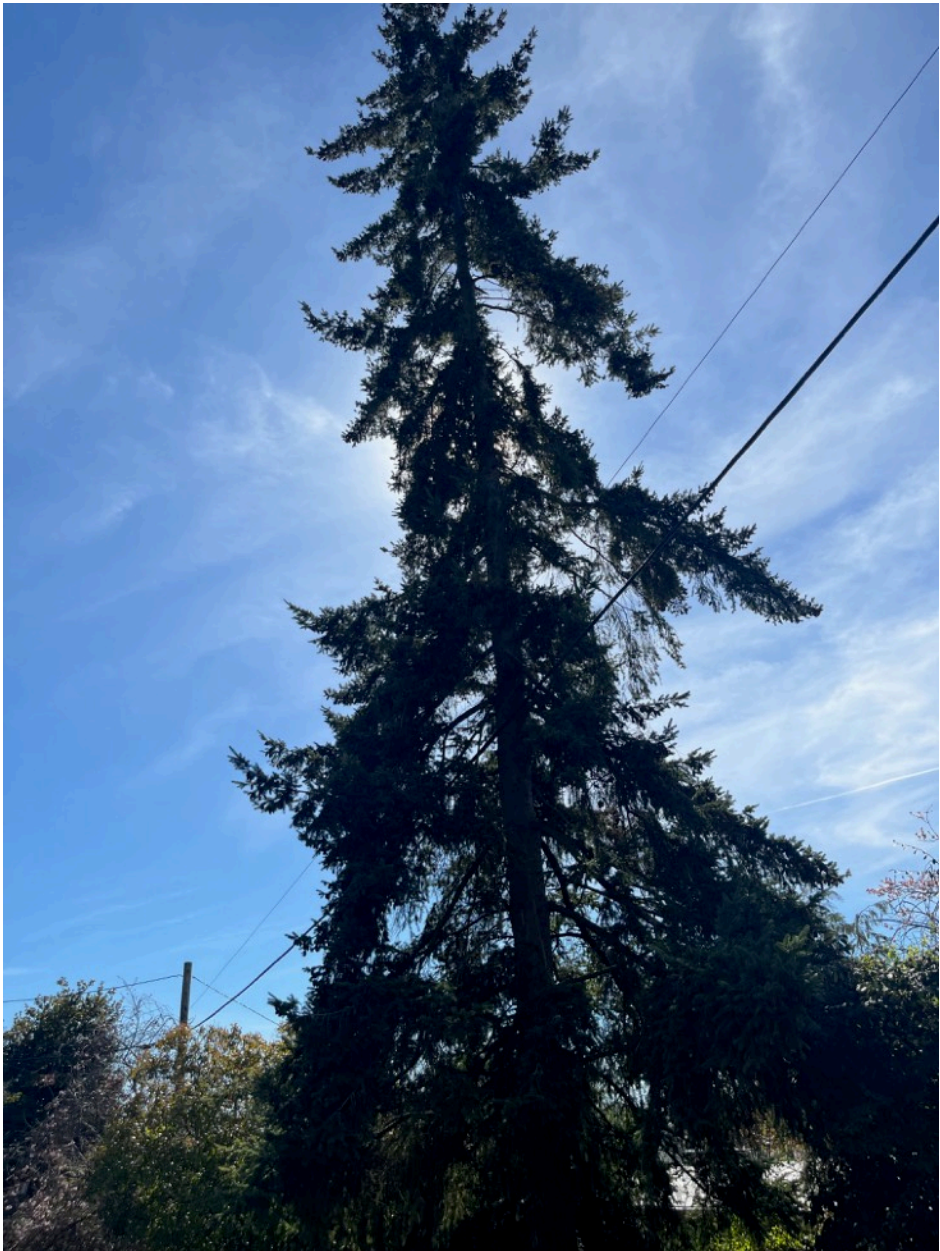
Looking south at 2479

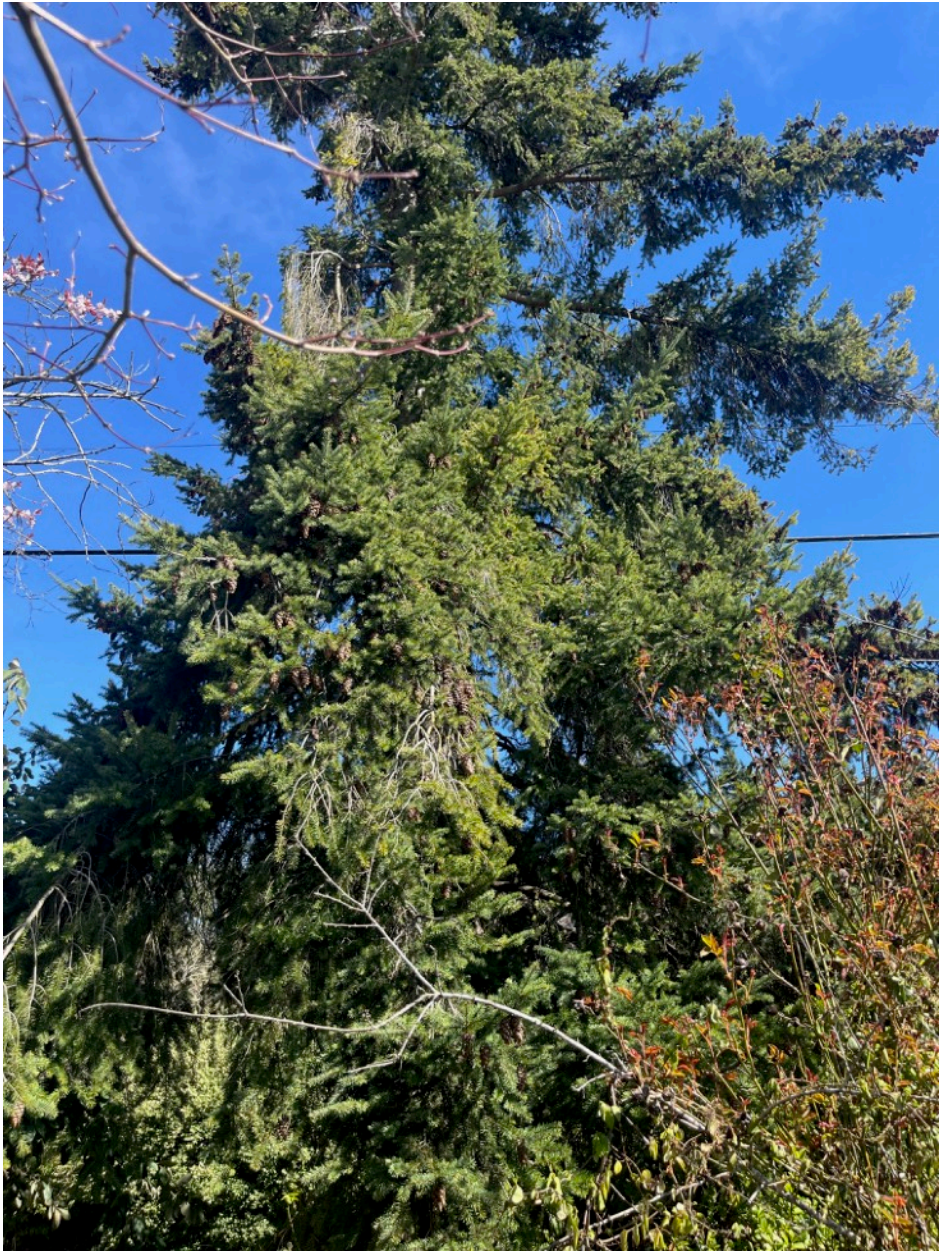
Looking east at the low canopy of 2479

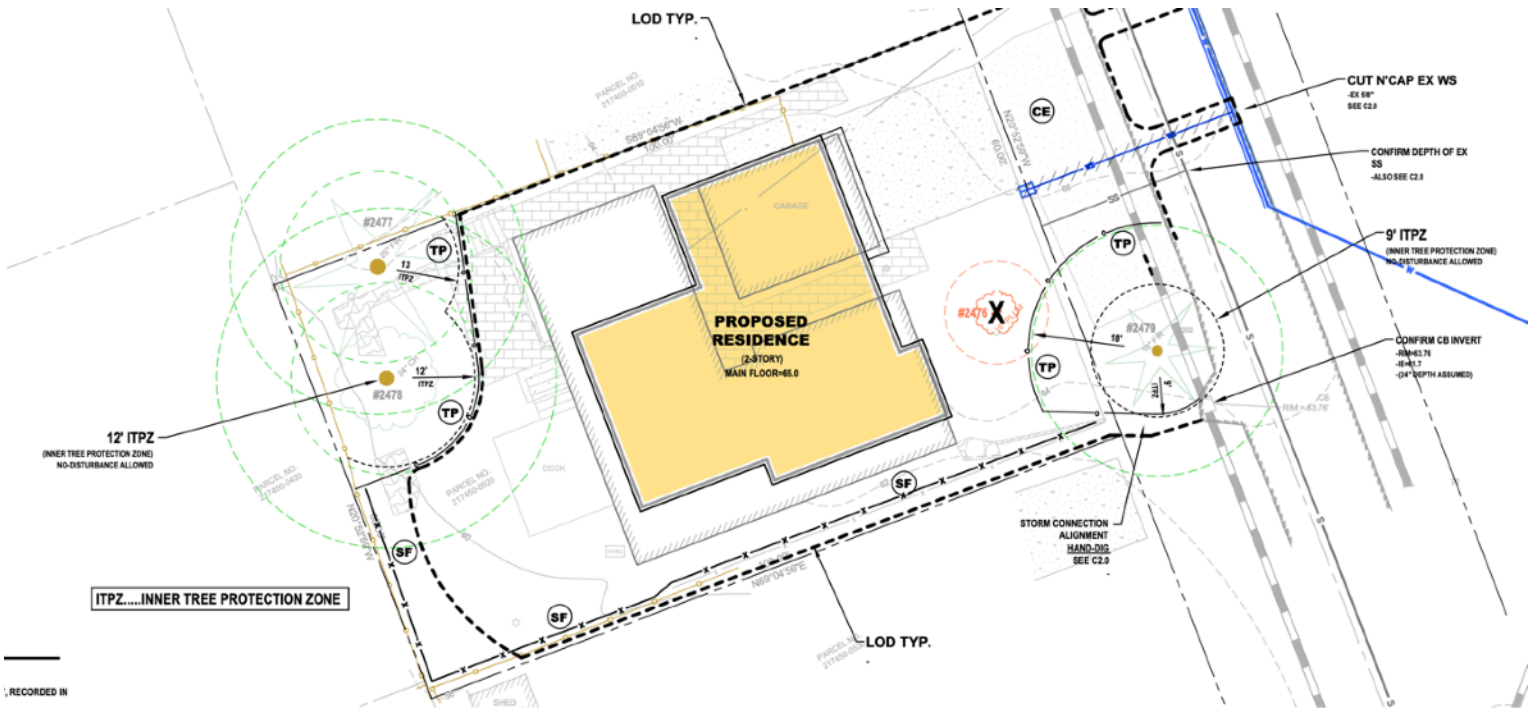
Aspen Homes Report and Inventory-3029 62nd Ave SE

I have looked at the new site plan that is available and the proposed disturbances are within the accepted tolerances and it is my professional opinion that the revised approach will not have an adverse effect on the health or the stability of the the trees that are being retained. A version of the updated Site Plan is included on the following page.

- Moved new water meter further north out of Tree 2479's dripline to have one less disturbance in dripline.
- added ITPZ radius to trees 2477, 2478, 2479
- added annotation about no disturbance within ITPZ
- adjust storm connection alignment in tree 2479 dripline to ensure no disturbance to ITPZ 9' radius
- fine tuned tree protection

The tree protection fencing is scheduled to be installed at the limit of disturbance and outside of the inner tree protection zone of all of the trees that are being retained. The water line has been moved north so that it avoids the TPZ of Tree 2479 and the installation will not have an adverse effect on that tree. The fencing should be installed prior to the project commencing and needs to remain in place for the duration of the project.
