Arborist Report

To: 3H Development, LLC c/o Sisi Duan
Site: 2419 72nd Ave SE, Mercer Island, WA 98040
Re: Tree Inventory
Date: July 24, 2024
Project Arborist: George White
ISA Certified Arborist PN-8908A
ISA Qualified Tree Risk Assessor
Reviewed By: Tyler Bunton
ISA Certified Arborist PN-8715A
ISA Qualified Tree Risk Assessor
Referenced Documents: Site Plan G1.0 (5ft2 Studio Architects, 6.5.2024)
Attached: Table of Trees
Tree Site Map

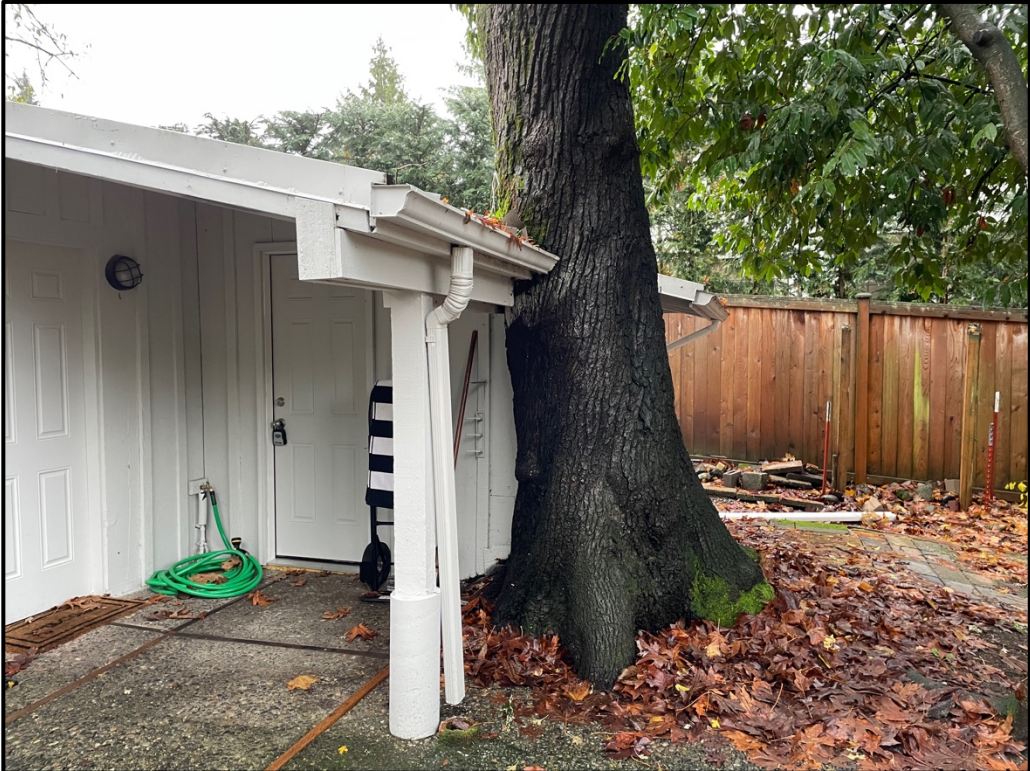
Tree 88 is an exceptional bigleaf maple in good health and good structure, growing immediately north of the existing building. While this tree has a high retention value, its retention may be difficult due to its proximity to the existing structure that is proposed for demolition.

Photograph 1. The base of tree 88. Careful demolition will be required to retain this tree.

Because tree 88 is growing in immediate proximity to existing structures. All demolition should be conducted carefully under direct supervision of the project arborist. Where feasible, existing below-ground structures (such as concrete footings) should be abandoned in place to avoid unnecessary root damage. All demolition machinery must be operated from existing hardscapes, or soil protection methods must be implemented to avoid compaction and mechanical root damage. The concrete patio surrounding the tree should be demolished/removed by hand and the areas exposed following removal should be immediately covered with a 4-to-6-inch layer of uncomposted woody mulch.

Tree Protection fencing should be installed outside of the MLOD (5x trunk diameter) from the base of tree 88 to the east. The fencing should include the entire RLOD in all other cardinal directions.

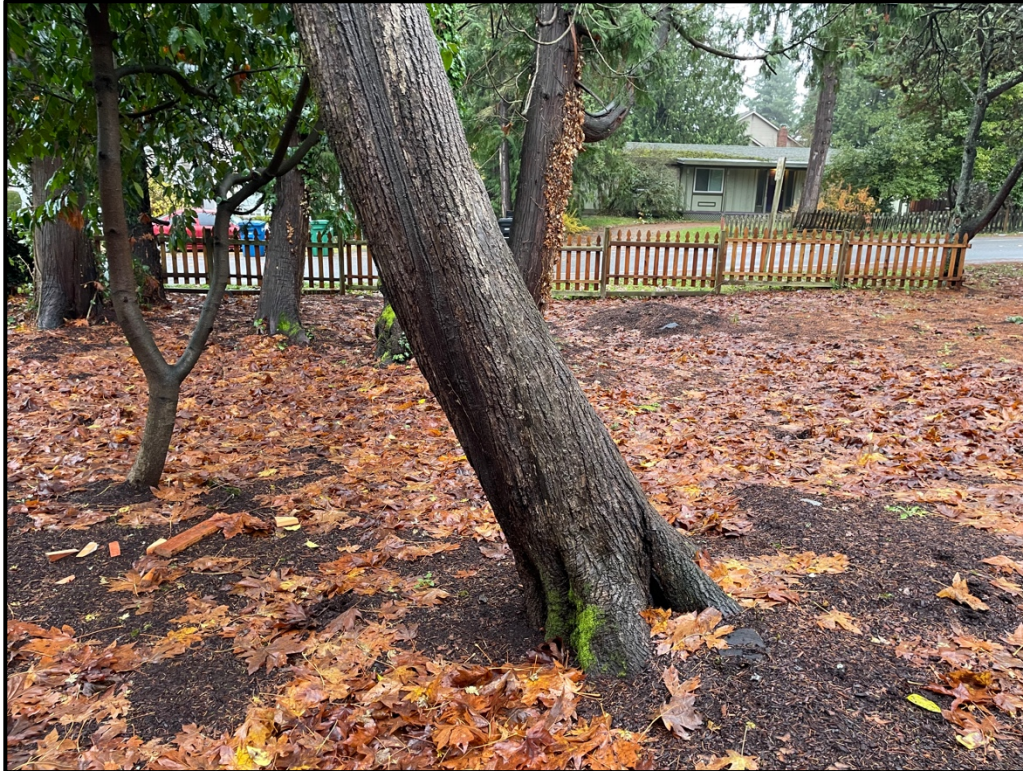
Tree 94 is a bigleaf maple located centrally near the north property line. This tree has a significant phototropic lean to the north and sounds hollow near the base when sounded with a hammer. I identified signs of *Armillaria* sp. and *Kretschmeria deusta* at the base of this tree. This tree should be prioritized for removal because it targets the house to the north and may be considered a hazard tree.

Photograph 2. The base of tree 94. This tree poses a hazard to the house north of the property and should be prioritized for removal.

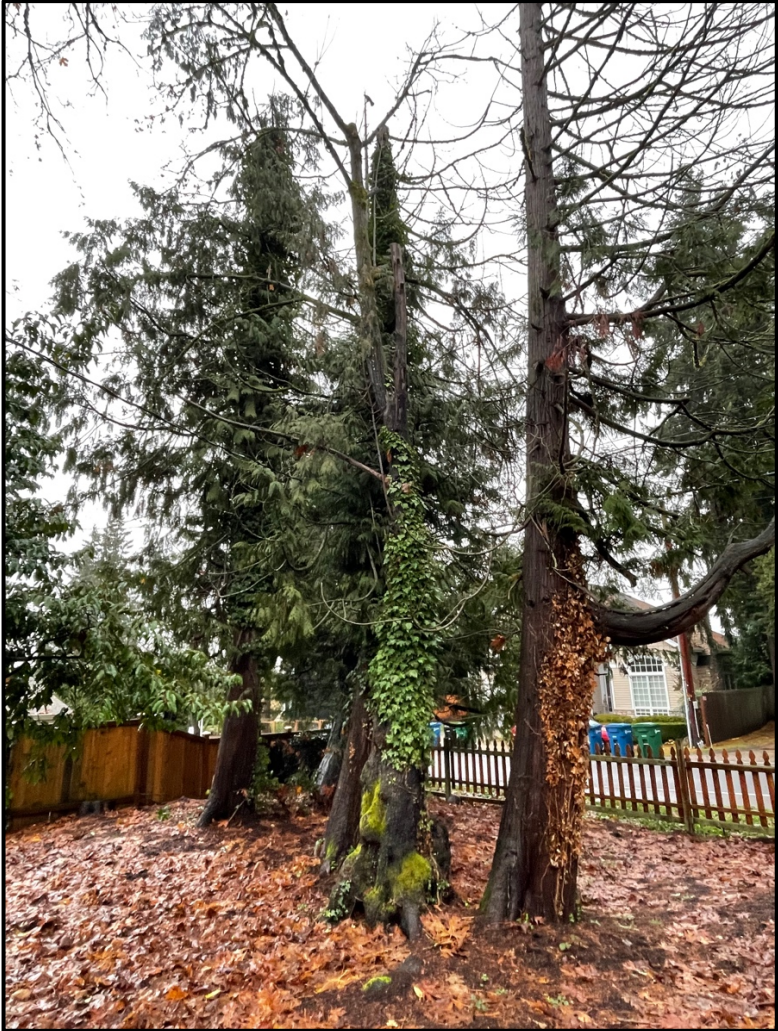
Trees 97, 99, and 100 are western redcedar trees in poor health located near the eastern property edge. These trees should not be prioritized for retention because they are unlikely to recover due to the species susceptibility to construction impacts.

Photograph 3. Trees 97-99. Trees 97 and 99 are western redcedars in poor health.

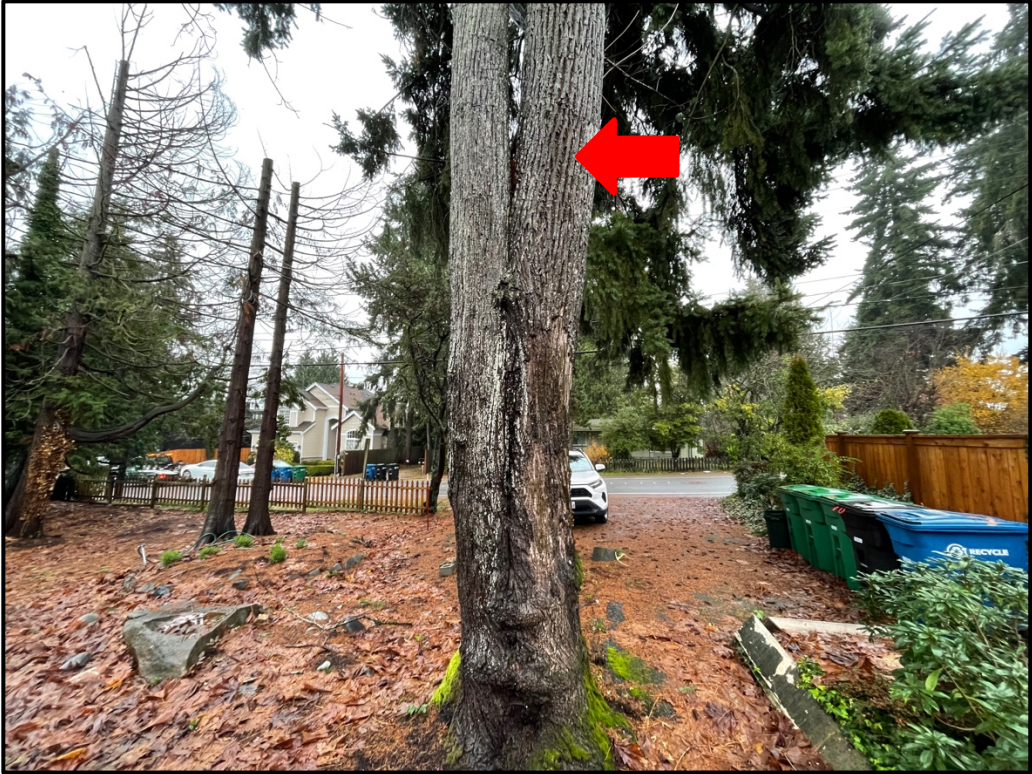
Tree 101 is a 28-inch bigleaf maple located near the southern property edge. This tree is in good health but is in poor structural condition. This tree is codominant at 8 feet with a narrow union and included bark. The southern stem, which targets the house south of the subject property is poorly attached and poses a risk to the adjacent structure. I recommend mitigating this hazard by reducing the southern stem of the tree and installing a dynamic cable between the two stems to prevent failure.

Photograph 4. The base of tree 101 with a poor union. The southern stem (red arrow) should be reduced to mitigate the hazard posed by this tree to the adjacent house.

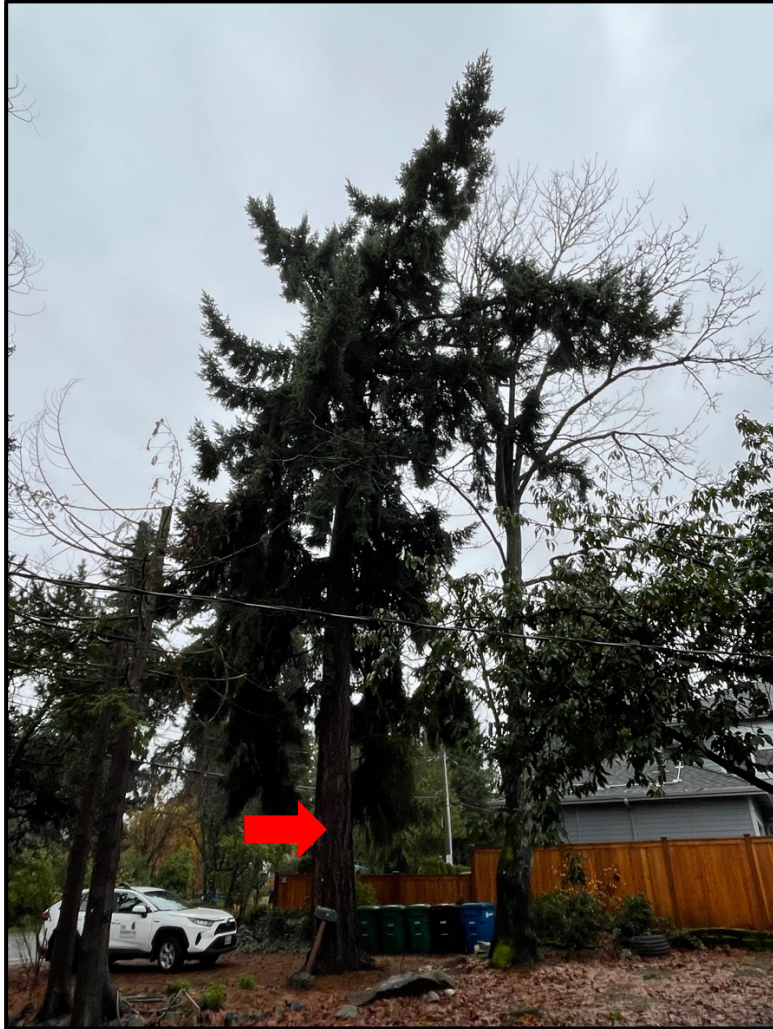
Tree 102 is an exceptional Douglas-fir located near the existing driveway. This tree is in excellent health and fair structural condition, as it has been previously topped. This tree has a high retention value, but the remaining crown should be managed through pruning.

Photograph 5. Tree 102 (red arrow). This tree should be prioritized for retention. Growth in the upper crown should be managed through pruning.
