DOWNSTREAM ANALYSIS
FOR
SINGLE FAMILY RESIDENCE
2419 72ND AVE SE
MERCER ISLAND, WA 98040

May 20, 2024

C2MY Engineers, LLC
P.O. Box 52883
Bellevue, WA 98015-2883
Contact: Choomeng Chin
(206) 451-7856
cmchin.c2my@gmail.com

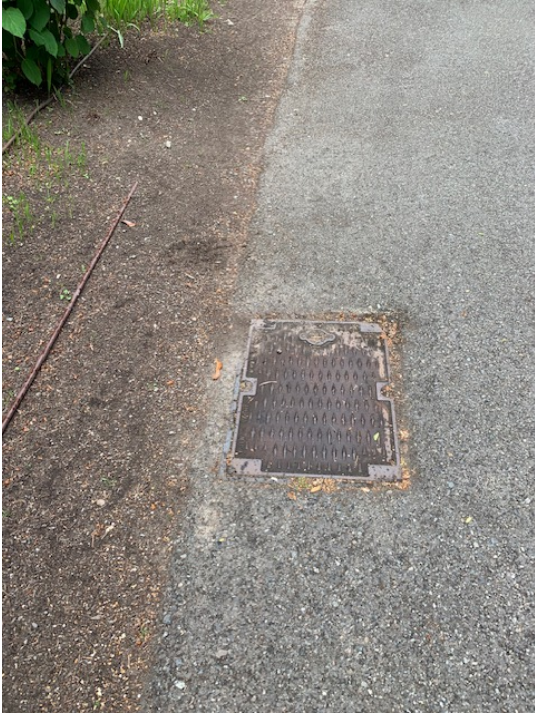
Catch Basin – At point B, Looking Downstream

- Presently, site runoff discharges sheet flow at the east property line (**A**) to the street drainage system and flows northerly. Surface flow enters a Type 1 CB (**B**) with solid grade from an open grate catch basin next to it approximately 109 l.f. from the property (See Figure 5, Downstream Map). It continues in a 12" concrete pipe on the east edge of the street approximately 57 l.f. that connect to the SE 24th St drainage system at point (**C**) without a structure per GIS record. Then, it continues travels easterly approximately 33 l.f. to a CB (**D**) with vaned grate located near the southeast corner of the intersection, it then continues to another catch basin (**E**) with vaned grate located at the curb line approximately 22 l.f. From here, runoff travels approximately 85 l.f. in the same direction to a CB (**F**) with grate located at the driveway approach. Then, it continues approximately for another 22 l.f. to a solid grate CB (**G**) located at another driveway approach. At this point runoff continues through multiple catch basins (**H** to **L**) with solid grate located at the asphalt sidewalk approximately 502 l.f. to the southwest corner intersection of 74th Ave SE and SE 24th St. It then crosses 74th Ave SE approximately 56 l.f. to another solid grate catch basin (**M**) located at the sidewalk. From here, it continues at the similar fashion approximately 146 l.f. to another solid grate CB (point **N**). Then , it continues approximately 59 l.f. to another catch basin (**O**) with vaned grate located at the curb line. From here, it continues to another solid grate CB (**P**) approximately 38 l.f. It

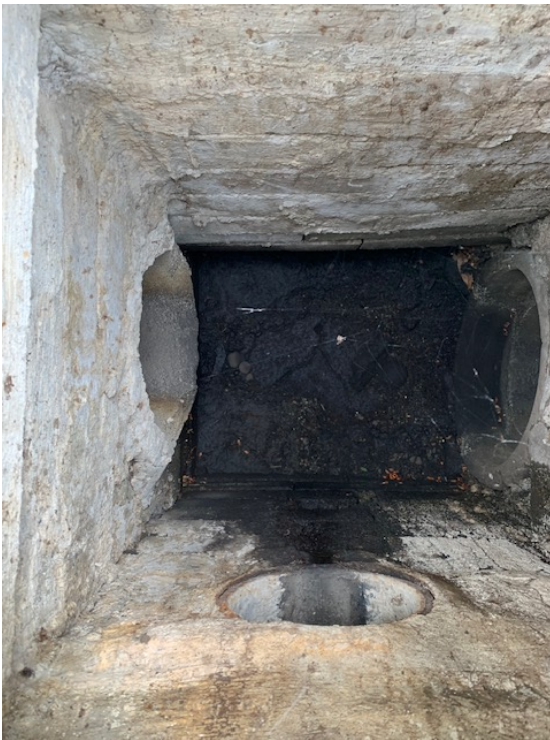
The downstream drainage system as described above is not prone to stream bank erosion, siltation, and slide and does not threaten destruction of aquatic habitats. Catch basins as observed are mostly clean and sediment in the catch basins are below the invert of the outlet pipes. No open ditch existed along the route. Due to the fairly steep slope of the analysis route, the conveyance pipes system does not appear to have a capacity problem or show any sign of overtopping in any of the structure.

Inside Catch Basin – At Point B

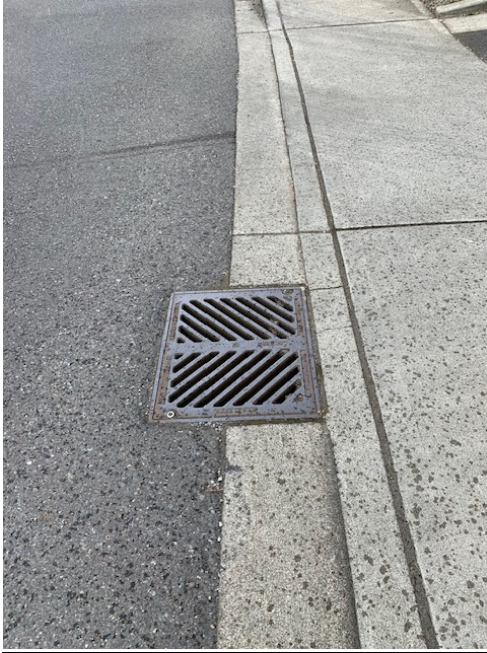
Catch Basin At Point Q at driveway

then enters another catch basin (Q) approximately 23 l.f. located at the curb line of a driveway. It continues easterly approximately 22 l.f. to yet another solid grade CB (R) near the curb line. Then, it travels approximately 126 l.f. to another CB (S) with vaned grate located at the curb line. At this point, runoff continues southeasterly direction approximately 84 l.f. to a Type II CB (T) with round solid grate. Runoff continues southeasterly approximately 46 l.f. to discharge to a pipe water course in a Type II CB (U) with open round grate where the analysis is terminated for a total approximately distance of 1,380 l.f. During the downstream drainage field visit, no drainage issues were observed and no areas of any existing or potential major drainage problems were apparent.
