ARBORIST REPORT
For:
NATHAN KORPELA
8441 SE 33rd Place Mercer Island, WA

September 11th, 2023

Our assignment is to prepare a written report on current tree conditions which is to be filed with the preliminary permit application for redevelopment of the subject parcel and identify the potential for tree retention in the proposed layout.

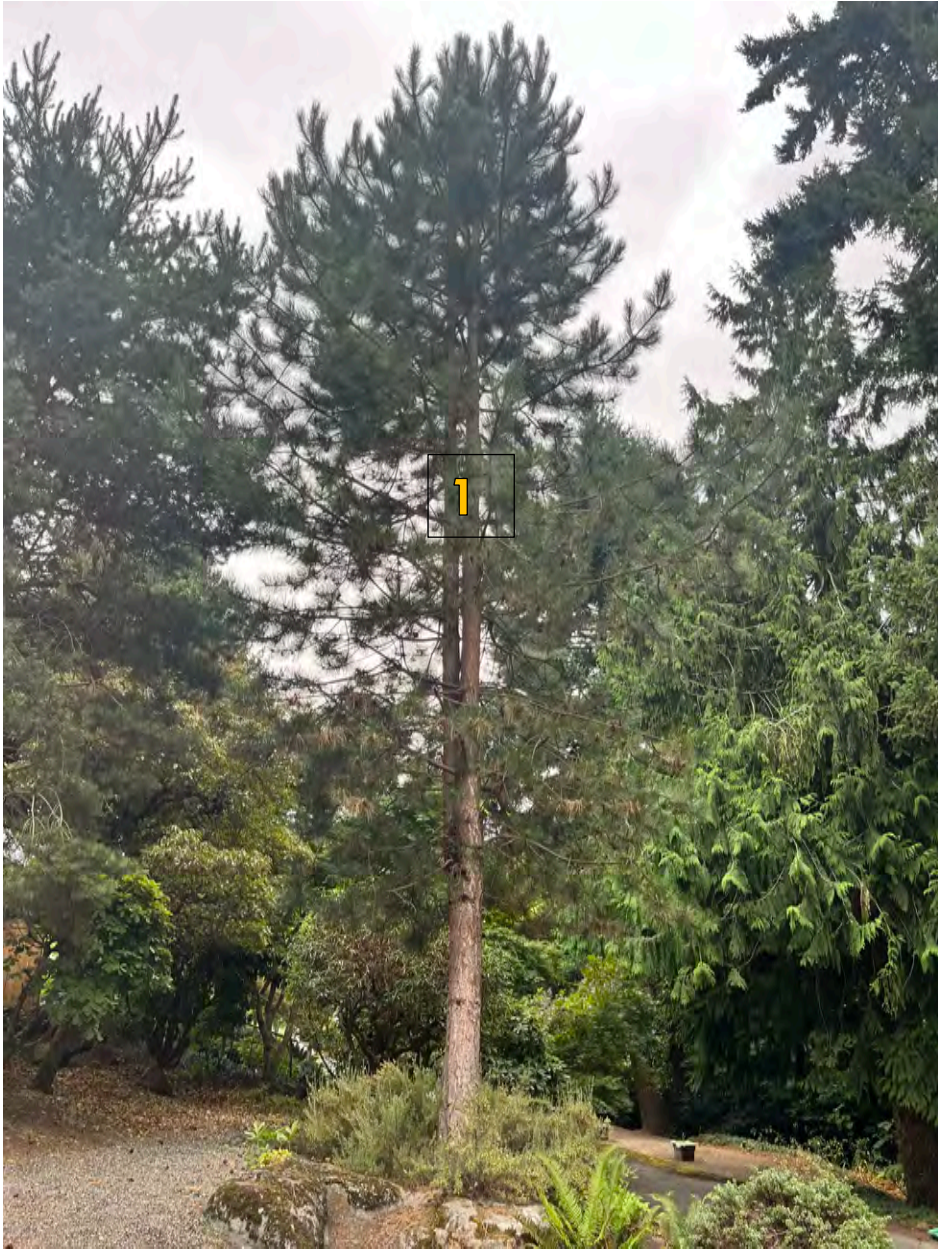
Tree #1 is a Japanese black pine (*Pinus thunbergia*) with a DBH of 10.8 inches found on a slope south of the driveway leading the existing home. This tree is in good health and structural condition. Its trunk is forked into codominant stems joined at ten feet. This tree is 17 feet west of the existing garage.

PHOTO 1: Tree #1 viewed from the north. Note codominant stems.

The site plan shows Trees #1 and #2 are in conflict with the proposed site improvements and will need to be removed to accomplish the development goals. Tree #3 is not a Regulated Tree due to its size. It is in poor condition and should be removed. All other Regulated and Neighboring Trees are to be protected throughout the construction period.

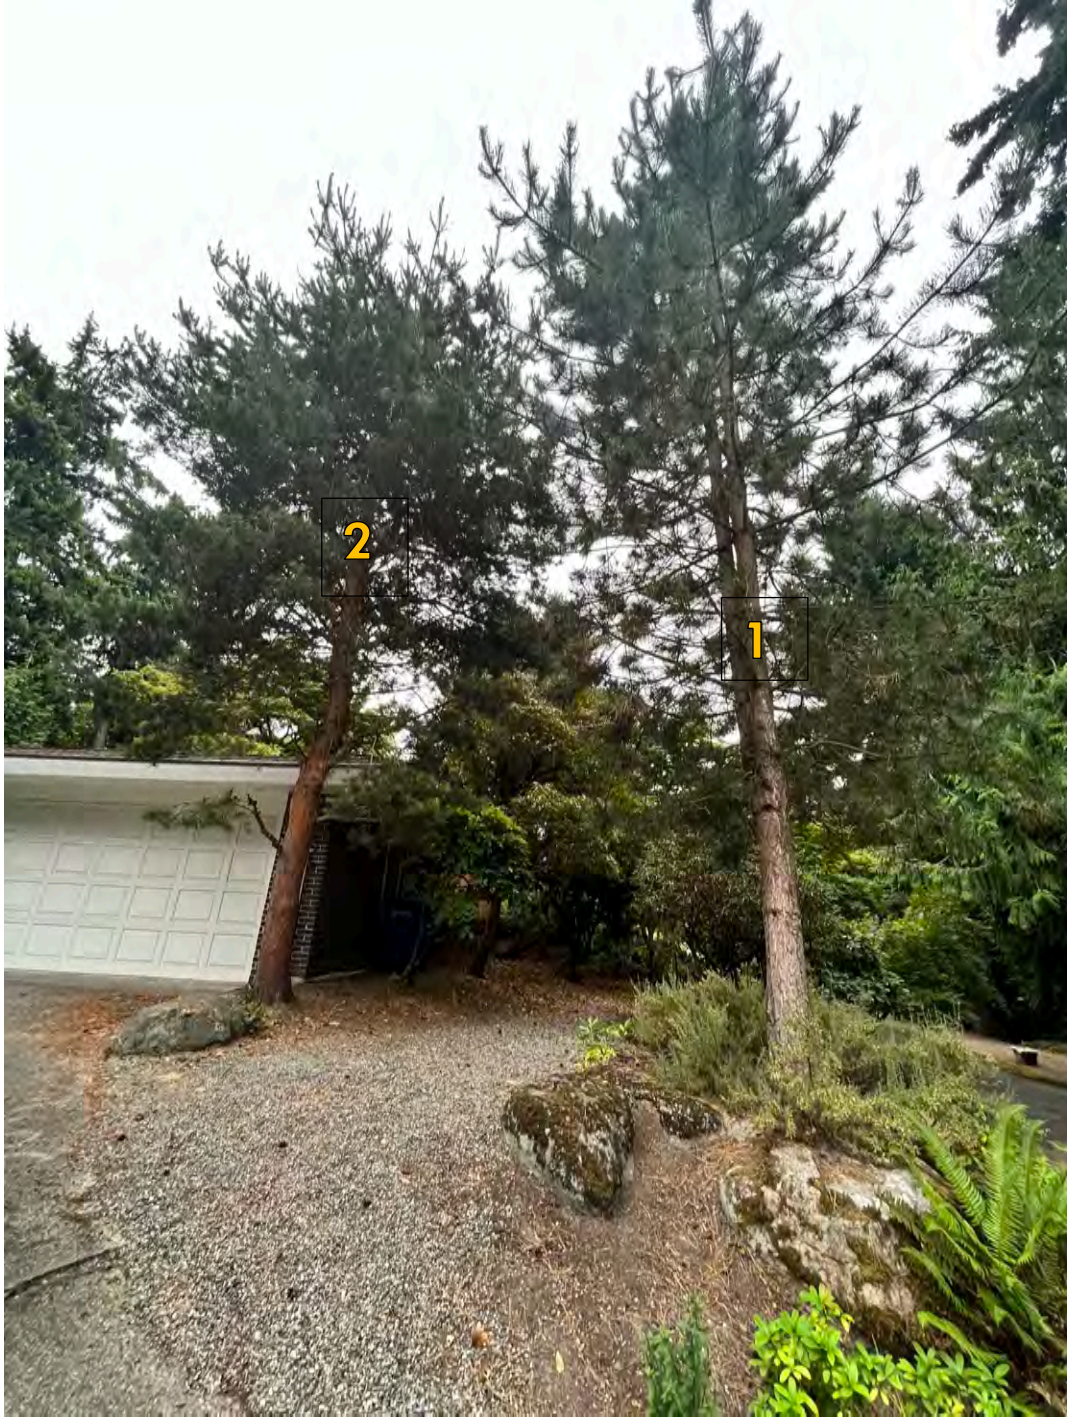
Tree #2 is a Scot's pine (*Pinus sylvestris*) with a DBH of 10.7 inches found 4.5 feet west of the existing garage. This tree is in good health and structural condition. It will likely need to be removed to accomplish the development goals.

PHOTO 2: Trees #1, #2 viewed from the north. Note proximity to existing garage

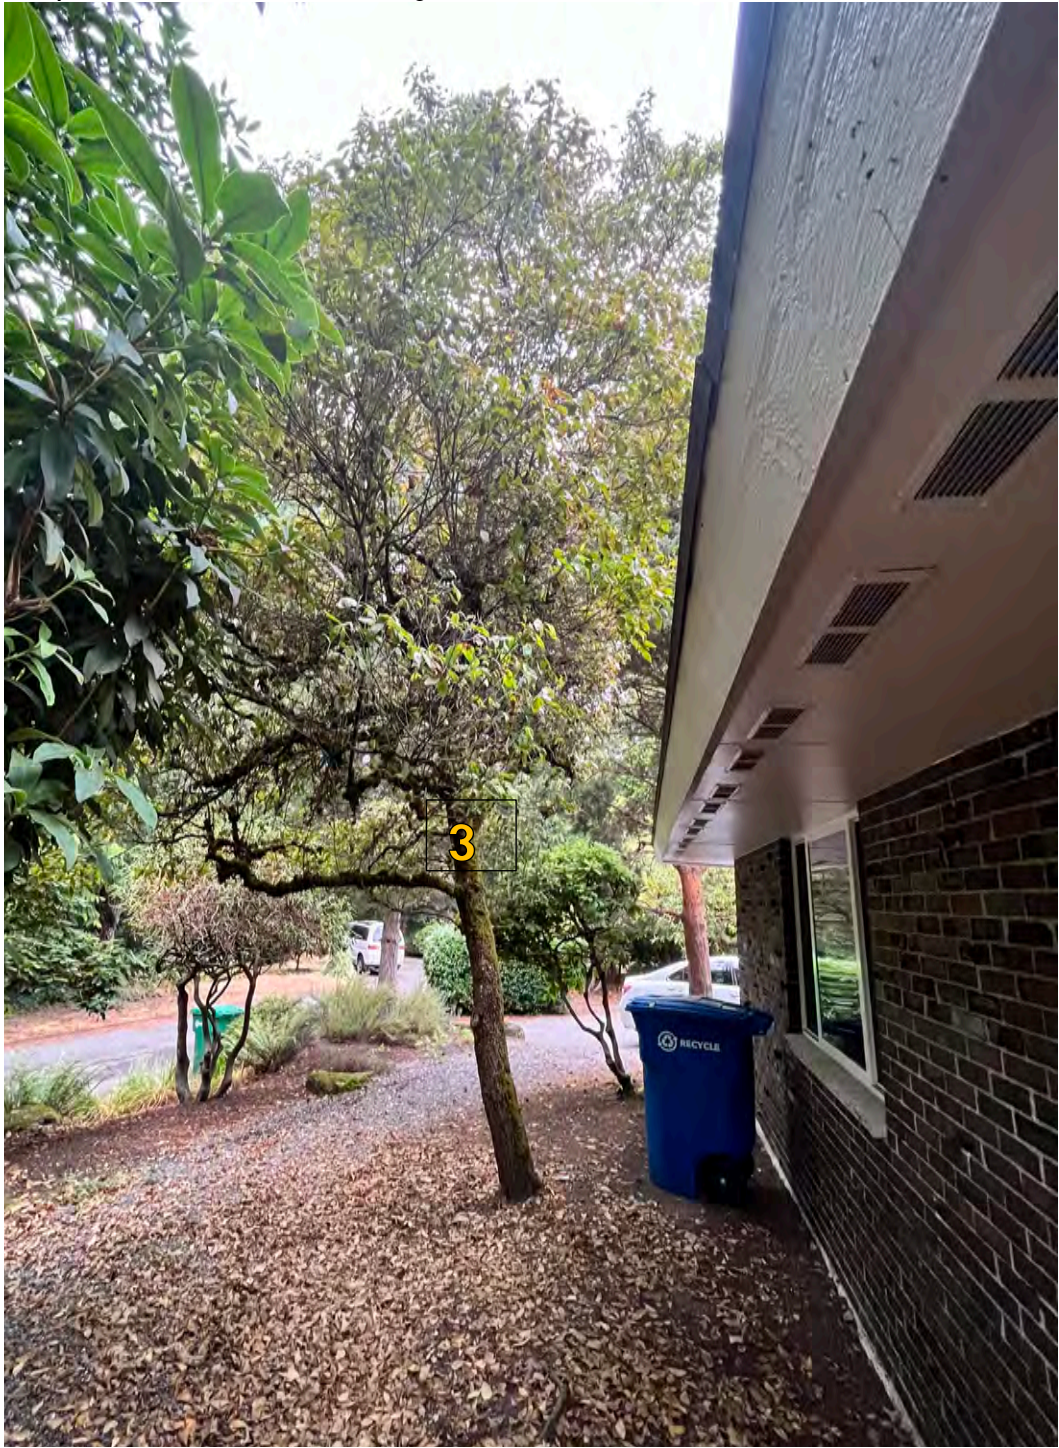
Tree #3 is a Florida dogwood (*Cornus florida*) with a DBH of 6.8 inches found five feet south of the existing house. This tree is in poor health and structural condition due to a fungal infection (anthracnose) and extensive pruning. This is not a 'Regulated Tree' due to its size, and it is not likely to remain viable in the long term.

PHOTO 3: Poor condition dogwood Tree #3 viewed from the south. Note lack of live foliage.

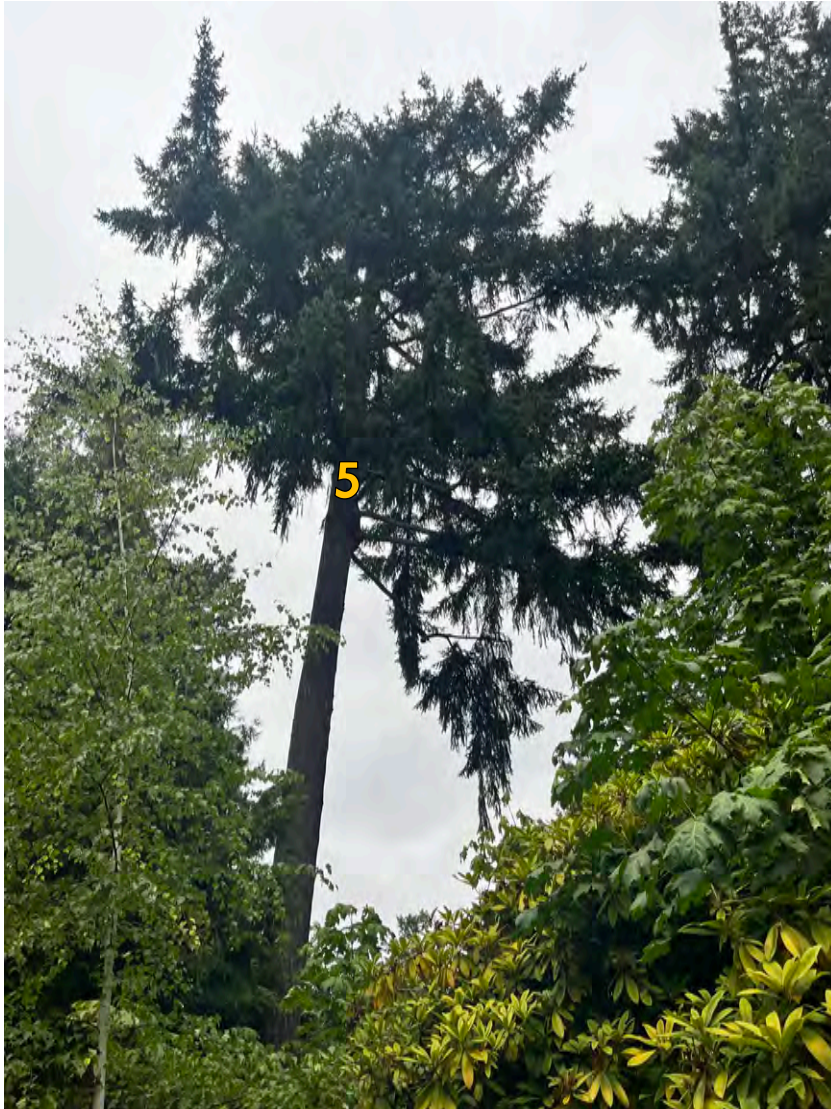
Tree #5 is a remnant old-growth Douglas-fir (*Pseudotsuga menziesii*) with a DBH of 63 inches found on a steep slope near the east boundary of the subject property. This tree is in good health and fair structural condition. The top has blown out at approximately 60 feet and long, over-extended branches reach to the south and east. several codominant leaders have emerged to form the crown. This tree has a strong taper and well-developed root flare and is the dominant tree in the area. Further loss of limbs can be expected in high winds or heavy loading.

PHOTO 4: Tree 5 viewed from the southwest. Note overextended branches and low live crown ratio

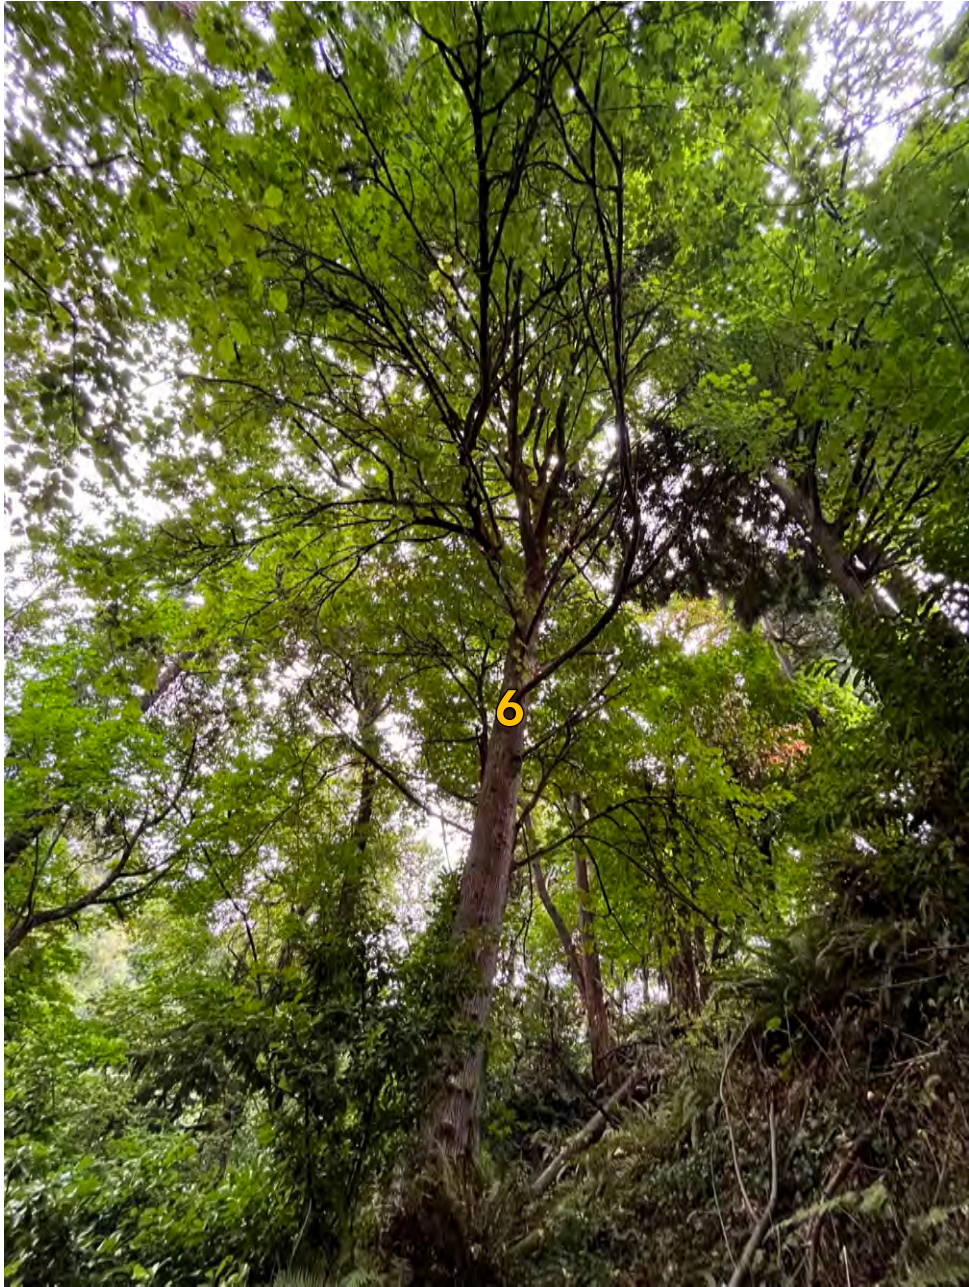
Trees #6, 7, 8, and 9 comprise a group of big leaf maple (*Acer macrophyllum*) found near the southeast property corner. Tree #6 has a DBH of 32.8 inches and is generally healthy. It is growing on a steep slope and is in fair structural condition with a very large overextended crown. A corrugated drain pipe from the house was found just north of its root flare. Loss of limbs can be expected in high winds or heavy loading.

PHOTO 5: Tree #6 viewed from the northeast. Note long overextended branches.

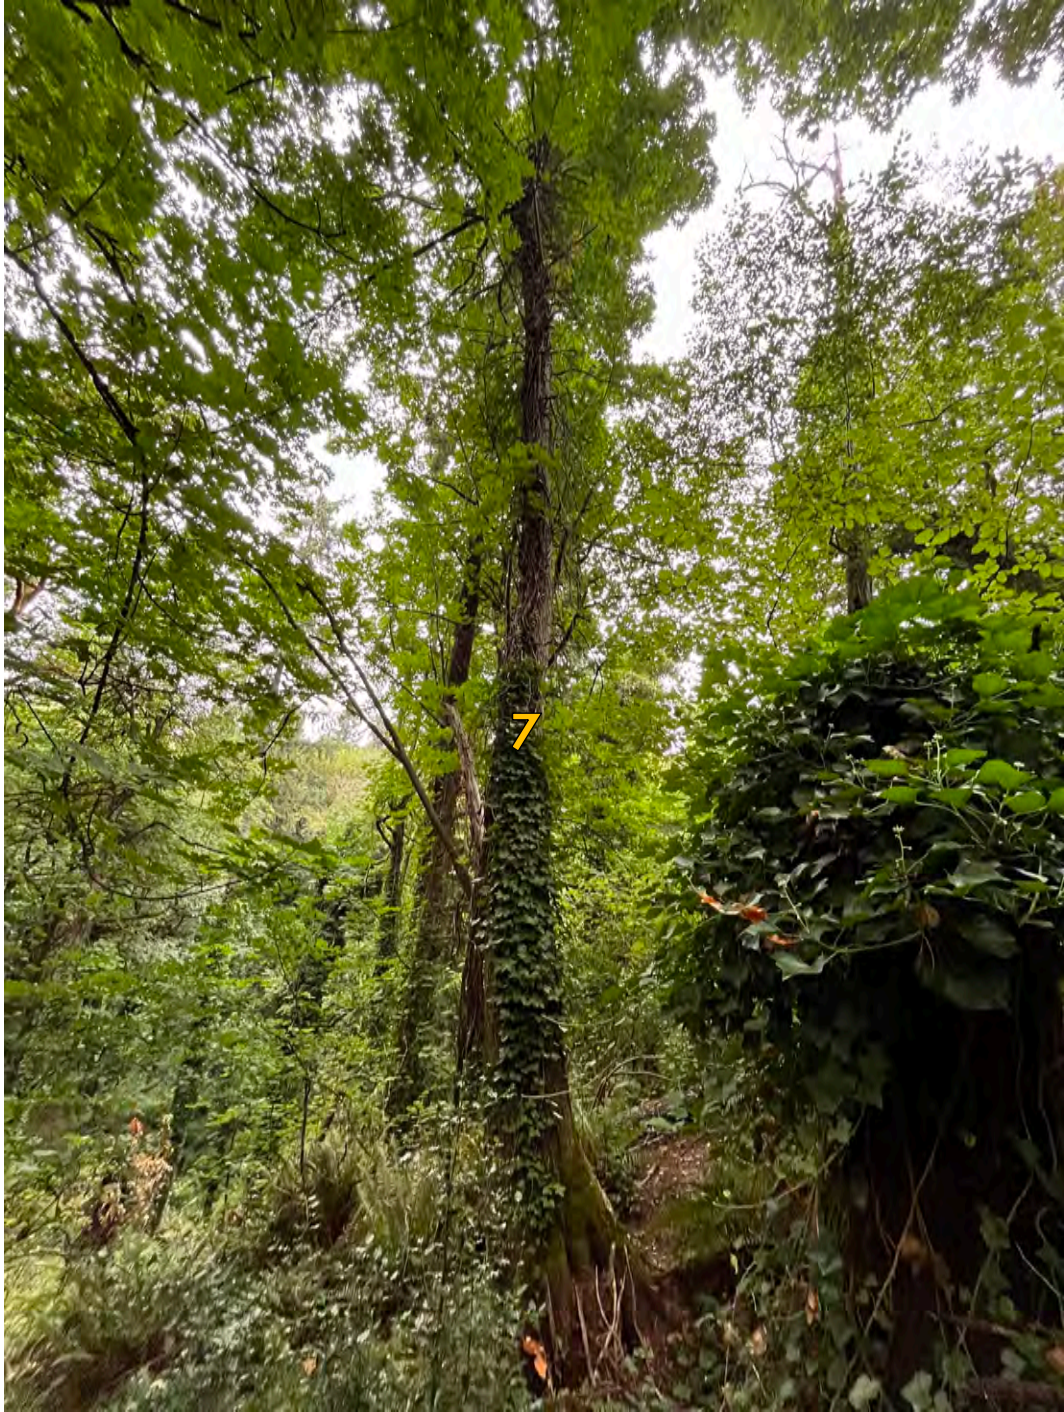
Tree #7 is a big leaf maple in fair-poor health condition with a DBH of 13 inches. This tree is dominated by the adjacent larger trees in the grove. Its crown is mostly lost to windthrow and a large codominant leader is dead. A column of decay extends into the root flare.

PHOTO 6: Tree #7 viewed from the northeast. Note large dead branches.

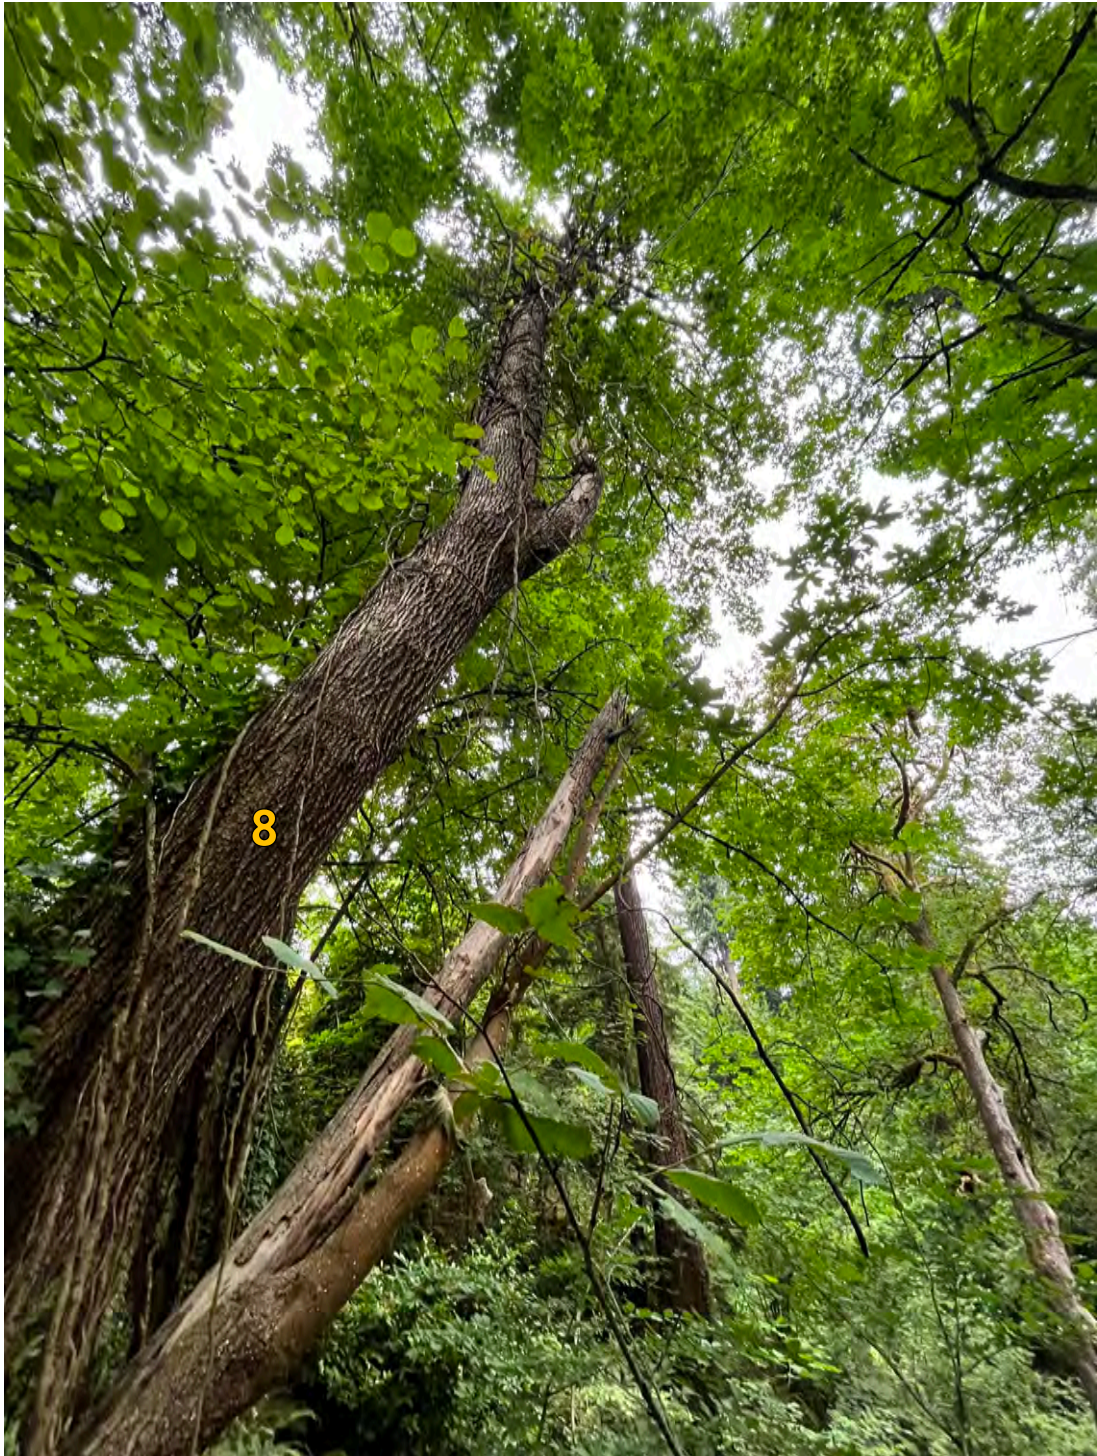
Tree #8 is a big leaf maple in fair-poor health condition with a DBH of 24 inches found near the southeast corner of the property. Large dead and broken stems are present on the east side with decay extending through the trunk. Its crown is off-balance to the east.

PHOTO 7: Tree #8 viewed from the south. Note large dead codominant leader and off-balance crown.

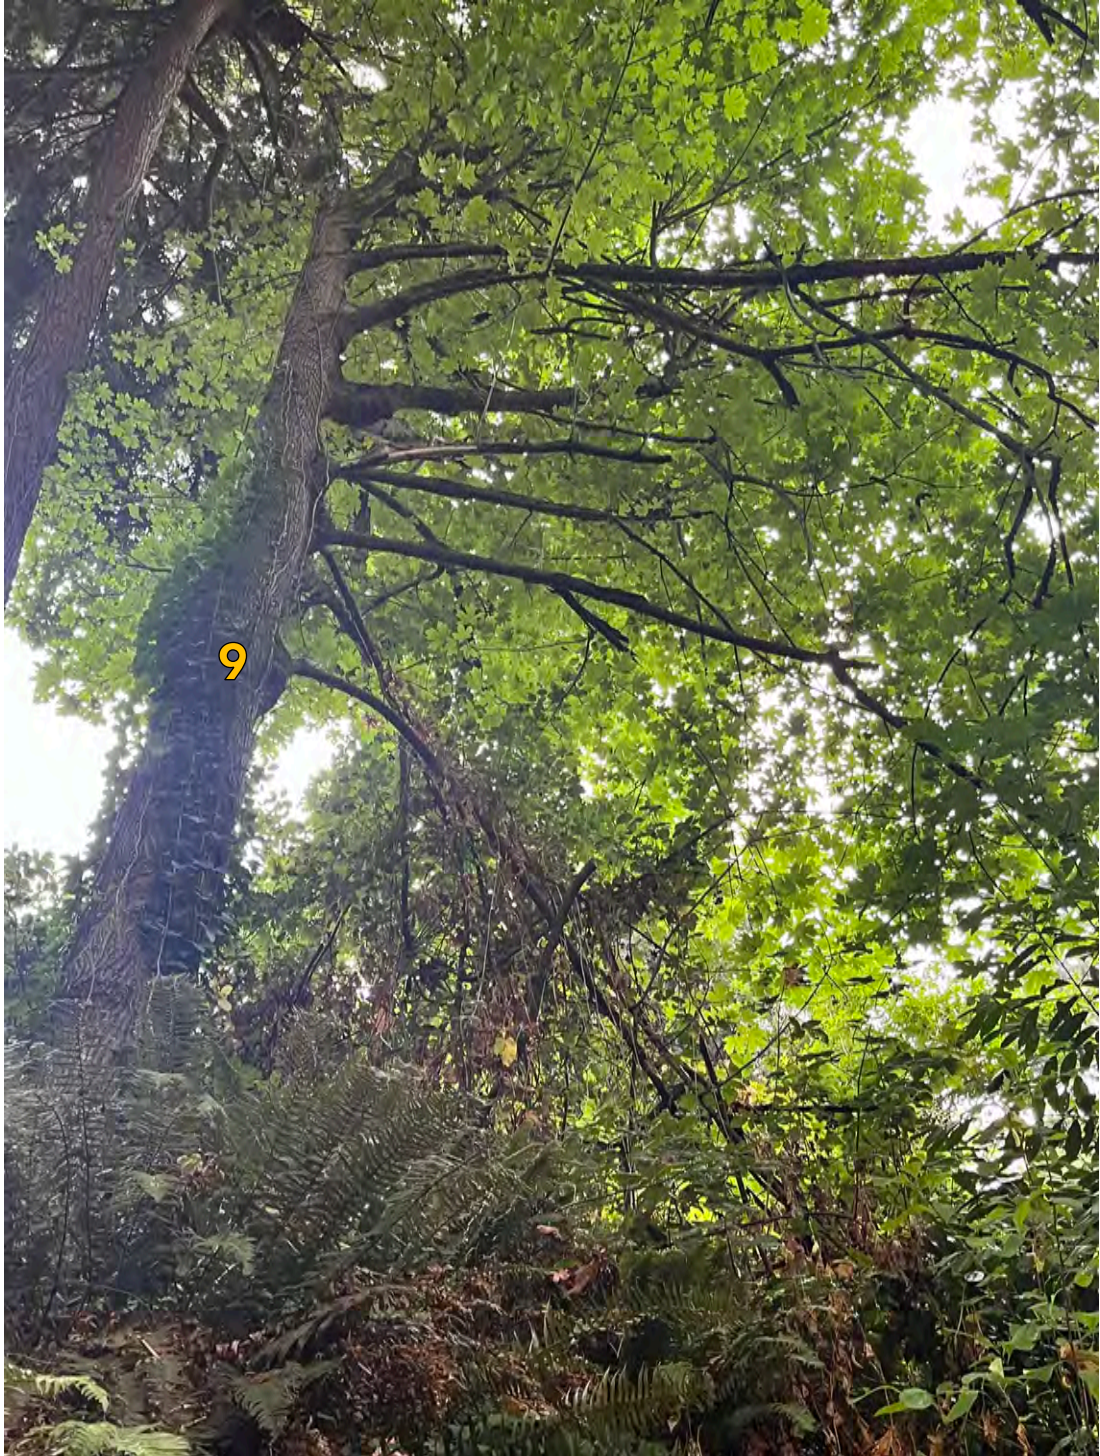
Tree #9 is a big leaf maple with a DBH of 19 inches found near the south property line. This tree is in fair health and structural condition. Its top has blown out and it is dominated by a neighboring Douglas-fir which has resulted in large lateral branches extending to the north.

PHOTO 8: Tree #9 viewed from the east. Note missing top and long, overextended branches.

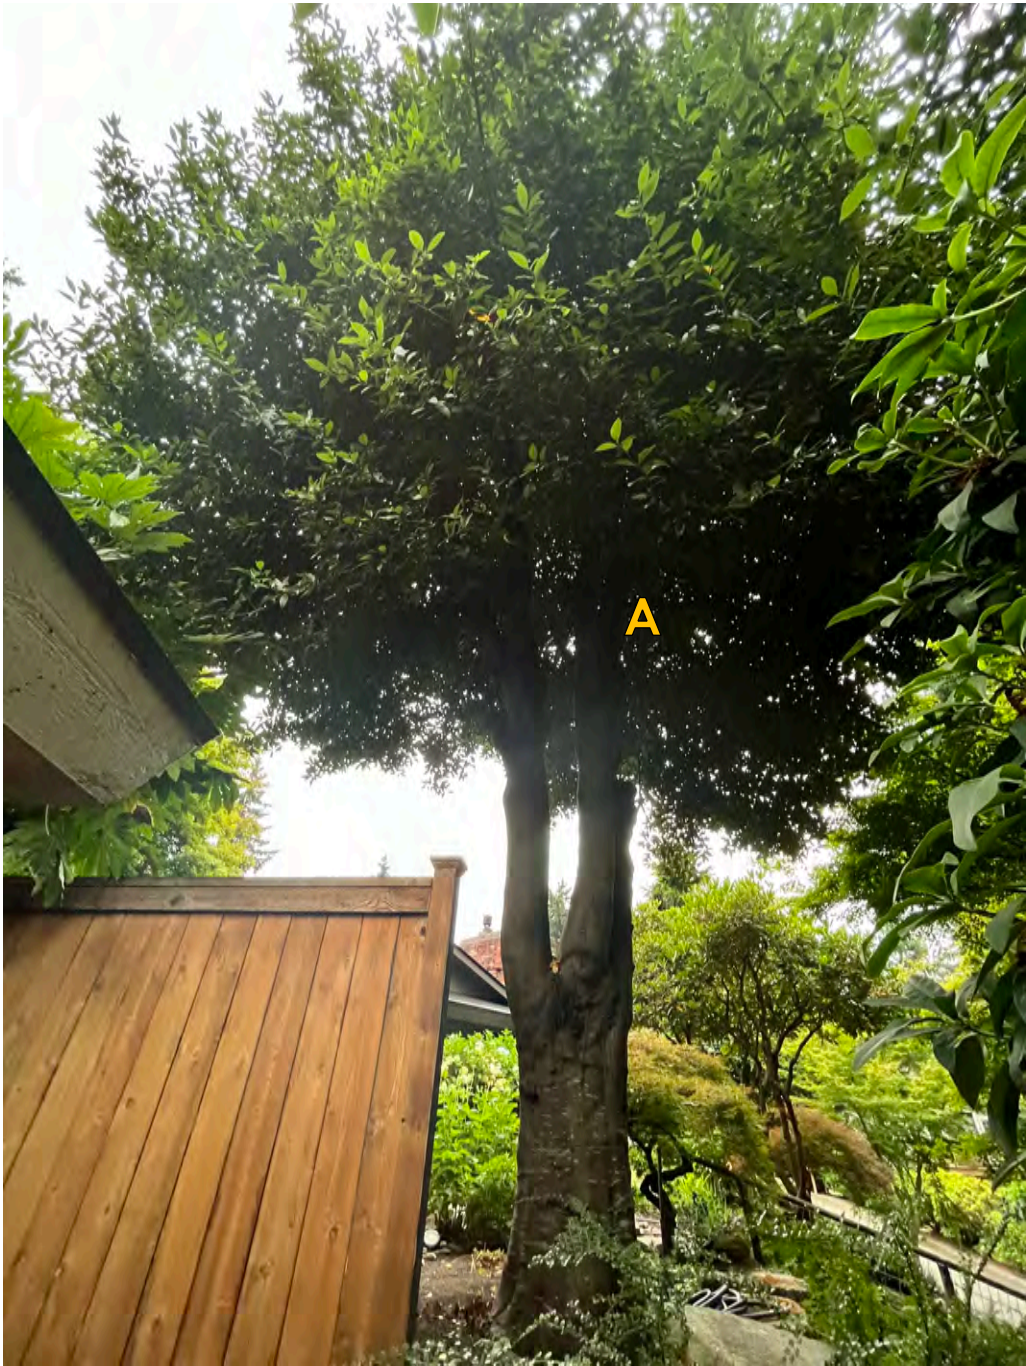
Tree #A is a Portuguese laurel (*Prunus lusitanica*) with three codominant stems for a calculated DBH of 13.8 inches. This tree is in good health and fair structural condition. It is located south of the subject property beyond a stone retaining wall. It is unlikely any significant roots of this tree extend into the construction zone.

PHOTO 9: Neighboring Tree #A viewed from the north. Note codominant trunks.

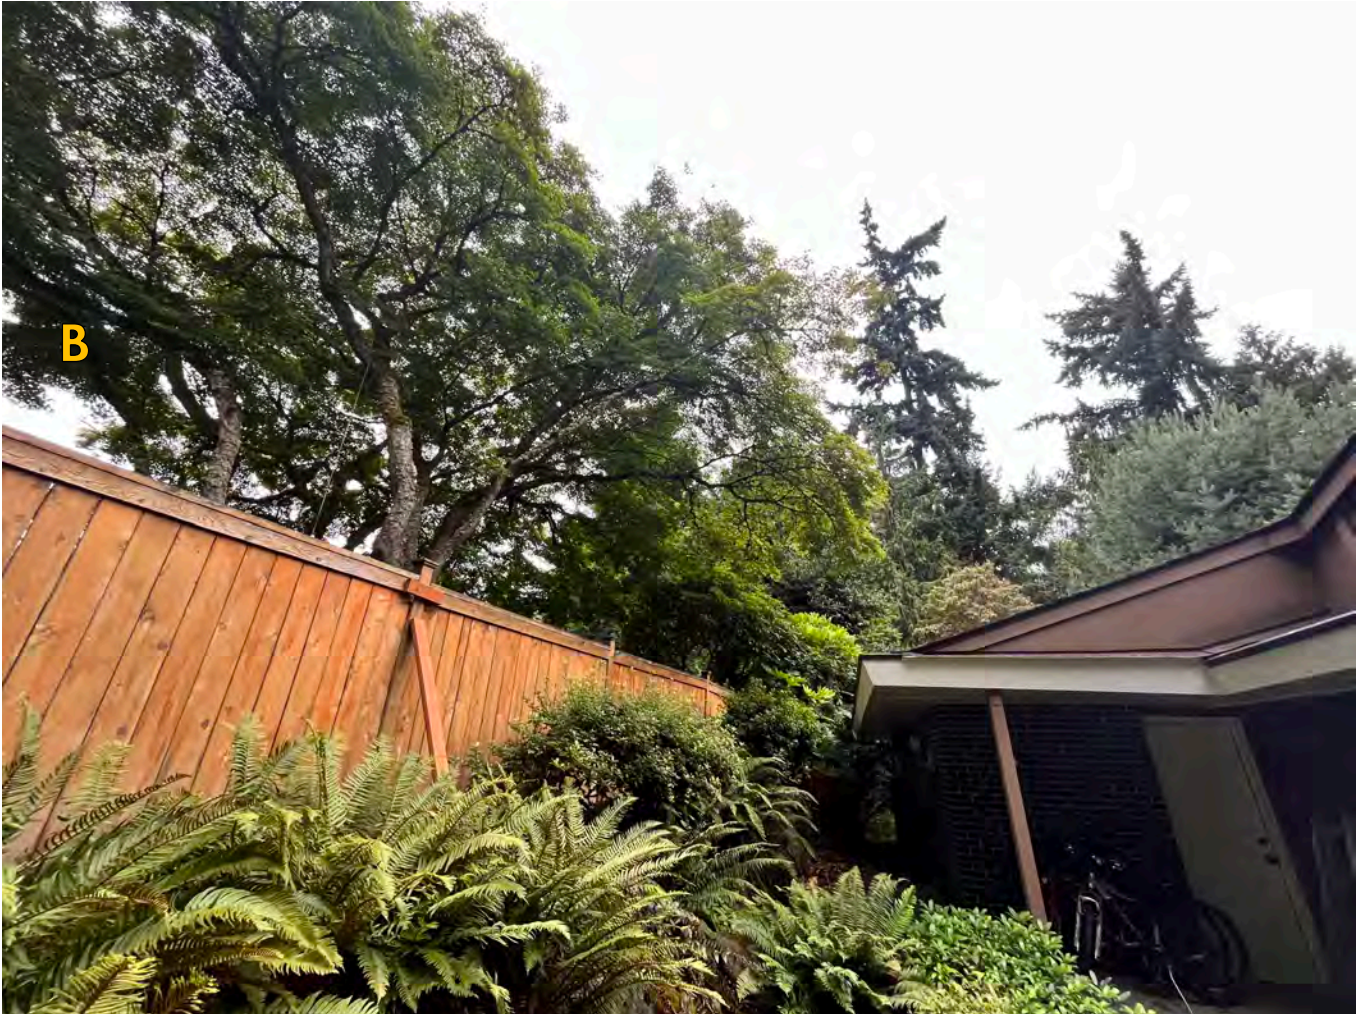
Tree #B is a Japanese maple (*Acer palmatum*) in good health and fair structural condition. This tree has four codominant trunks with a calculated DBH of 15 inches. It is located beyond a rock retaining wall on the subject property six feet to the north of this tree. Its lowest branch slightly overhangs the existing house six feet above the south gutter line.

PHOTO 10: Neighboring Tree #B viewed from the northeast. Note large pruning wounds.

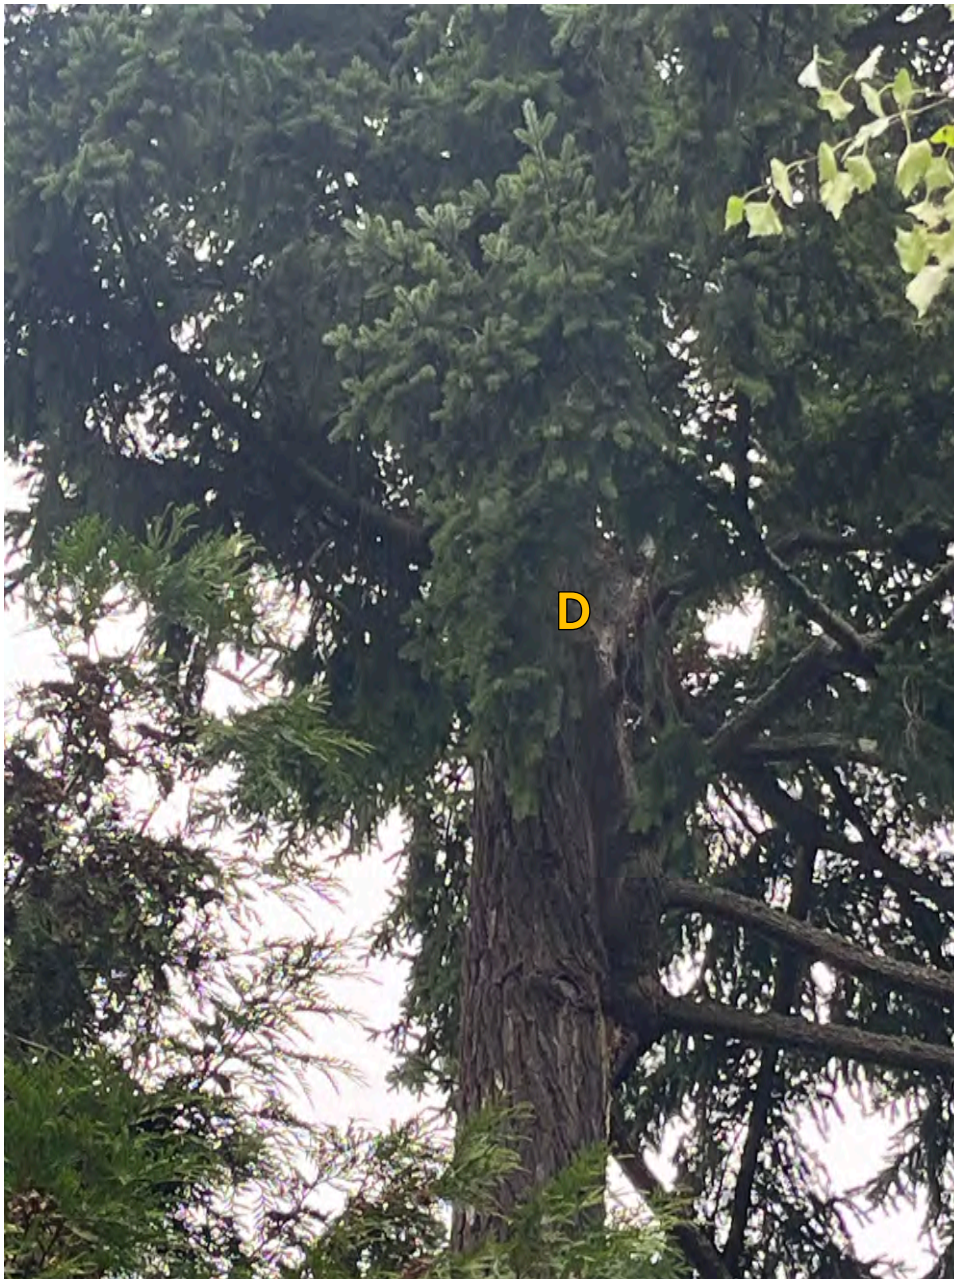
Tree #D is a Douglas-fir with a DBH of 45.4 inches in fair health and structural condition. The top of this tree has blown out resulting in a low live crown ratio. The trunk is rolled under on the east side as a physiologic response to the steep slope. A girdling branch was observed at approximately 80 feet above grade on the south side.

PHOTO 11: Neighboring Tree #D viewed from the south. Note girdling branch in the crown.

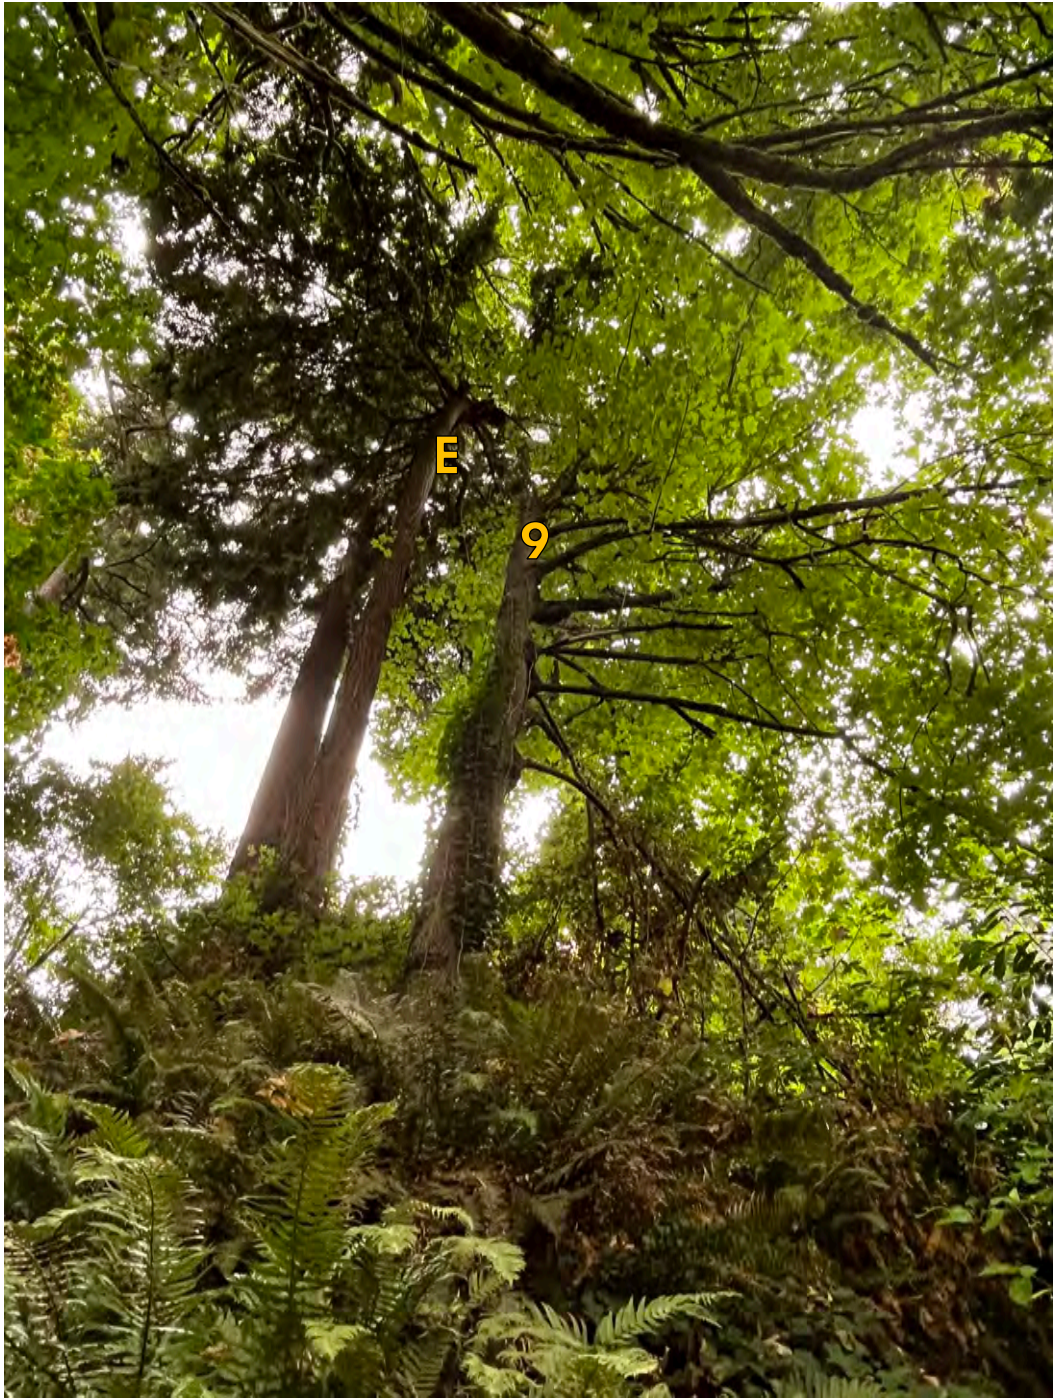
Tree #E is a Douglas-fir with a DBH of 19 inches in fair health and structural condition. The top of this tree has blown out at 55 feet resulting in a low live crown ratio. The canopy mostly extends to the east and west and dominates on-site tree #9 to the north.

PHOTO 12: Neighboring Tree #E and On-site Tree #9 viewed from the east.
