ARBORIST REPORT

8904 SE 58th Street
Mercer Island, WA

March 8, 2024
Updated June 14, 2024

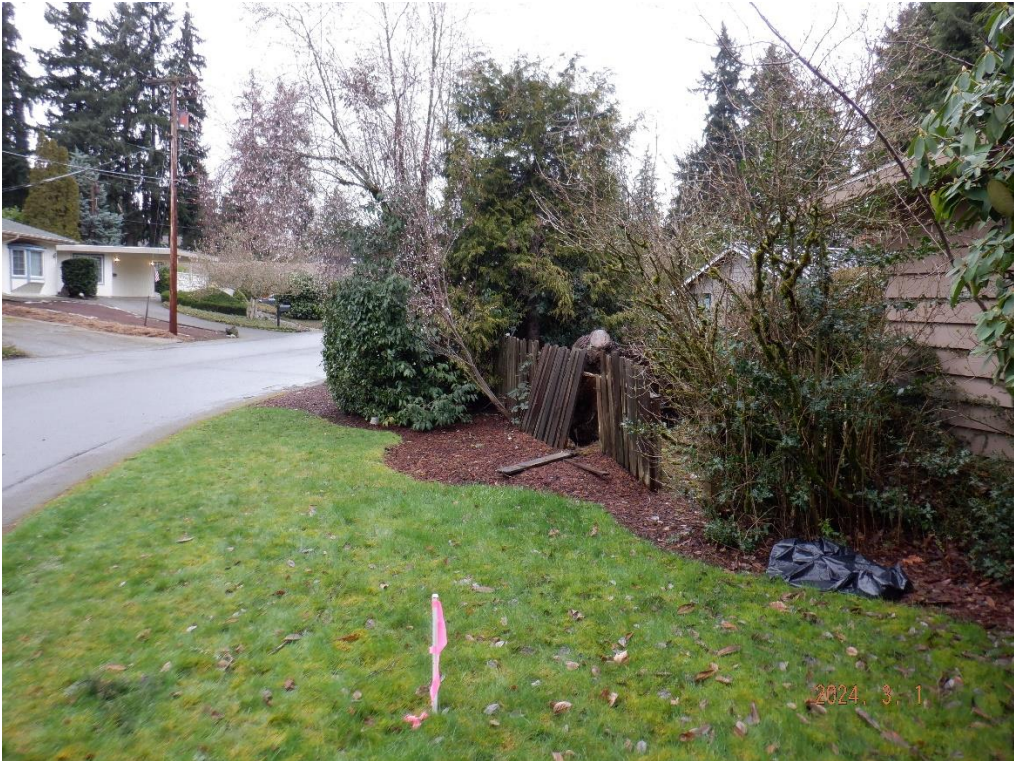
Tree #1 is a young to semi-mature ‘Zebrina’ red cedar. It is of fairly good vigor. Foliage is of normal color and density for this time of year. It has a noticeable lean to the north. It is in fair-to-good condition. It was part of a row with two other cedar trees that have recently failed, see pictures below.

Tree #2 is a young to semi-mature cherry plum, located close to #101. It has a natural lean west away from Tree #1. Vigor appears to be good. Overall condition is rated as fair. It is in need of pruning to remove sucker growth and more uniformly shape the canopy.

Looking north down west property line to Trees #1 and #2

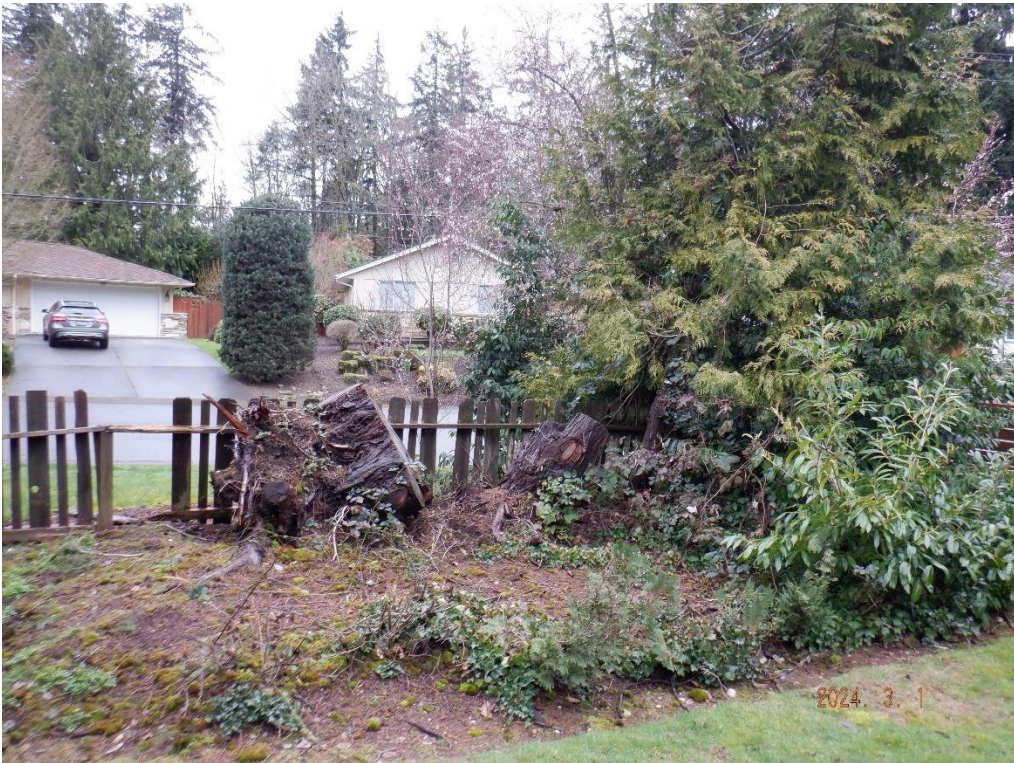
Tree #1 on right

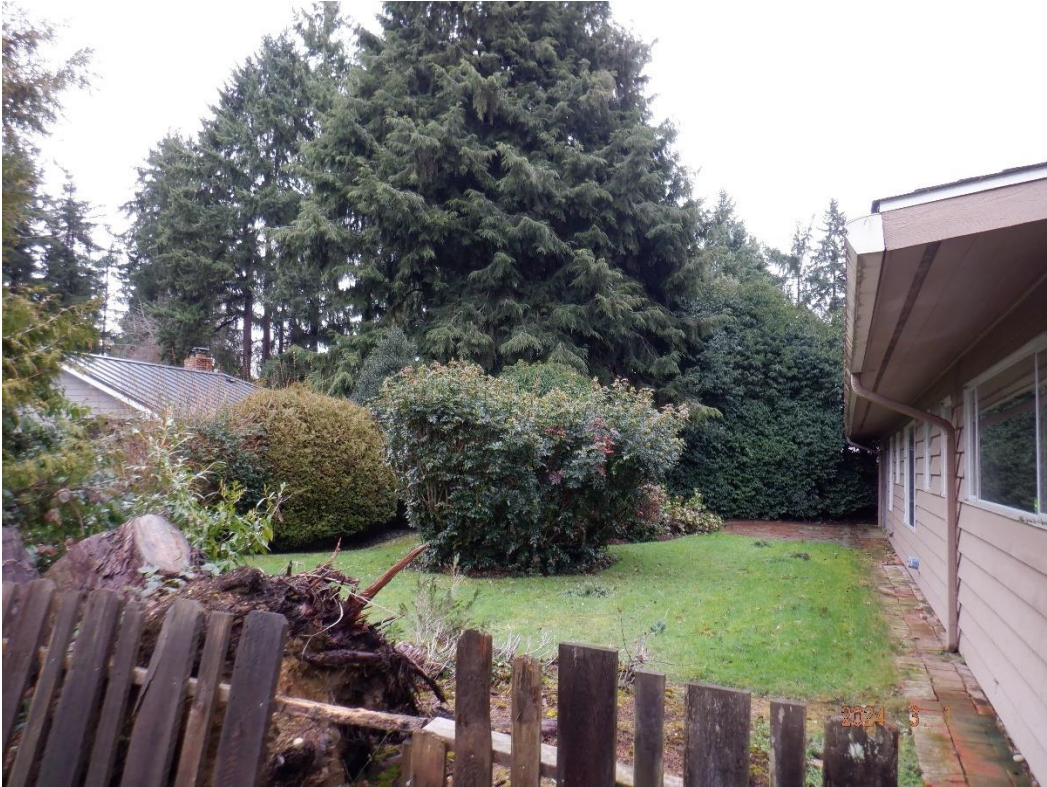
Tree #3 is a semi-mature Western hemlock located close to the north property line. Vigor is good, foliage is of normal color and density. The lower trunk is sound with no outward indicators of any internal decay issues. It is in good condition. The lower trunk is covered with English ivy vines. It has developed large lower lateral limbs.

Trees #4 and #5 are semi-mature Portuguese laurel. These are part of a large hedgerow of laurel adjacent to the east property line in the backyard. These are not 'regulated' trees. Condition is fair.

Looking east across backyard, Trees #3, #4 and #5 in background

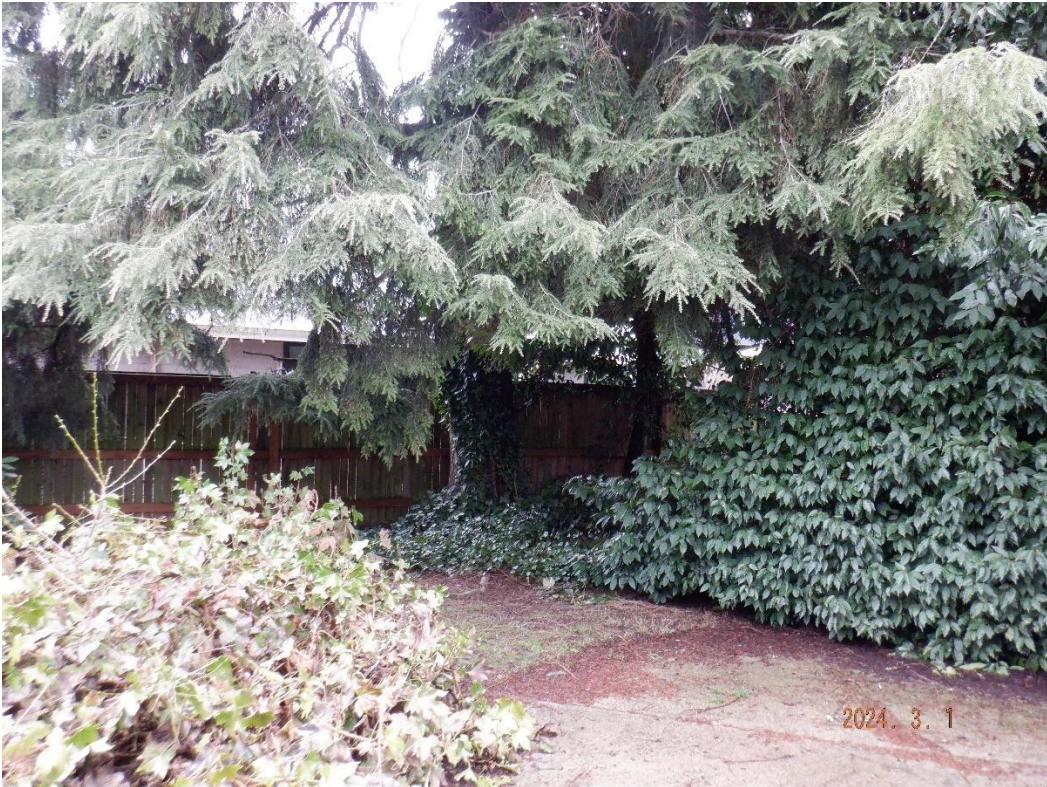
Trees #3 and #4

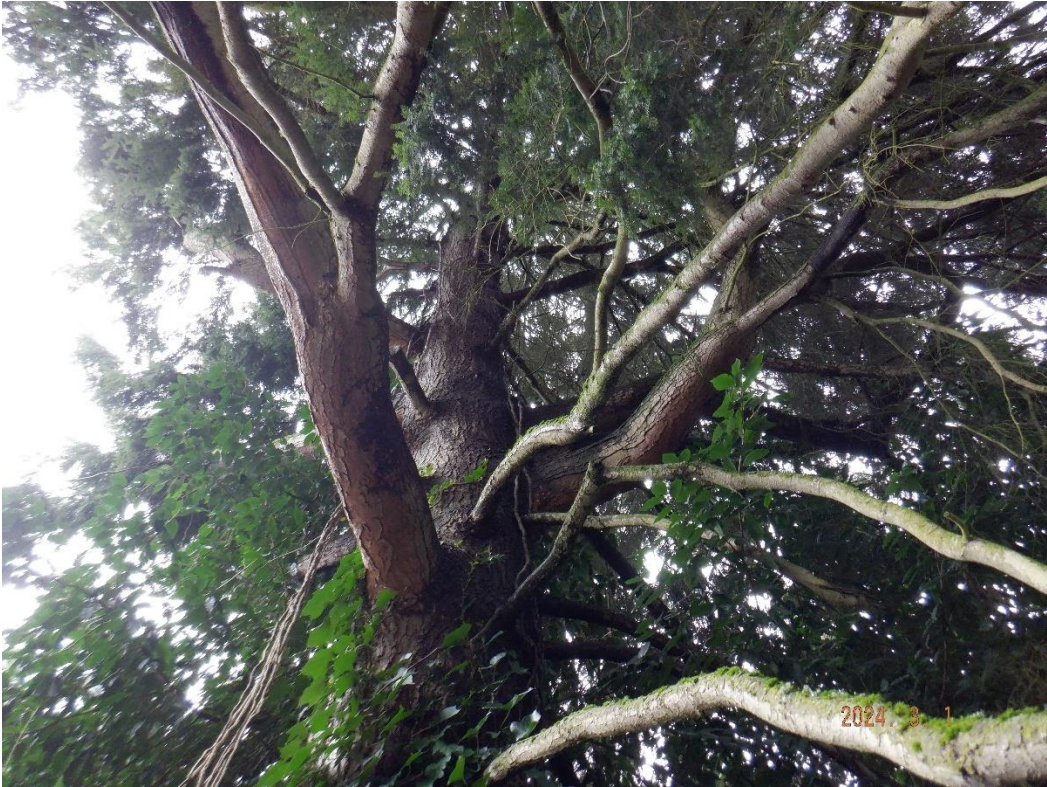
Tree #3, mid-crown

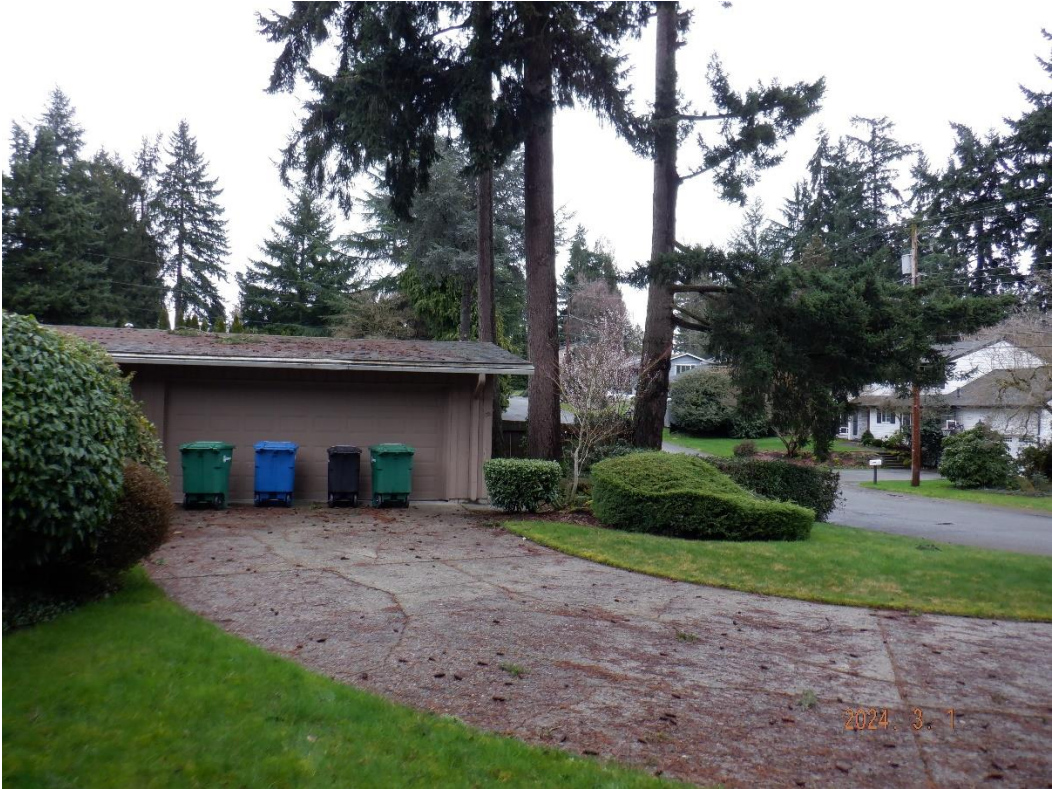
Trees #6 and #7 are semi-mature Douglas fir located close to the southeast corner of the existing structure. Both are of good vigor. #6 has been significantly crown-raised in the past. #7 has a natural lean to the northwest. Both have developed good structural form.

Tree #101 is a semi-mature Douglas fir located next to the southeast property corner, within the street right-of-way. It has been significantly pruned (wind-sailed) in the past. Vigor is fairly good. Condition is 'fair-to-good'.

Looking east across front yard to Trees #6, #7 and #101

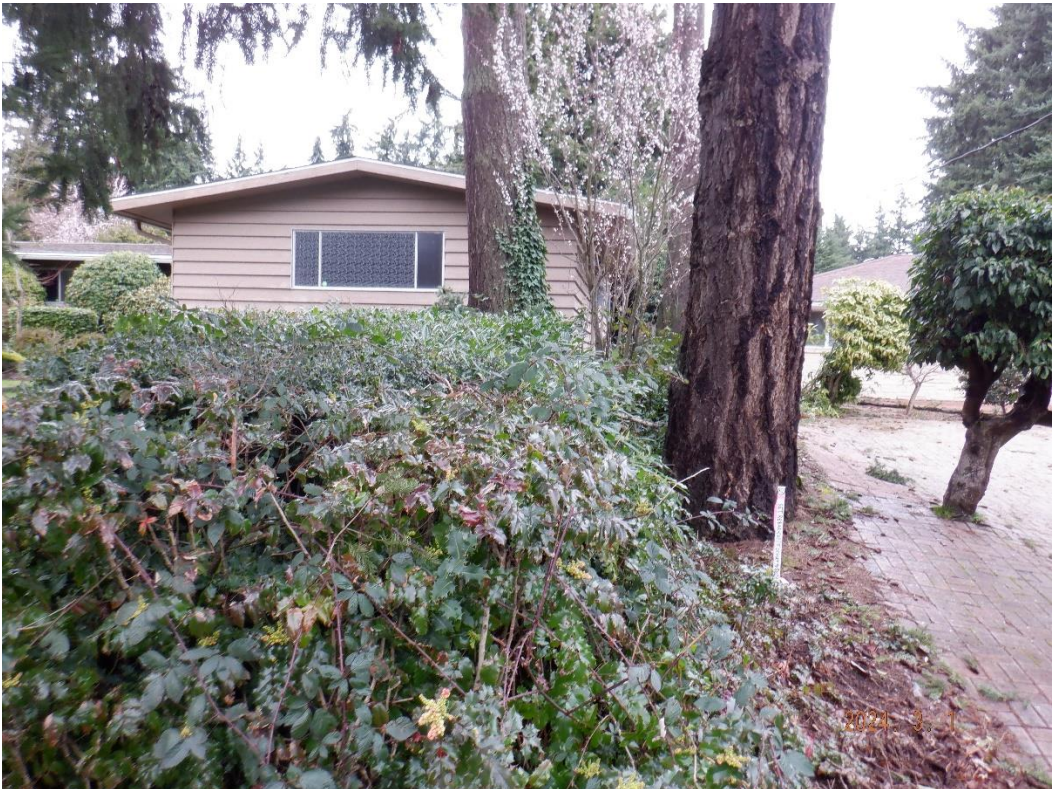
Looking north down east property line, Tree #101 in foreground, #7 on left

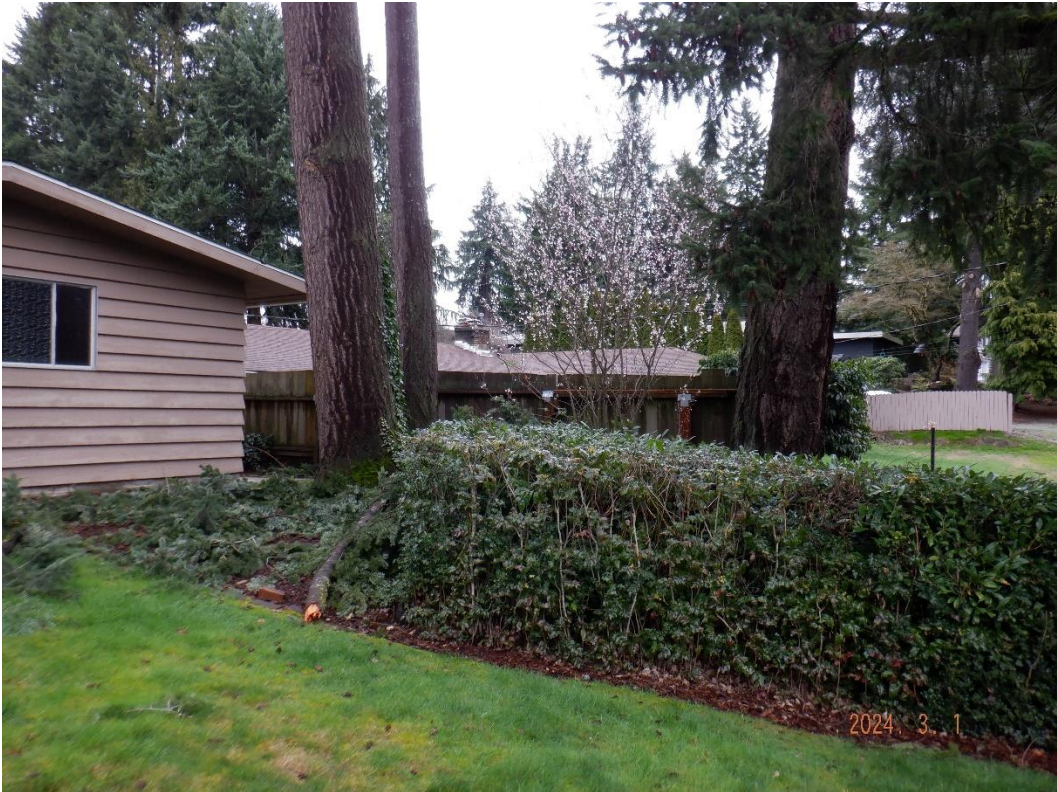
Trees #6, #7 and #101

If the existing concrete walkway adjacent to the existing foundation near Trees #6 and #7 is to be removed; concrete shall be broken up with a manual jackhammer and removed by hand-labor only. Cover any newly exposed ground with a +/- 4-inch layer of coarse arborist wood-chip mulch or hog fuel to protect soils and surface roots.

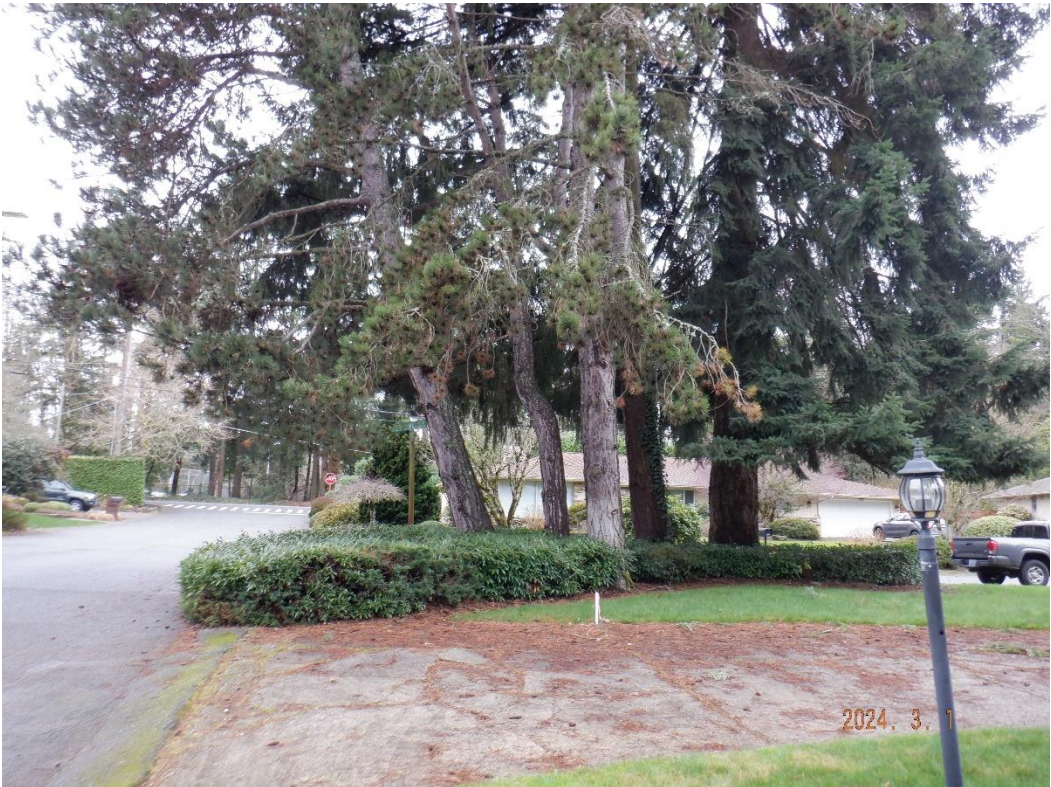
Tree #9 is a semi-mature black or Austrian pine. It is part of the large tree grouping within the street right-of-way. The main trunk forks into three tops or stems. The forked attachments appear sound. Vigor is fairly good. It is in fair-to-good condition.

Trees #102 and #103 are semi-mature to mature Austrian pines. They have developed typical form for the species and appears to be of good vigor. Both have natural leans to the south. #103 is somewhat suppressed by the larger fir tree.

Trees #104 and #105 are semi-mature Douglas fir. Both are of good vigor. No concerning issues were observed. #105 has a forked top. These are in good condition.

Trees #9 and #102 > #105 in street right-of-way

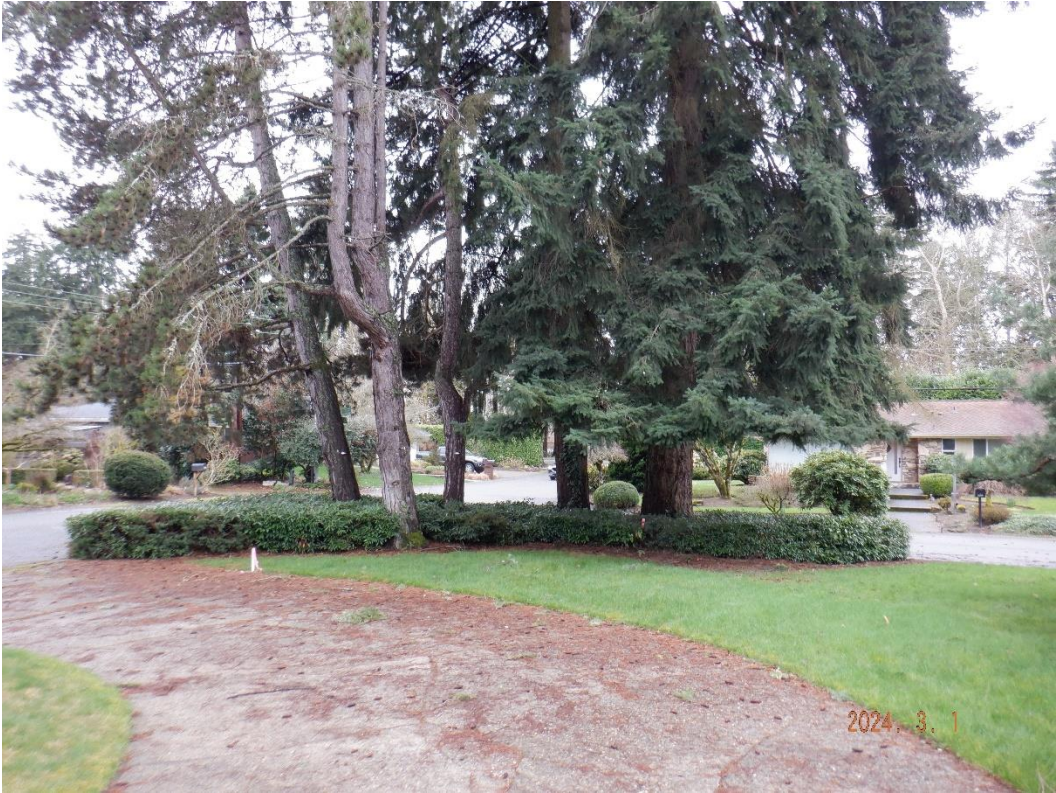
Trees #9 and #102 > #105 in street right-of-way

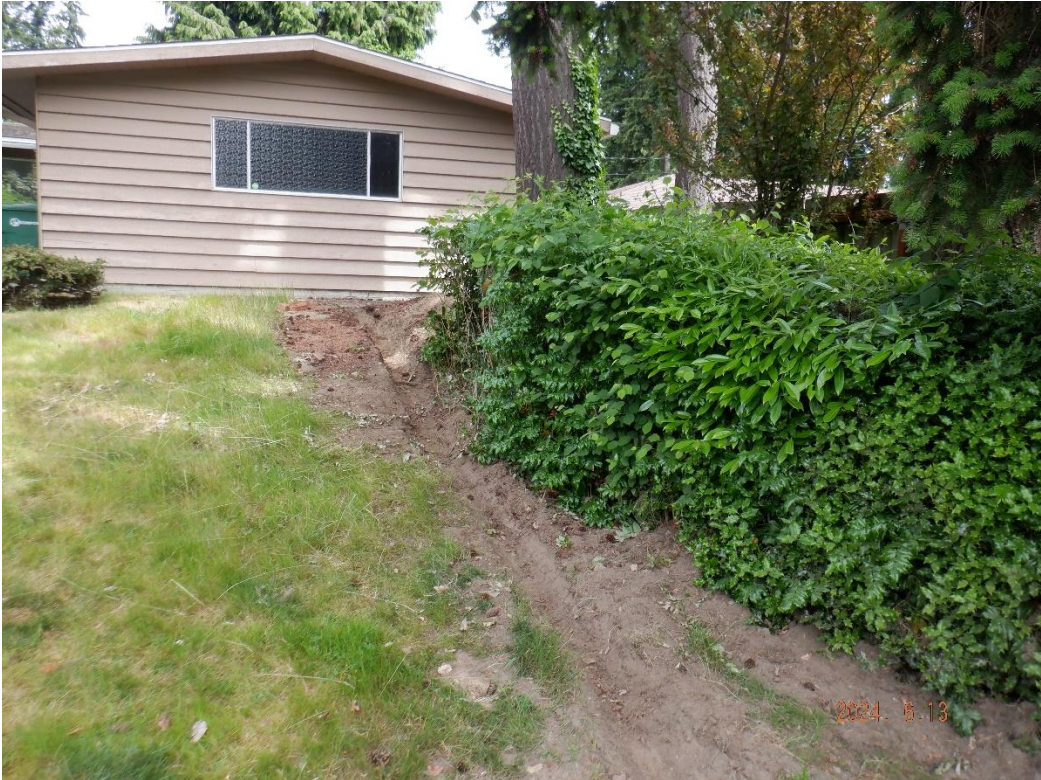
The proposal is to move the driveway to the east side of the lot to facilitate the addition and remodel. This would require impacts within the typical limits of disturbance for Trees #7 and #101. An exploratory trench was hand-excavated at 5-feet from the trunk face of #7 and 12-feet from #101 on the west side at the proposed driveway edge to a depth of 10-inches. That would be the maximum depth required to construct the driveway subbase. No large structural roots were encountered in the trench. Only two small roots, 1-inch and a ½-inch in diameter were encountered, see pictures below. A new pervious driveway could be constructed at this location without having noteworthy impacts on these trees, so long as work is carried out diligently, only excavating what is necessary to prepare the new gravel subbase. This work would remove some feeder roots, but not be expected to have consequential impacts on or threaten long-term tree health per MICC 19.10.080 - Tree protection standards. The project arborist shall be on-site to oversee the driveway excavation work so the necessary precautions can be taken to minimize impacts as much as possible. Phase the tree protection fencing for these trees

Hand-excavated trench at edge of proposed new driveway

as shown on the attached map. Only move the protection fencing to Phase II when work is ready to commence on the driveway.

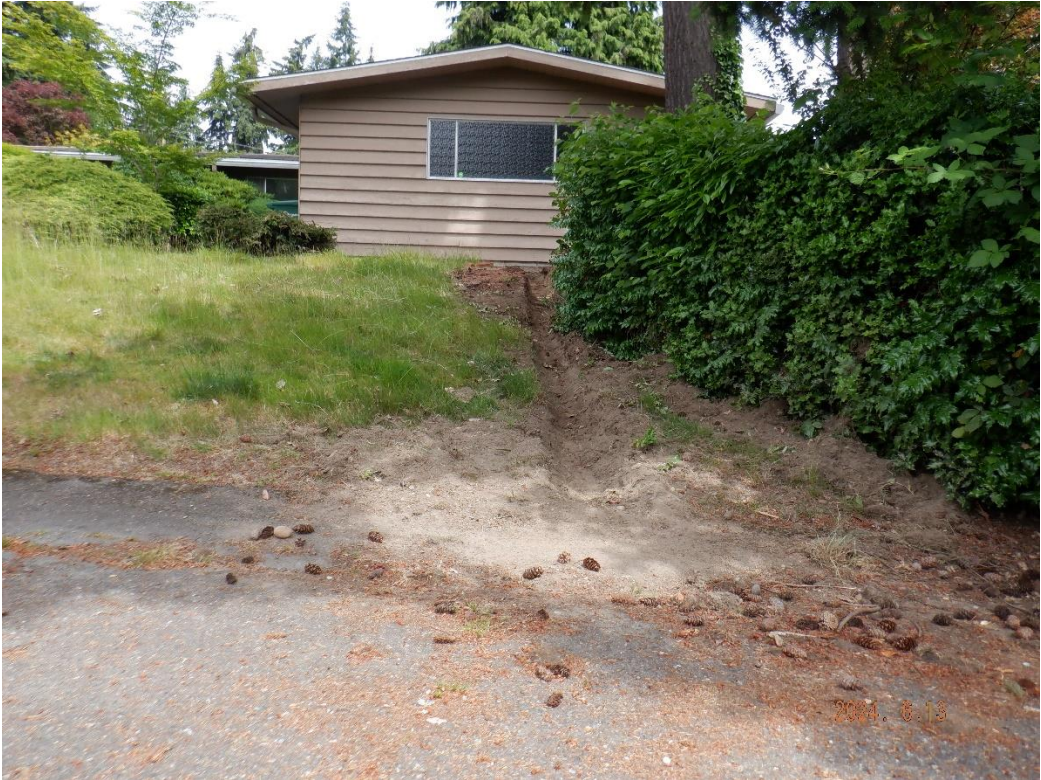
Hand-excavated trench at edge of proposed new driveway

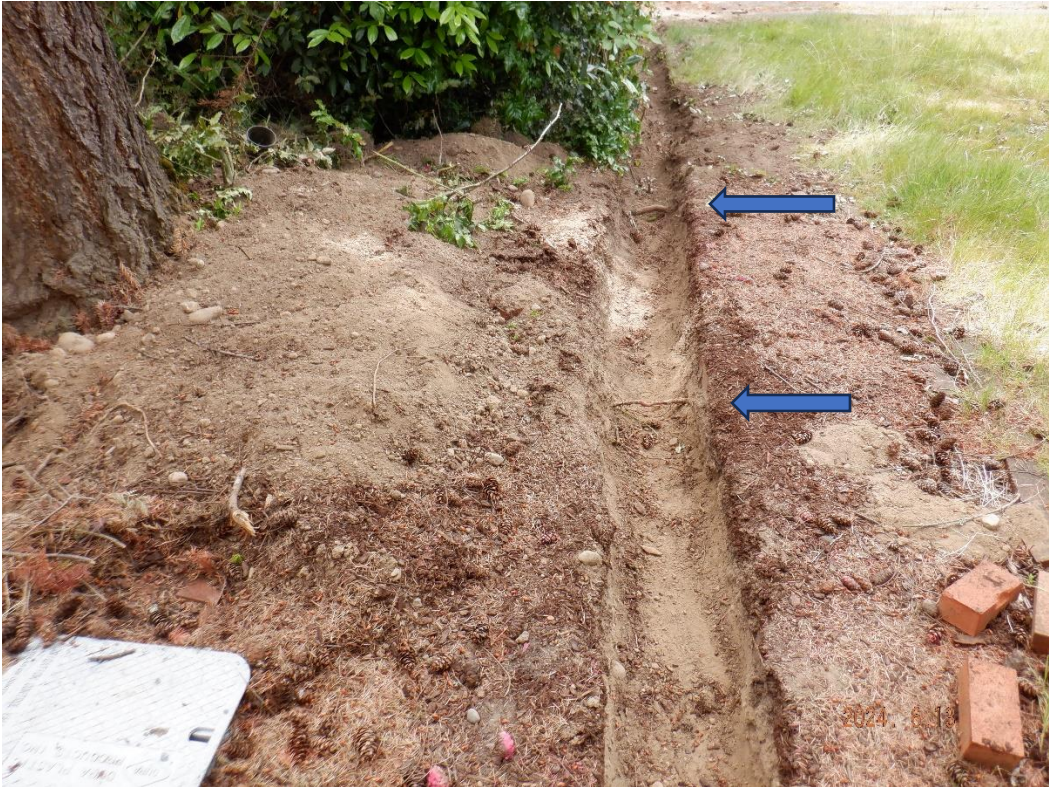
Two small roots encountered within trench

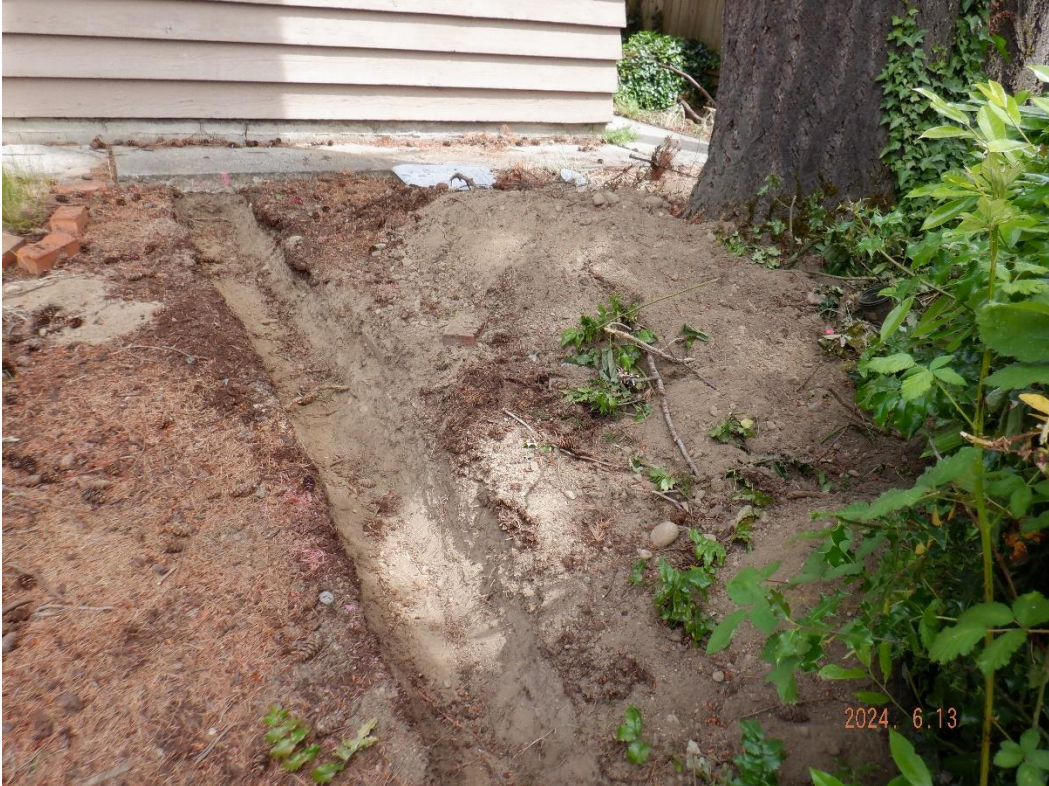
Hand-excavated trench 5-feet from trunk face of Tree #7
