Memorandum

To: Seascape Homes LLC c/o Jon Tellefson
CC: Sturman Architects c/o Kati Eitzman
Site: 5222 Forest Ave SE, Mercer Island, WA 98040
Re: Exploratory Pneumatic Excavation
Date: June 20, 2024
Project Arborist: Connor McDermott
ISA Certified Arborist PN-8704A
ISA Qualified Tree Risk Assessor
John Wells
Arborist Technician
Referenced Documents: Site Plan A1.1 (Sturman Architects, 05/14/2024)

Summary

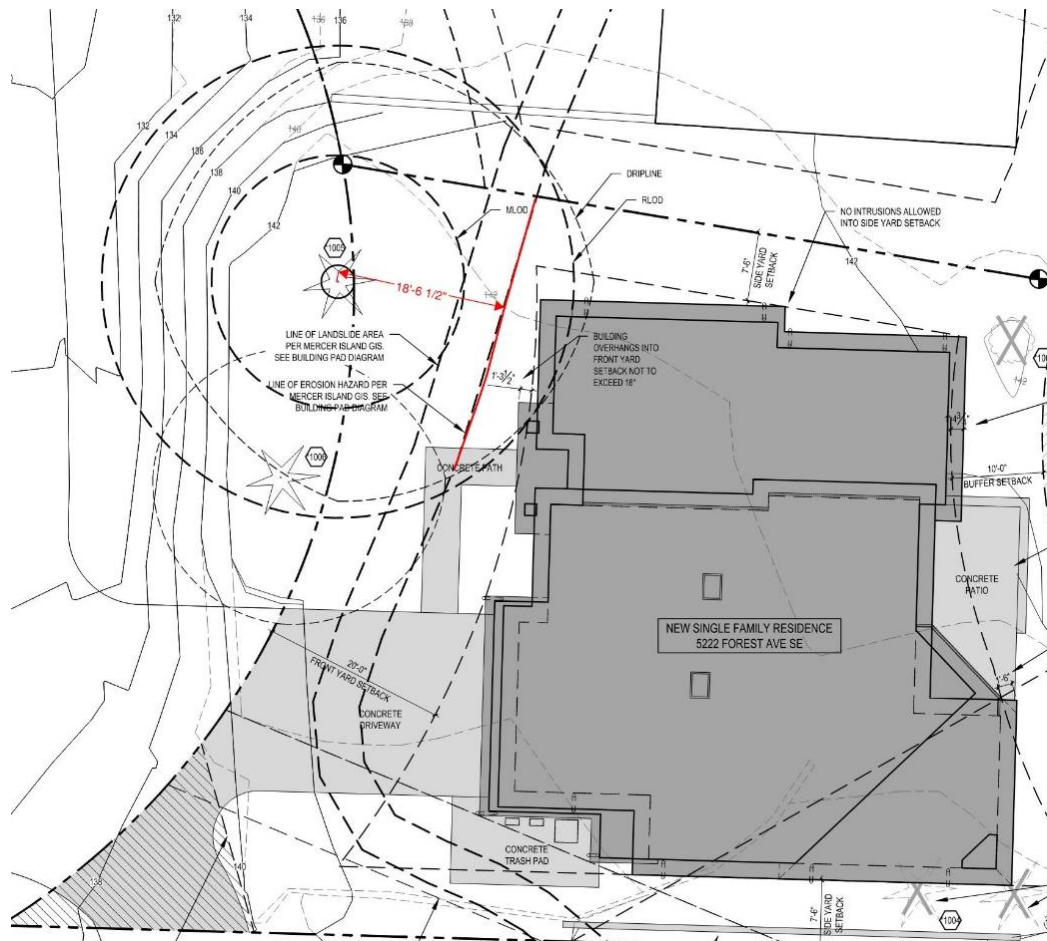
This memorandum documents the site visit of Connor McDermott and John Wells, of Tree Solutions Inc., to the above referenced site on June 14, 2024. We were asked to visit the site and perform exploratory pneumatic excavation at the proposed limits of disturbance for tree 1005 in preparation for a site development. We were asked to provide a memo with our findings and evaluation of proposed impacts. This memo only includes the tree within the immediate construction area as delineated on site plan specifically referenced in this memo (Figure 1).

Figure 1. Snip of the provided site plan (Site Plan A1.1, Sturman Architects, 05/14/2024). The approximate location of the excavation performed is indicated by the red line.

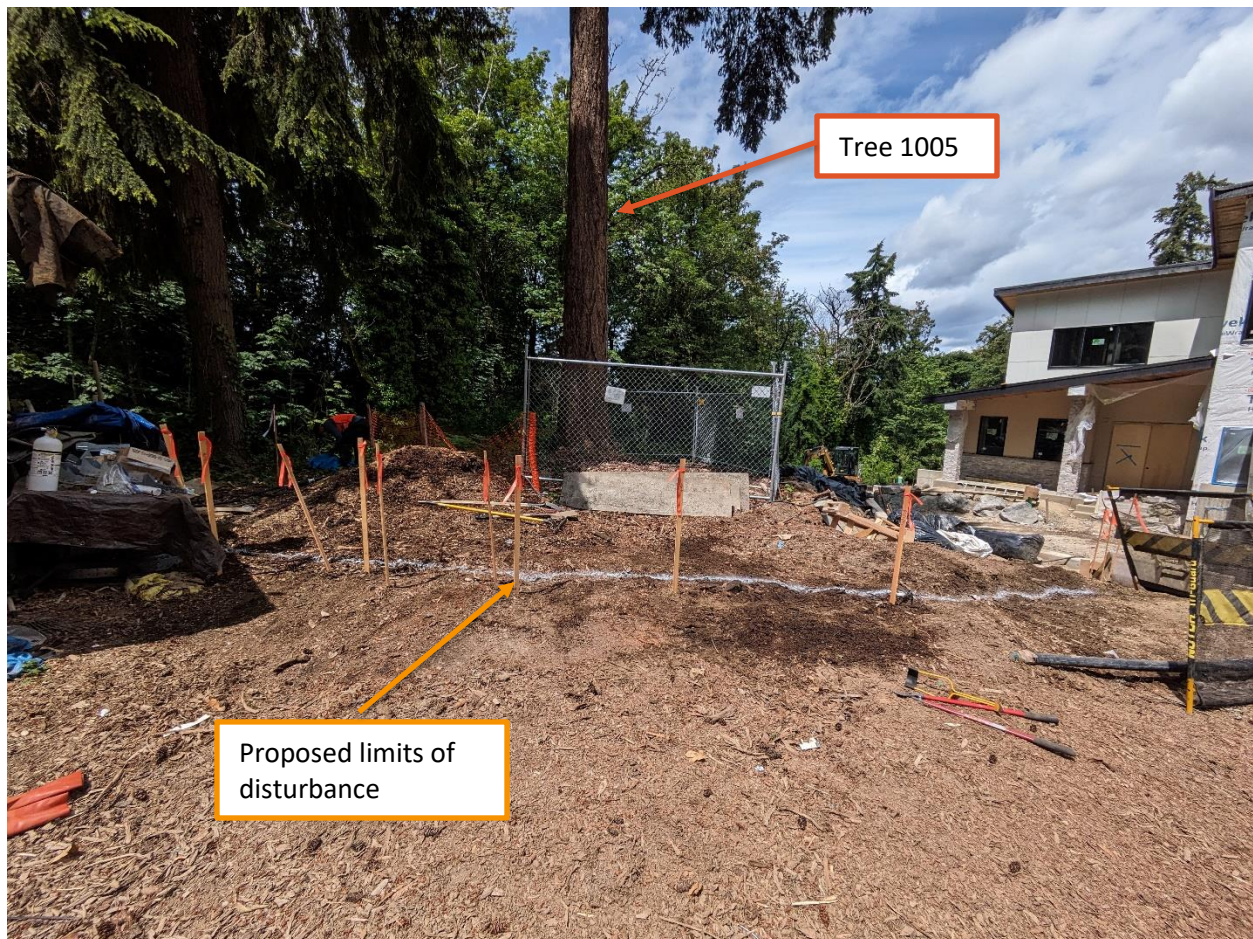
We utilized staking by the contractor, Jon Tellefson of Seascape Homes LLC, to determine the proposed limits of disturbance adjacent to the tree (Photo 1). We excavated an approximately 30 foot long trench 19 feet east of tree 1005 to a depth of 24 inches (Photo 2). We exposed no structural roots, roots over 2-inches diameter, during our excavation and exposed minimal fine roots (Photo 3). Photos documenting our excavation can be found in Appendix B.

Photo 1. Tree 1005 indicated above. The proposed limits of disturbance, and where we trenched, is indicated by the orange staking.

In our professional opinion, the proposed disturbance will have a minimal impact to the health and structural condition of the tree. We recommend tree protection measures in accordance to Mercer Island Municipal Code 19.10.080, including tree protection fencing, are set at the proposed limits of disturbance.

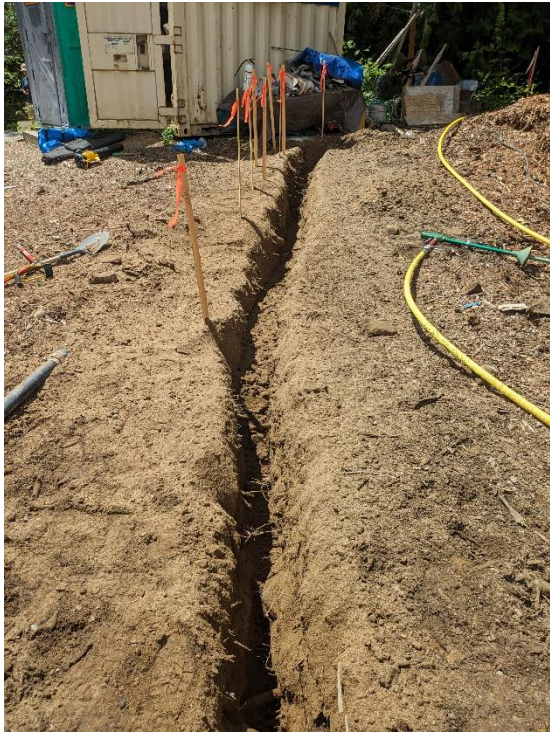
Photo 2. View of the trench from the north following pneumatic excavation.

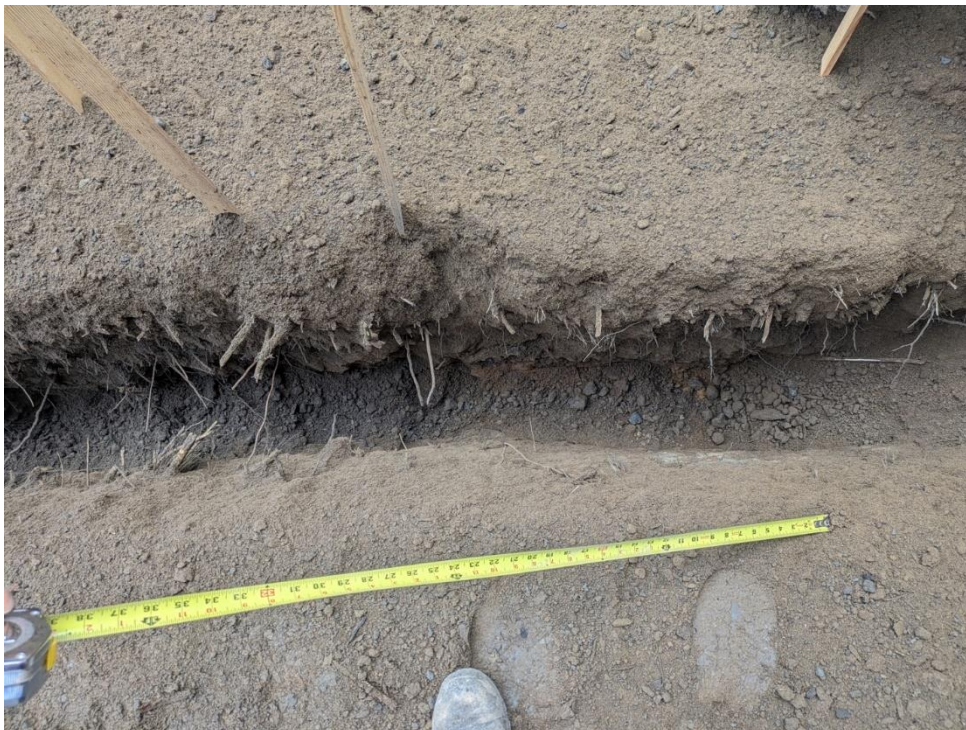
Photo 3. A typical section of trench with small feeder roots are exposed.
