March 25, 2025

Project: Pre-construction assessment for property re-development at 4661 Forest Avenue SE, Mercer Island, WA. Parcel number 4045000065.

Objectives: Evaluate health of existing trees and establish criteria for the preservation of those to be retained.

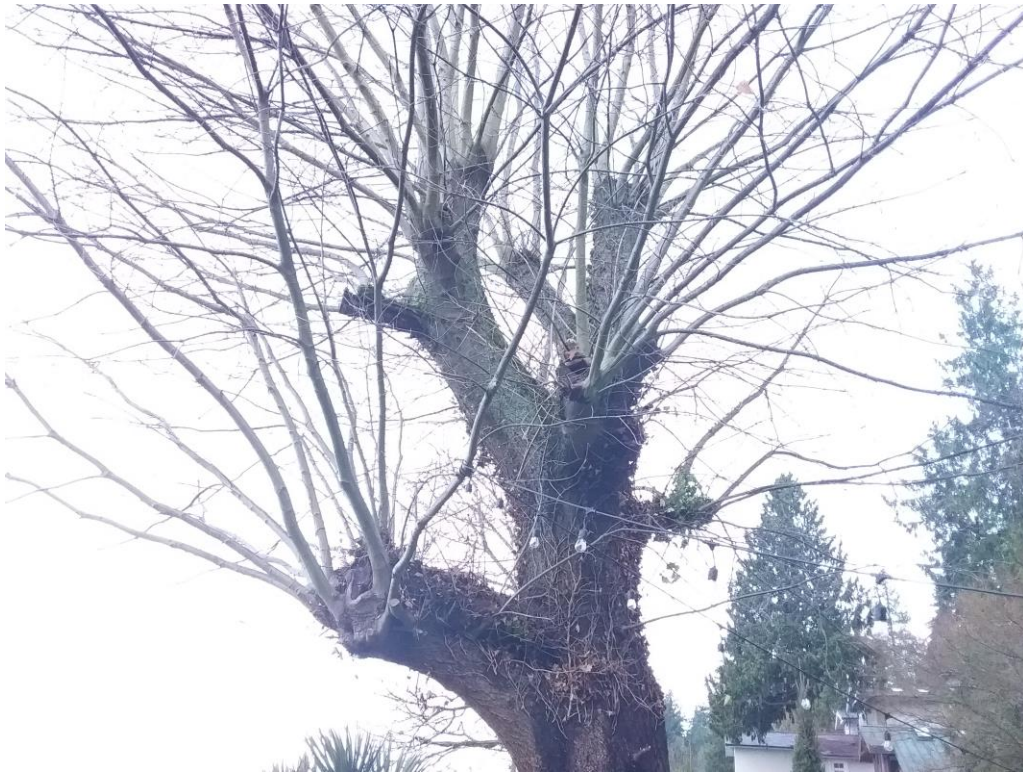
1. Pin oak (*Quercus palustris*) 40" DSH standing 19' W of the NW corner of the existing house, 9' S of the north property line, and 35' E of the sea wall. The tree was cut back to the property line between 2007 and 2009 (Figures 7 and 8) and then was severely stubbed back between 2013 and 2015 (Figures 9 and 10). The top cuts were made between 25' and 28' above grade and the scaffolds were cut back to no more than 8' off the main stem. Currently there are epicormic sprouts extending off each of the cut points in groups of 5-10 and out 12-25' long. There is conflict and some die back present (Figure 11-13). Tree exhibits good health with decent new growth and color. It reaches up to near the 50' level and has a 20' radial spread. There is utility vault, maybe a pump house, in the northwest quadrant of the root spread 4' off the base of the tree (Figure 14). Concrete stairs lead up from the lower yard to the lower concrete patio. The tree has engulfed the top stair and a couple of the large stones lining it (Figure 15). There is uplift of the concrete path leading to the concrete patio and uplift in the patio itself (Figure 16). This tree is Exceptional by definition.

Figure 11. Looking north at the structure of the #1 oak.

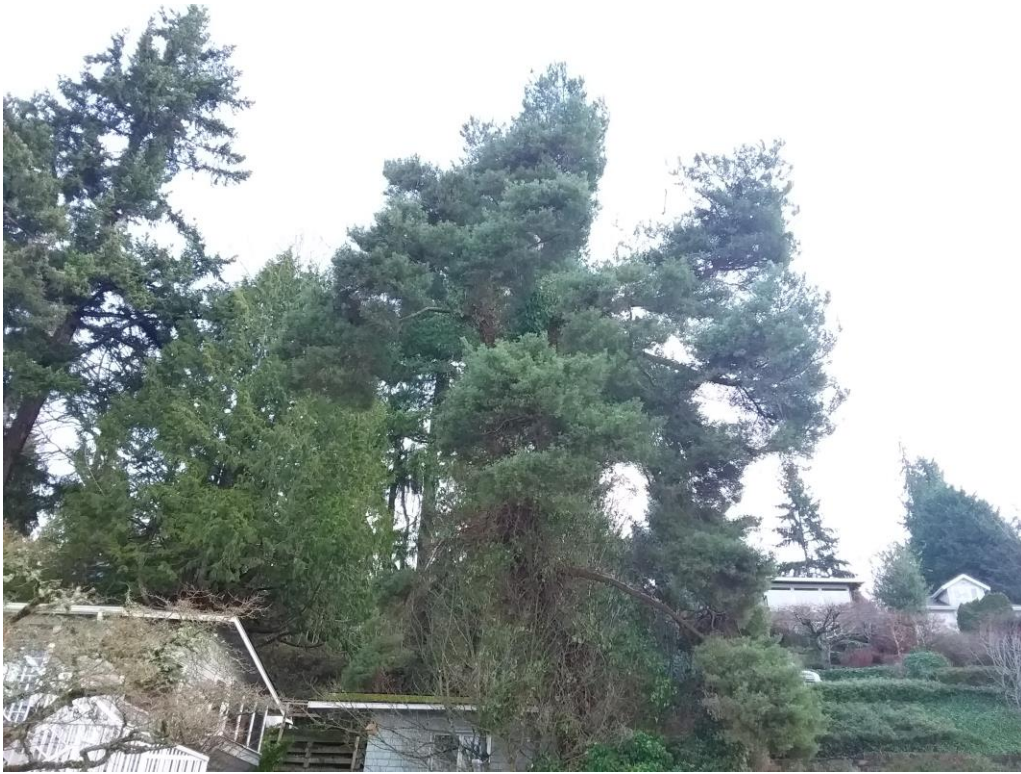
4. Shore Pine (*Pinus contorta*) 24" DSH, 50' tall standing 26.5' S of the house foundation and 8' W of the southwest corner of the little boathouse building. Ivy has filled the canopy to within 8' of the top and out the branches (Figure 18). It was recently cut at the base of the tree. Pine is in fair health but many of the branches are overextended and the canopy is windswept. There is a little existing fence filled with ivy that runs east to west 3' S of the tree. Just outside this fence and 16' E of the base of the tree there is some kind of drain system (Figure 19). This tree is Exceptional by definition.

Figure 18. Looking east at the #3 pine showing the ivy growing through the tree and its structure.

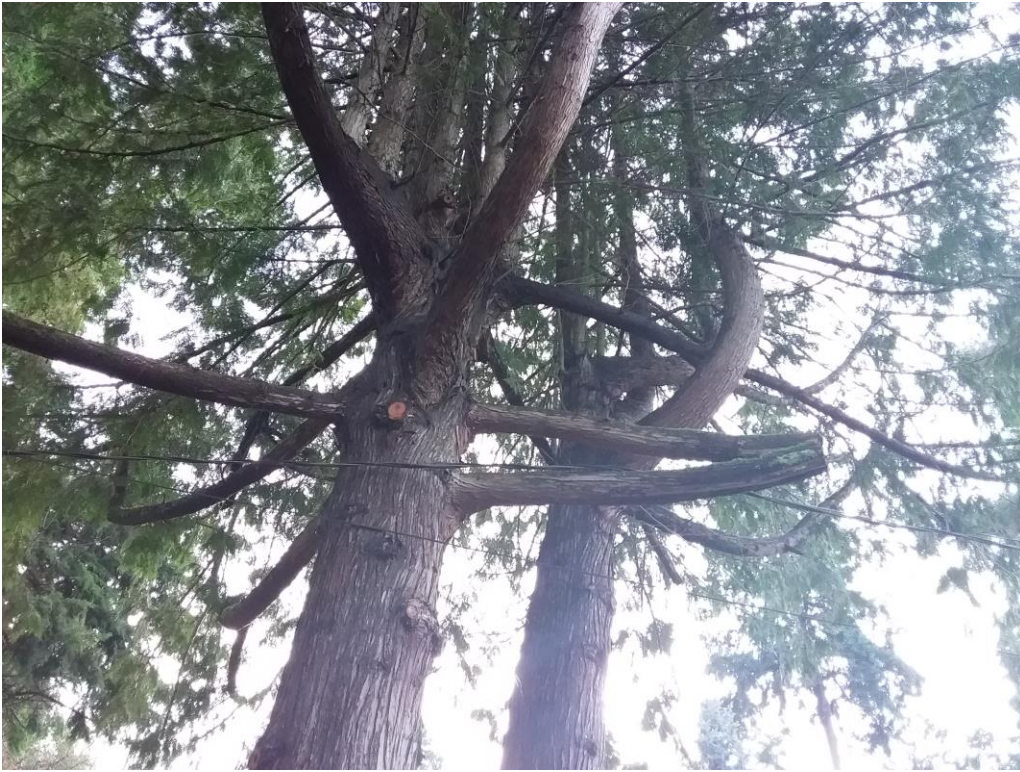
5. Dual stem Western Red Cedar (*Thuja plicata*) 21" and 25" DSH and both were topped near the 18' level at least once. Currently they each have multiple leaders coming off these points going up to the 60' level (Figure 20). On the smaller stem most of the subordinates extend out to the west and southwest before curling vertical 4-6' out from the main stem. On the larger stem the majority of the spars turn vertical within 24" of the column. Almost all the limbs that originate below the topping point are turning up past their midpoints. The tree stands 11' E of the SE corner of the existing house in what is a de facto planter box (Figure 21). The west (house side) of the structure reaches at least 3' down and the retaining wall support system for the lower parking forms the east side. The base of the tree is against the east wall, 3.5' E of the west wall, and 2.5' SE of where the west wall angles to the NE. The 21" stem had poor resonance and is likely hollow.

Figure 20. Looking at the lower canopy structure of the #5 cedar.

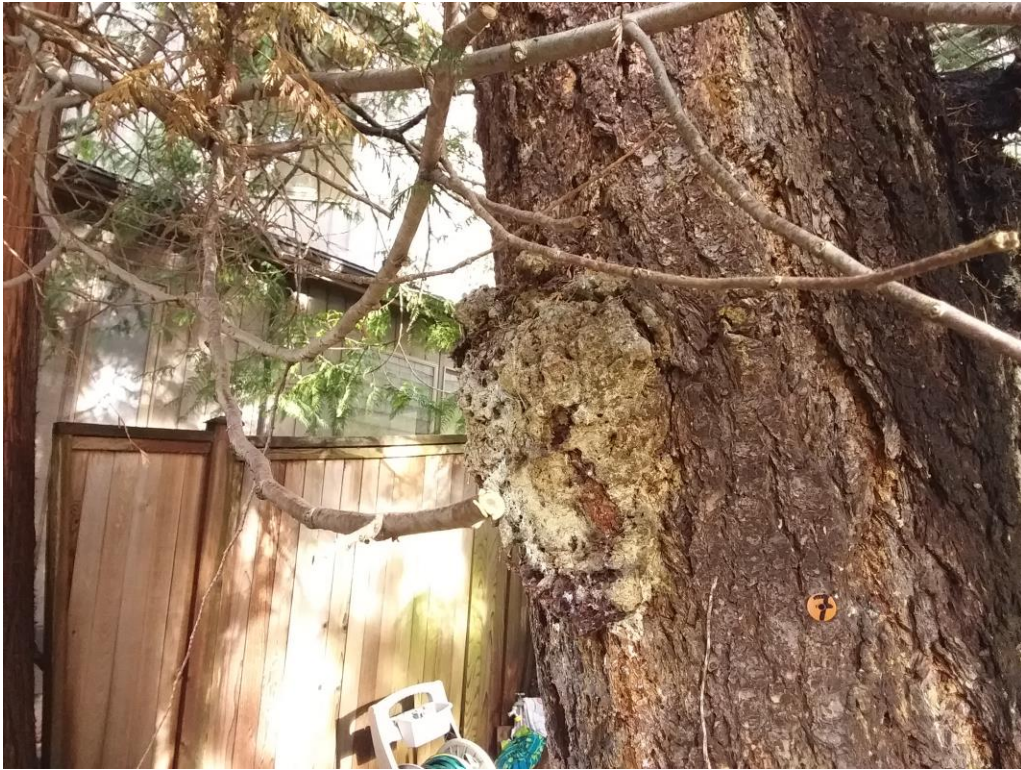
Figure 25. Canker at base of #7 fir.

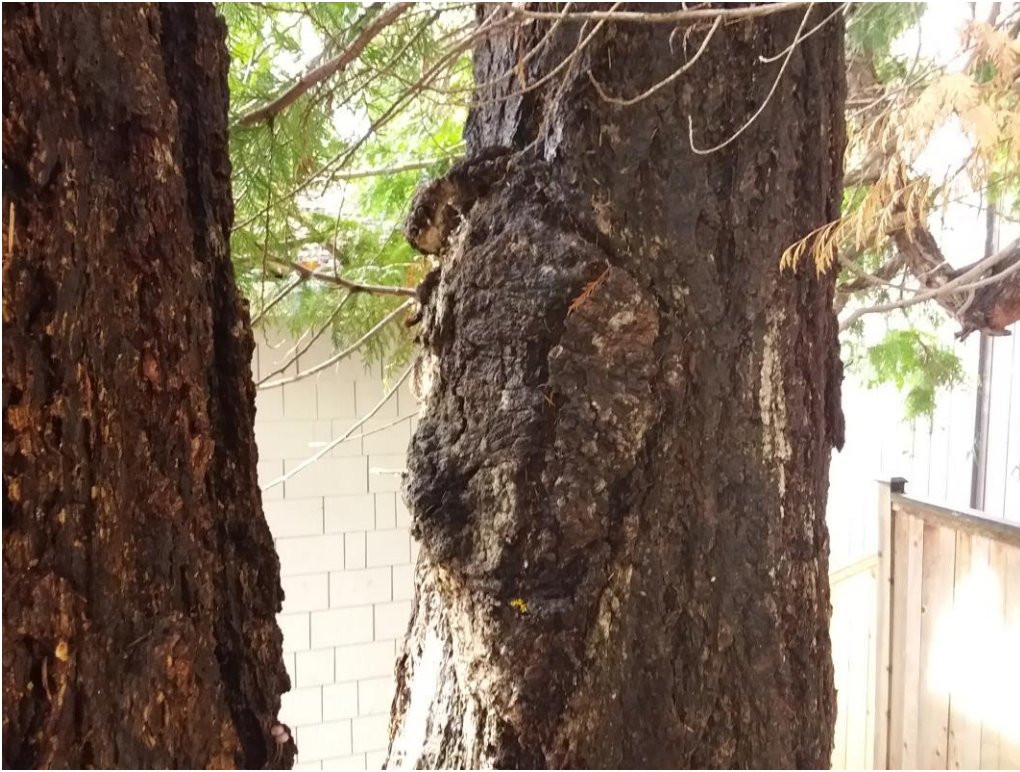
Figure 26. The other large canker at the base of the #7 tree.

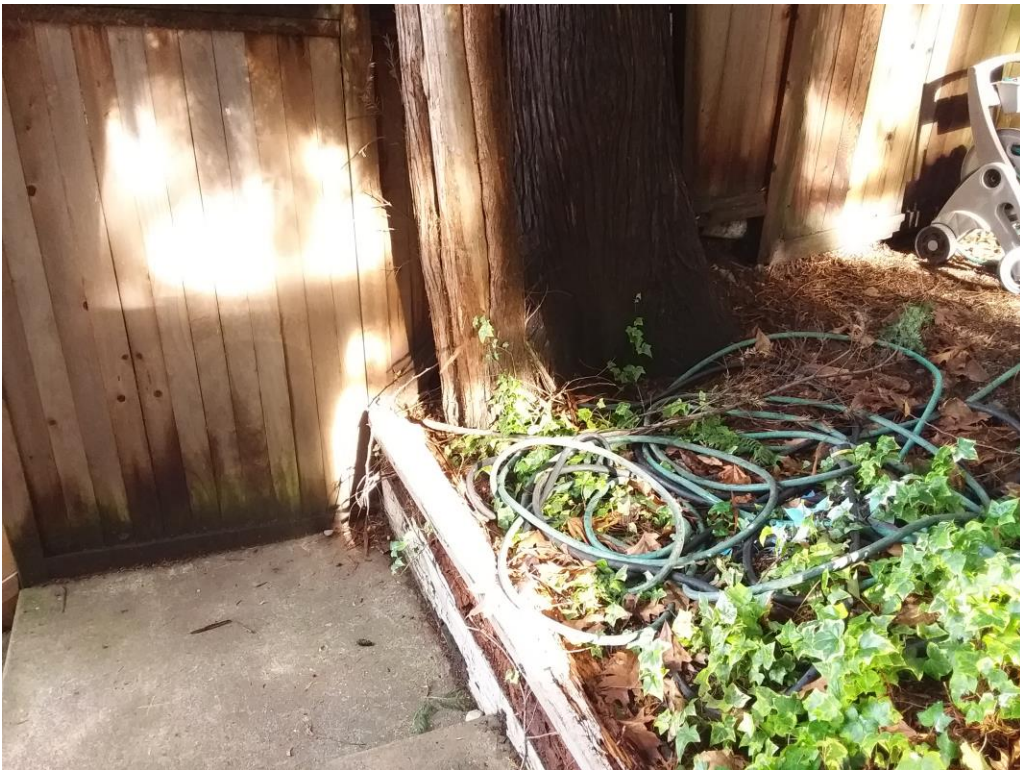
8. Western red cedar 29" DSH standing in the north fence 8' N of the #7 tree, 8' W of the retaining wall foundation for the garage, 6' S of the 4651 foundation, and 12" E of the concrete for the stairs leading down around the north side of the subject house. There is a small wood retaining wall above the concrete and the tree is bowing it out (Figure 27). A subordinate that has been topped comes off the base of the main stem. The subordinate has an exposed decay column and atrophy running down its west face (Figure 28). The main tree was damaged or topped near the 40' level. There is a large leader growing up and out to the northwest that originates at the damage point and a number of subordinate spars reaching out all around the same level. The majority of the canopy extends north over the neighbor's roof. Tree is in below average condition with a light canopy cover and poor color.

Figure 27. Looking down and north at the base of the #8 cedar. Note the wood retaining wall bowing out on the left (west) of the tree. The atrophy on the lower column of the subordinate spar is clearly visible.

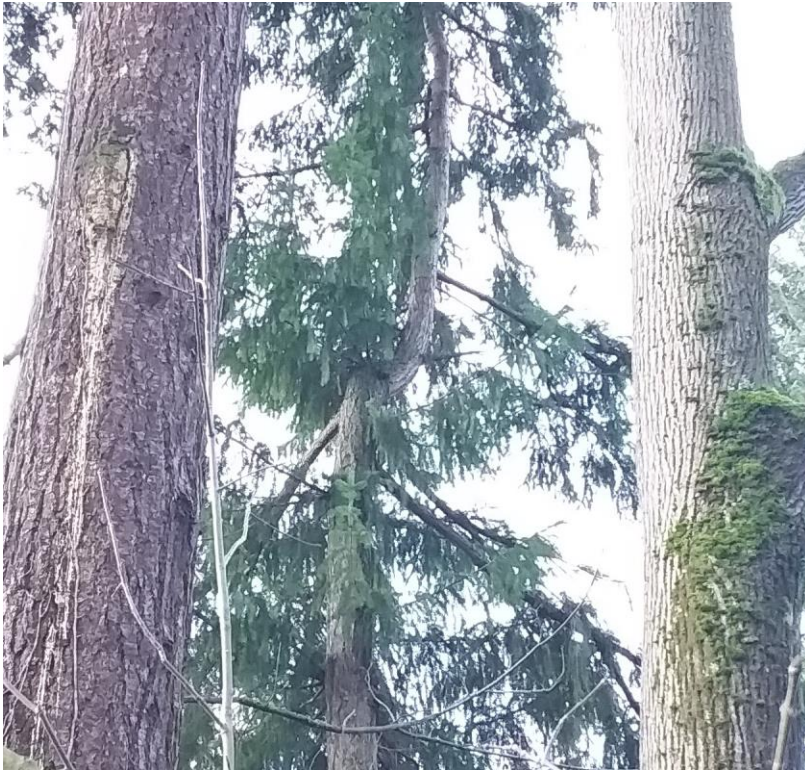
10. Douglas fir 20" DSH, 65' tall standing 9' E of the end of the retaining wall running down the east side of the lower driveway. Tree is in below average condition and its entire canopy goes to the west side. It leans slightly northwest from the base does not correct. Tree was damaged or topped near the 40' mark. It has a new leader that kinks markedly to the northwest turning vertical as it rises (Figure 29).

Figure 29. Looking up and west at the structural fault in the #10 tree.

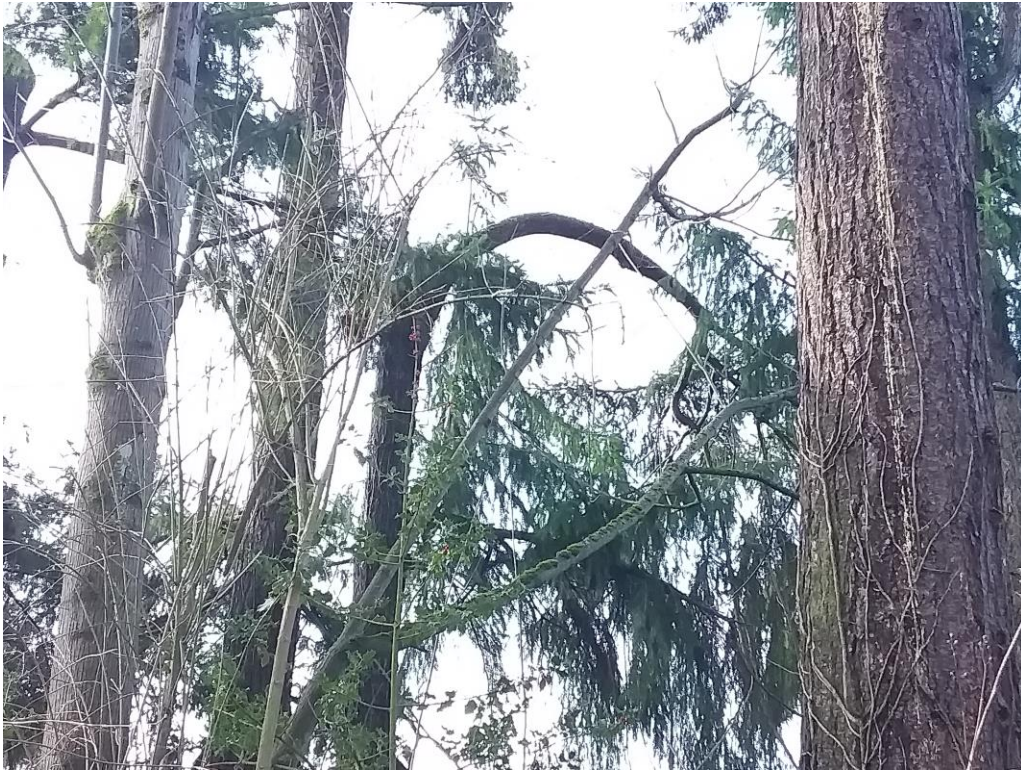
11. Douglas fir 20" DSH, topped near the 40' level, and now has one large leader bending over to the Northwest that extends nearly 25' over the driveway (Figure 30). It only has a couple of other live limbs. Base of the tree is 9' E of the east edge of the lower driveway and 17' N of the inside edge of the last curve of the driveway. There are fungal bodies at the cut point. Tree is in extremely weak structural condition.

Figure 30. Showing the spar coming off the top of the #11 tree.

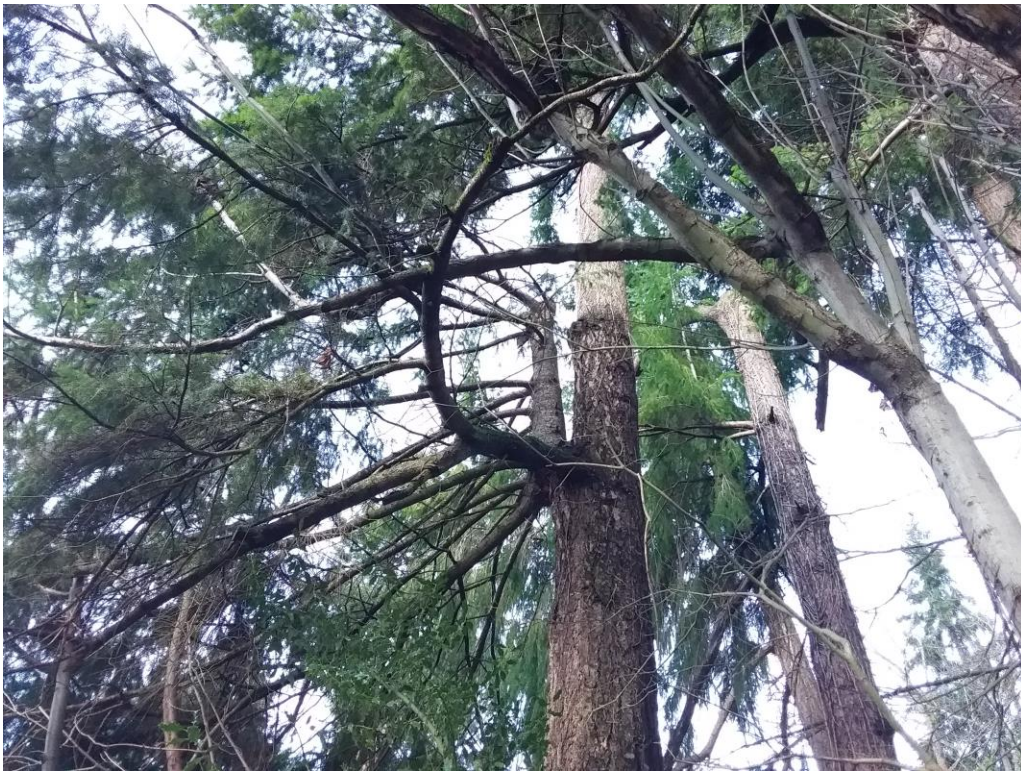
12. Douglas fir 39" DSH, topped or damaged near the 65' mark, now rises into the 90' level. There is an atypical growth pattern around the 65' area with a number of heavy lateral branches present and a larger subordinate coming off at this point. Tree has a subordinate spar that originates at the 20' level that has been pruned down to 8' tall and has a multitude of branches sprouting from it (Figure 31). Tree shows average new growth and color. It stands 40" E of the inside edge of the existing entry drive (Figure 32). The driveway curves completely around the tree scribing close to a 270 degree arc. There is a large amount of pitch leakage on the southwest base of the tree. Tree is Exceptional by definition.

Figure 31. Showing subordinate spar coming off low on the column of the #12 tree.

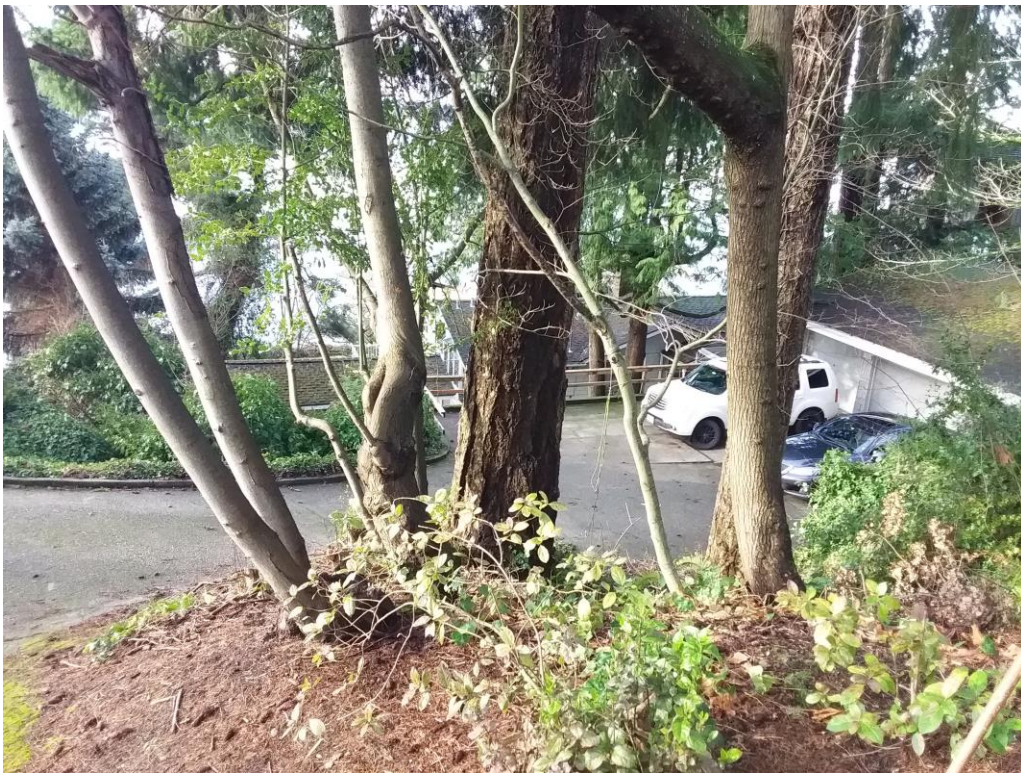
13. There is a stand of three Big Leaf maple stump sprouts in the inner curve of the entry drive 10' above and east of the #12 tree (Figure 33). They have all been cut back multiple times likely both to their bases or using topping cuts around the 12' level. Their bases have decay pockets and their limbs have surface sunscald (Figures 34-37). Really poor condition.

Figure 33. Looking west at the stems of the stump sprout #13 maple.

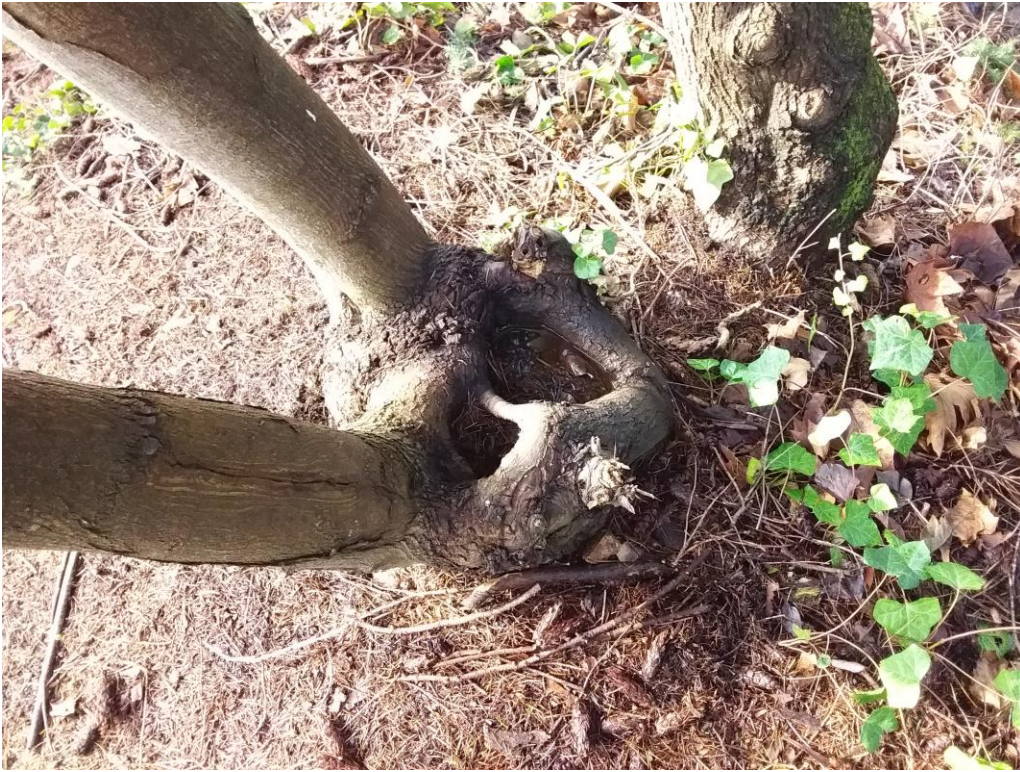
Figure 34. Looking down at the decayed base of one of the #13 maples.

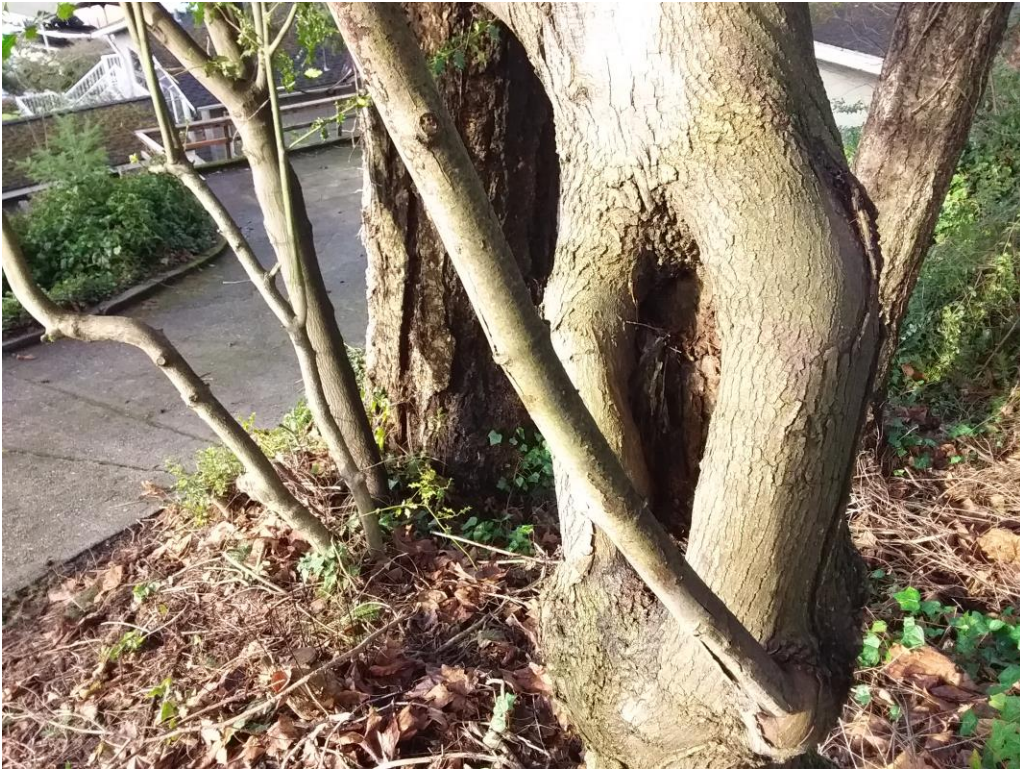
Figure 35. Decayed area at base of another of the #13 maple stems

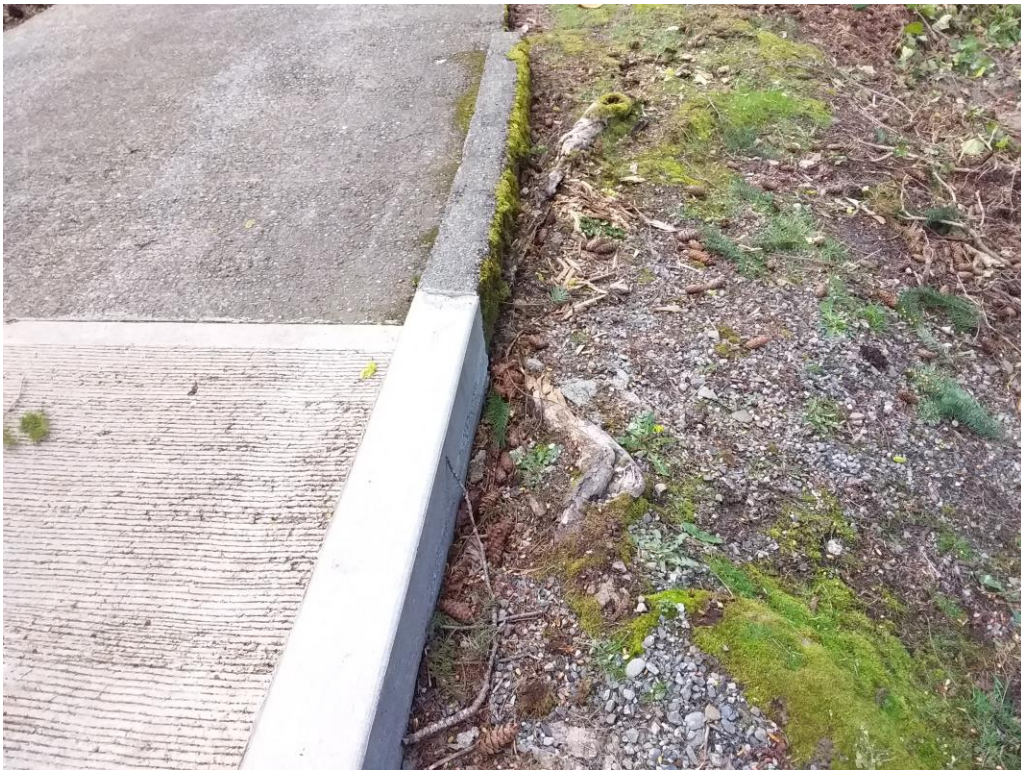
The #19 would be expected to have a 10' SRP. It does have large roots pressing up to and most likely under the existing entry drive which is only 7.5' away. The previous work on the driveway had to have cut through a large sector of the cottonwood's structural roots based on the proximity and extent. This tree should have been removed at the time due to impact concerns. The current driveway replacement impact will occur within its theoretical SRP.

Figure 43. One of the #19 cottonwood roots pushing up against the entry drive curb.

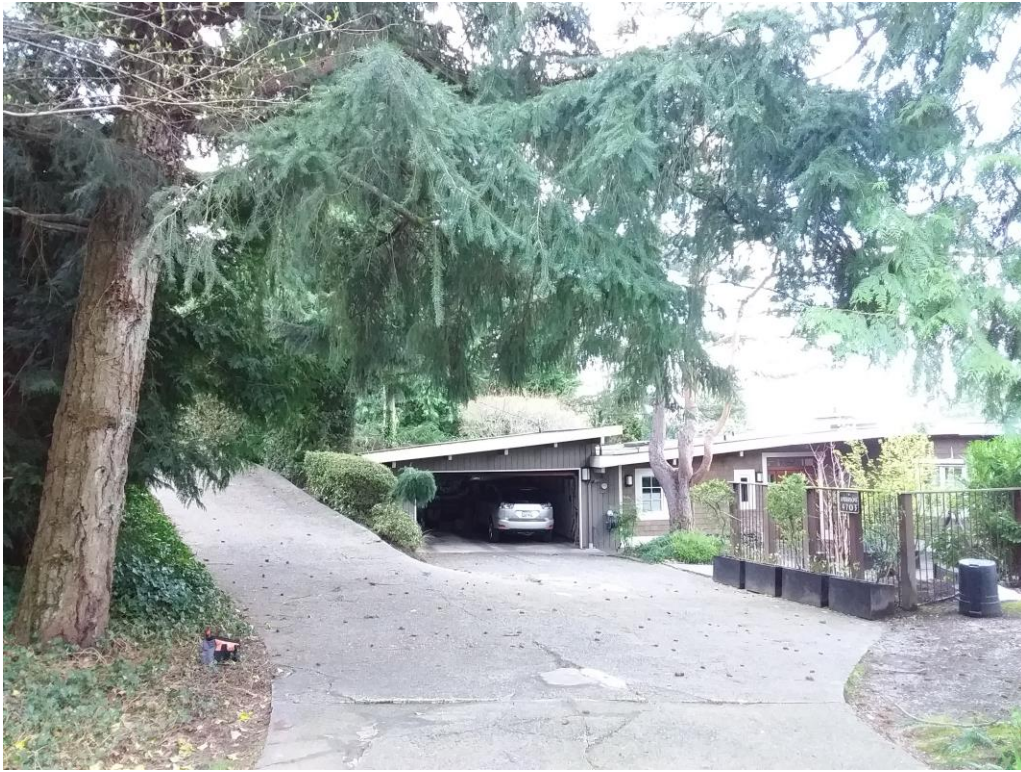
It appears on the site plan that the new driveway will set about 12" closer to the #32 fir. Which means that the cut for the edge forms could be 2.5' closer to the tree resulting in 30-40% of its existing SRP being severed on its west side. It will necessitate the removal of the fir. If there is a desire on the part of the home owners to retain the #32 tree then this part of the driveway will have to shift west to maintain the fir's existing root system undisturbed. It is a 'better' tree than the #30 cedar all things considered.

Figure 50. Looking south at the #32 fir extending over the driveway

Either the #30 cedar or the #32 fir may have to be removed depending on the final layout of the driveway. Neither is in great condition but neither is in such poor condition that it can be condemned outright.
