# LAYTON TREE CONSULTING, LLC

## ARBORIST REPORT

2247 66<sup>th</sup> Avenue SE  
Mercer Island, WA

**May 3, 2024**  
**Updated December 2, 2024**

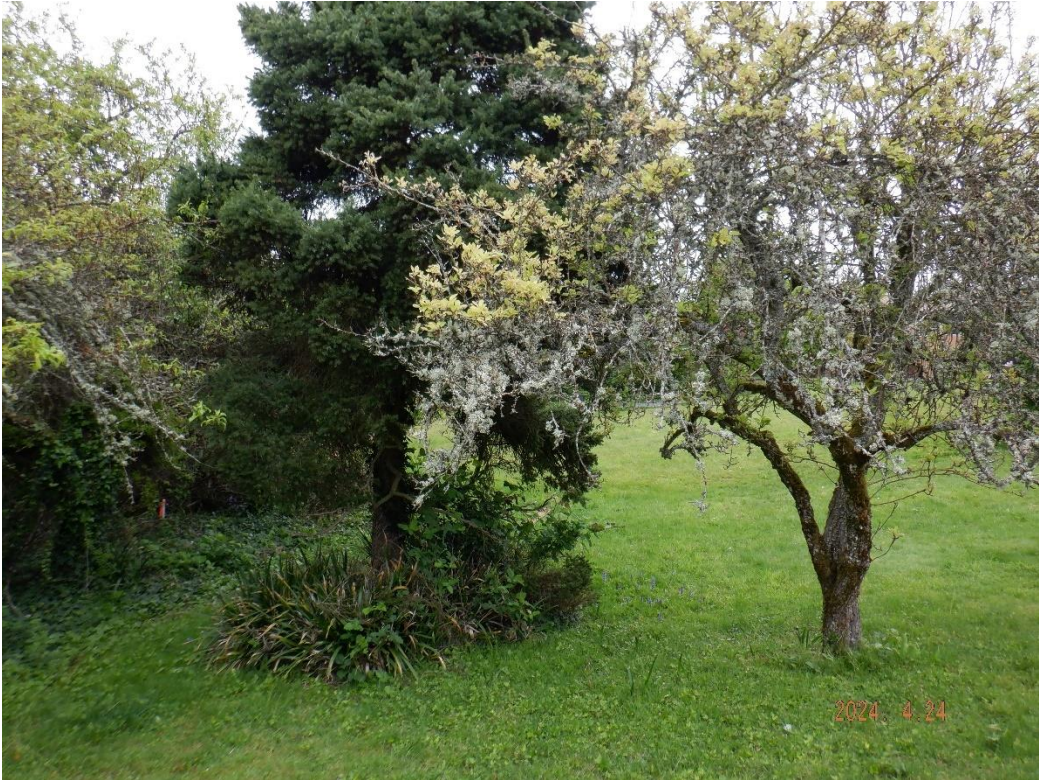
Trees #6 and #7

Tree #6 is a young to semi-mature Douglas fir in the middle of the fruit tree orchard. It has been routinely topped and side sheared, likely to maintain desirable views. Vigor appears to be good. Overall condition is rated as fair.

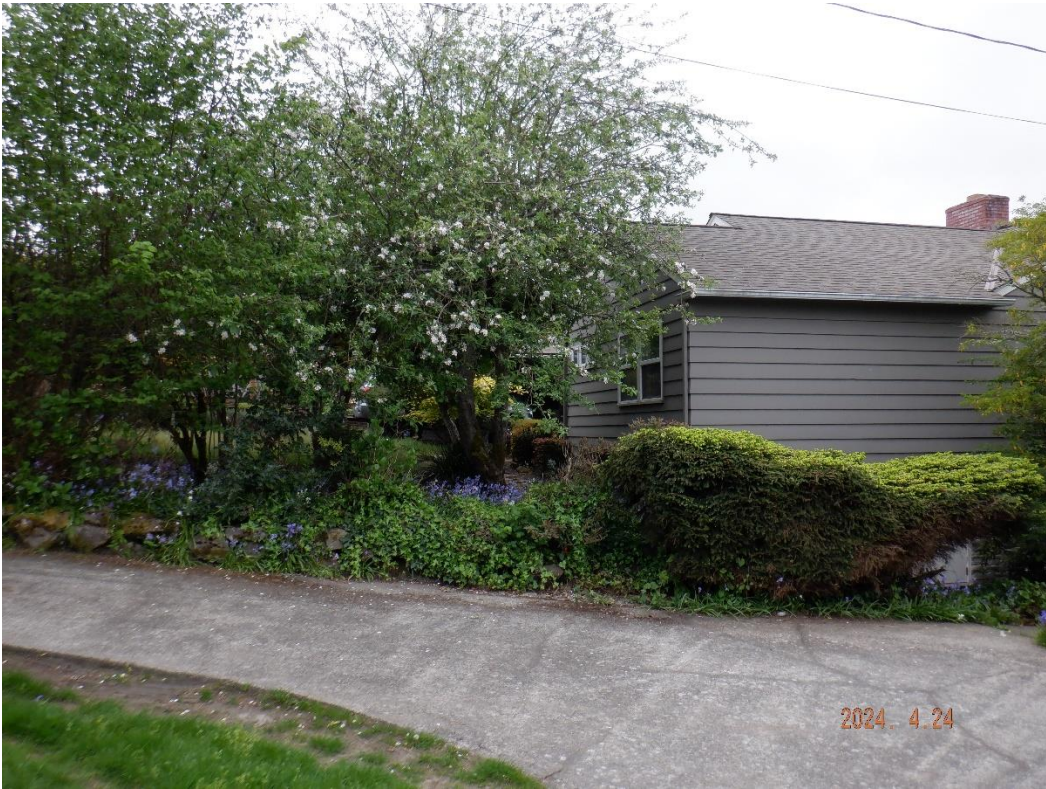
Tree #101 is a semi-mature apple variety located roughly 10-feet off of the south property line. No concerning issues were observed from the subject property side. It is in good condition.

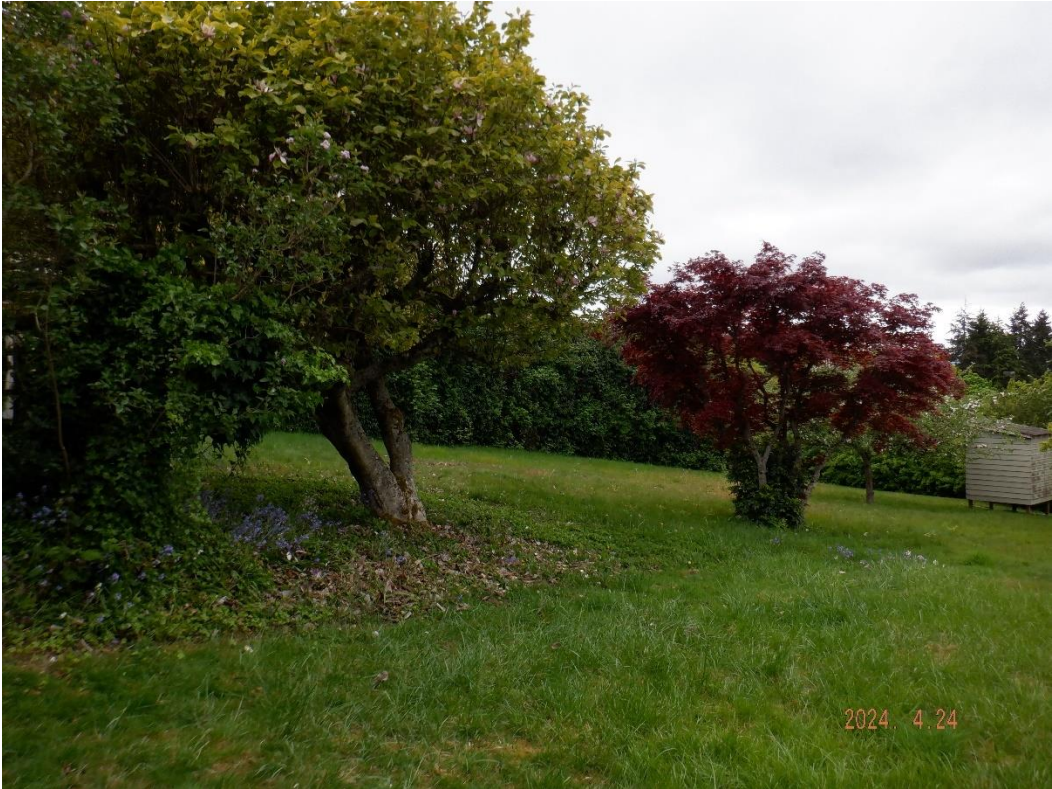
Trees #102 and #103

Tree #102 is a semi-mature Campbell's magnolia. It is comprised of three stems or trunks that contribute to one uniform canopy. No concerning issues were observed from the subject property side. It is in good condition. It has been pruned back on the north side in the past.

Tree #103 is a young Japanese maple. It is small and non-regulated. No concerning issues were observed from the subject property side. It is in good condition.

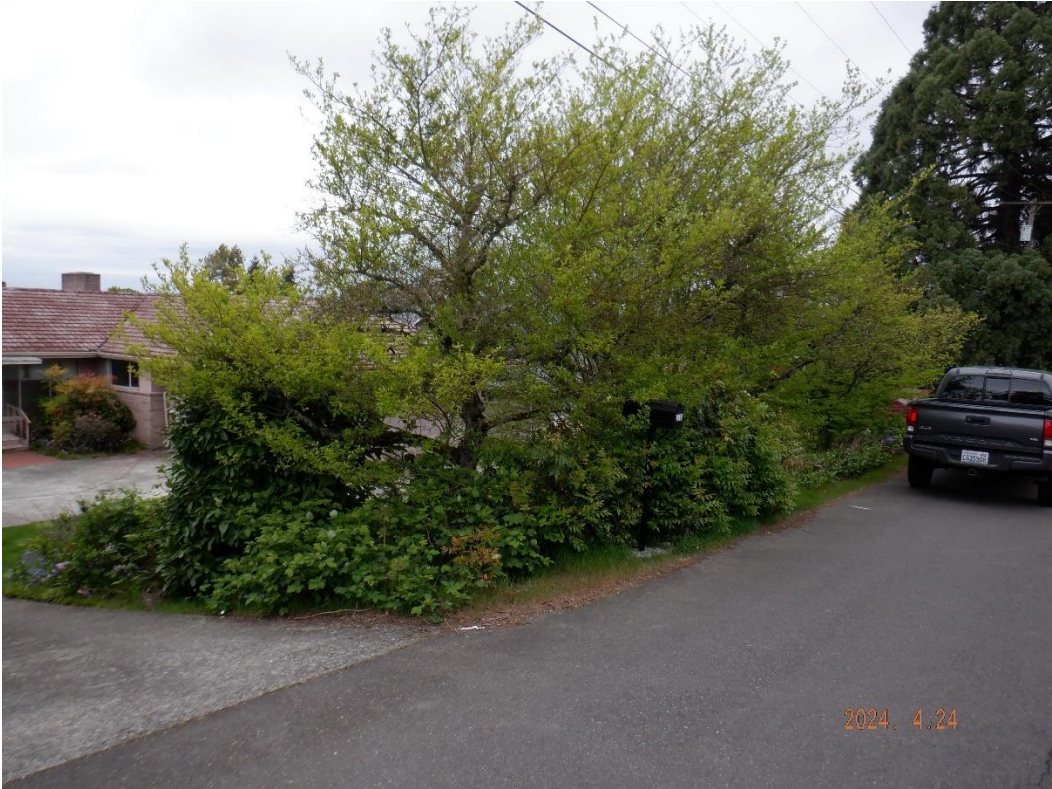
#104 is a row of four small, non-regulated Japanese snowbell trees near the 66<sup>th</sup> Avenue roadway. All are of fairly good vigor with no concerning issues.

#104 – row of four small, non-regulated Japanese snowbells

Two of the four small non-regulated Japanese snowbell trees in the right-of-way will be removed to construct the new driveway. The others are in a location where they can be retained.
