# LAYTON TREE CONSULTING, LLC

## Trees & Construction Memo

To: Greg Arms  
From: Bob Layton  
CC:  
Date: July 8, 2025  
Re: 7621 SE 22<sup>nd</sup> ST – Lot 1 Tree Retention Issues – Tree #1

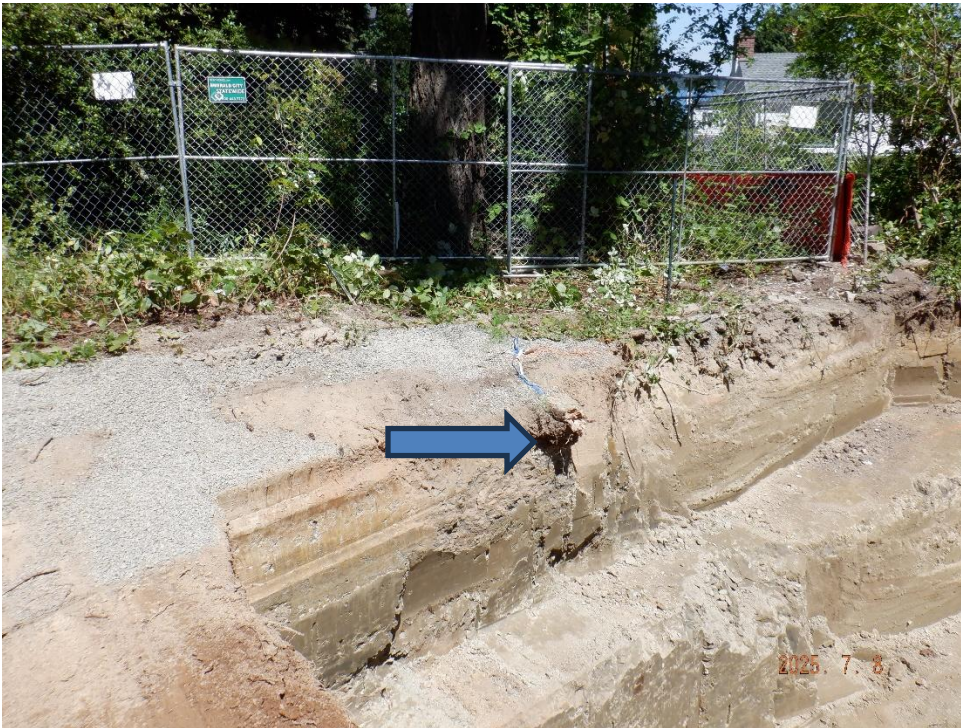
Unfortunately, there are issues with the continued retention of Tree #1, a 31-inch diameter Douglas fir. A large shallow structural root was exposed by the operator at roughly 18-feet from the trunk face on the south side during the excavation. The excavation needed for the approved house location or to facilitate the foundation construction will have to sever this root at 6-feet from the trunk face, see the attached exhibit.

Large structural root exposed at cut bank roughly 18-feet south of Tree #1

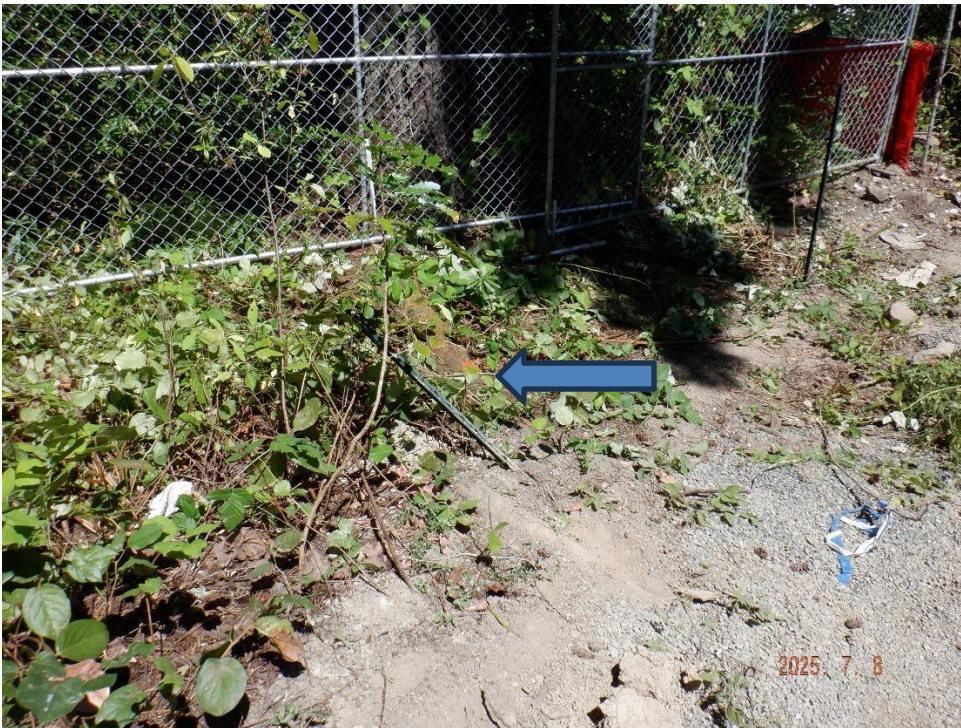
Based on bulges at the root crown, the subject has only four buttress or structural roots. These basically radiate from the trunk in the four cardinal directions – north, south, east and west as shown on the attached exhibit. Once the south root is severed, there will be no supporting roots left on the south or windward side of the tree. Trees in the vicinity are very shallow-rooted. Based on the recent excavation work, roots only exist within about the top foot of the ground surface. There is a dense shallow hardpan layer, preventing roots from penetrating deeper into the ground.

Large structural root needs to be cut at 6-feet from trunk face (at arrow) to accommodate foundation work

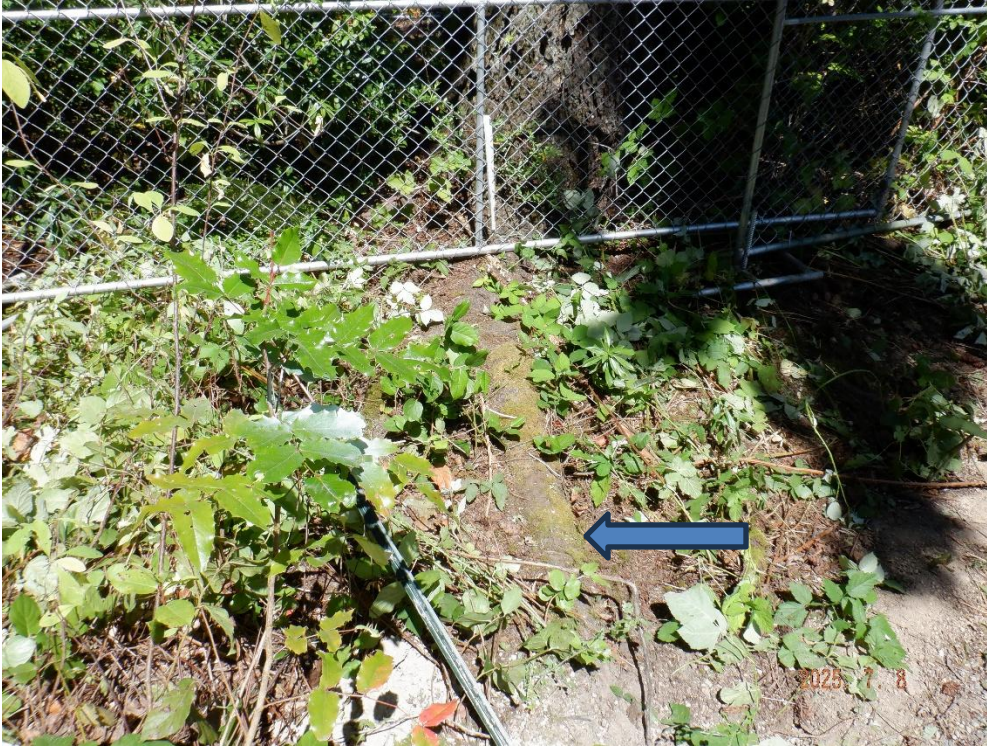
Large structural root needs to be cut at 6-feet from trunk face (at arrow) to accommodate foundation work

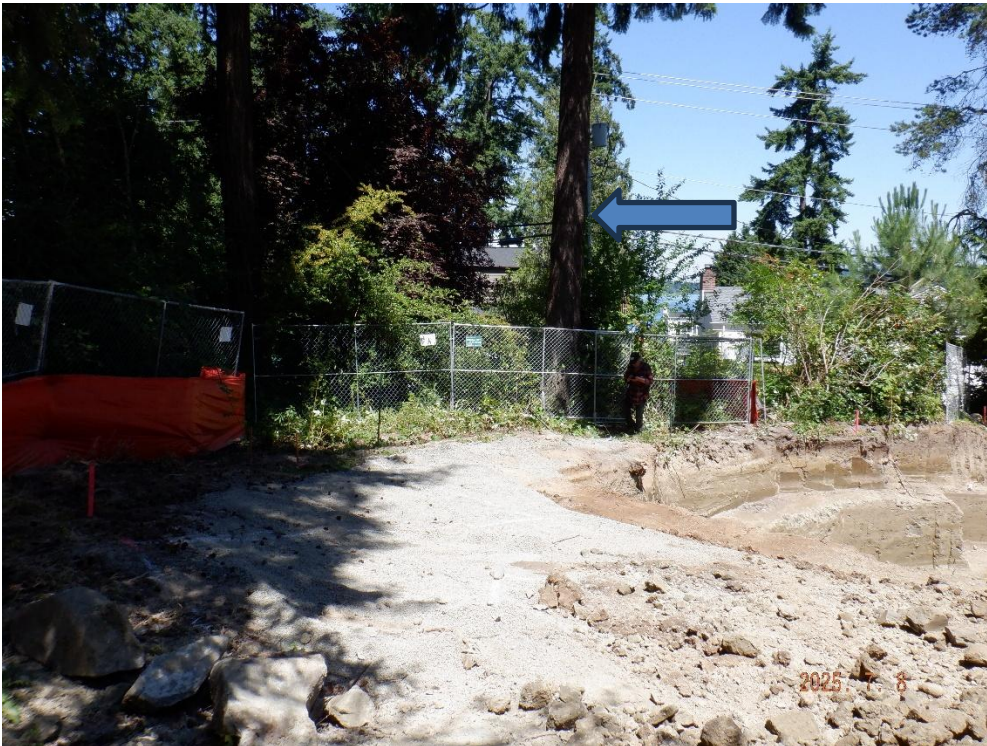
I have concerns that if this root is cut, the trees' ability to remain standing when loaded by strong southwest prevailing winds may be in jeopardy. The subject is roughly 120-feet in height. The tree is well within the striking distance of powerlines and the neighboring houses to the north across SE 22<sup>nd</sup> Street. To abate the potentially hazardous condition, removal and

Subject tree

replacement is recommended. Three new Douglas fir trees could be planted in the vicinity to mitigate the canopy loss.

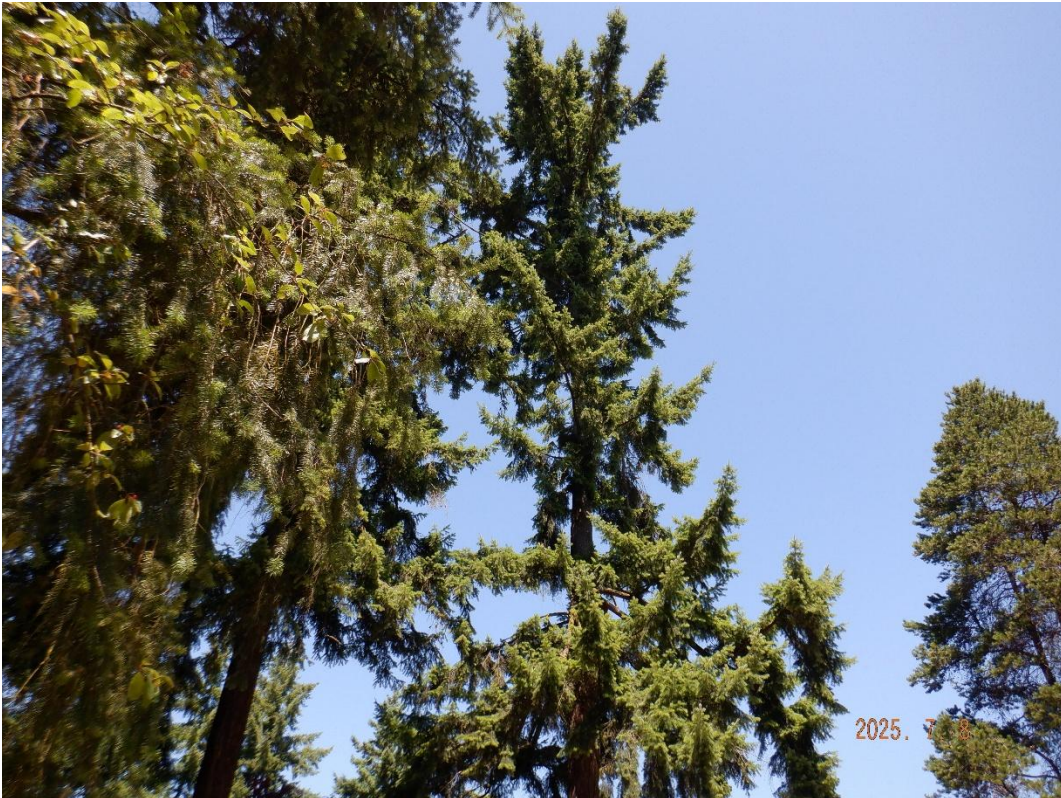
Upper crown of subject tree (center)

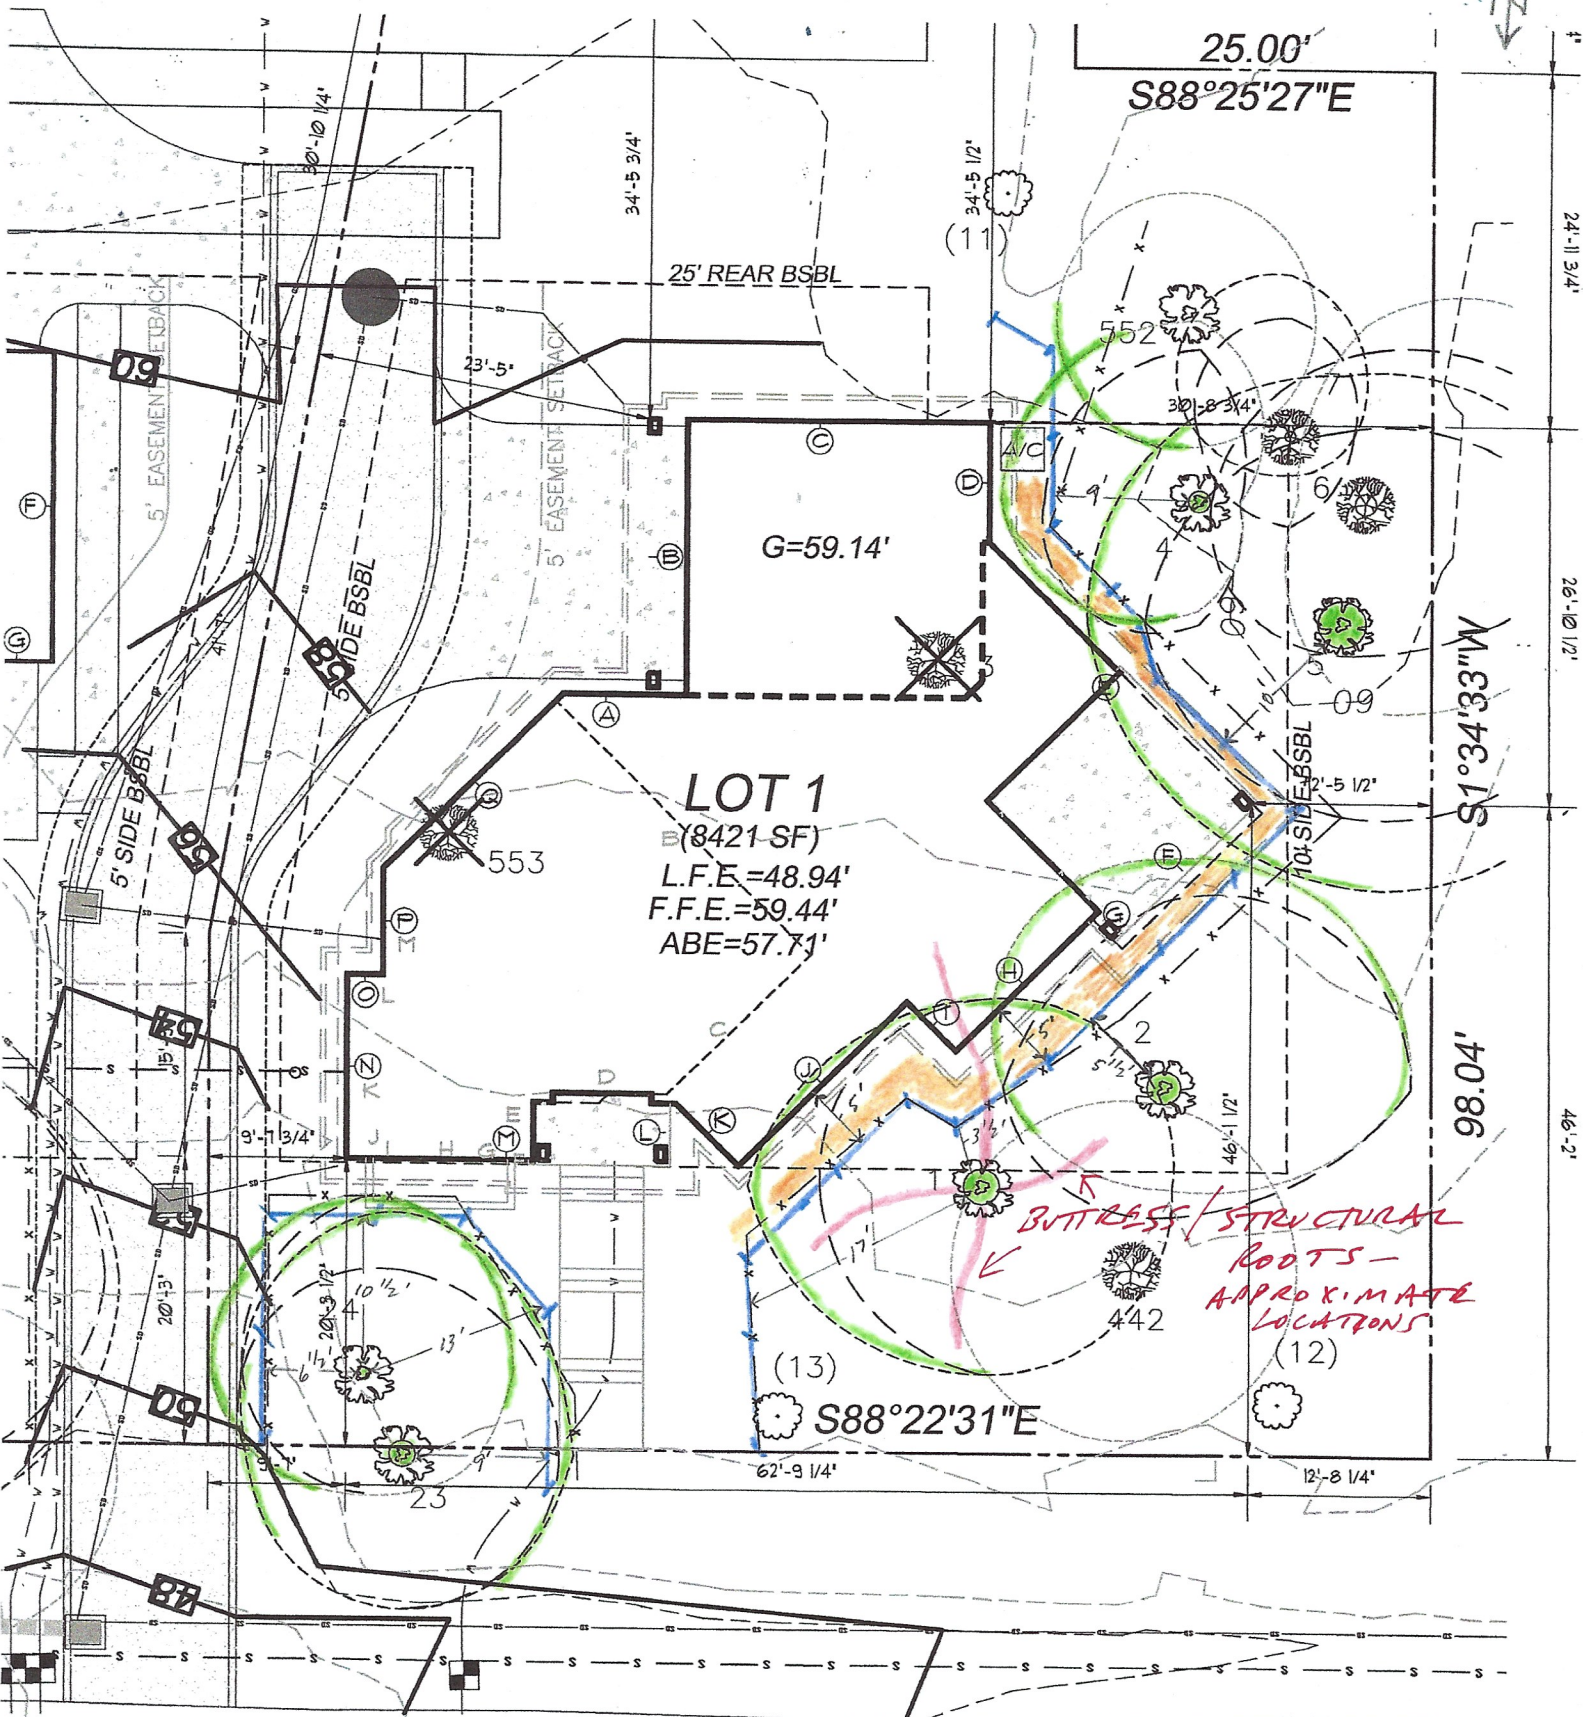
LOT 1 TREE PROTECTION PLAN

*BUTTRESS/STRUCTURAL  
 ROOTS -  
 APPROXIMATE  
 LOCATIONS  
 (12)*
