LAYTON TREE CONSULTING, LLC

ARBORIST REPORT/TREE PLAN

7621 SE 22nd Street
Mercer Island, WA

March 30, 2020

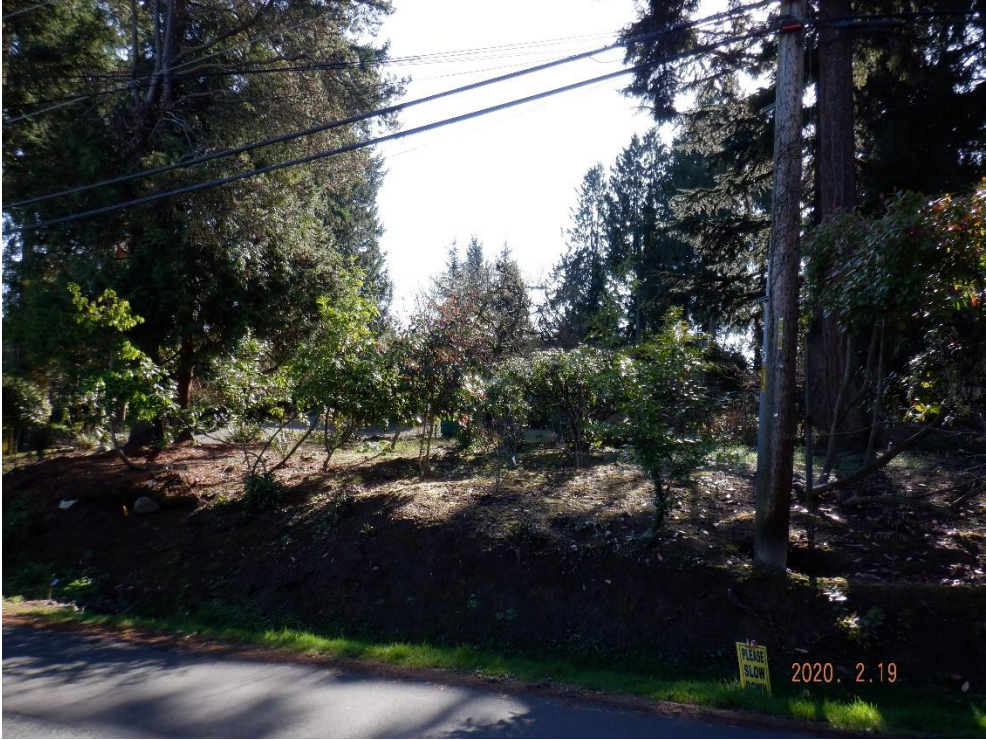
Tree #23 is a mature shore pine at the front of the property. It has multiple forked tops. It has been pruned back in the past for power line clearance.

Front of property, Tree #1 on right, Trees #23 and #24 on left

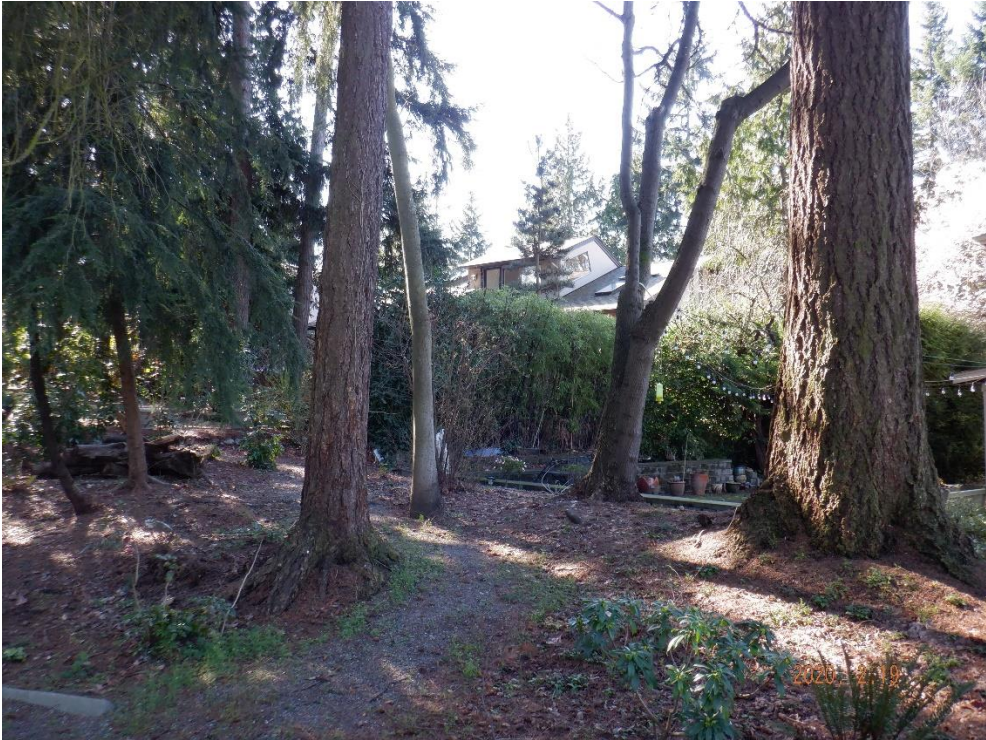
Trees #4, #5, #6 and #7

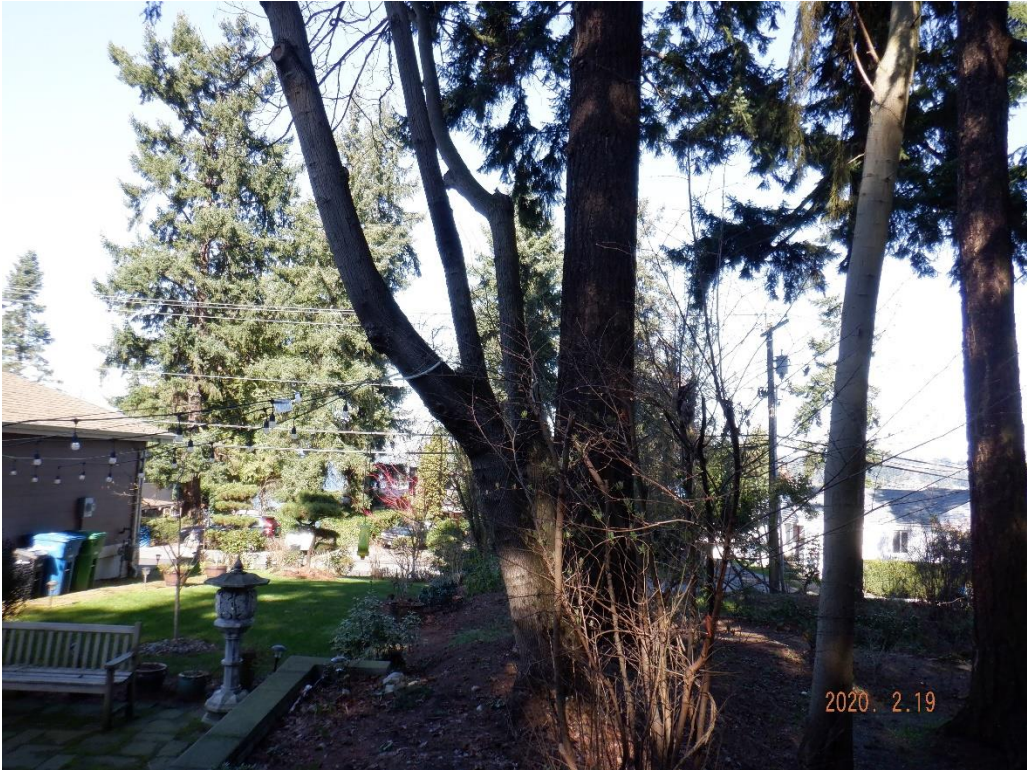
The subject bigleaf maples have developed typical form and structure. Tree #6 is a semi-mature bigleaf maple close to the west property line. It has an asymmetric crown to the west onto the neighboring property. Vigor is fair.

Trees on west perimeter, looking north, Tree #6 (maple) with lean to west towards neighbor

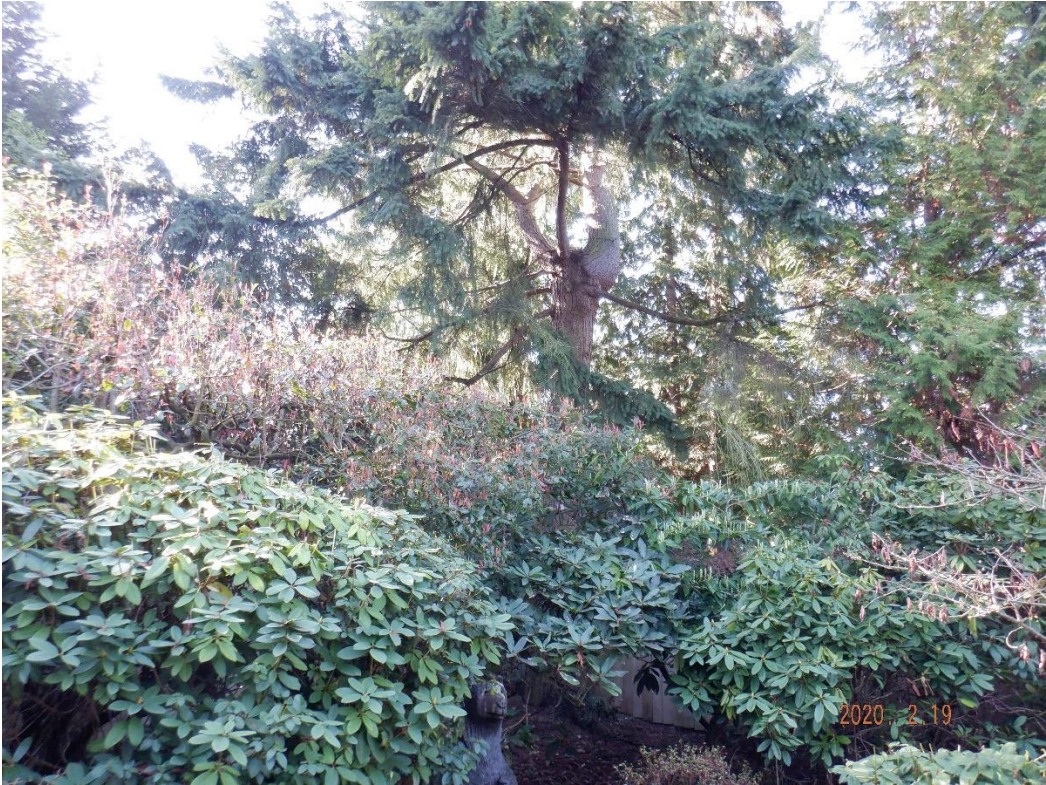
Tree #8 in southwest corner of property

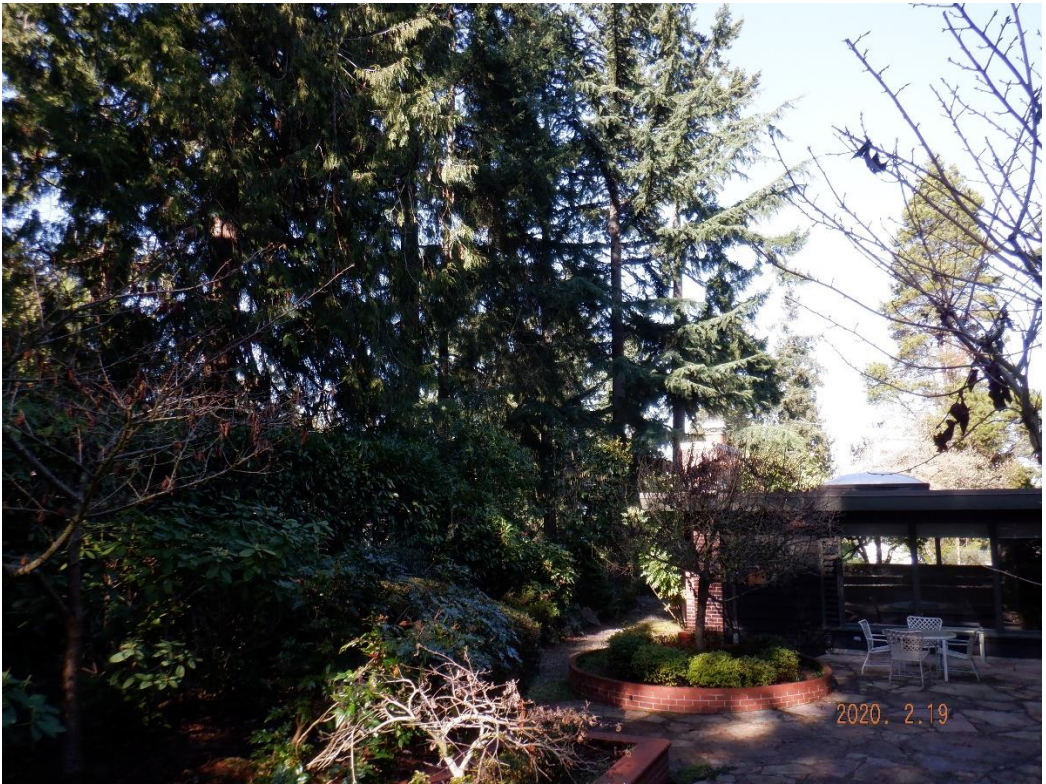
The Western red cedar is of fairly good vigor. Foliage is of normal color and density. The foliage in the upper crown of Tree #101 is a little sparse. The lower trunks are sound and free of any outward indicators of internal stem decay.

Back of property, Trees #101 and #102 on left

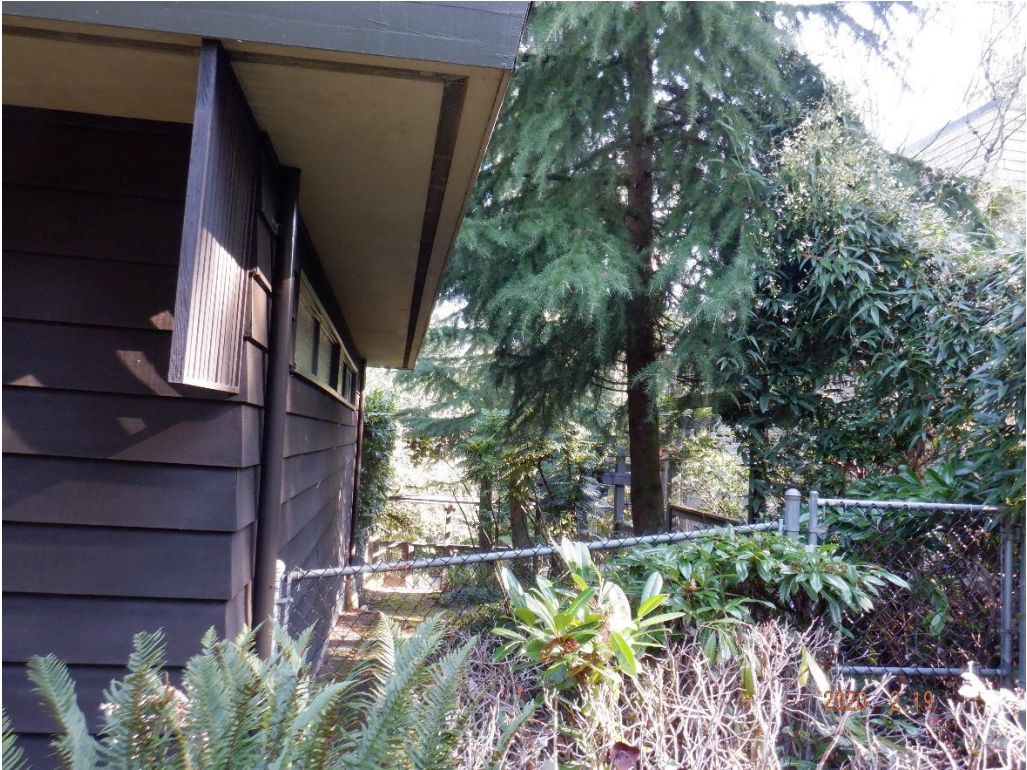
Trees #9, #10 and #11 are young planted Deodar cedar on the south perimeter. All are of good vigor and in good condition.

Trees #9, #10 and #11 on south perimeter

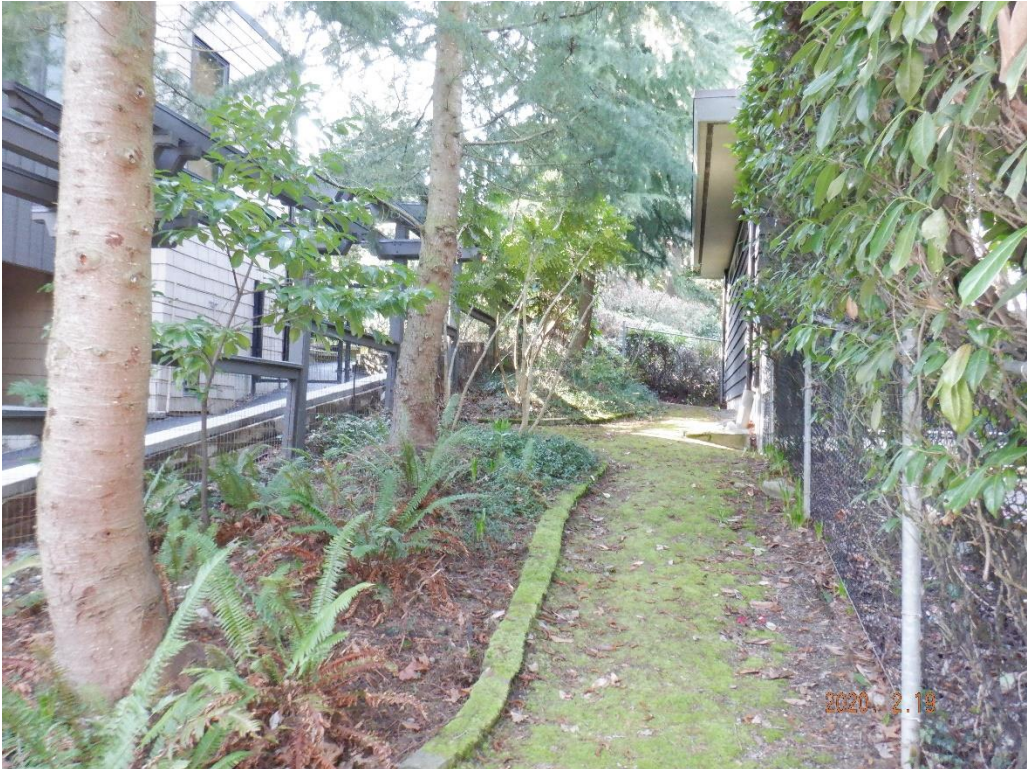
Lower trunks of young Deodar cedar trees

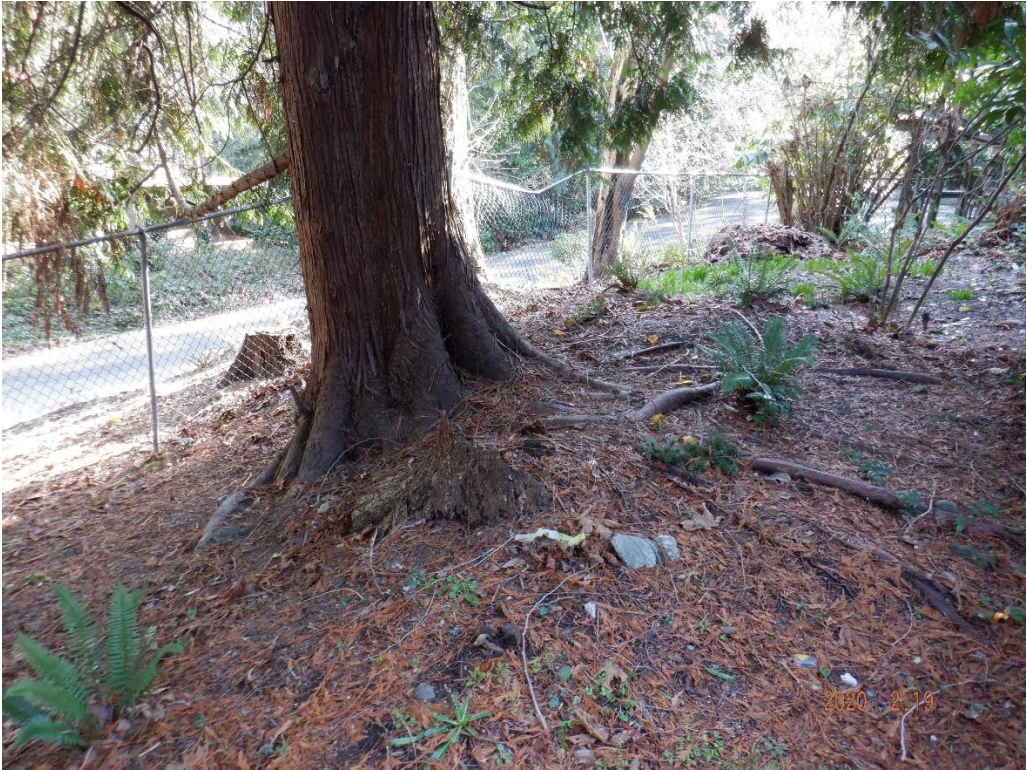
Tree #12 on east perimeter

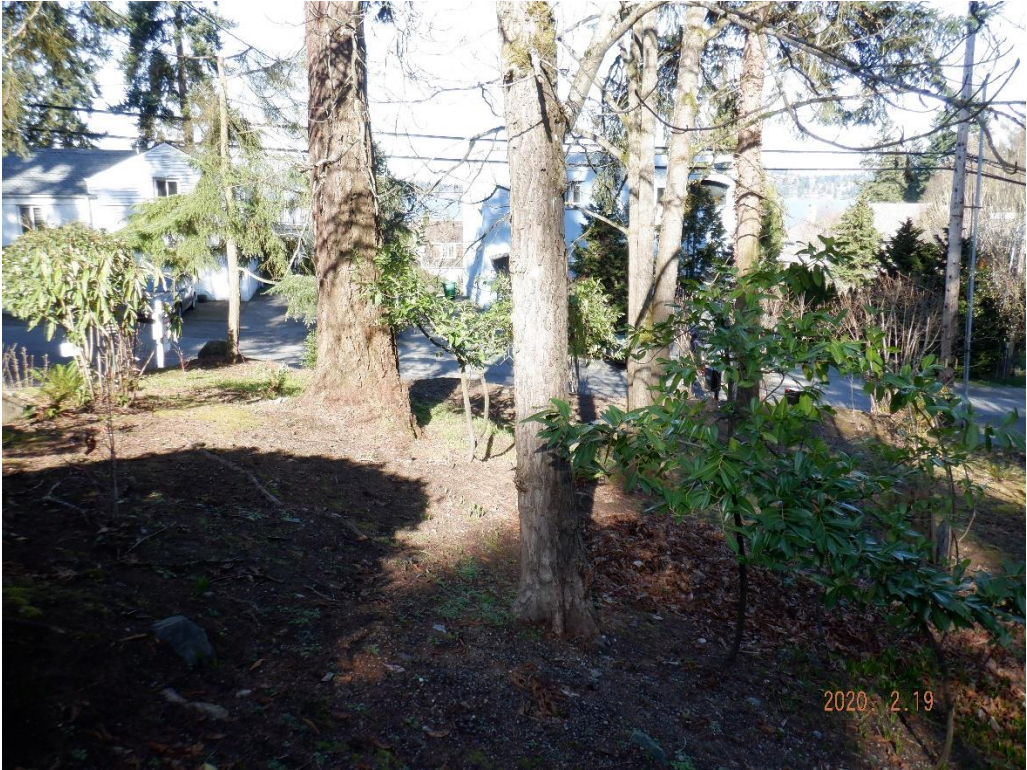
Grouping of trees in northeast portion of property

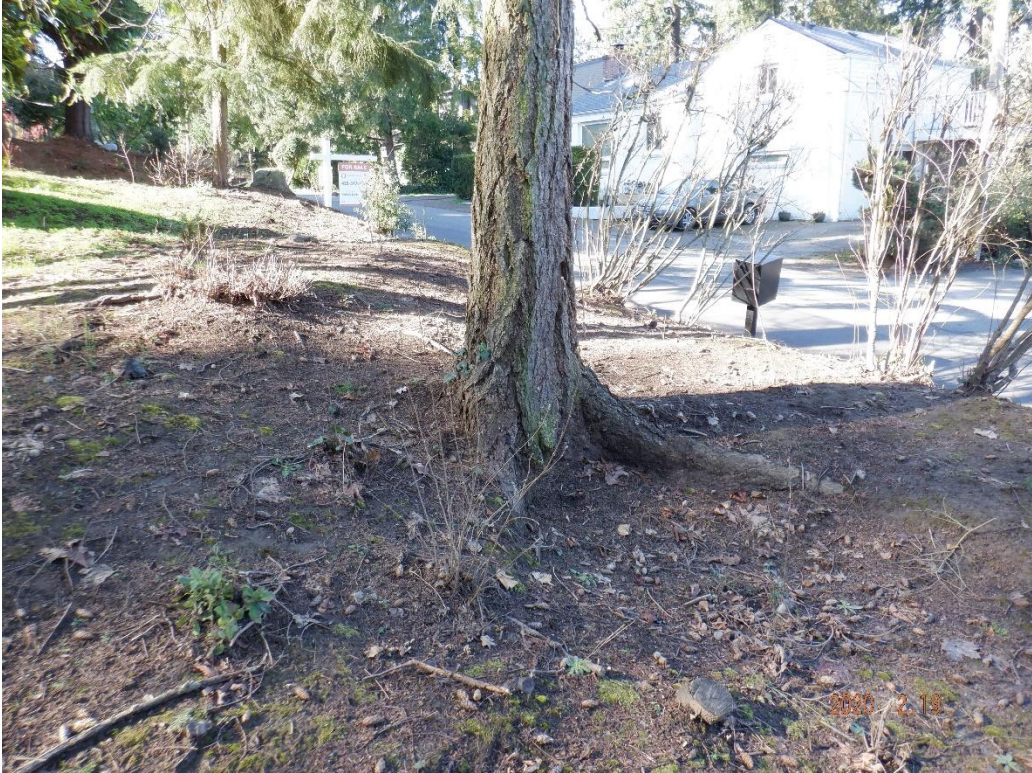
Lower trunk of Tree #21

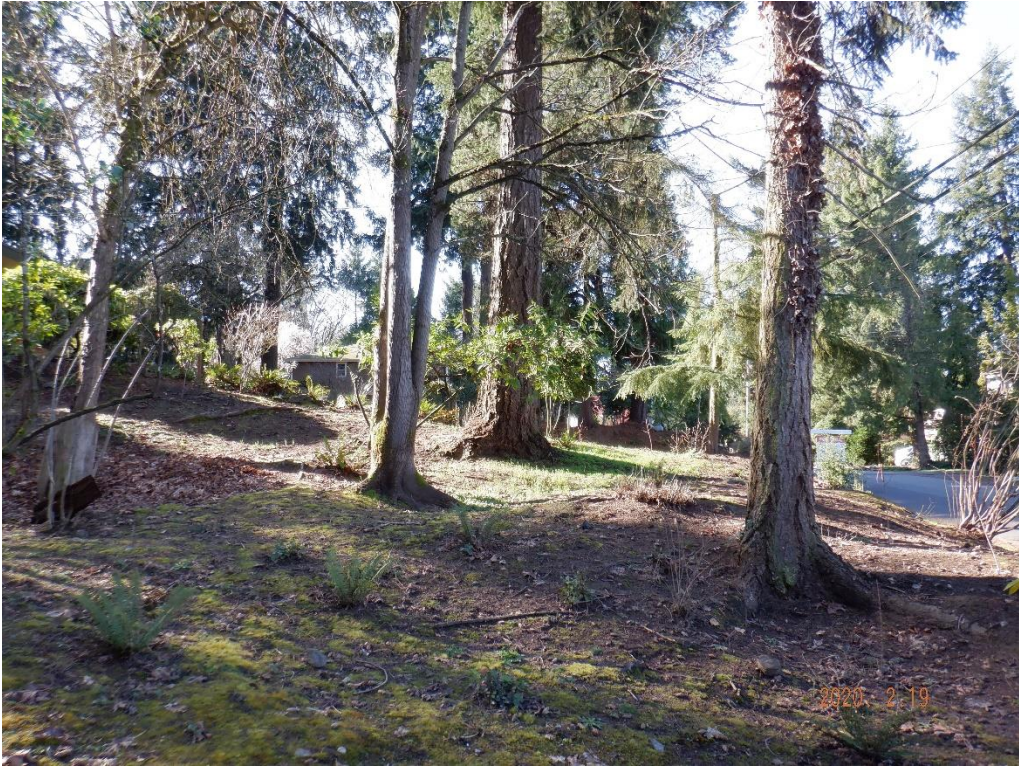
Trees #20, #21 and #22 at front of property

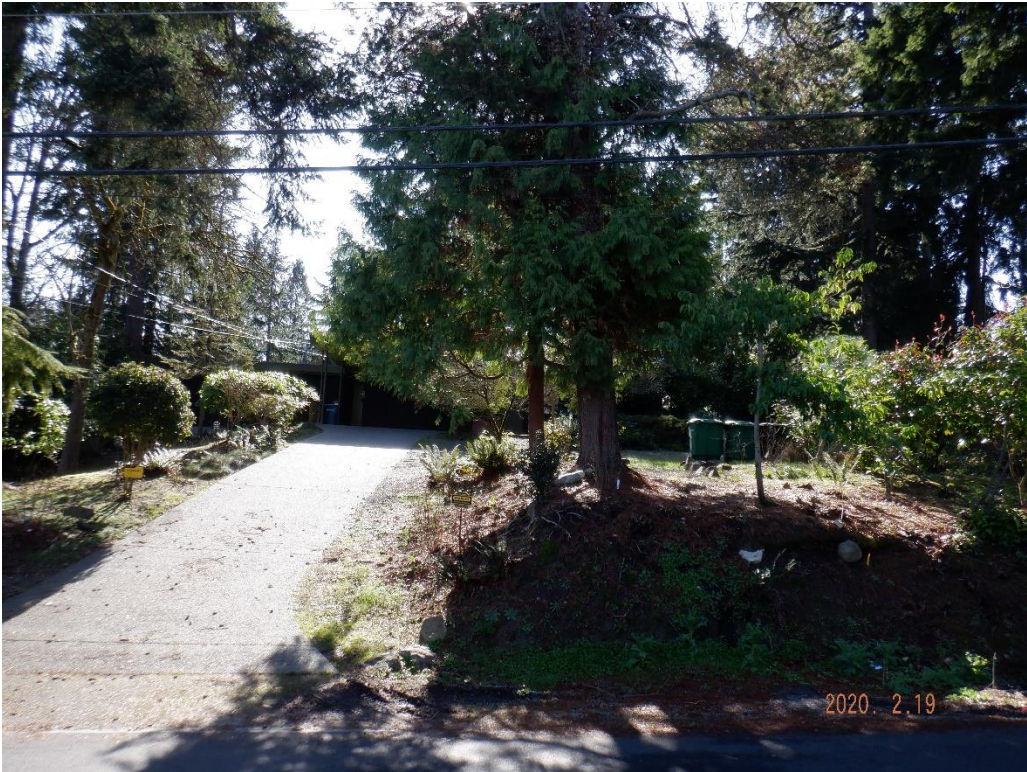
Trees #23 and #24 at front of property

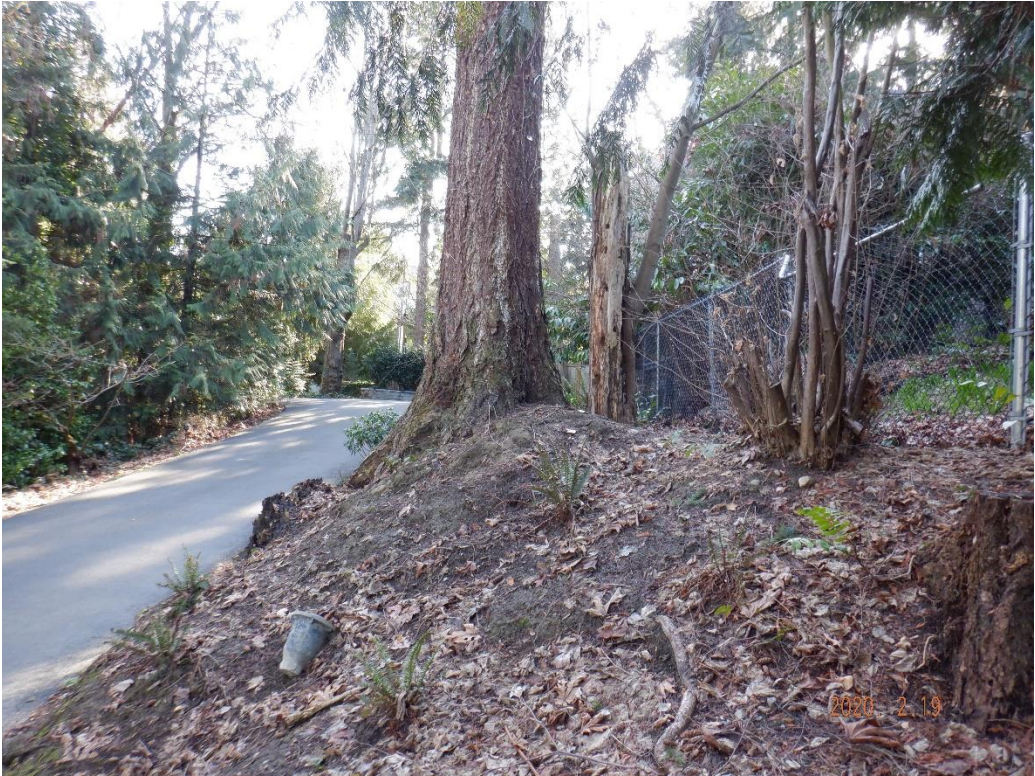
Tree #25 on east property line

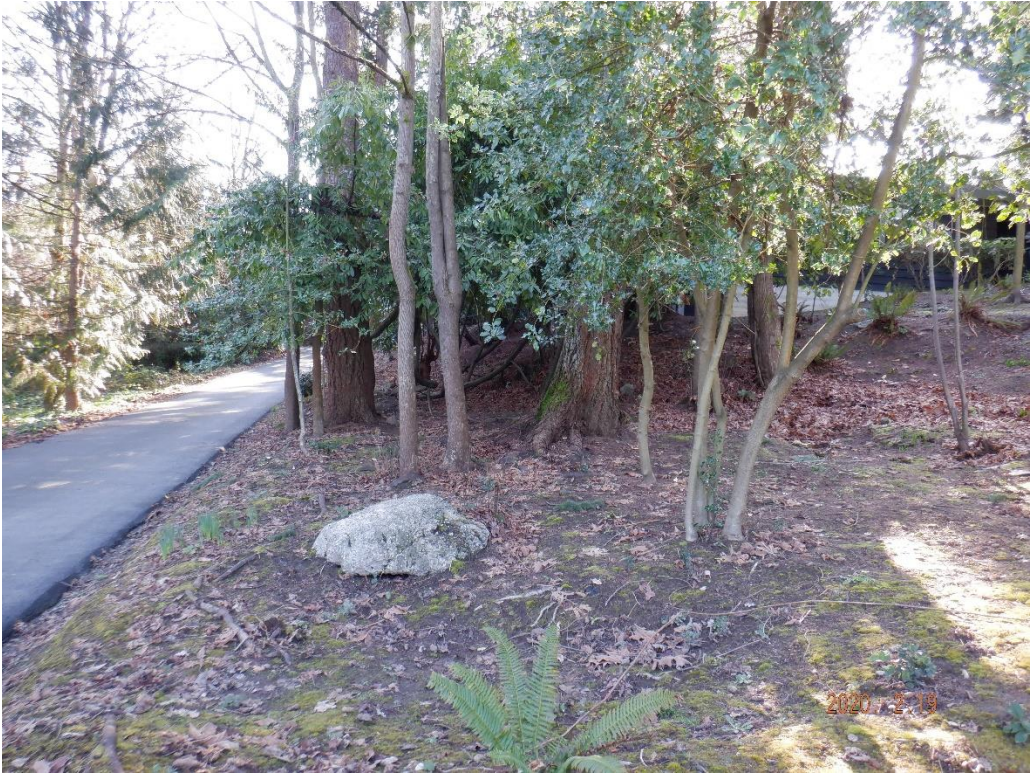
Looking south down east property line
