LAYTON TREE CONSULTING, LLC

Trees & Construction Memo

To: Greg Arms
From: Bob Layton
CC: Scott McMillen
Date: March 20, 2025
Re: 7621 SE 22nd ST – Lot 1 Tree Protection

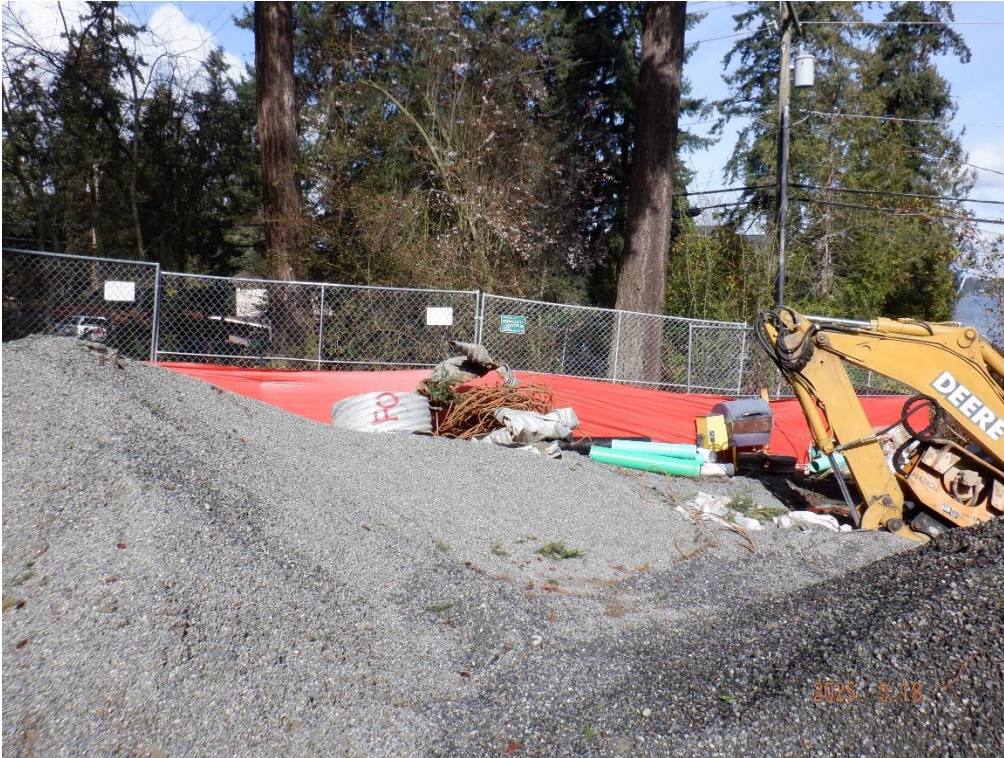
Trees #1 and #2

On March 18th per your request, I visited your current project site at 7621 SE 22nd Street on Mercer Island to evaluate potential impacts to trees associated with the construction of the Lot 1 residence. Trees potentially impacted by the foundation excavation include Trees #1, #2, #4 and #5. These are all semi-mature to mature native Douglas fir. All of these are currently in good condition, see pictures below.

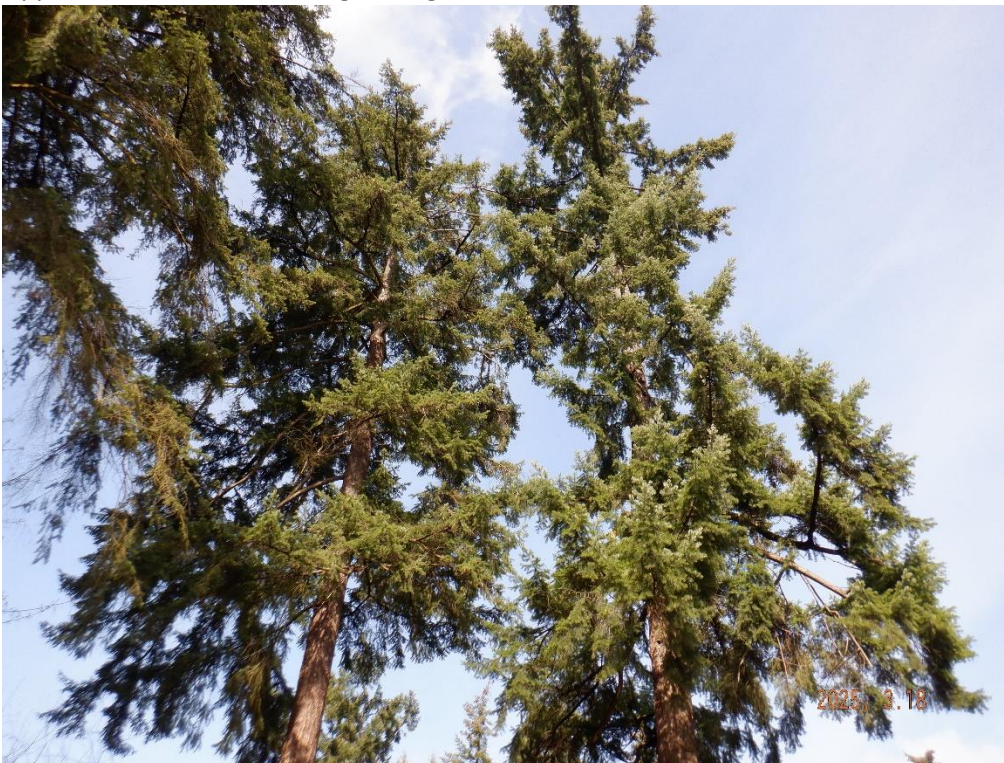
Upper crowns of #1 and #2, good vigor

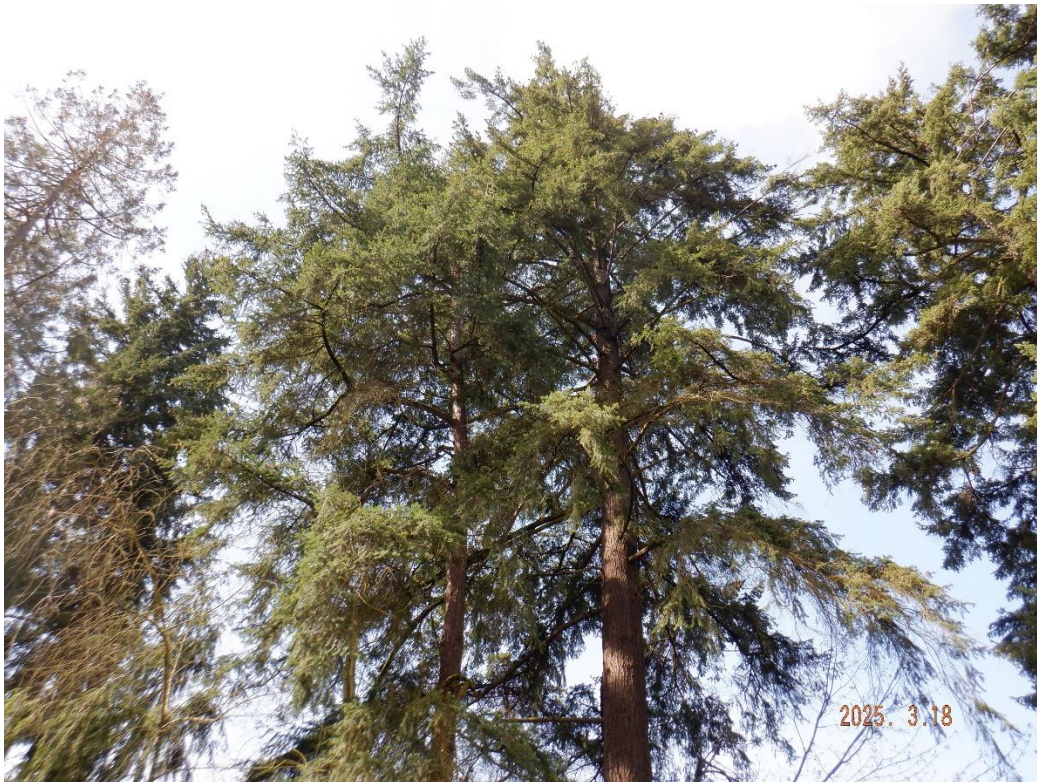
Upper crowns of #4 and #5, good vigor

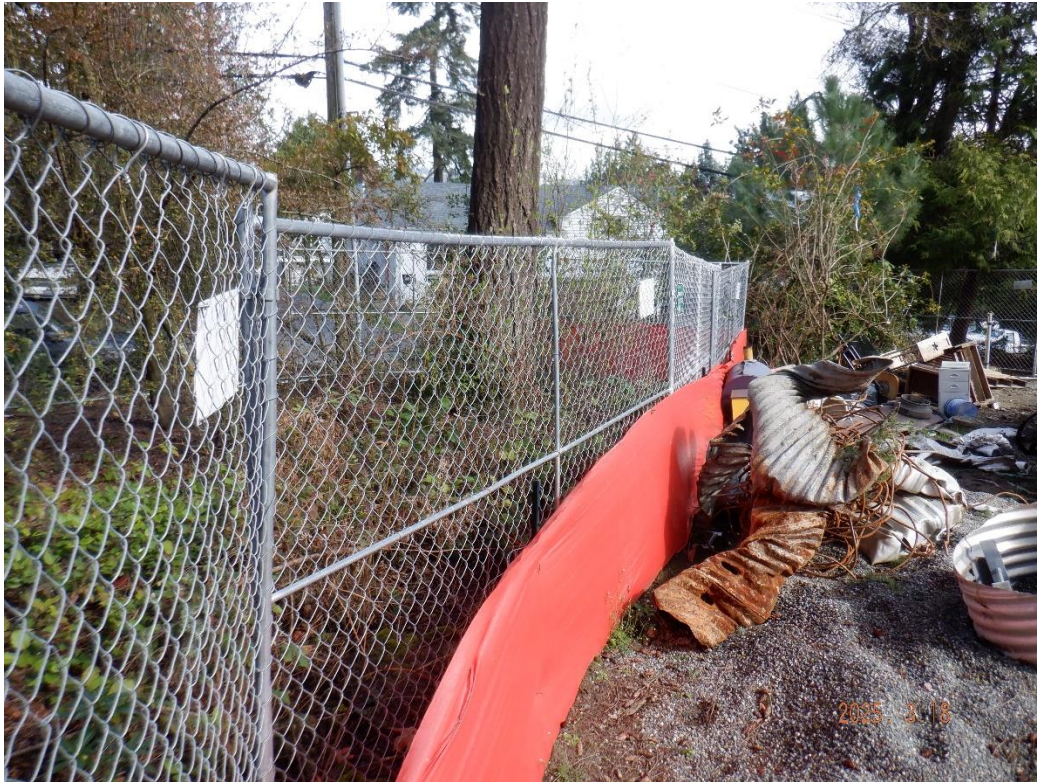
Tree Protection fence positioned roughly 5-feet from trunk face of #1

To best protect the trees, lay out and mark on the ground the extent of excavation; and expand the tree protection fencing as shown on the attached plan. The tree protection fence shall be set at 5-feet from the new house walls to provide adequate construction clearance. The ground between the cut for the new foundation and protection fence shall be covered with a 4 to 6-inch layer of coarse wood/bark chip mulch or hog fuel to protect soils and surface roots during construction, per the attached map.

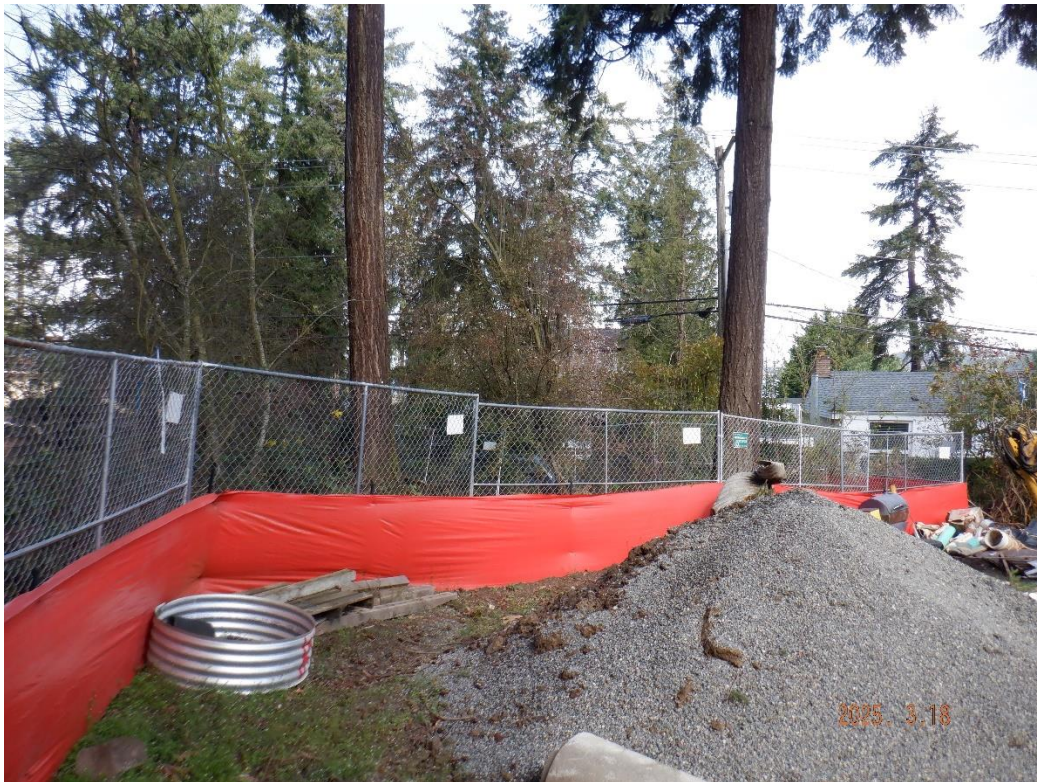
Trees #1 and #2

Excavation for the new foundation is within a proximity of the subject trees. Tree #2 is the closest at roughly 9-feet from the excavation limit. The area to be excavated for the house foundation has been previously disturbed by the demolition of the prior residence and the installation of utilities. The protection fence is currently positioned as shown on the approved plans.

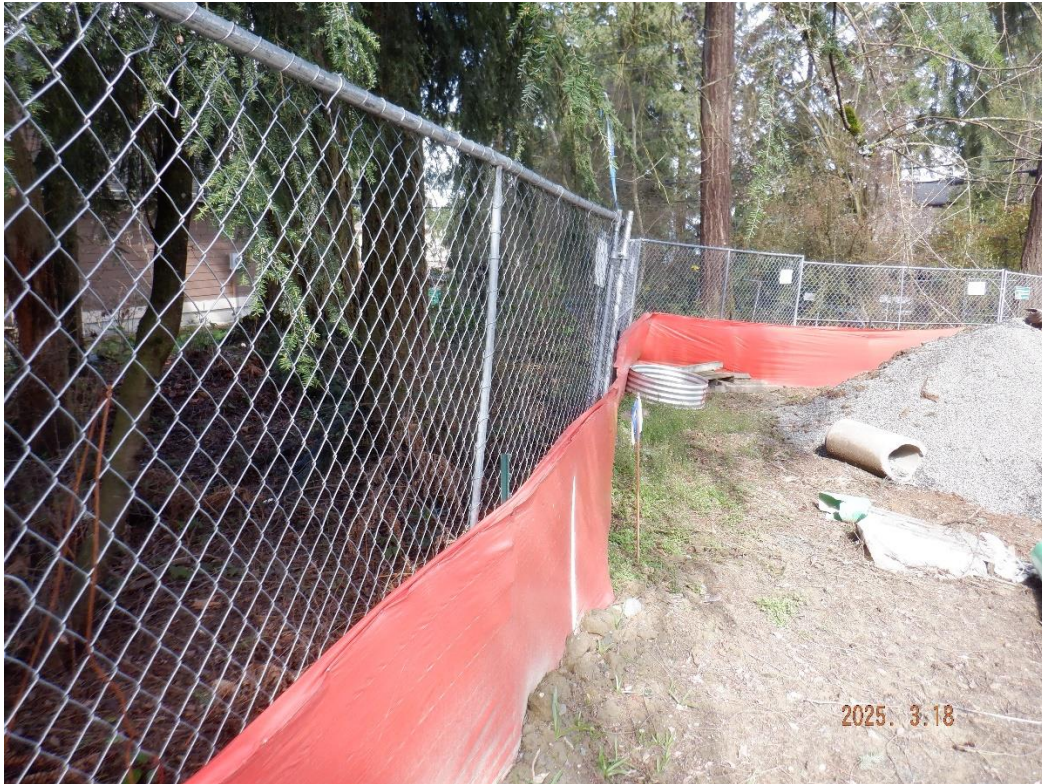
Tree Protection Fence adjacent to Tree #4
