Arborist Report

Site: 4332 W Mercer Way, Mercer Island, WA, 98040

Re: Tree Inventory and Assessment

Date: May 9, 2024

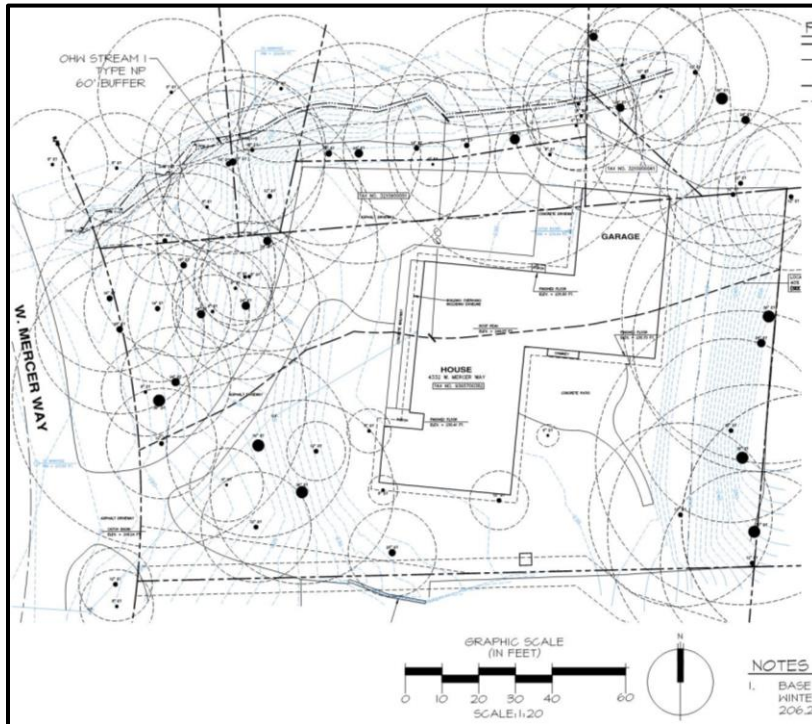
Figure 1. Cropped section of Critical Areas Map (Altmann Oliver Associates LLC, 03/07/2024).

According to the Critical Areas Map (Altmann Oliver Associates LLC, 03/07/2024) there is a steep slope area east of the existing home and a stream and 60 foot stream buffer that runs through the northern third of the site (Figure 1).

Trees, driveway and structure remain the same

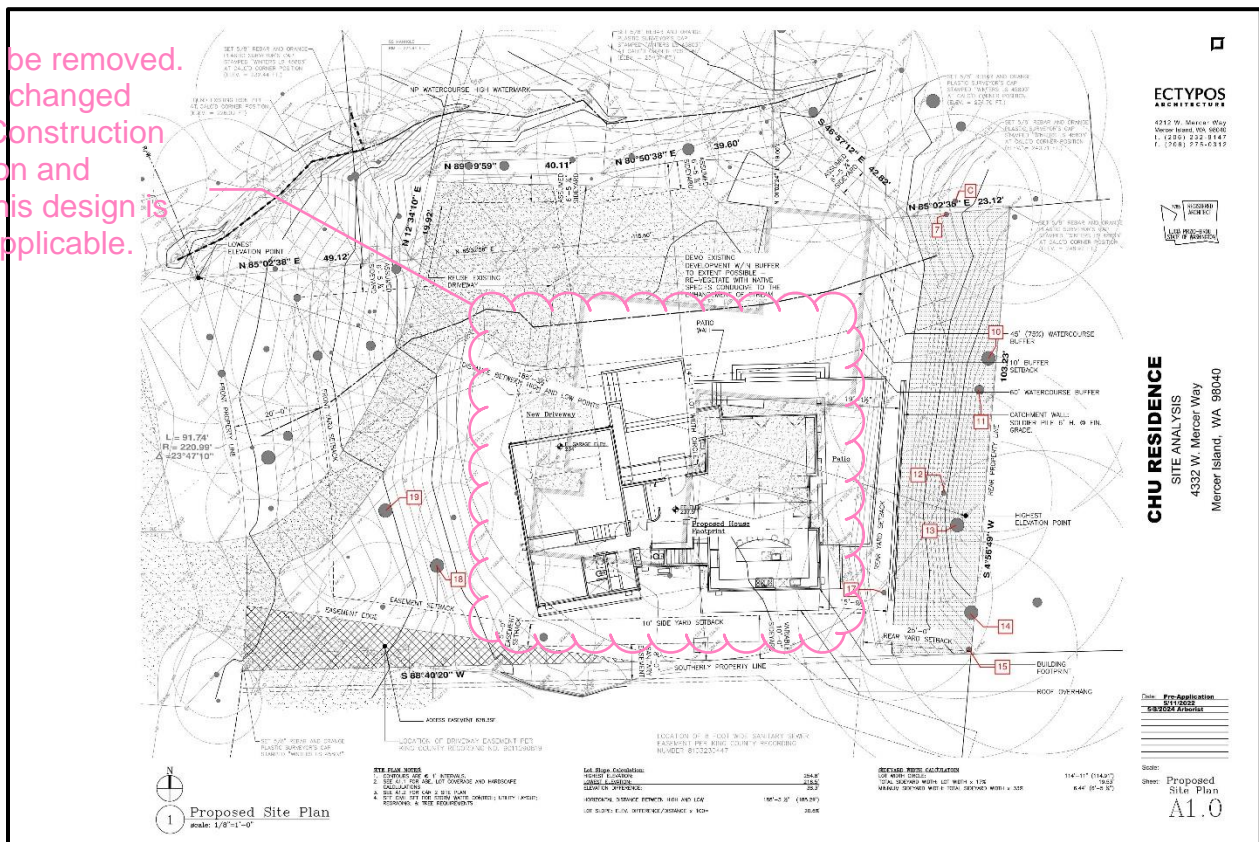
Figure 2. Proposed Site Plan A1.0 (Ectypos Architecture, 05/11/2024).

No tree will be removed. The project changed from New Construction to Alternation and Addition. This design is no longer applicable.

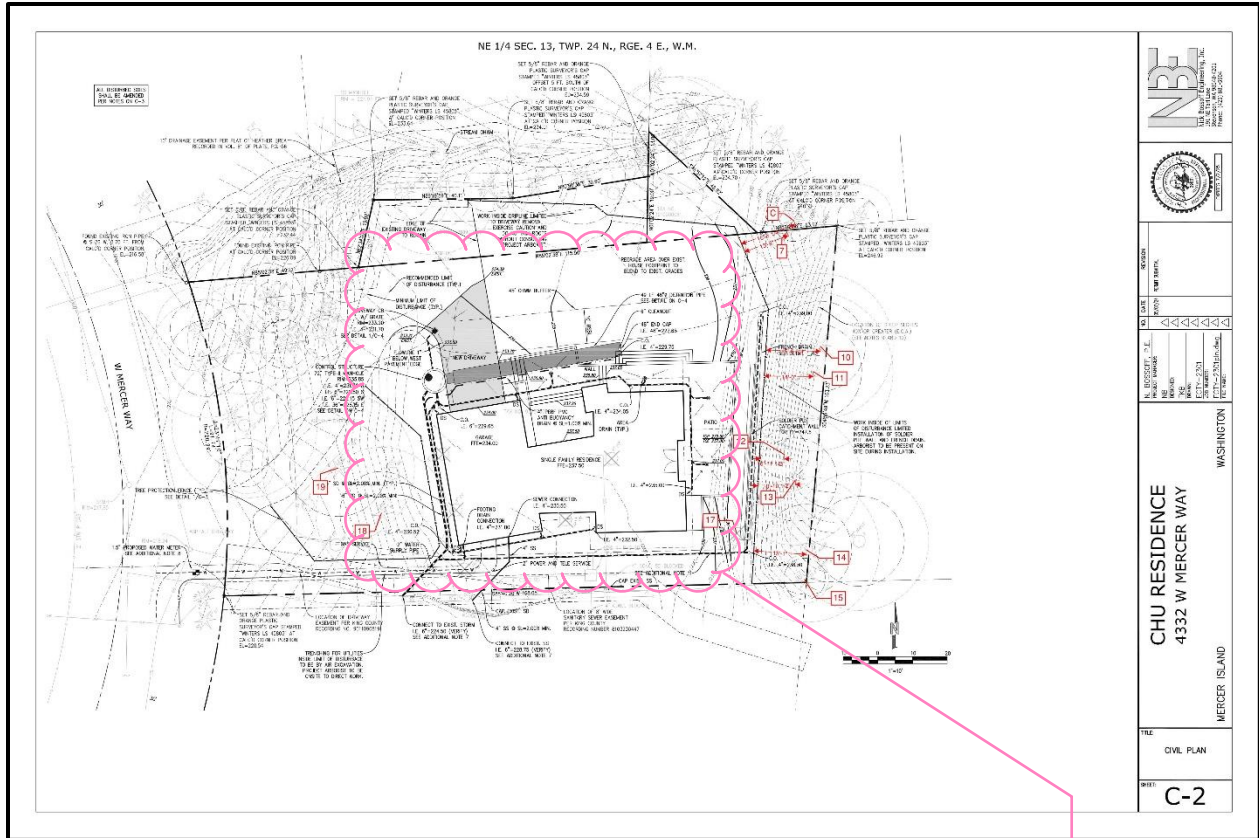
Figure 3. Civil Plan Sheet C-2 (Nick Bossoff Engineering, 05/07/2024)

No tree will be removed. The project changed from New Construction to Alternation and Addition. This design is no longer applicable.

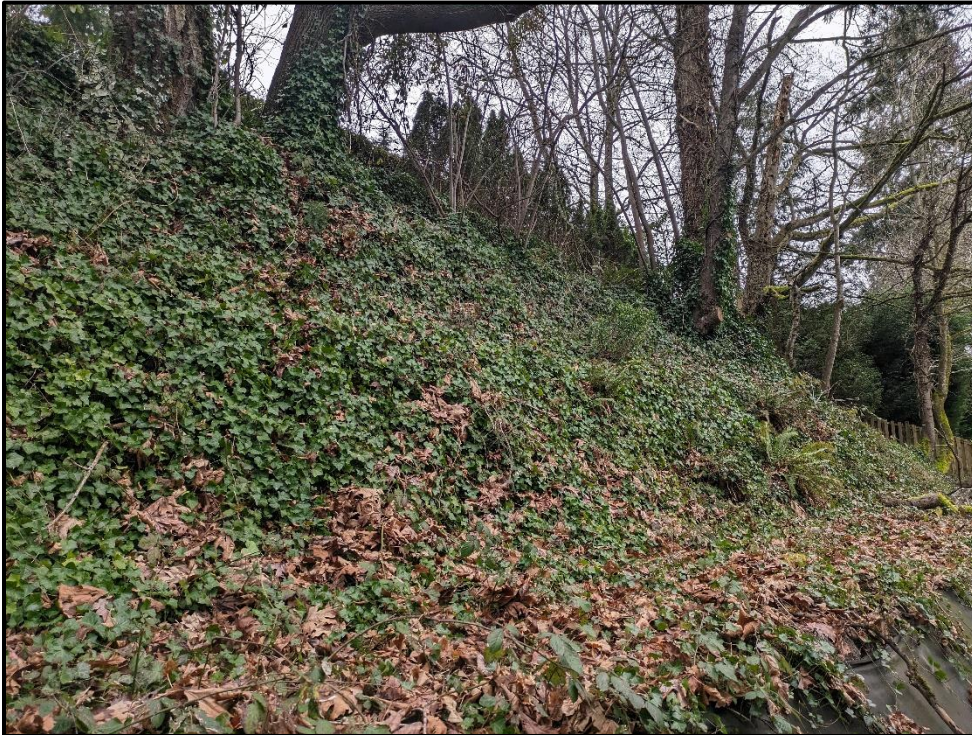
The slope on the eastern boundary of the site had extensive invasive ivy (*Hedera spp.*) that was growing at the base and on the trunk of several of the trees. The combination of the ivy and the steep slope limited my assessment. The ivy should be removed so I can reassess the base of trees prior to construction (Photo 1). Once ivy is removed, I recommend establishing erosion control measures such as jute matts, straw waddles, and planting.

Photo 1. View of the base of trees along the eastern boundary of the site. I observed extensive ivy at the base of these trees and I recommend the ivy is removed prior to construction and for the base of the trees to be reassessed.

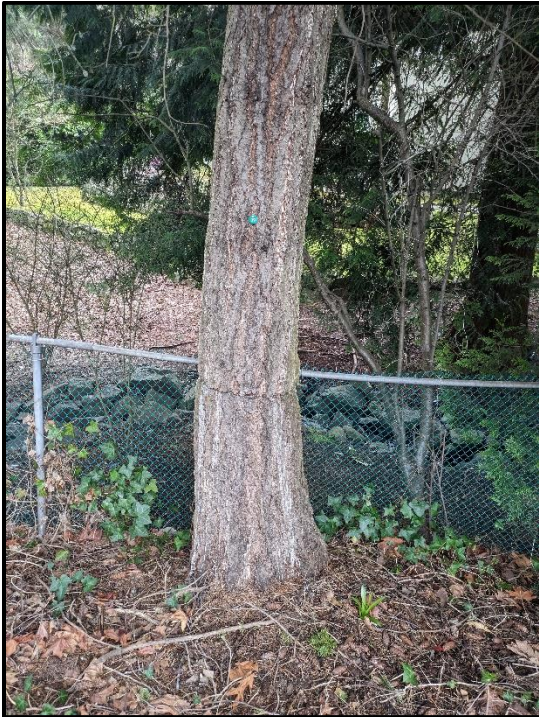
Trees 38 to 40 are Douglas-fir (*Pseudotsuga menziesii*) trees that are growing north of the property. I observed the trunks were girdled by a wire at 2 to 3 feet above the base (Photo 3). I recommend removing wires to improve the long-term health function of the trees.

Photo 3. Tree 39 viewed from the south. There is a wire that is girdling the base that I recommend is removed to improve and maintain the long term function of the tree.

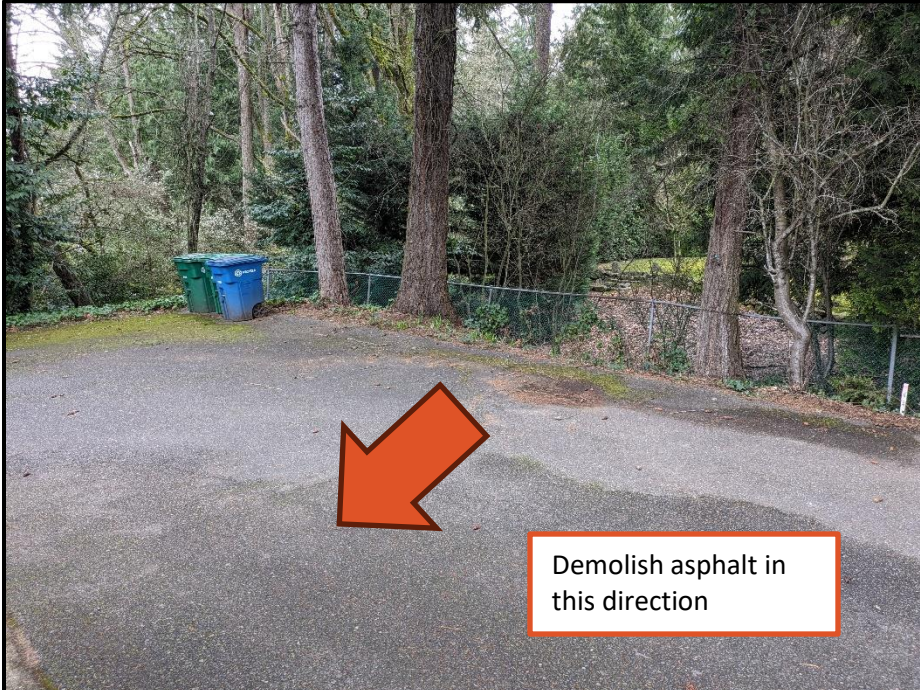
Photo 4. Base of tree 38 viewed from the south. The driveway is proposed for removal in this area. I recommend the asphalt removal begins closest to the tree and moves backwards. Once the pavement is removed no machinery traffic or materials are allowed. I recommend the project arborist is called if any large roots over 2-inches diameter are encountered.

Project arborist should be present during driveway demolition to ensure no damage occurs to tree roots. The asphalt should be removed closest to the trees and the machinery should work backwards or south of the trees (Photo 4). No machinery traffic is allowed across exposed soil. No materials may be stored on the uncovered soil once the asphalt is removed.

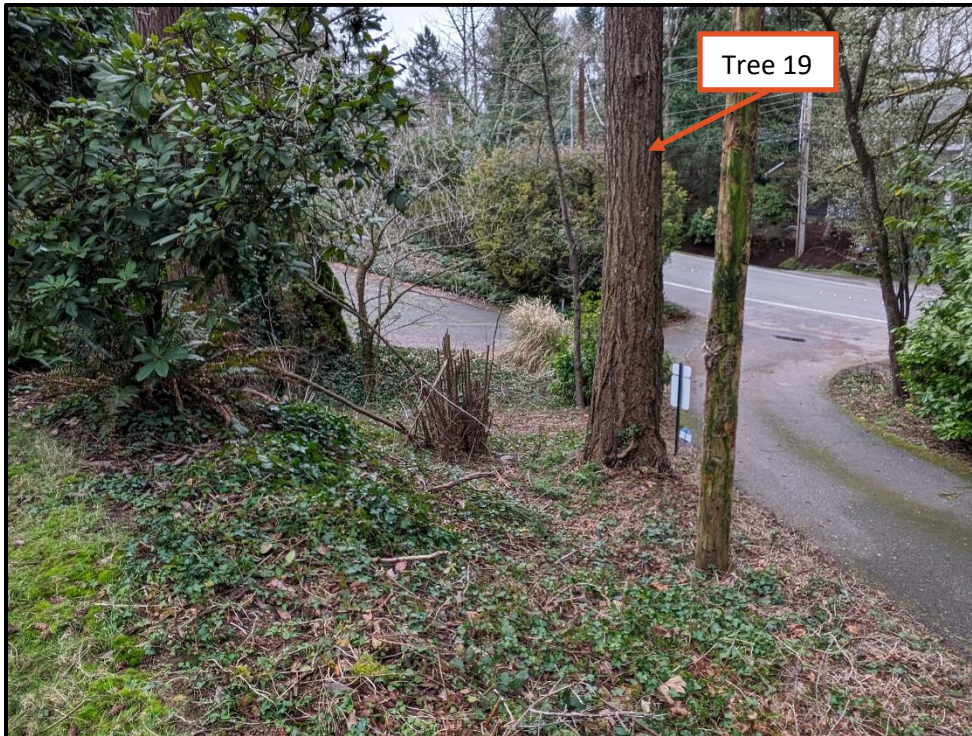
The plans propose installation of gas, water, power, and sewer utilities on the south end of the site. Installation of these utilities will require excavation within the RLOD of tree 18. Disturbance will be 13.5 feet from the tree.

Photo 5. Base of tree 19 viewed from the north. Utilities are proposed within the RLOD of the tree. I recommend excavation within the RLOD occur with either hydro or air excavation.

- Tree protection fencing is set along the RLOD of trees 18 prior to any construction
- Excavation within the RLOD is monitored by the project arborist, who will assess and document root impacts
- Excavation within the RLOD uses alternative methods such as pneumatic or hydro excavation (Photo 5).

Air excavation should be utilized to the extent feasible but if the utilities are required to be more than 18 inches below the existing grade I recommend hydro excavation is utilized.

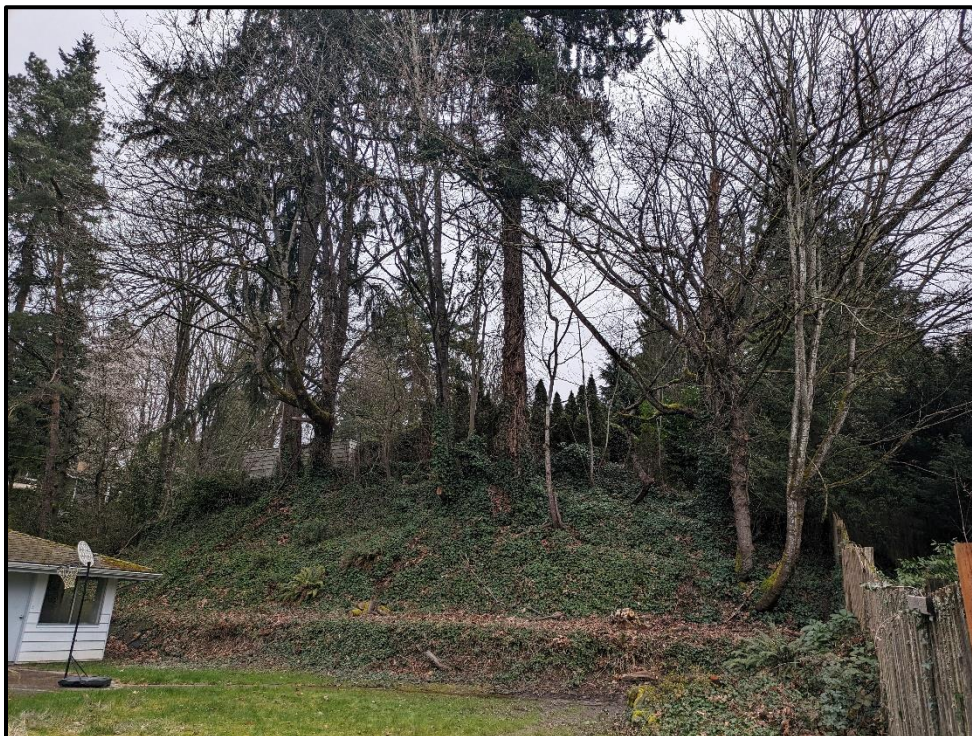
The plans propose the installation of a catchment wall on the east side of the property. The limits of disturbance to install the catchment wall are proposed within the RLOD of trees 10, 11, 12, 13, and 14 and within the MLOD of tree 13 (Photo 6).

Photo 6. View of trees 10, 11, 12, 13, 14, and 17 viewed from the west. A catchment wall is proposed within the RLOD of the subject trees and I recommend the footings for the walls are installed by hand or air excavation.

In discussion with the project team, I understand that the catchment wall is proposed to be constructed with a foundation of 2-inch pin piles with helical anchors. If impacts within the MLOD of tree 13 are limited to pin piles, I believe the wall can be constructed as proposed if the following measures are utilized within the RLOD of trees 10, 11, 12, 13, and 14:

- Tree protection fencing is set along the RLOD of trees 10, 11, 12, and 13 prior to any construction

- When construction of the catchment wall is to begin tree protection can be moved to the location shown on the TESC plan.
- No machinery is allowed within the RLOD of these trees without tree protection.
- Any excavation within the RLOD must be approved and monitored by the project arborist.
- Excavate the location of the pin piles either by hand or air-excavation with the arborist present to assess locations of roots and assess impacts to the trees.
