MERCER ISLAND TREE INVENTORY & REPLACEMENT SUBMITTAL INFORMATION

ARBORIST REPORT

8427 SE 62nd St Mercer Island, WA 98040 / Parcel #1924059171

Kim Ettari - ISA Certified Arborist PN1301A / TRAQ

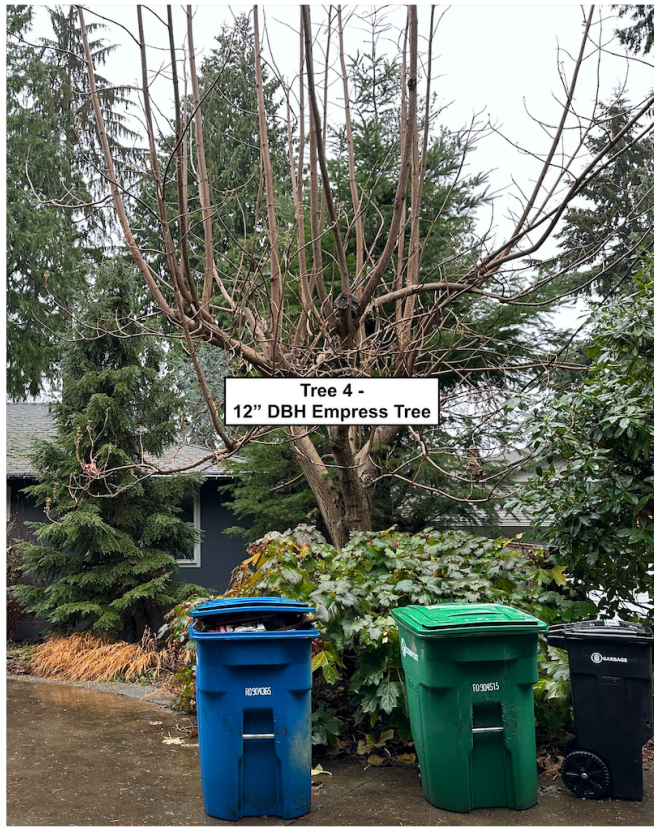
Tree 4 -
12" DBH Empress Tree

REMOVAL CALCULATION - The proposed construction project will require the removal of regulated Tree #4. This tree represents 12 caliper inches or 8.9% of the 134 total caliper inches on the site.

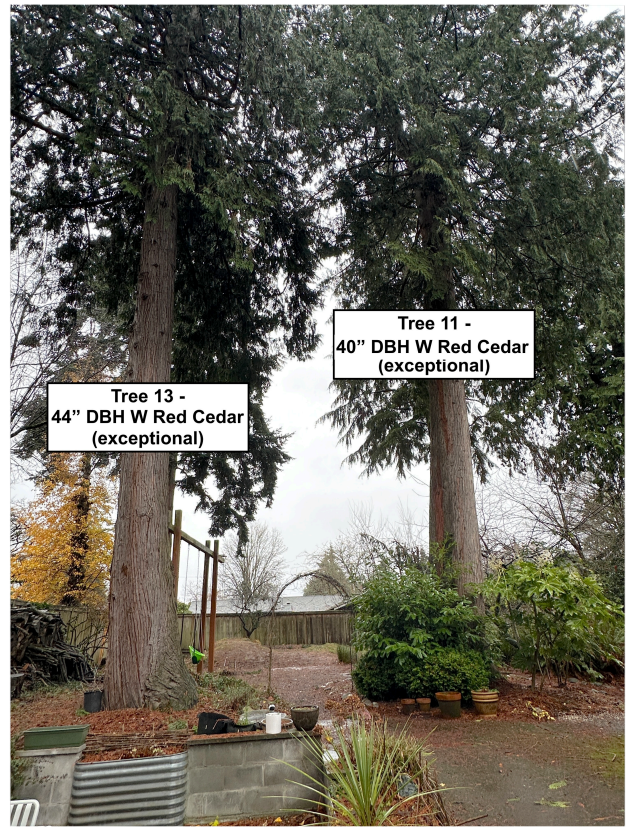
Tree 11 -
40" DBH W Red Cedar
(exceptional)

Tree #11 - Thuja plicata / Western Red Cedar - 40” DBH (exceptional) - This tree is at a higher elevation (approximately 4’) than the residence. Tree protection fencing is to be installed at the drip line (20’) on the north, west and south sides and at 15’ to the east. The new paver patio and a small crushed stone area will encroach approximately 4’ into the eastern drip line but represents less than 10% of the overall canopy. I anticipate no long term impacts to the health of this tree is protected as shown.

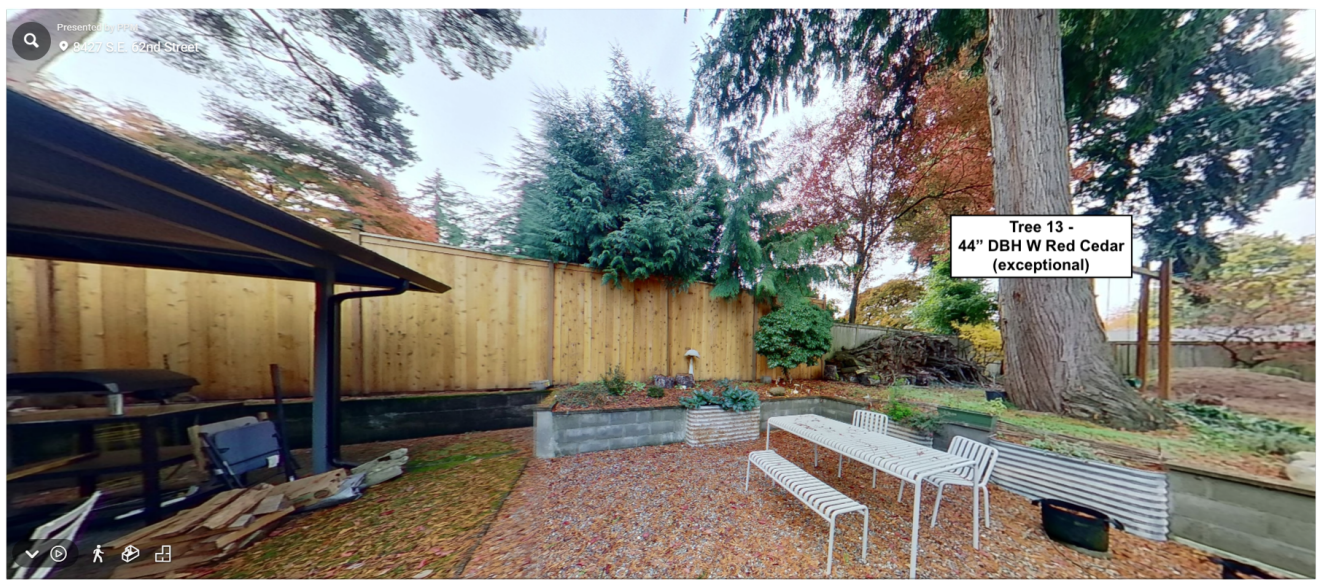
Tree 13 -
44" DBH W Red Cedar
(exceptional)

Tree #13 - Thuja plicata / Western Red Cedar - 44” DBH (exceptional) - This tree is at a higher elevation (approximately 4’) than the residence and an existing retaining wall and crushed stone patio rest under the south east quadrant of the drip line. The proposed construction will replace the retaining wall and patio. Tree protection fencing is to be installed at the top of the retaining wall approximately 5’ from the base of the tree. Absolutely no construction materials or debris is to be placed at the top of the retaining wall. I anticipate no long term impacts to the health of this tree is protected as shown.
