**TO:** Frank Imani  
**SITE:** 2728 63rd Avenue SE Mercer Island 98040 (parcel #217450-3575)  
**RE:** Tree Protection Plan  
**DATE:** December 7, 2024  
**PROJECT ARBORIST:** Scott Selby  
ASCA Registered Consulting Arborist #749  
ISA Board Certified Master Arborist #PN-1775B  
ISA Qualified Tree Risk Assessor

Imani Remodel: 2728 63rd Avenue SE Mercer Island 98040 (parcel #217450-3575)

The project proposes the remodel of an existing single-family residence.

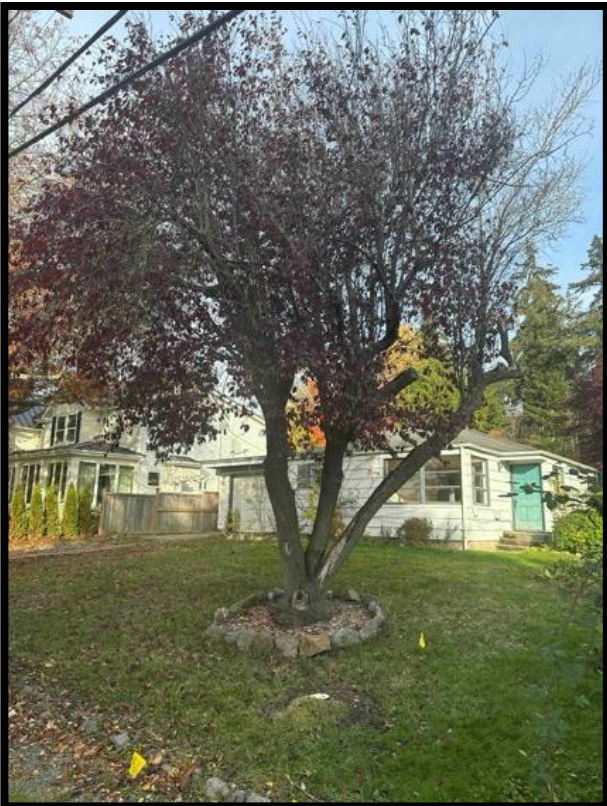
Tree #	Common Name	Scientific Name	*DSH (inches)	N	E	S	W	**RLOD (feet)	Condition	Comments	Proposal	Exceptional
1	Purple leaf plum	<i>Prunus cerasifera</i>	18.9	12	8	6	7	n/a	poor: trunk rot	multi 9.5,10.5,12.5	remove	no
2	Purple leaf plum	<i>Prunus cerasifera</i>	12.5	14	10	8	14	n/a	poor: structural deformity, lean		remove	no
3	American mountain ash	<i>Sorbus americana</i>	6	5	5	4	3	5	fair	multi 4,4.5	retain	no
A	Japanese maple	<i>Acer palmatum</i>	8			8		S6	good	multi 4,4,4,4	n/a	no
B	Western redcedar	<i>Thuja plicata</i>	16			12	14	S10,W10	fair: topped		n/a	no
C	Apple	<i>Malus sp.</i>	6	4	4	4	4	n/a	fair	elevated yard, no conflict	n/a	no
D	Pin oak	<i>Quercus palustris</i>	24			35		20	fair: line clearance pruned		n/a	no

*Photo 2. Tree 1, Purple leaf plum.*

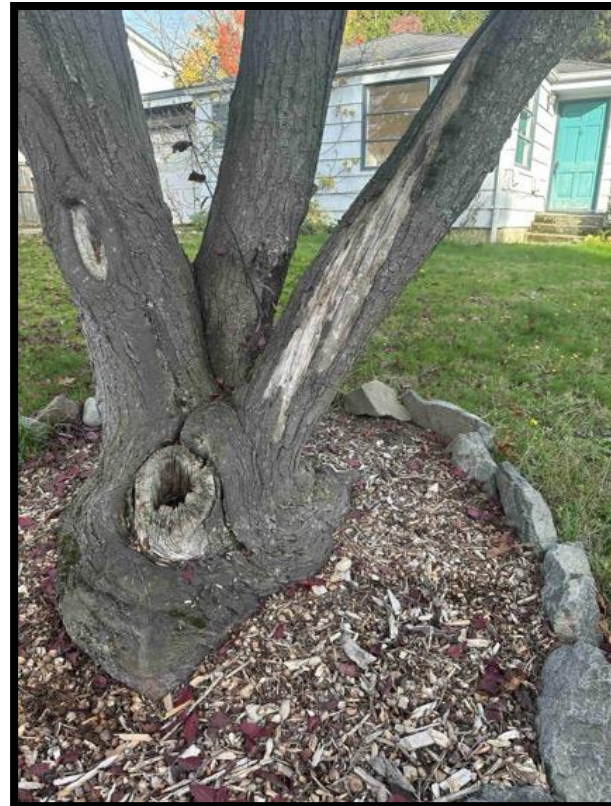
*Photo 3. Close up image of tree 1 showing rot at base.*

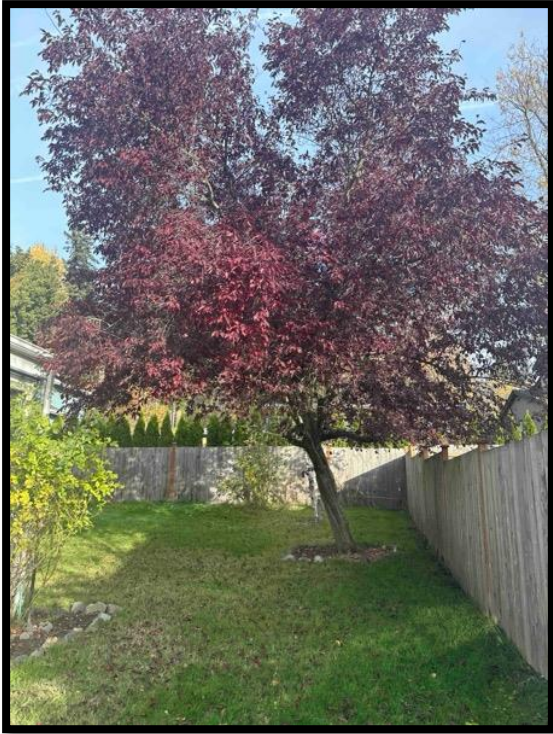
*Photo 4. Tree 2, Purple leaf plum*

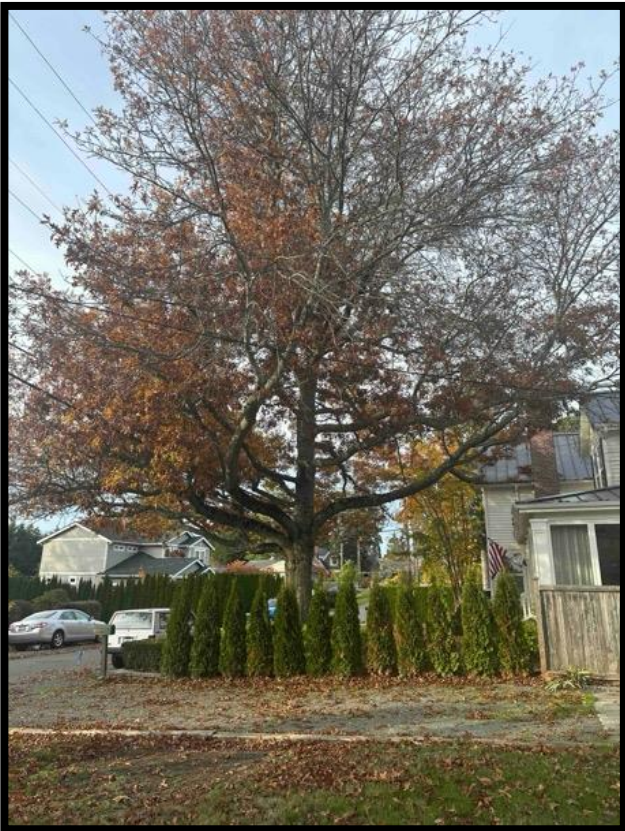
*Photo 6. Tree D, Pin oak (off-site).*
