# LEVEL ONE DOWNSTREAM ANALYSIS

Proposed Residence  
2728 63<sup>rd</sup> Avenue SE  
Mercer Island, WA 98040

Tax Map #217450-3575  
January 3, 2025

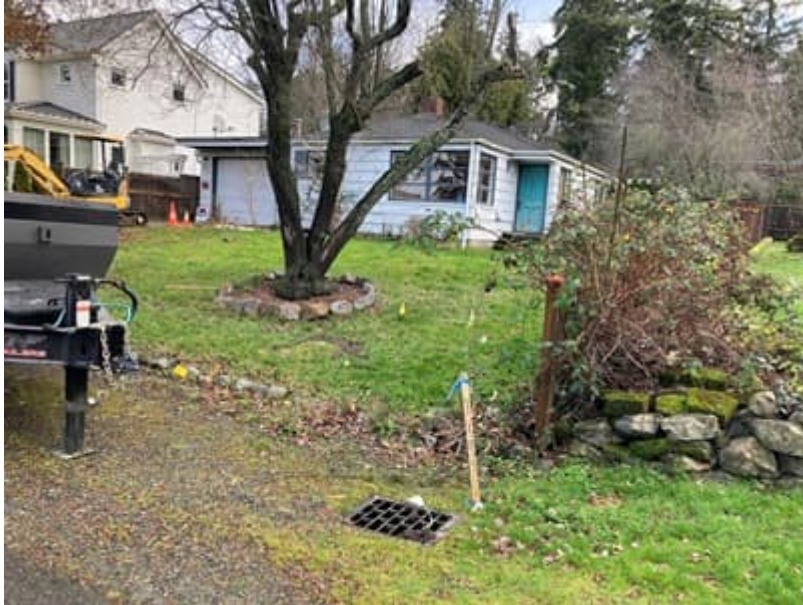
**Picture 1:**  
project site – 2728 63<sup>rd</sup> Avenue SE  
connection catch basin shown

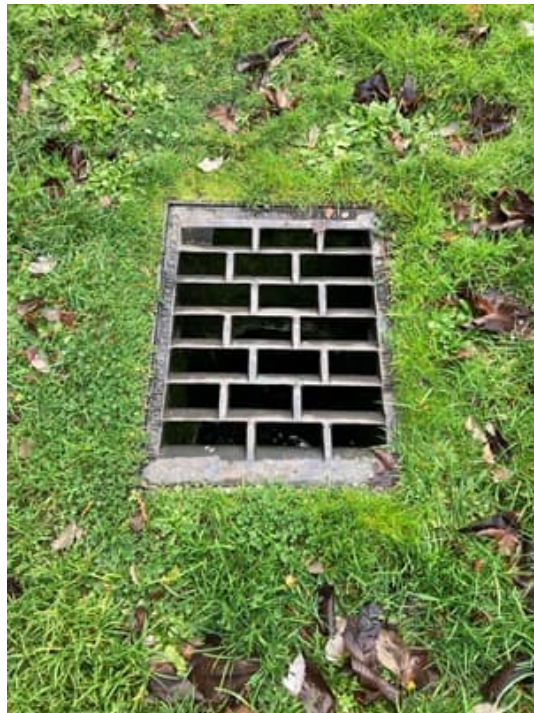
**Picture 2:**  
ROW on the west side of 2736 63<sup>rd</sup> Ave SE  
Looking south

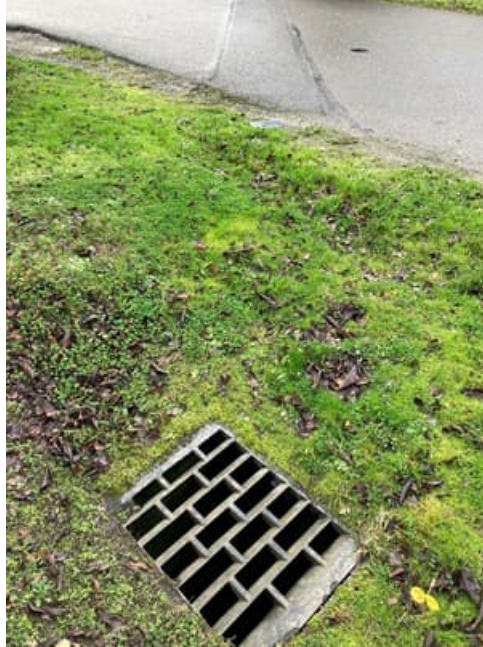
**Picture 3:**

Northeast corner of 63<sup>rd</sup> Ave SE and SE 28<sup>th</sup> St. (CB 16-93)  
Drainage pipe goes southwest under the street here (following the cut)

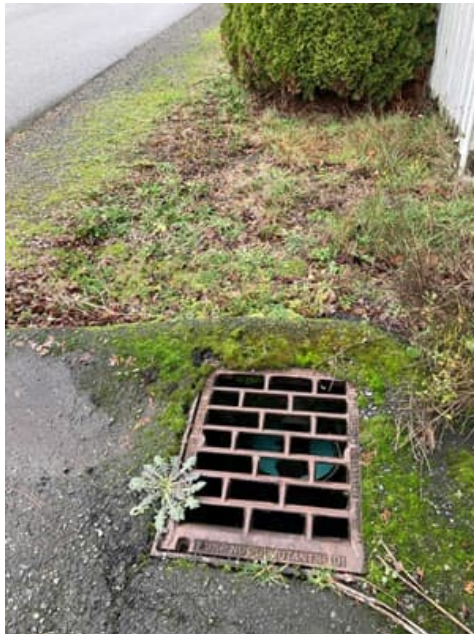
**Picture 4:**

NW corner of 63<sup>rd</sup> Ave SE and SE 28<sup>th</sup> St.  
This CB has two outlets, the lower one's pipe crosses under SE 28<sup>th</sup> St. (toward the left in the photo)

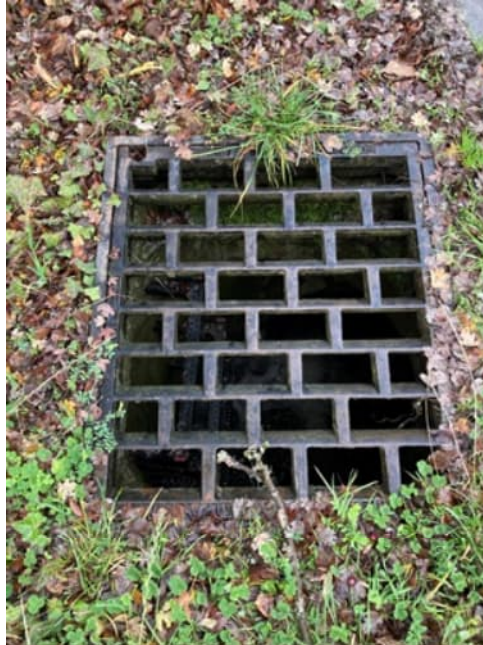
**Picture 5:**  
CB at the SW corner of 63<sup>rd</sup> Ave SE and SE 28<sup>th</sup> St  
Heading west

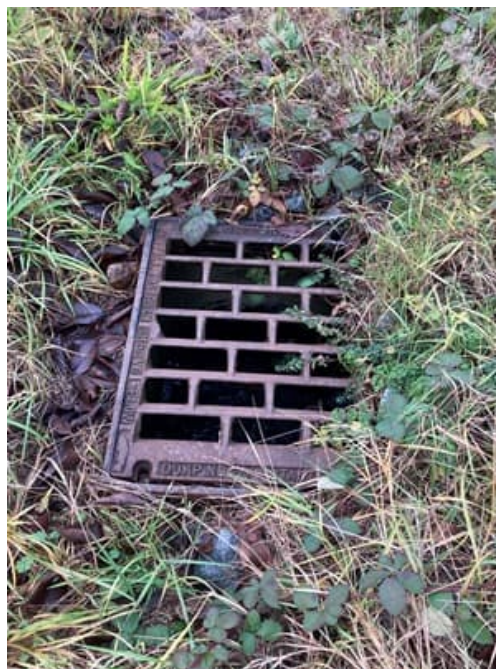
**Picture 6:**  
ROW CB next to driveway of 2825 W. Mercer Way (vacant lot)  
Water continues flowing west

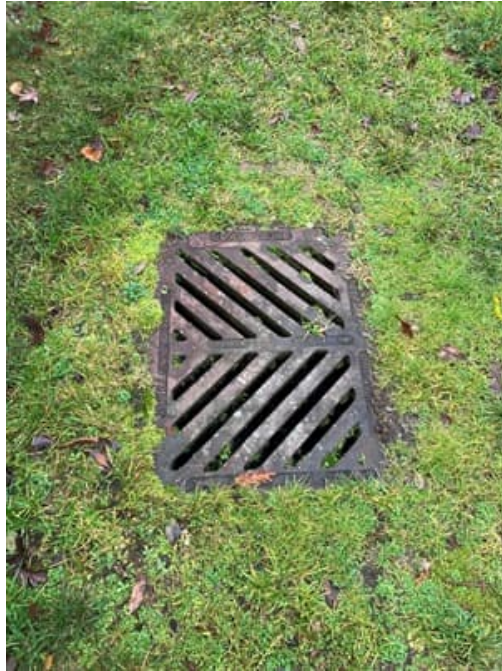
**Picture 7:**  
CB at the southwest corner of 62<sup>nd</sup> Ave SE and SE 28<sup>th</sup> St

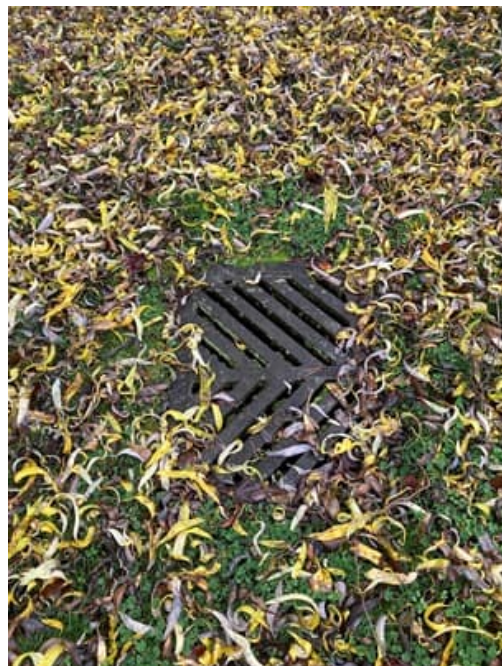
**Picture 8:**  
CB in the ROW on the north side of 6119 SE 28<sup>th</sup> St.  
Flowing north

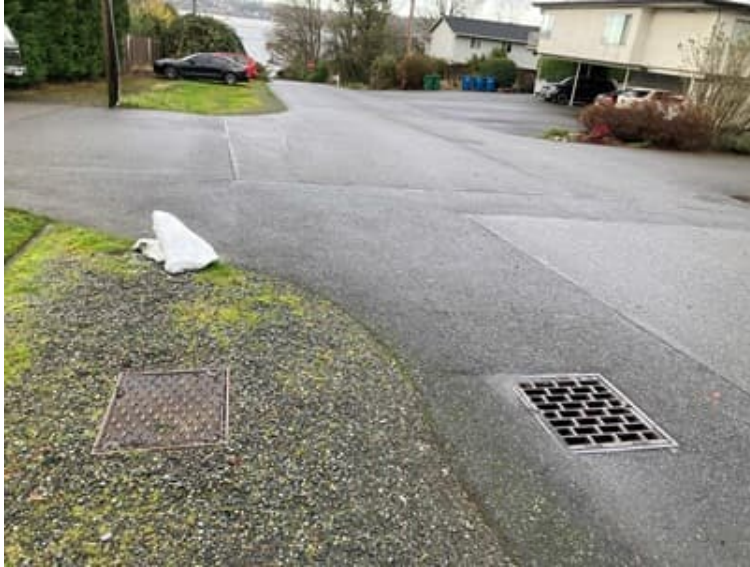
**Picture 9:**  
Southeast corner of 61<sup>st</sup> Ave SE and SE 28<sup>th</sup> St, looking west  
Our water flows through the solid lid CB

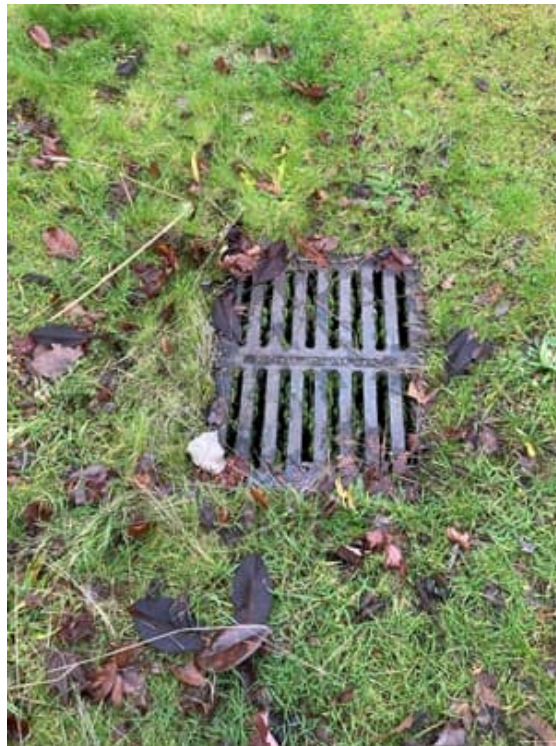
**Picture 10:**  
Southwest corner of 61<sup>st</sup> Ave SE and SE 28<sup>th</sup> St, looking west  
Still heading west, looking good.

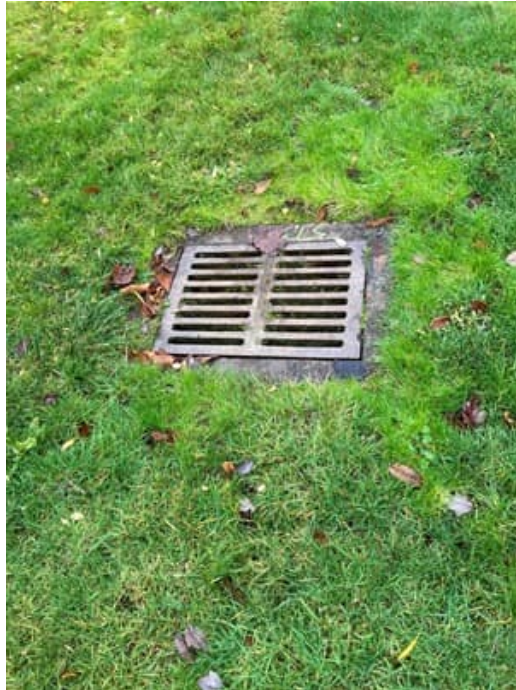
**Picture 11:**  
ROW on the north side of 2800 60<sup>th</sup> Avenue SE, looking west

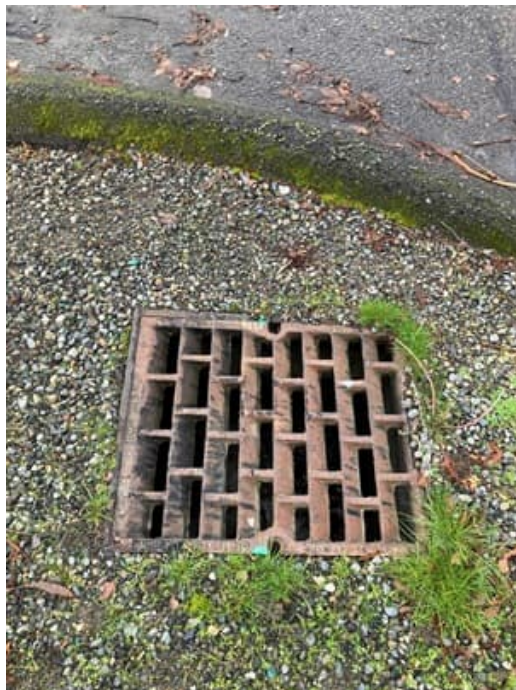
**Picture 12:**  
Southeast corner of 60<sup>th</sup> Ave SE and SE 28<sup>th</sup> St, looking west

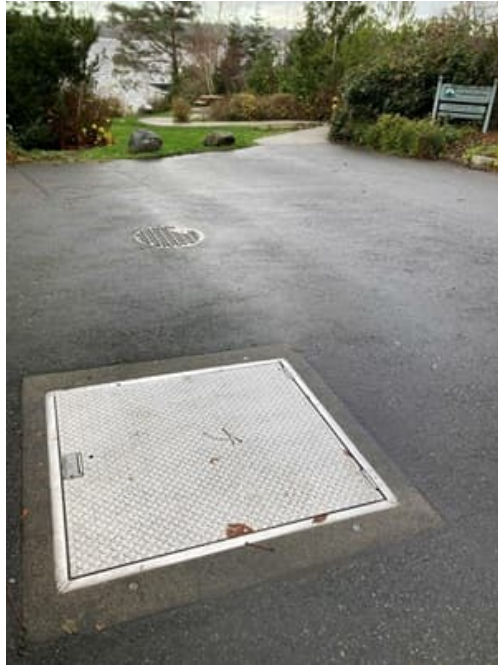
**Picture 13:**  
Parking lot of Calkin's Landing, looking west toward Lake Washington

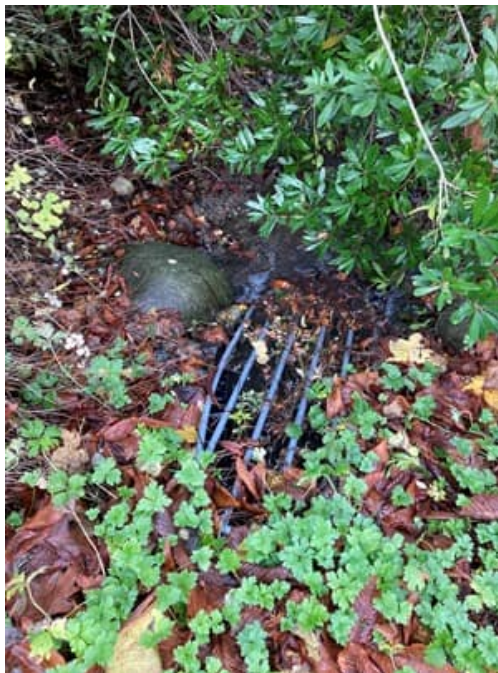
**Picture 14:**  
West of parking lot at Calkin's Landing, inlet to creek flowing west toward Lake Washington

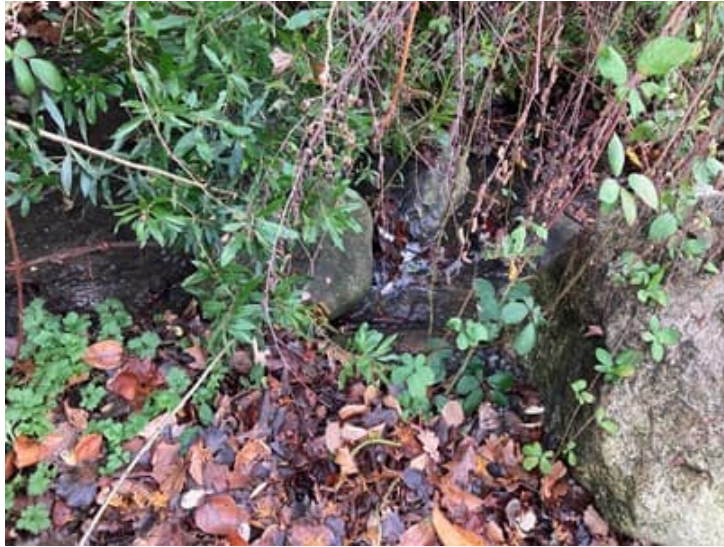
**Picture 15:**  
West of parking lot at Calkin's Landing, creek flowing toward Lake Washington

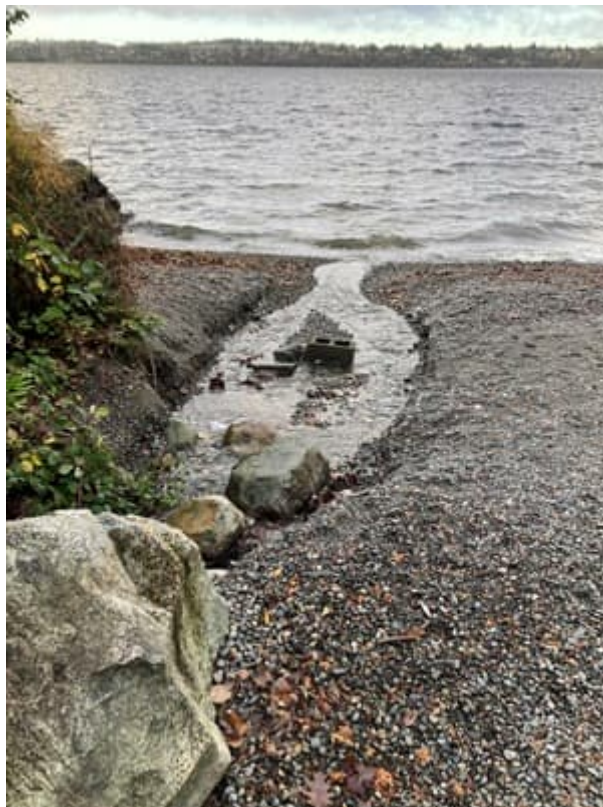
**Picture 16:**  
West of parking lot at Calkin's Landing, creek flowing into Lake Washington
