Arborist Tree Inventory Preliminary Report

Client: Level Capital LLC

Job Site: 5236 W Mercer Way Mercer Island, WA 98040

Date: 11/9/2023

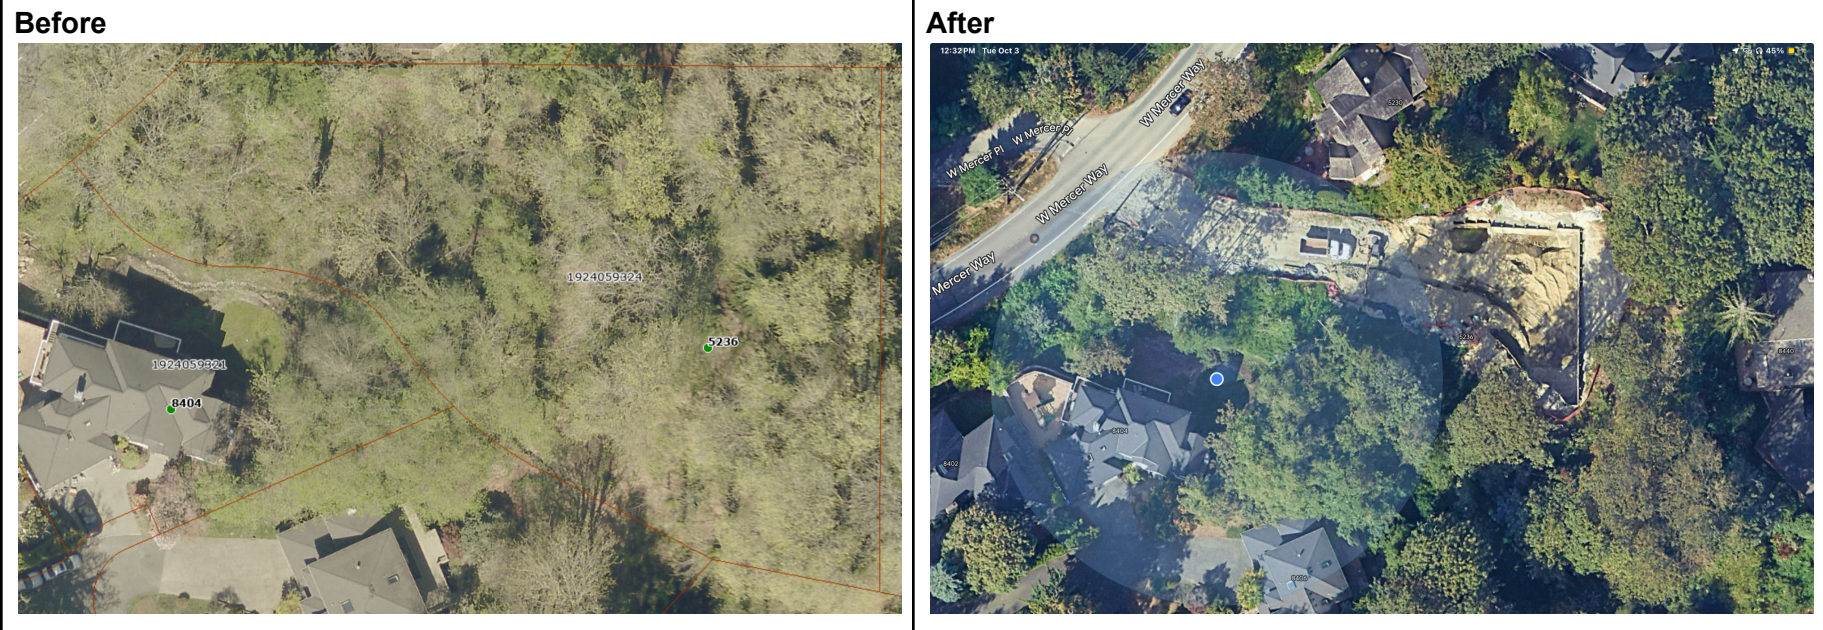
5. Photographic Documentation

Site Description - Mid development. The development site had been cleared prior to my survey. Currently the footprint of new construction and foundational walls were constructed. The trees remaining onsite were protected with a barrier that is up to industry standard to protect the root zones of remaining trees. The site sits on a 10-15 degrees slope to the West.
