March 26, 2024

Re: Arborist Report – Mercer Island/Hackett Residence

DCG/Watershed Reference Number: 2312.0315.00

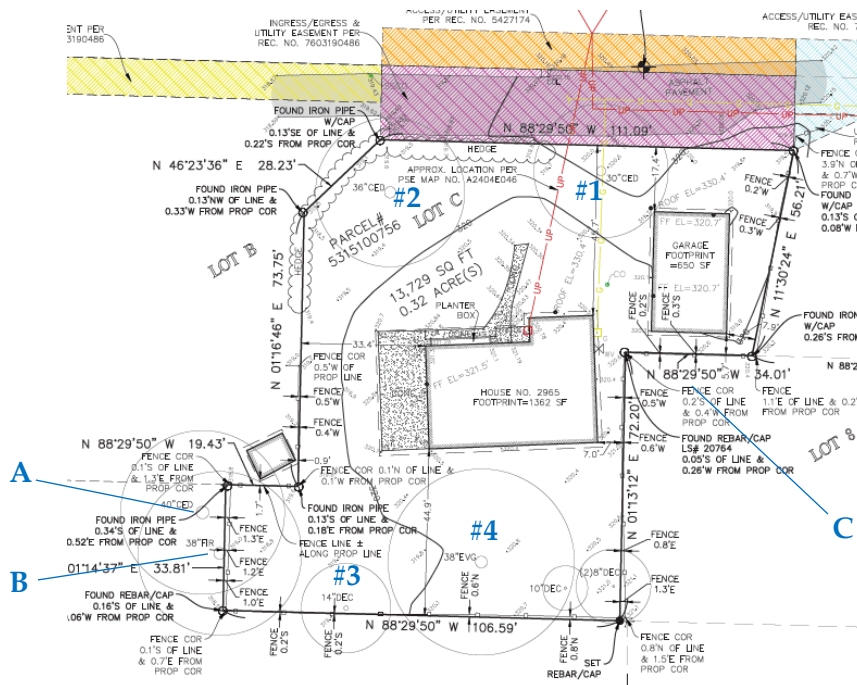
Figure 2. Site Plan

Tree #1 - 18-foot radius

Tree #2 - 18-foot radius

Tree #3 - 7-foot radius

Tree #4 - 19-foot radius

Tree #1 - It appears that underground utility trenching may be proposed within Tree #1 TPZ. Utilities that cannot be routed outside the TPZ should be installed by tunneling or other methods to avoid root damage. If minimum TPZ cannot be achieved, removal and mitigation should be followed per MICC.

Tree #2 – Fencing shall be installed at the minimal TPZ to provide adequate tree protection, however if site conditions allow, increase the TPZ/fence location to the maximum feasible that can remain through the duration of construction. Only specified and approved activities may occur within the TPZ.

Trees # 3-4 - Because Douglas fir can tolerate a moderate amount of root loss and Tree #4 is in excellent condition/well-suited for retention efforts, the minimal TPZ is appropriate for Tree #4. If tree protection fencing placed 19 feet north of Tree #4 (parallel to the south property line), extending to the east and west property lines, Offsite Trees A-B to the west of the subject property and Tree #3 would receive adequate tree protection.

Adequate tree protection would be afforded to offsite Tree C if fencing were to be installed at the east property line inset corner and run east and south 20 feet to minimize potential impacts.

All minimum required tree protection measures shall be shown on the development plan set, to scale, at these distances. All site improvements shall be designed and located to minimize tree removal during and following construction.
