September 20, 2024

G-6137

Subject: **GEOTECHNICAL / CRITICAL AREAS EVALUATION REPORT
PROPOSED HOUSE ADDITION
2707 – 70TH AVE SE
MERCER ISLAND, WASHINGTON**

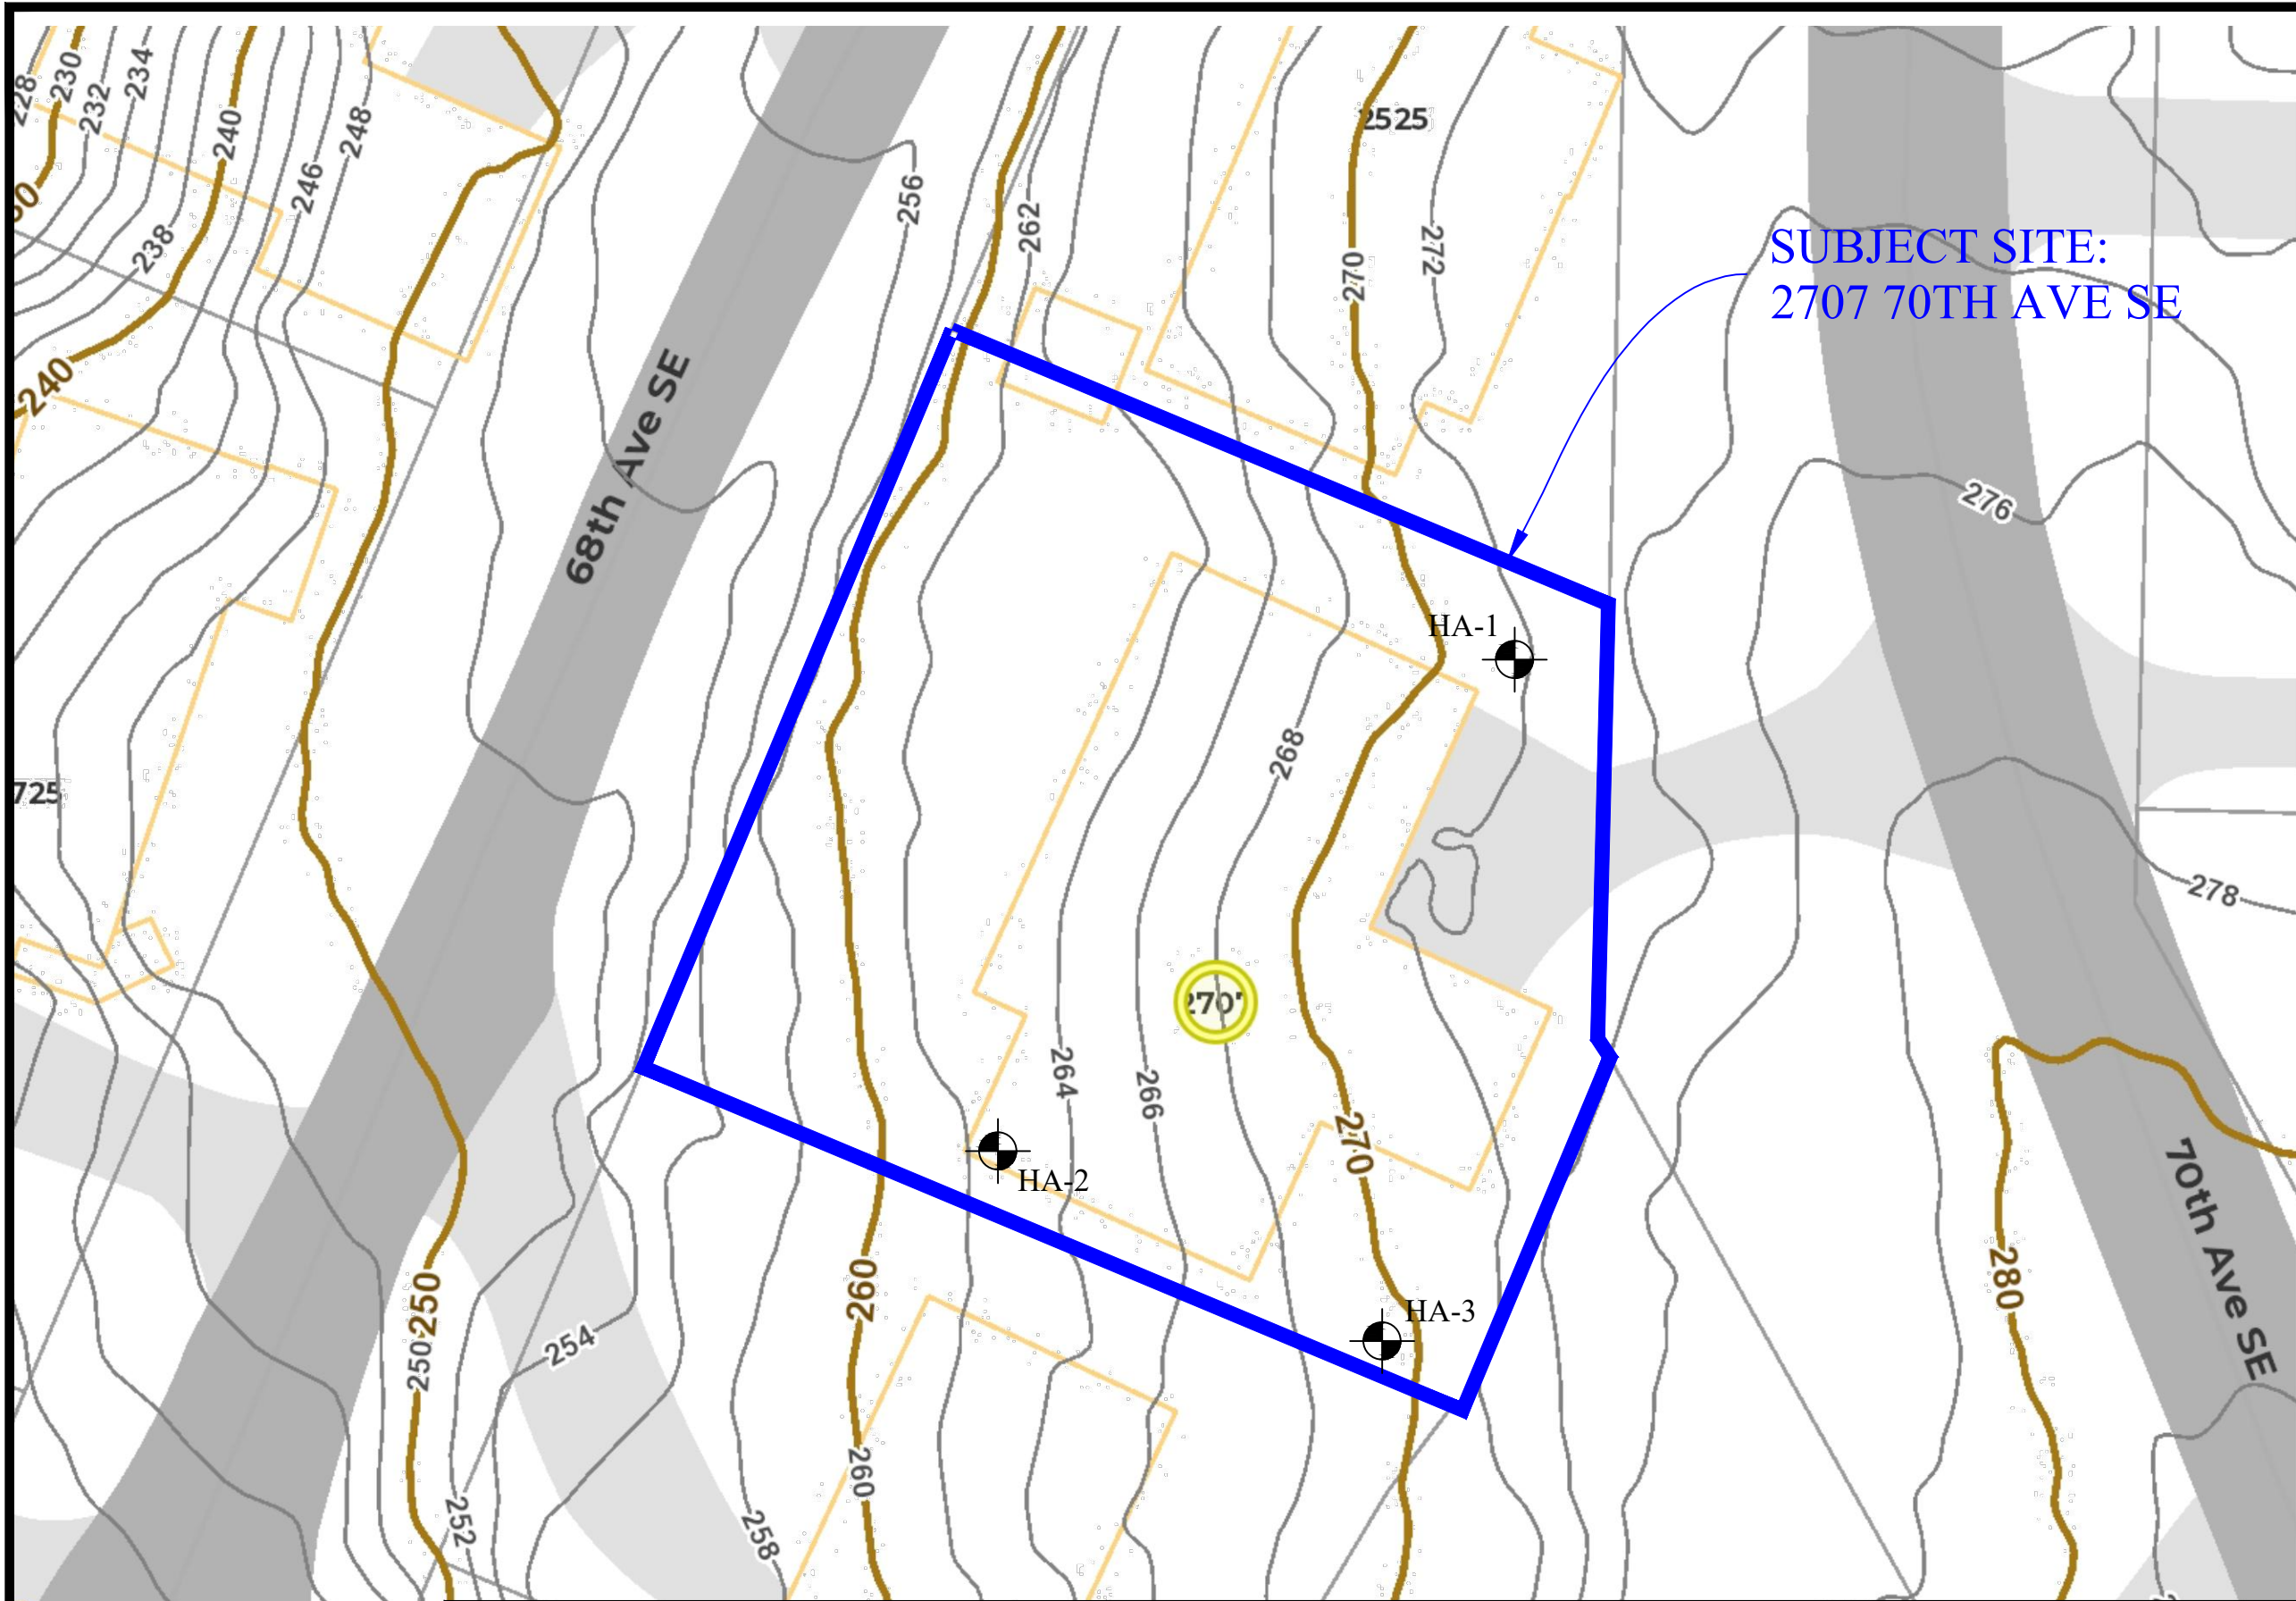
SITE PLAN
2707 - 70TH AVE SE
MERCER ISLAND, WASHINGTON

On September 3, 2024 GEO Group Northwest explored the subsurface soil and groundwater conditions near the existing residence by advancing three hand-augered borings labeled HA-1 through HA-3 as located on the attached **Plate 2 – Site Plan**. Probing at various depths was performed via a ½-inch diameter steel T-probe in order to qualitatively evaluate soil strengths.

The soils encountered at the boring HA-1 consists of loose topsoil having a thickness of around 10-inches overlying dense gravelly silty SAND to sandy SILT. At the borings HA-2 and HA-3 soils encountered consist of loose to medium dense soils overlying competent medium dense to dense SAND with some silt which becomes a relatively clean SAND at depth. The competent underlying medium dense to dense site soils at the HA-2 and HA-3 are located below depth of 12-inches and 6-inches, respectively.
