ARBORIST REPORT

4103 78th Avenue SE
Mercer Island, WA

July 31, 2025

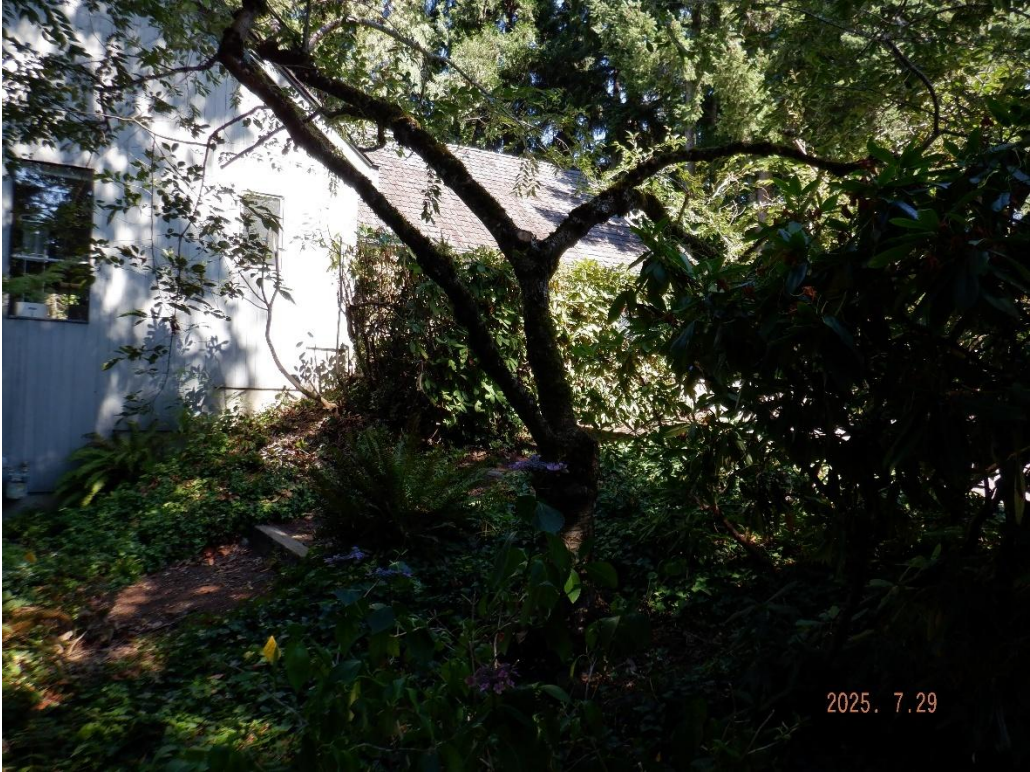
Tree #15 semi-mature Japanese flowering cherry variety in the front yard. It has developed poor form from lack of sunlight. Overall condition is rated as fair.

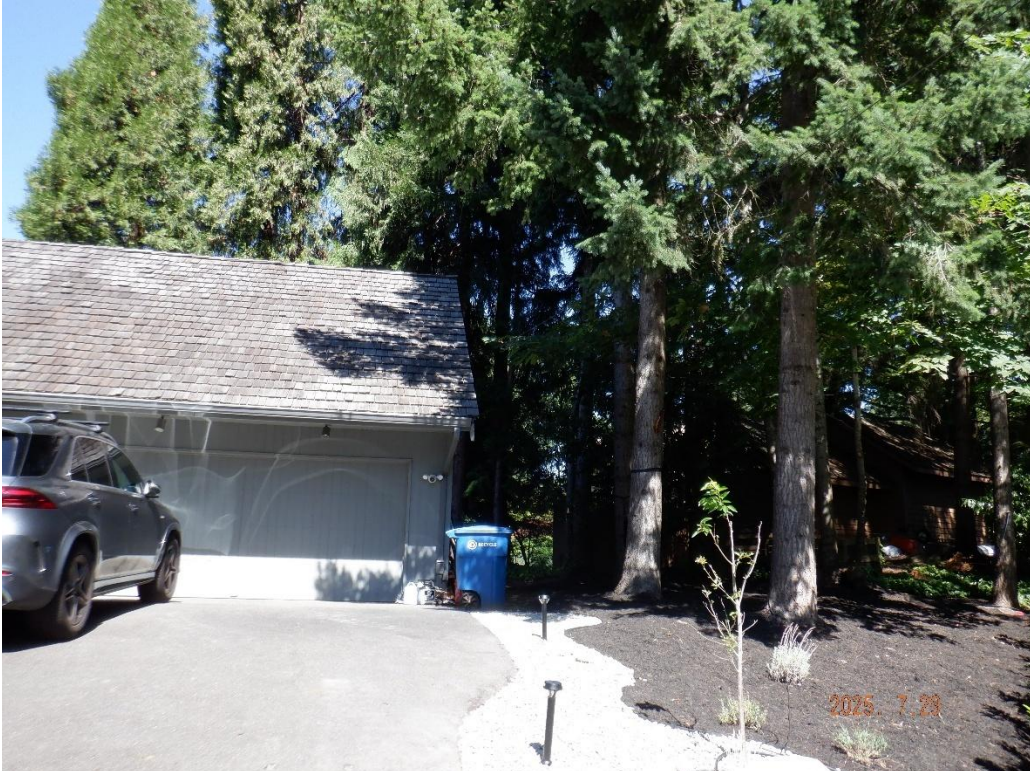
Trees north of the garage are comprised of a mix of Douglas fir, incense cedar and Western red cedar. All are of good vigor, with foliage of normal color and density. All are structurally sound with no concerning defects. Tree #5 is situated closest to the house, at 9 ½-feet from the house corner to the trunk face.

Trees #5 and #6 north of driveway

No trees are proposed for removal as part of this project. Trees #5 and #6 may require some minor pruning for adequate construction clearance. Only remove those lower limbs that are interfering with the required work.

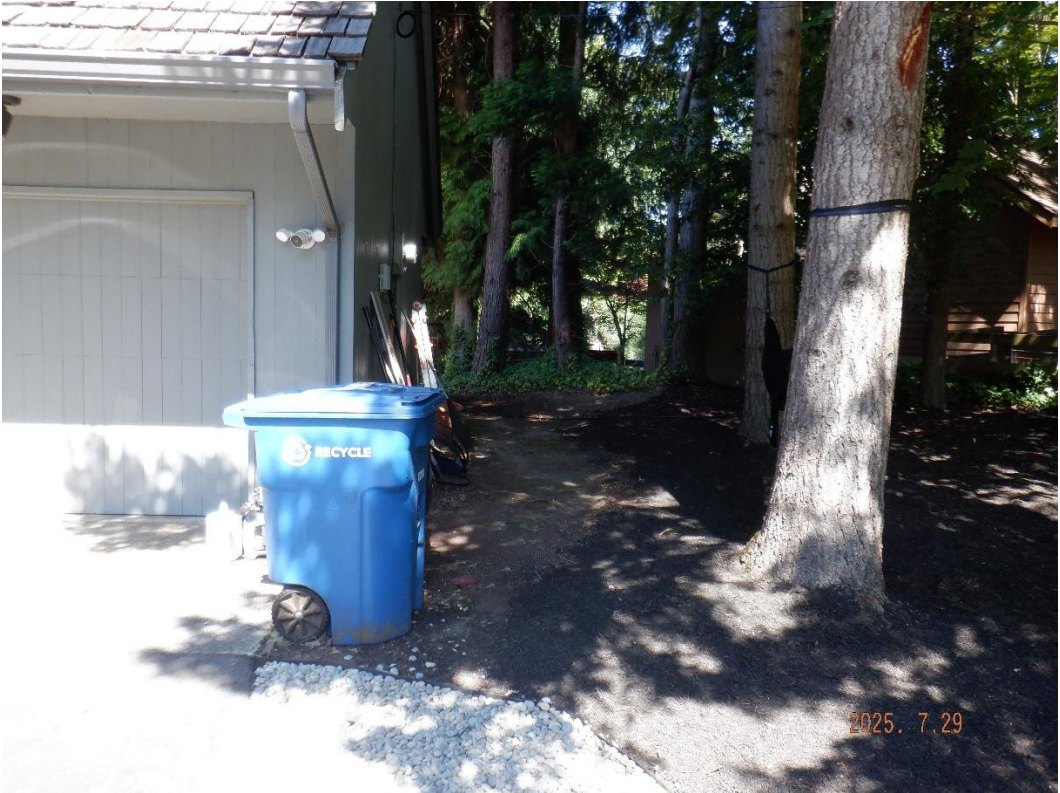
Trees #3 and #5 on right, located +/- 10-feet from house

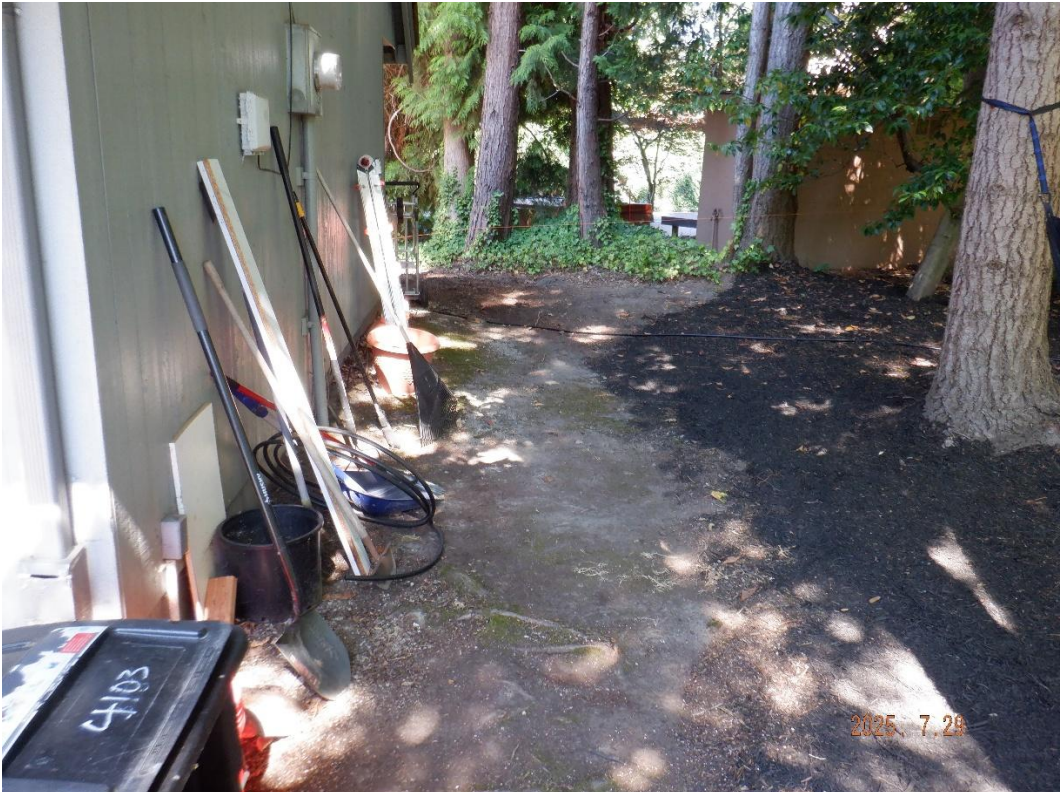
Tree #3 on right, #7, #8 and #9 in background

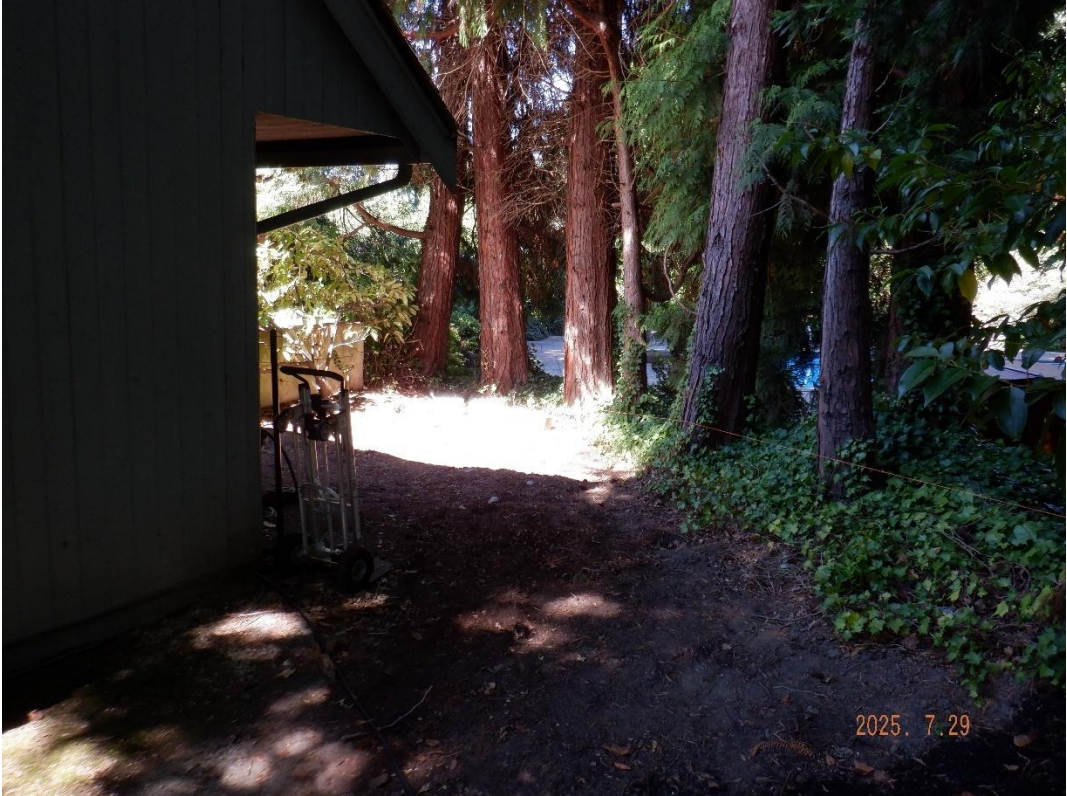
Trees #8 and #9 on right, neighboring cedar trees in background

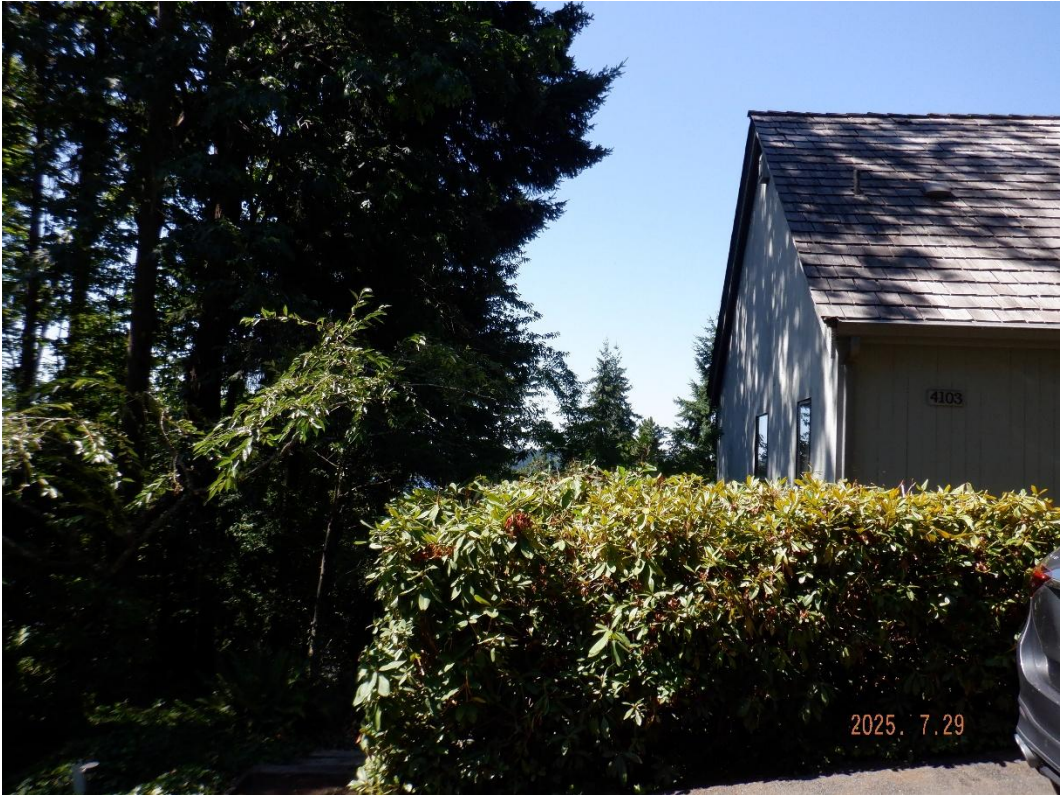
Looking southwest across front yard, Tree #15 in foreground

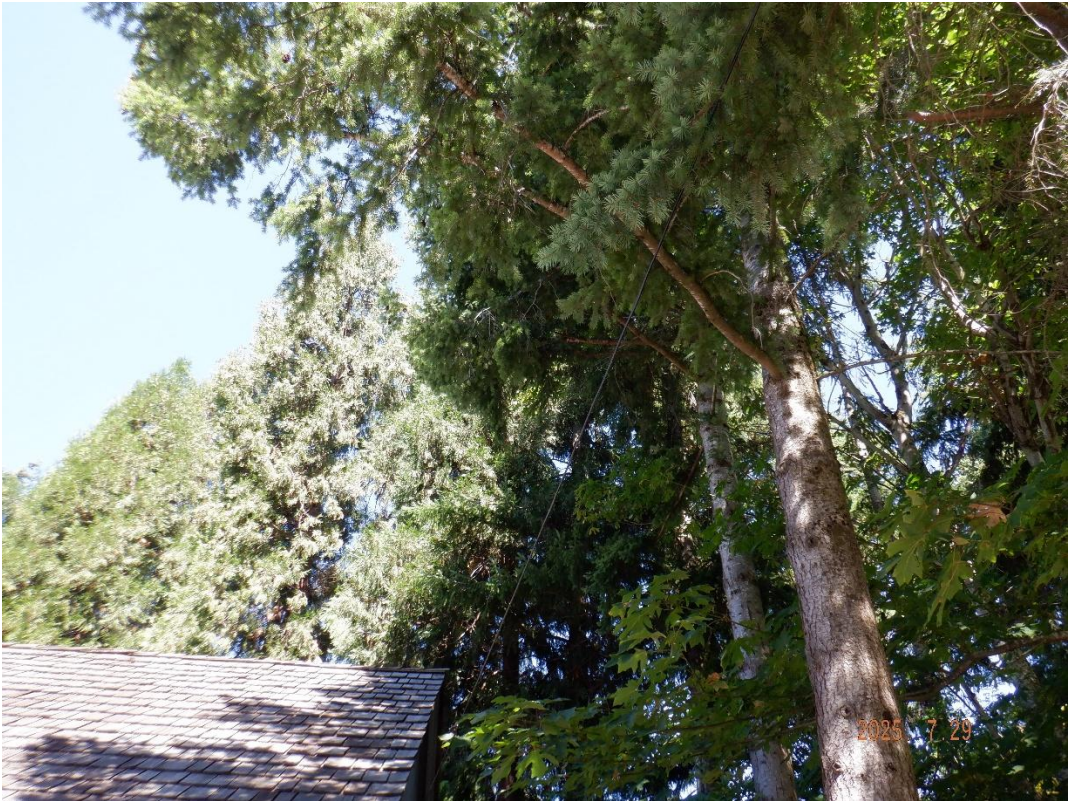
Trees #5 and #6 may require some minor crown-raising/pruning for new addition

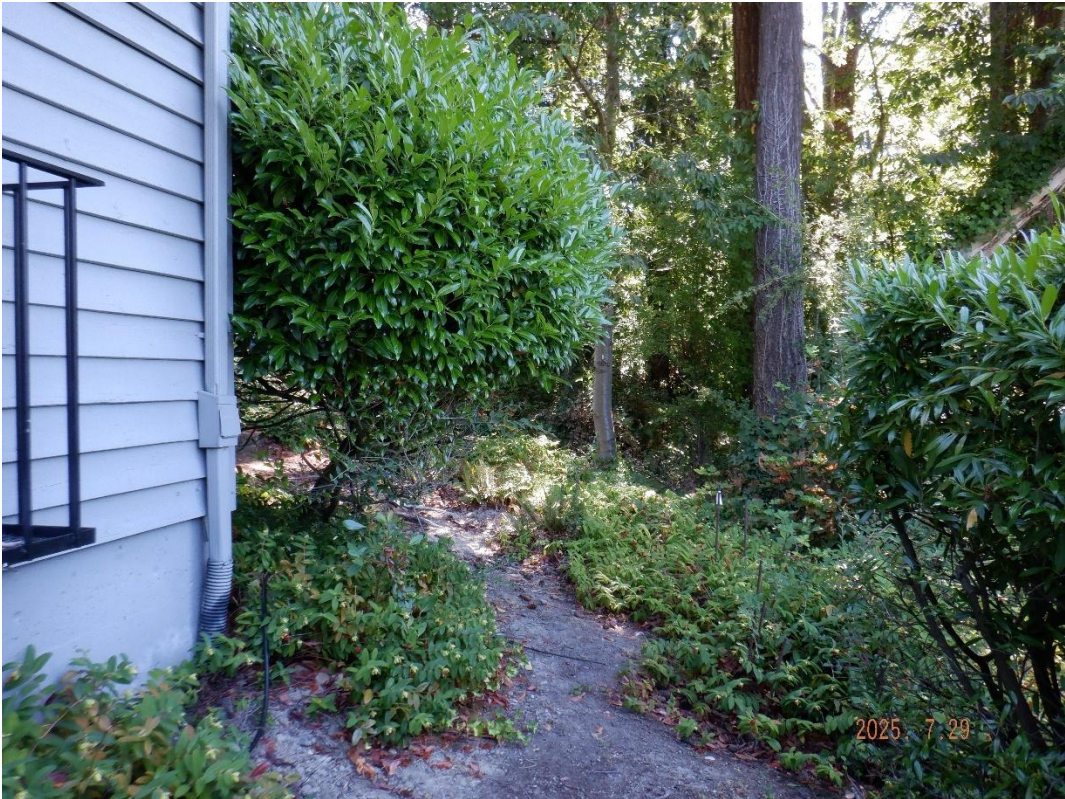
Trees #17 and #18 off south corner of house

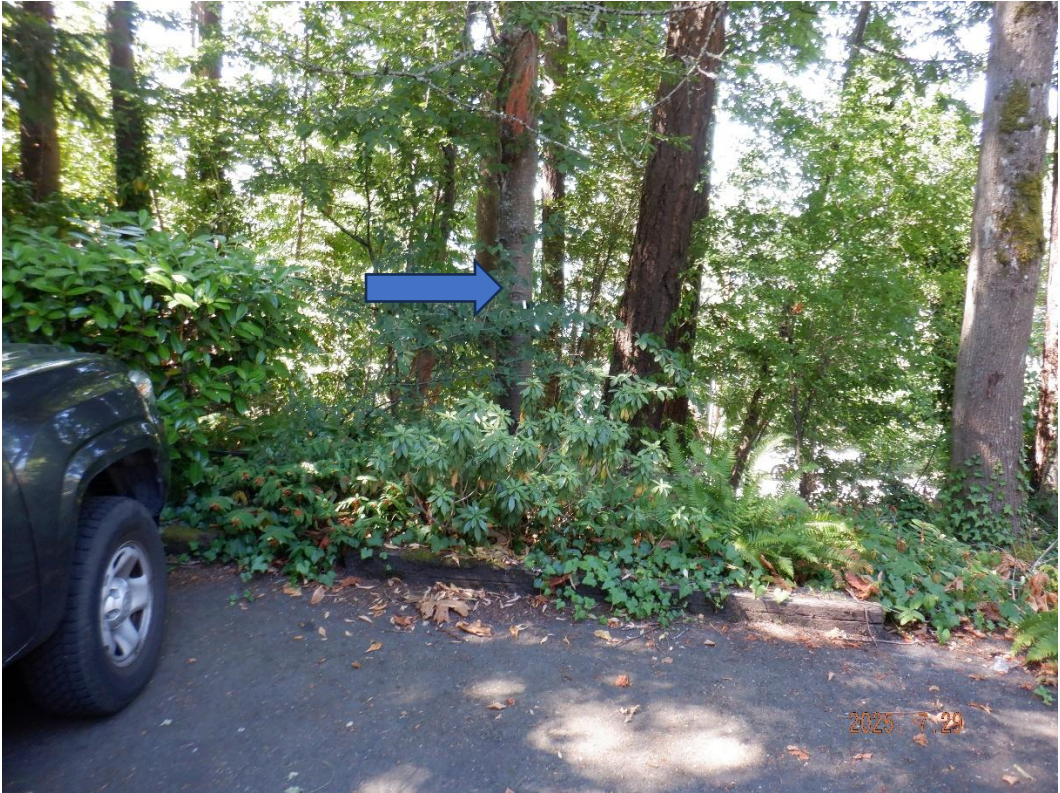
Tree #25 (center/arrow)

Tree #25 is a semi-mature native bitter cherry located near the south parking area. The top half of the tree is dead. It is in an ultimate state of decline. It is in poor condition and non-viable.

Tree #25 is mostly dead. Dead top sections are likely to fall toward or onto the adjacent parking area. Habitat snagging this tree to a safe height is recommended to abate its hazard potential. Snag the tree at roughly 15-feet above ground. No replacement is required for the removal of a hazard tree.

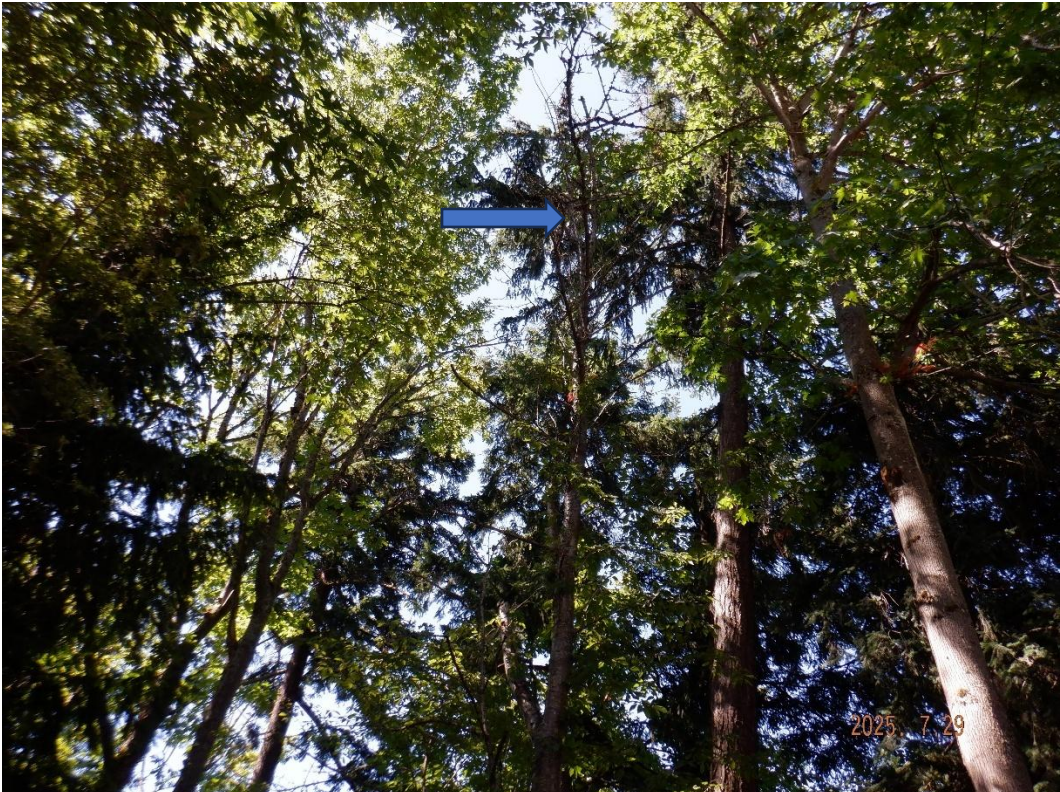
Tree #25, dead top
