ARBORIST REPORT

4103 78th Avenue SE
Mercer Island, WA

July 31, 2025
Updated September 18, 2025

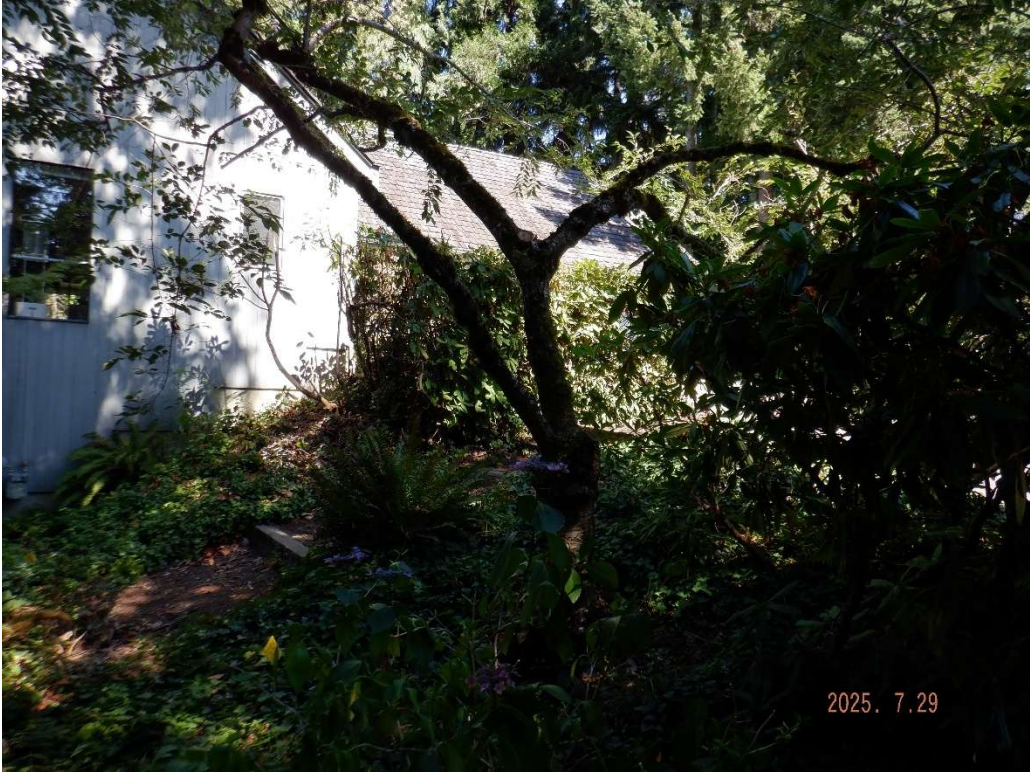
Tree #15 semi-mature Japanese flowering cherry variety in the front yard. It has developed poor form from lack of sunlight. Overall condition is rated as fair.

| Tree/ Tag # | Species Common Name | Species Scientific Name | DBH (inches) | Height (feet) | Drip-Line (feet) | | | | Condition | Regulated Yes/No | Exceptional Yes/No | Comments | Proposal |
|---|---|---|---|---|---|---|---|---|---|---|---|---|---|
| 15 | Japanese flowering cherry | <i>Prunus serrulata</i> | 12 | 16 | 10 | 8 | 10 | 8 | Fair | Yes | No | poor form, decent vigor | Protect |

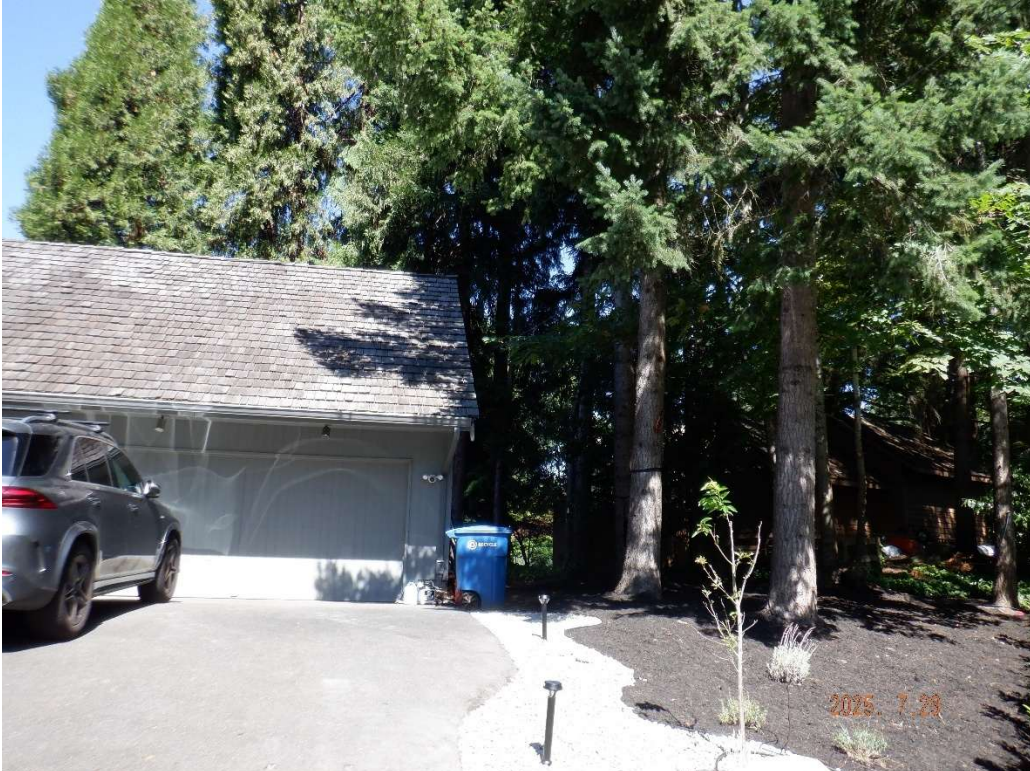
Trees #5 and #6 north of driveway

| Tree/ Tag # | Species Common Name | Species Scientific Name | DBH (inches) | Height (feet) | Drip-Line (feet) | | | | Condition | Regulated Yes/No | Exceptional Yes/No | Comments | Proposal |
|---|---|---|---|---|---|---|---|---|---|---|---|---|---|
| 6 | Douglas fir | <i>Pseudotsuga menziesii</i> | 17 | 73 | 8 | 12 | 14 | 6 | Good | Yes | No | no concerns | Protect |
| 5 | Douglas fir | <i>Pseudotsuga menziesii</i> | 17 | 75 | 8 | 10 | 10 | 8 | Good | Yes | No | may need minor clearance pruning | Protect |

No trees are proposed for removal as part of this project. Trees #5 and #6 may require some minor pruning for adequate construction clearance. Only remove those lower limbs that are interfering with the required work.

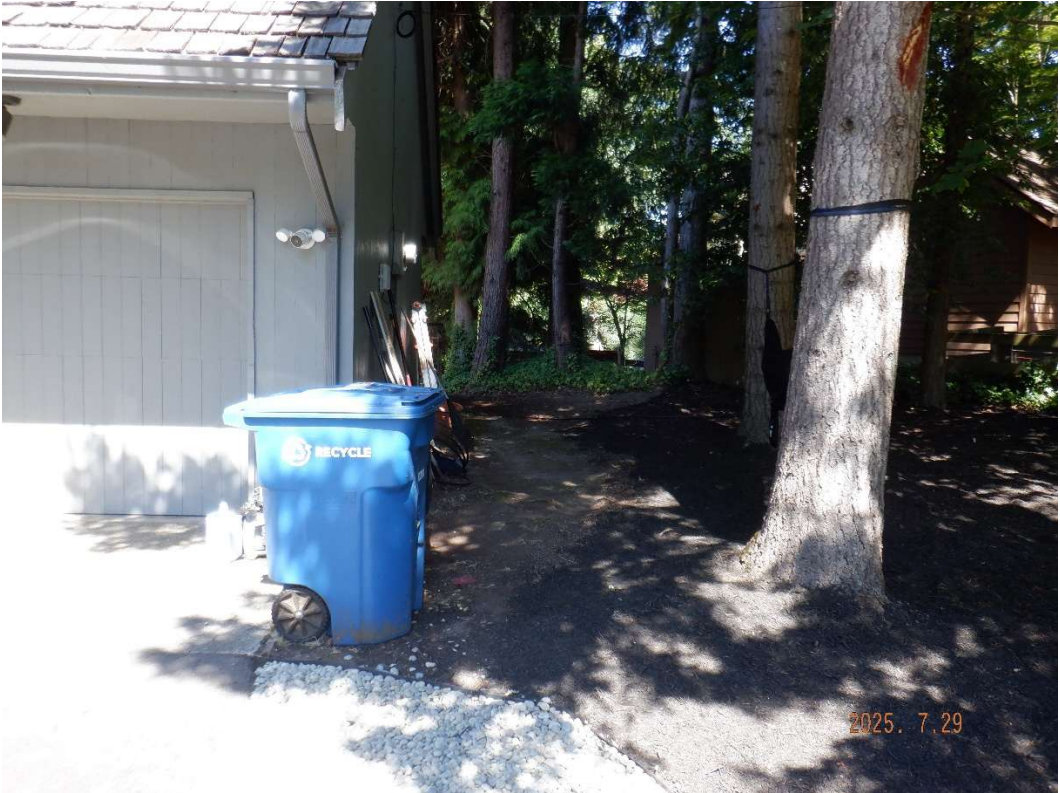
Trees north of the garage are comprised of a mix of Douglas fir, incense cedar and Western red cedar. All are of good vigor, with foliage of normal color and density. All are structurally sound with no concerning defects. Tree #5 is situated closest to the house, at 9 ½-feet from the house corner to the trunk face.

Trees #3 and #5 on right, located +/- 10-feet from house

| Tree/ Tag # | Species Common Name | Species Scientific Name | DBH (inches) | Height (feet) | Drip-Line (feet) | | | | Condition | Regulated Yes/No | Exceptional Yes/No | Comments | Proposal |
|---|---|---|---|---|---|---|---|---|---|---|---|---|---|
| 3 | Douglas fir | <i>Pseudotsuga menziesii</i> | 16 | 72 | 8 | 12 | 10 | 8 | Good | Yes | No | may need minor clearance pruning | Protect |

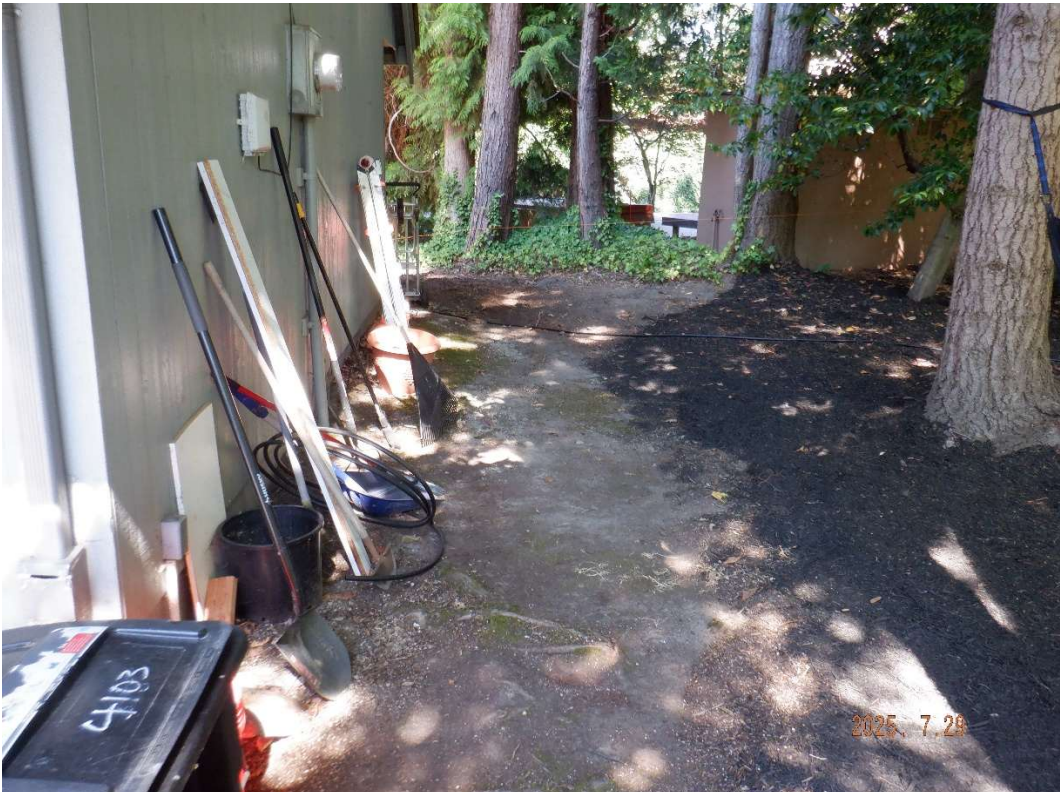
Tree #3 on right, #7, #8 and #9 in background

| Tree/ Tag # | Species Common Name | Species Scientific Name | DBH (inches) | Height (feet) | Drip-Line (feet) | | | | Condition | Regulated Yes/No | Exceptional Yes/No | Comments | Proposal |
|---|---|---|---|---|---|---|---|---|---|---|---|---|---|
| 7 | Douglas fir | <i>Pseudotsuga menziesii</i> | 16 | 72 | 10 | 12 | 8 | 6 | Good | Yes | No | boundary line tree, minor crook | Protect |

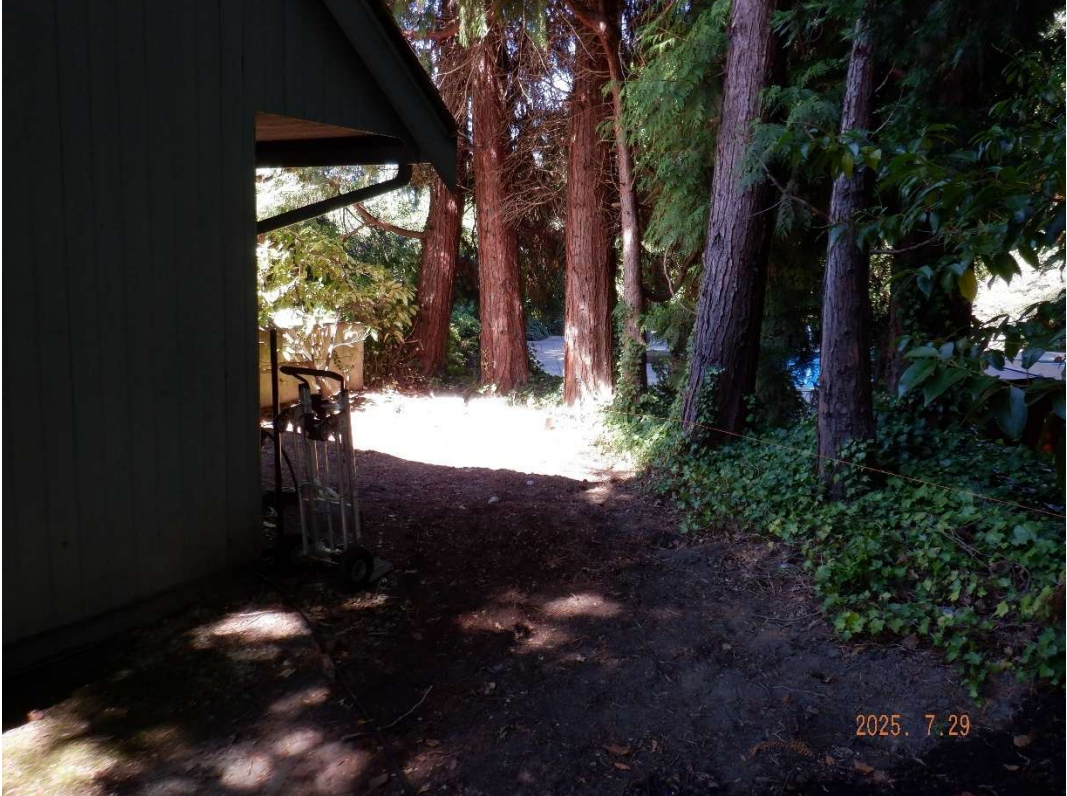
Trees #8 and #9 on right, neighboring cedar trees in background

| Tree/ Tag # | Species Common Name | Species Scientific Name | DBH (inches) | Height (feet) | Drip-Line (feet) | | | | Condition | Regulated Yes/No | Exceptional Yes/No | Comments | Proposal |
|---|---|---|---|---|---|---|---|---|---|---|---|---|---|
| 8 | incense cedar | <i>Calocedrus decurrens</i> | 11 | 32 | 4 | 4 | 6 | 2 | Fair | Yes | No | suppressed | Protect |
| 9 | incense cedar | <i>Calocedrus decurrens</i> | 19 | 68 | 8 | 8 | 8 | 6 | Good | Yes | No | no concerns | Protect |

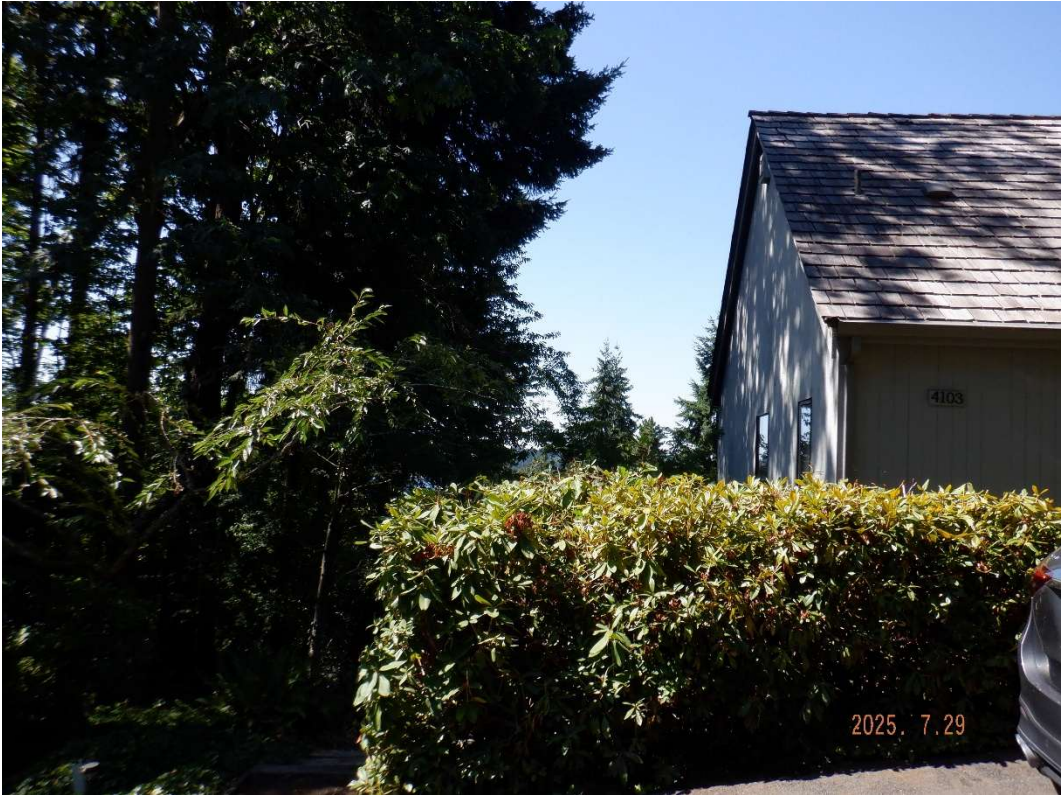
Looking southwest across front yard, Tree #15 in foreground

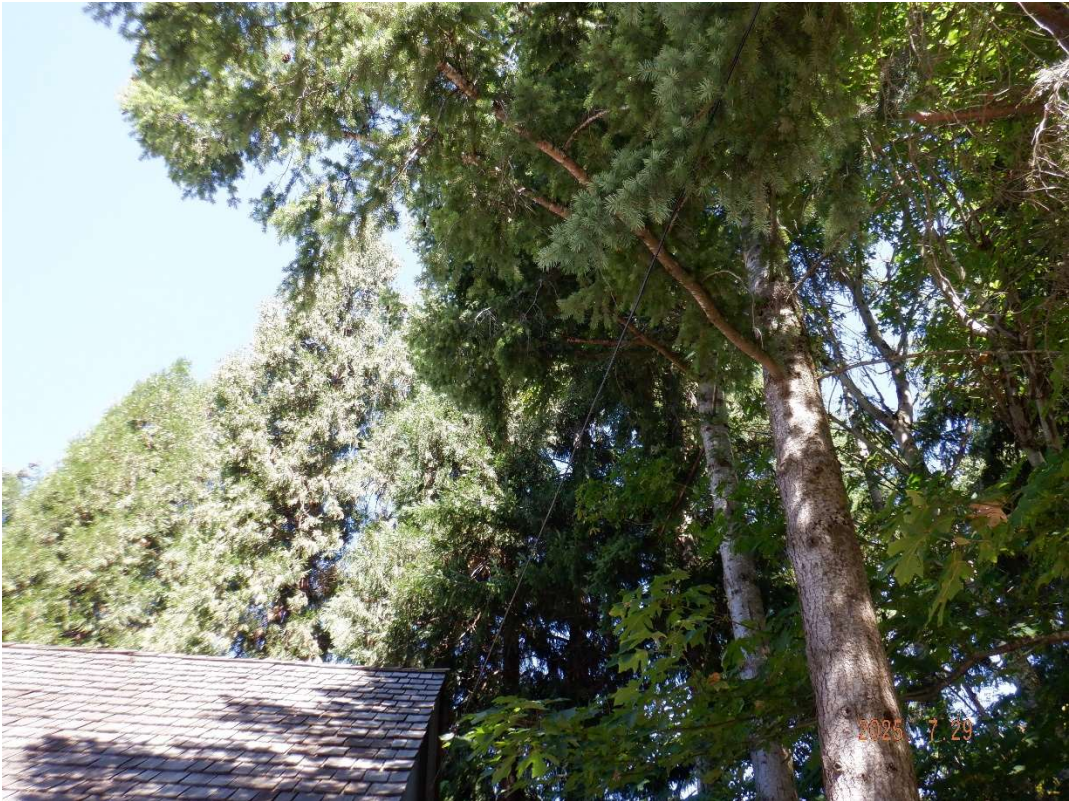
Trees #5 and #6 may require some minor crown-raising/pruning for new addition

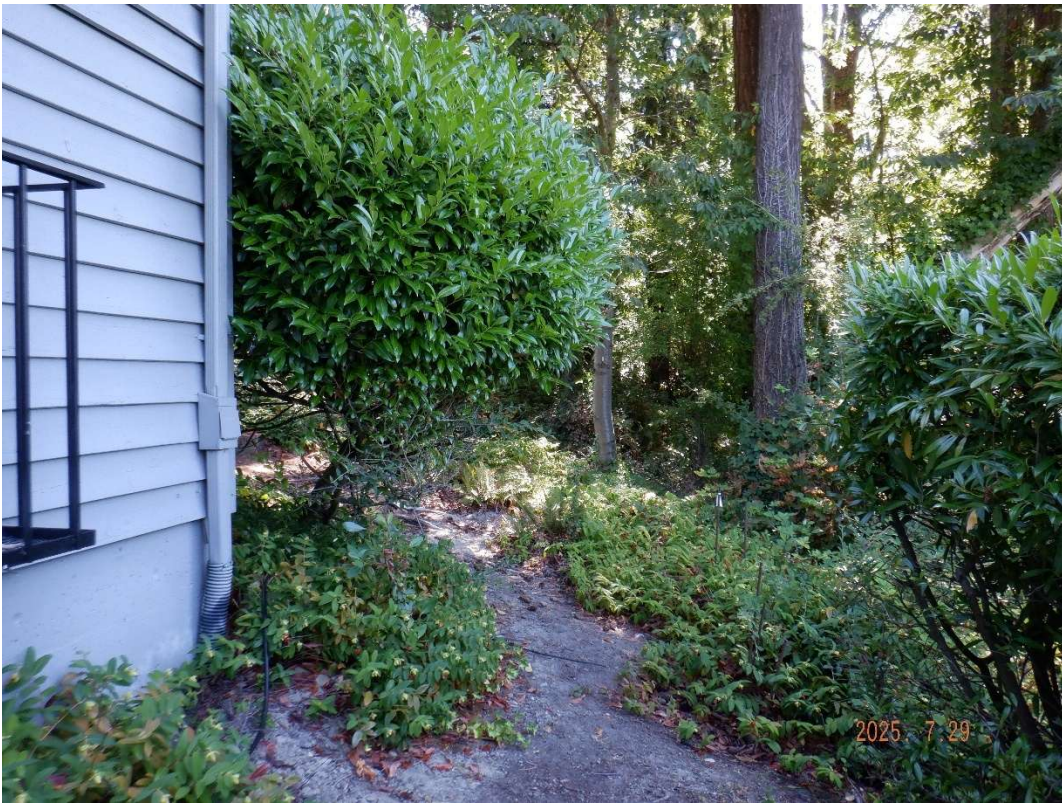
Trees #17 and #18 off south corner of house

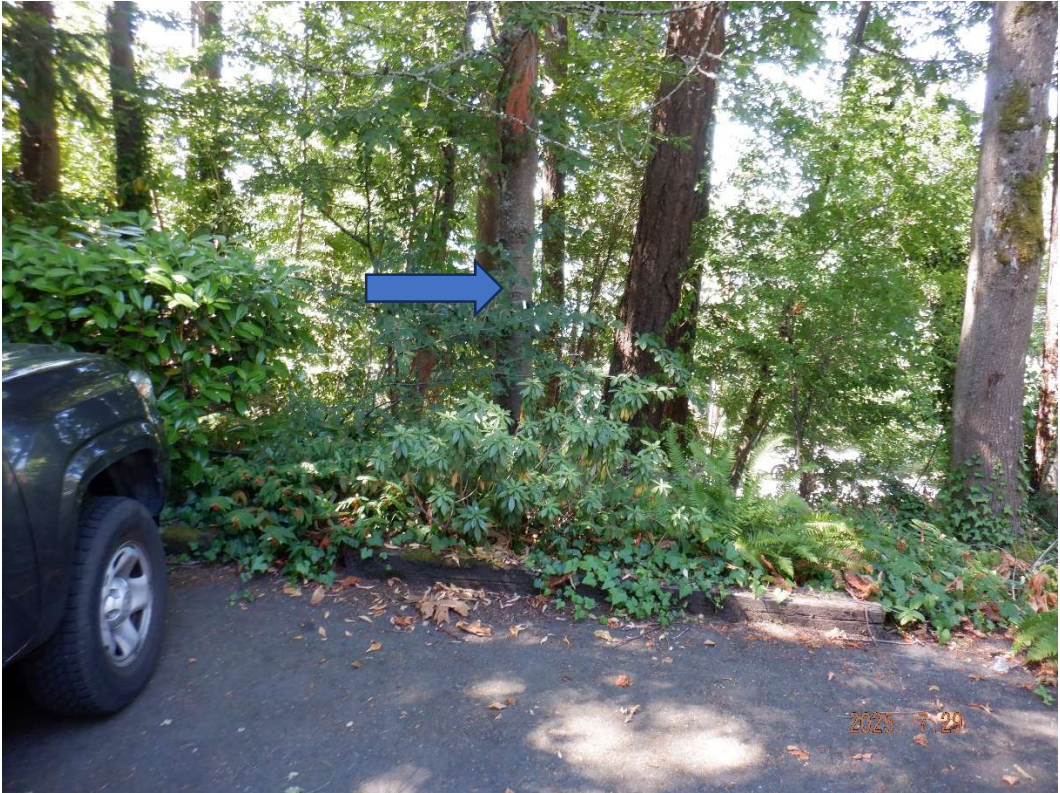
Tree #25 (center/arrow)

Tree #25 is a semi-mature native bitter cherry located near the south parking area. The top half of the tree is dead. It is in an ultimate state of decline. It is in poor condition and non-viable.

| Tree/ Tag # | Species Common Name | Species Scientific Name | DBH (inches) | Height (feet) | Drip-Line (feet) | | | | Condition | Regulated Yes/No | Exceptional Yes/No | Comments | Proposal |
|---|---|---|---|---|---|---|---|---|---|---|---|---|---|
| 25 | bitter cherry | <i>Prunus emarginata</i> | 13 | 55 | x | x | x | x | Poor | Yes | No | dead top, in ultimate decline | Remove |

Tree #25 is mostly dead, and expected to be dead within a year. Dead top sections are likely to fall toward or onto the adjacent parking area. Removal is recommended to abate its hazard potential. Replacement will be required per MICC 19.07.10. The planting of two Western red cedar trees within a

proximity of it is recommended. See the attached tree plan map. Replacement trees shall be a minimum of 6-feet in height.

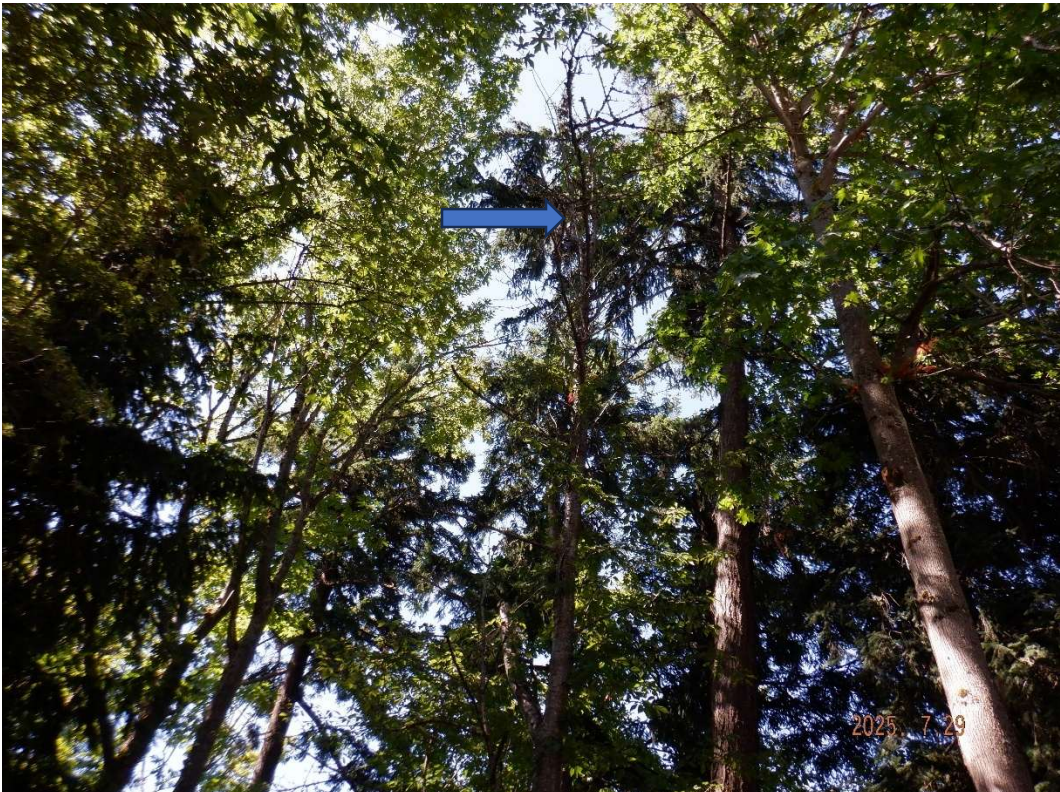
Tree #25, dead top
