ARBORIST REPORT

5330 Butterworth Road
Mercer Island, WA

March 11, 2025

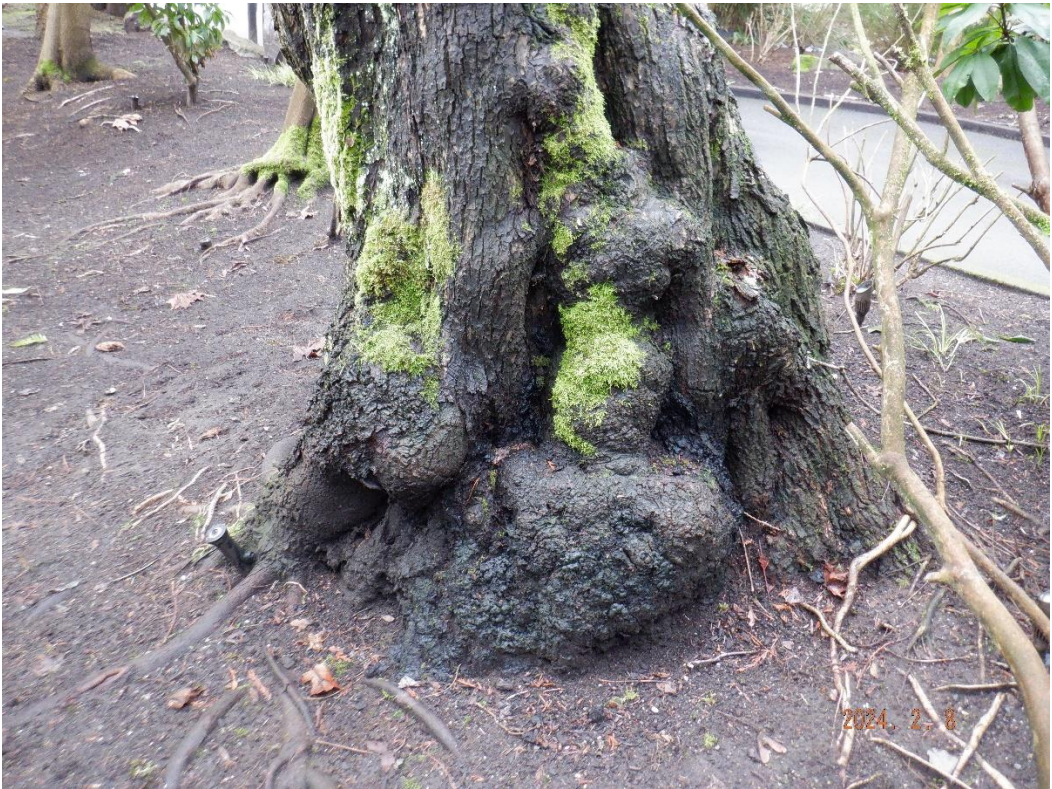
below. These appear as black crusty nodules resembling dried tar. Tree #18, another mature bigleaf maple also has an advanced infection. There is risk of complete trunk failure for both of these.

Lower trunk of #18, advanced soft rot infection

Trees #3, #15 and #18 have significant defects and pose an elevated risk. These trees are recommended for removal as part of this project.
