ARBORIST REPORT

5330 Butterworth Road
Mercer Island, WA

March 11, 2025

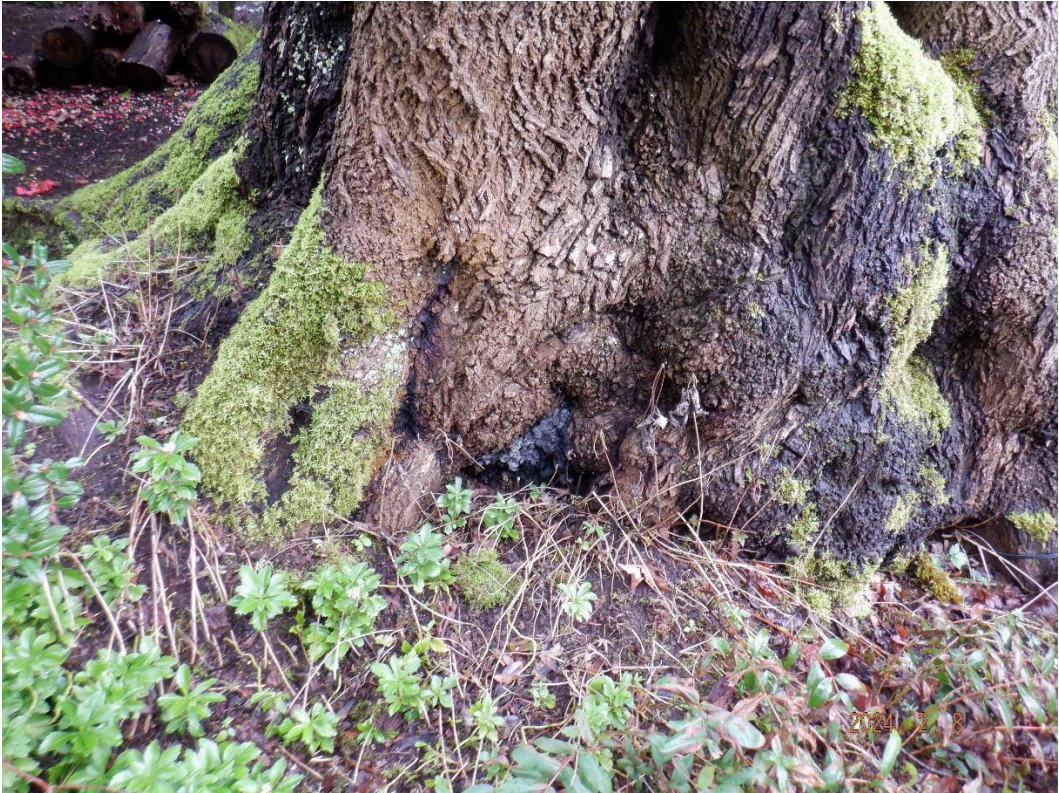
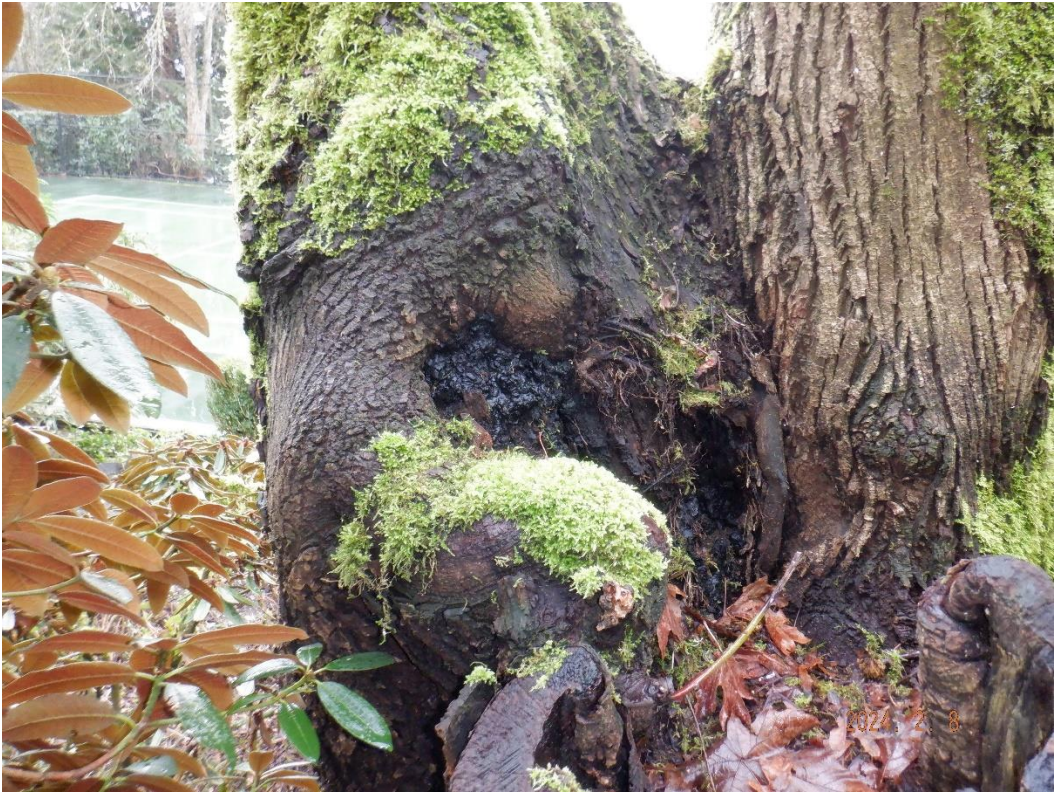
Five of the subject trees were found to be in a ‘poor’ condition. Tree #3 is a mature native bigleaf maple at the front of the property. It has an advanced soft rot infection, *Kretzschmaria deusta*. This is evident by multiple fruiting bodies of the fungus observed on the root crown and lower trunk. See pictures

below. These appear as black crusty nodules resembling dried tar. Tree #18, another mature bigleaf maple also has an advanced infection. There is risk of complete trunk failure for both of these.

Base of Tree #3, advanced soft rot infection

Trees #3, #15 and #18 have significant defects and pose an elevated risk. These trees are recommended for removal as part of this project.

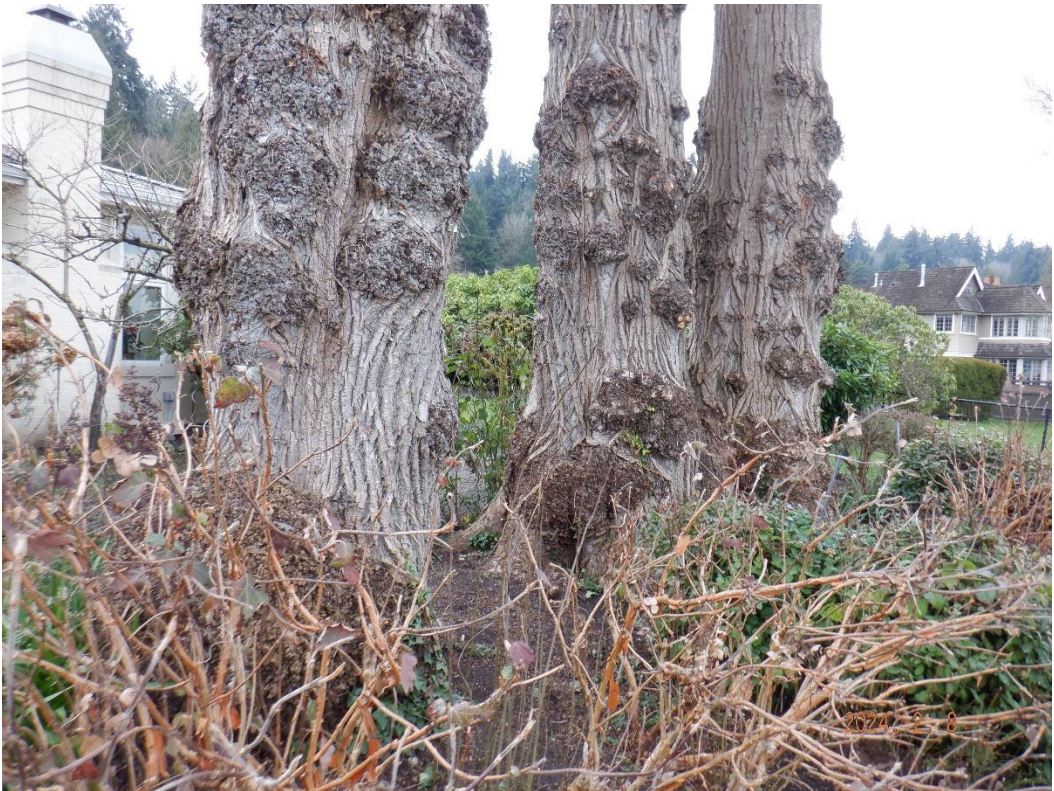
Lower trunks, #38, #39 and #40

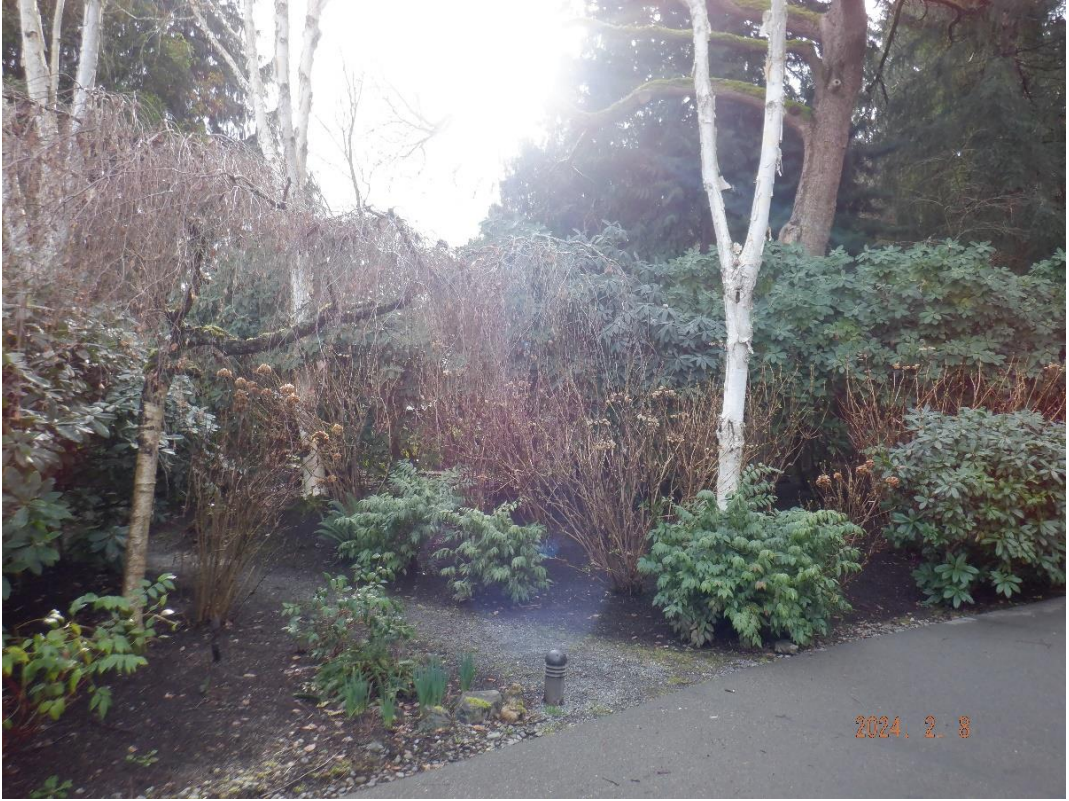
Tree #55 will be notably impacted by new road and turn-around construction. Root loss north of the tree would not be expected to compromise the stability of the tree, but may have adverse impacts on long-term tree health. Follow the tree protection guidelines and measures as outlined below to give the tree the best chance of survival.

Trees #52 > #55
