STORMWATER DRAINAGE REPORT ADDENDUM

WISHWAS SFR REMODEL

8203 Avalon Drive

Addendum to Minimum Requirement #5

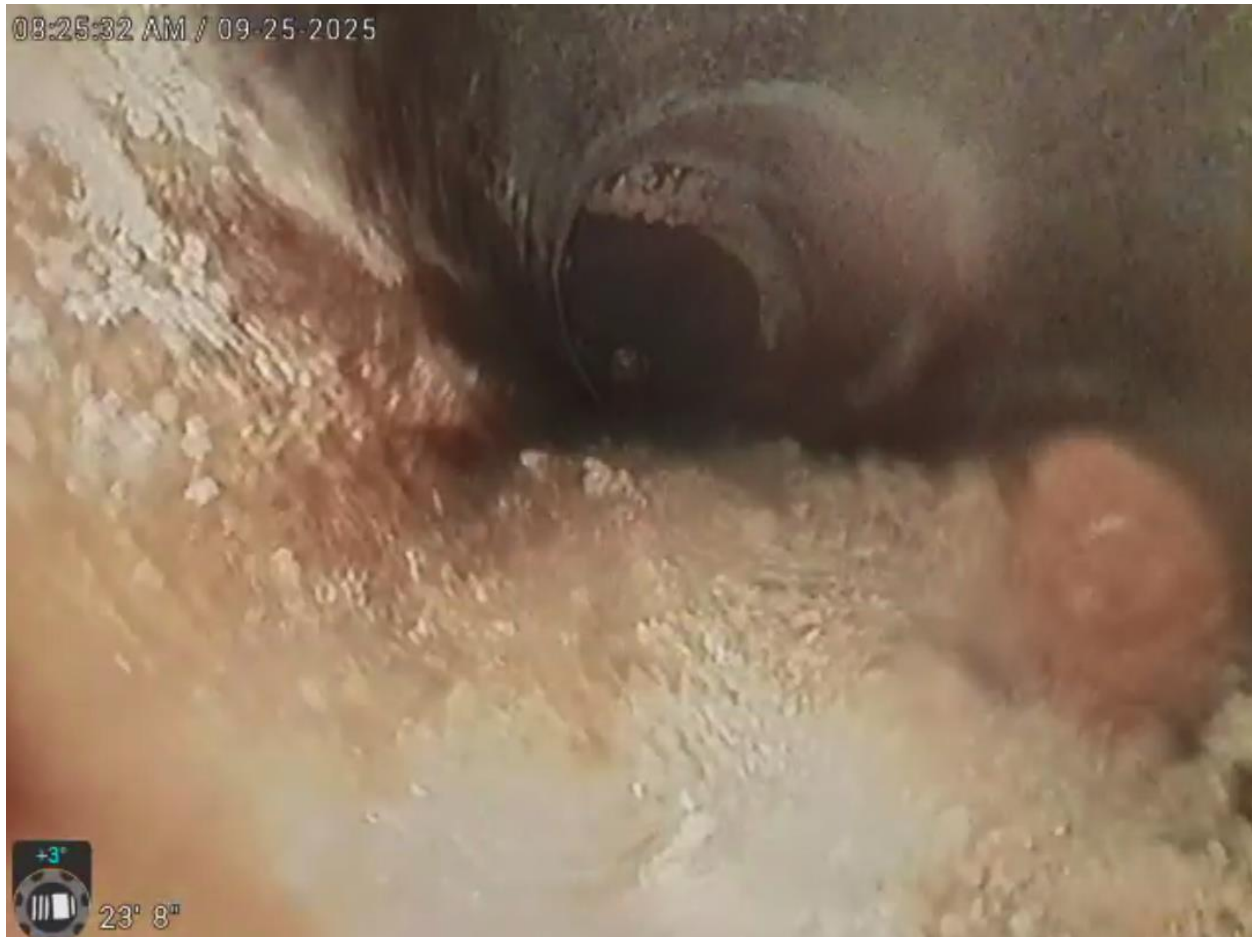
The 6-inch to 4-inch transition appears to be a cut-in grouted connection at less than 90 degrees to the larger line. Through the whole pull to the transition out, the line appears to be free flowing and free of damage.

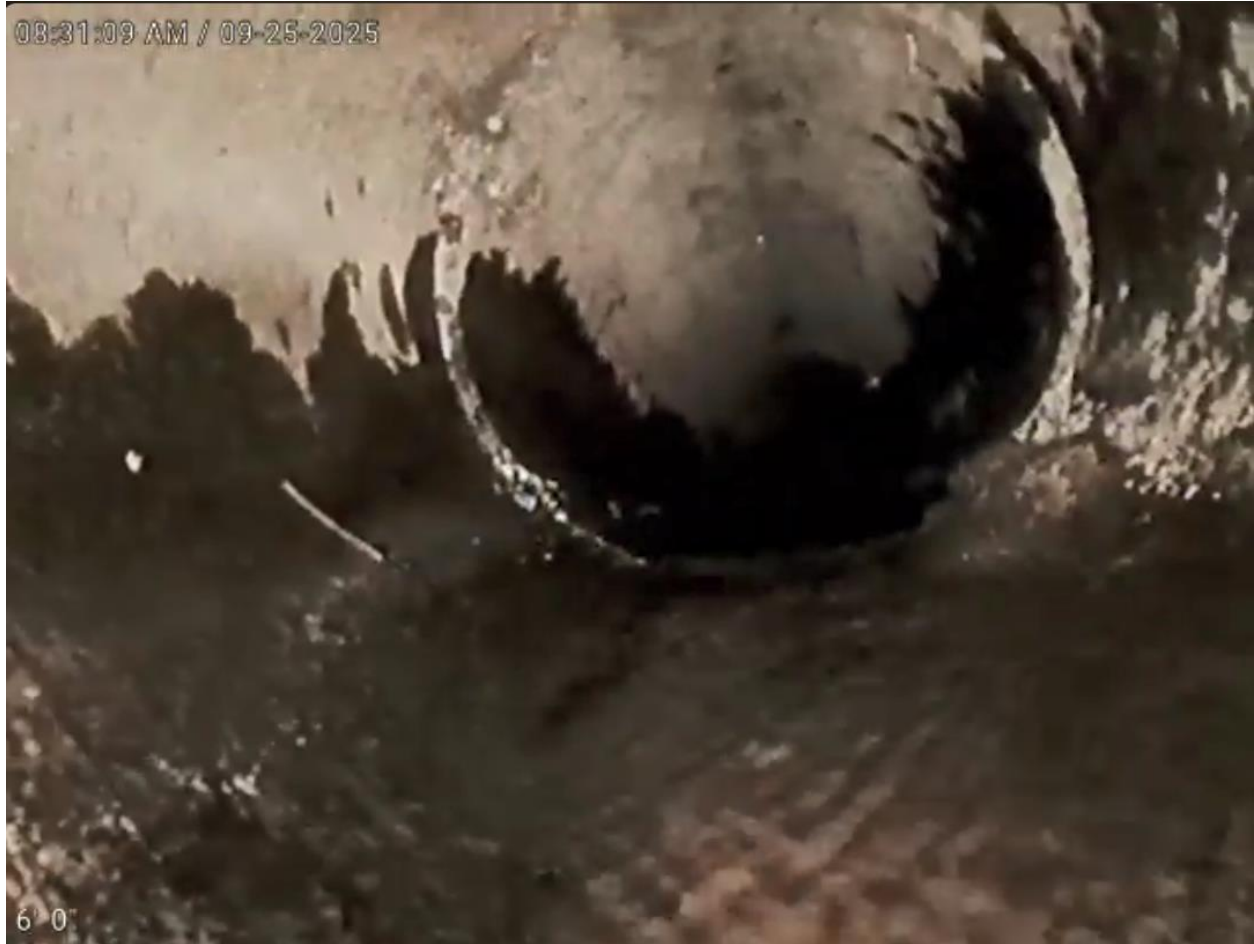
The next camera pull is from the lower end of the inspected pipe run, near the property frontage. For most of the length, as well, before the transition in size and angle, it appears the line is composed of 6 inch concrete pipe meeted together regularly at pipe bell-end on hard edge connections. The line appears to be free flowing and free of damage

The remodeled roof, having a similar area and runoff capacity, may utilized the concrete roof drain line from the house down to the street. To do so, the new or existing reused downspouts will connect into the roof drain where roof drain connections currently exist. There does not appear to be a noticeable need for repair or replacement of any part of the line. Per visual appraisal, there appears to be nothing preventing this line to be reused as-is after the remodel.
