Bruce S. MacVeigh, P.E.
Civil Engineer/Small Site Geotechnical
14245 59th Ave. S.
Tukwila, WA 98168
Cell: 206-571-8794

February 16, 2025

Subject: GEOTECHNICAL REPORT, Existing Parcel, 9756 S.E. 40th Street, Mercer Island, WA 98040 (PN: 265550-0167) (Client: Danny Tran)

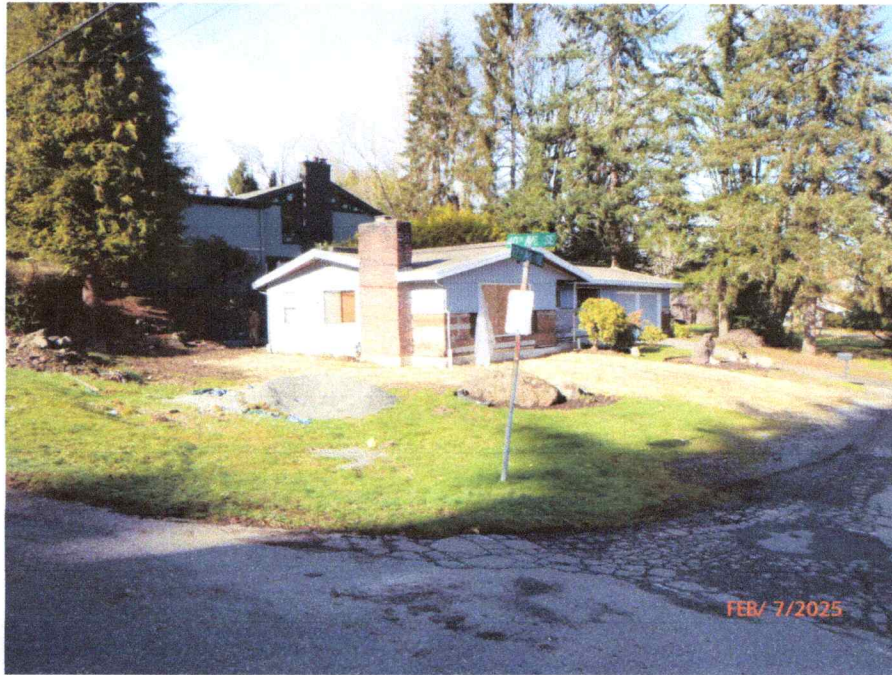
The site has original lawn around the residence, with limited landscaping. The house is undergoing some preliminary cleanup and some lawn areas are slightly disturbed. The original concrete driveway onto 97th Avenue S.E. is in place. It has several significant trees and an assortment of smaller trees along its west and north perimeter. The original site topography was a general downslope to the east at approximately 5 percent, with a slight north downslope. During the house construction, the building area and rear yard area (west area) were leveled, with cuts from the rear filling in the house location and some front yard area. At present, the rear or west limits of the site have two original down stepped rockeries, each about three feet high. The eastern front yard area slopes down from the house location approximately three feet.

STREET VIEW OF SITE- LOOKING NORTHWEST FROM CORNER

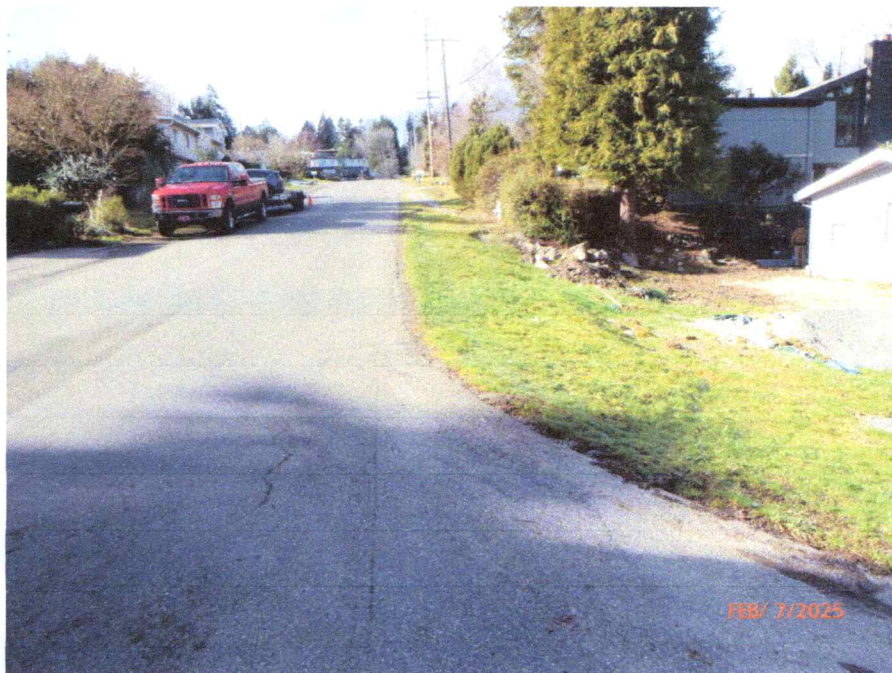
With the leveling of the house location, the south limits of the site along S.E. 40th Street were also leveled. Since S.E. 40th Street has a downslope to the east, the cut along the south side of the street has varying cut levels. (See Site Photographs). The east site frontage along 97th Avenue S.E. is relatively level.

STREET FRONTAGE ON S.E. 40TH STREET

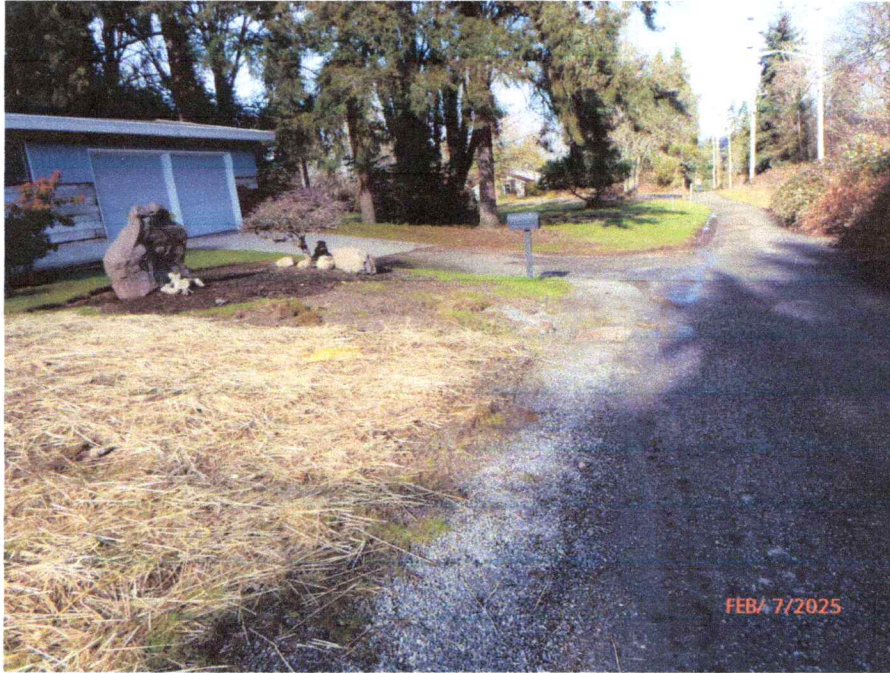
STREET FRONTAGE ON 97TH AVENUE S.E.

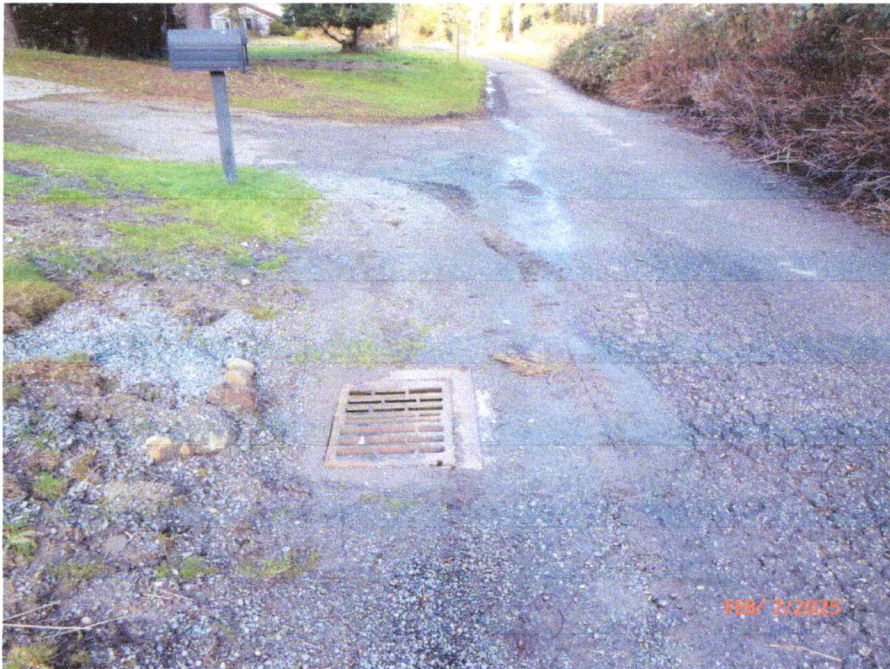
The site frontage on both streets is gravel shoulder. Noted is that at two locations along the site's frontage on 97th Avenue S.E. are catch basins. Based on site observations, the more central catch basin receives house runoff via a 4 inch pipe, with the catch basin 12 inch outlet running east, under 97th Avenue S.E.

EXISTING CATCH BASIN ON 97TH AVENUE S.E.

As an upgrade to the roof drainage system, it is recommended that in the run of line from the house to the catch basin, that a 2 foot wide by 10 foot long Perforated Pipe System is inserted in the line. The specifications for a Perforated Pipe Connection are per guidance in the King County Surface Water Manual, Appendix C, or as adopted by the City of Mercer Island.

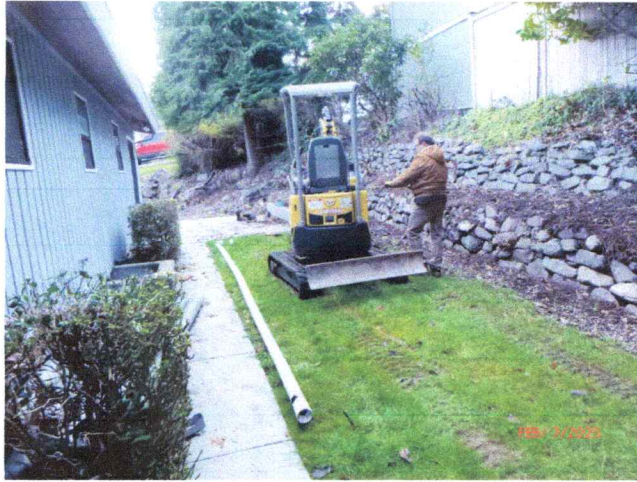
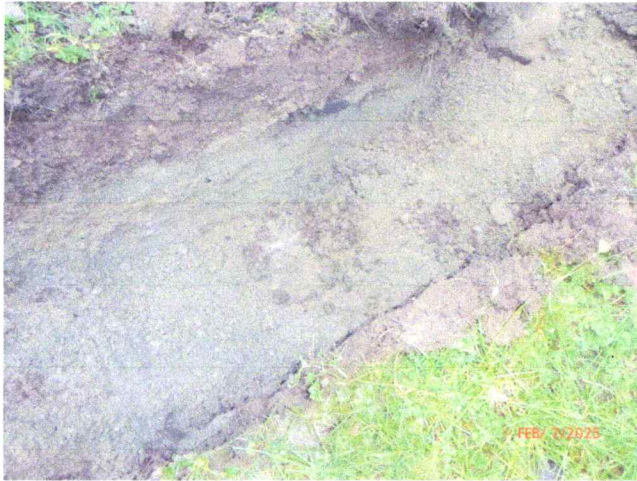
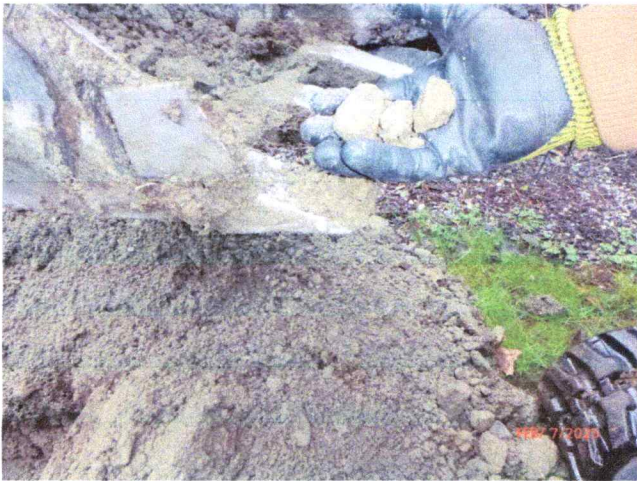
SOIL LOG 1

Both logs were excavated to a depth of 42 inches, or about 3.5 feet. Encountered in each log was an upper layer of Clayey Sand, slightly mottled, underlain to depth with a Sandy Hardpan, also slightly mottled. All soils were full-depth wet or saturated. (See attached Soil Logs). Noted is that the rear yard soils represent a cut area, the soils were dense and undisturbed. However, the logs may be assumed as reasonably representing general site soil conditions.

SL 1

0 - 36"

CLAYEY MEDIUM SAND W/ROCKS/SLIGHT MOTTLING

36" - 42"+

SANDY HARDPAN DAMP/SLIGHT MOTTLING

NO GROUNDWATER ENCOUNTERED

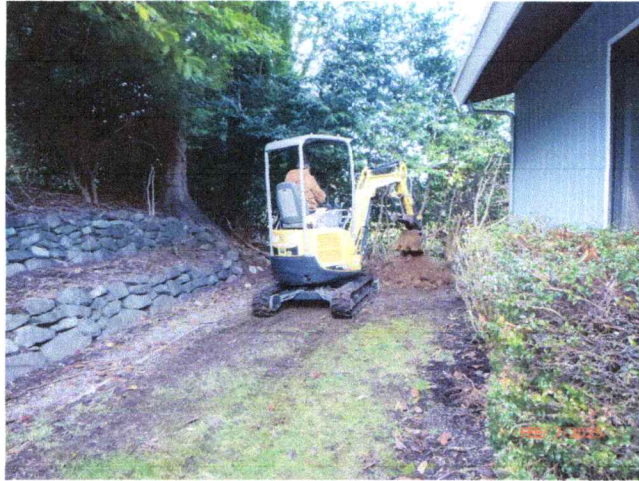
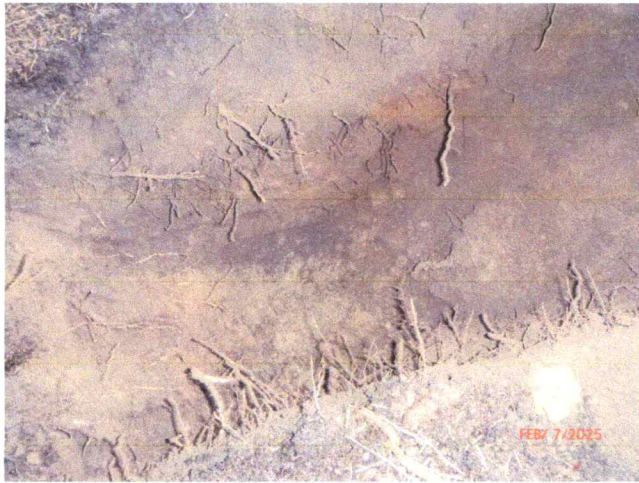
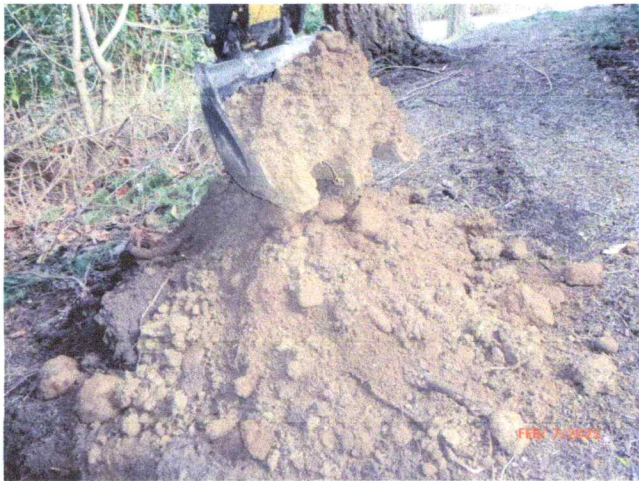
SOIL LOG 2

SL 2

0 - 36"

CLAYEY MEDIUM SAND W/ ROCKS/SLIGHT MOTTLING

36" - 42"+

CLAYEY SAND/HARDPAN DAMP/SLIGHT MOTTLING

NO GROUNDWATER ENCOUNTERED

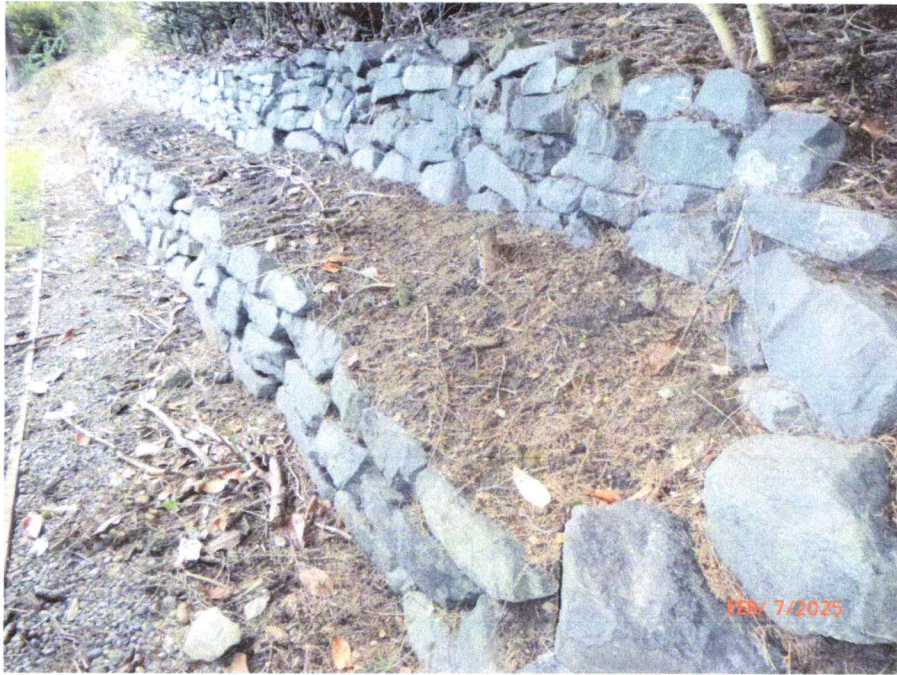
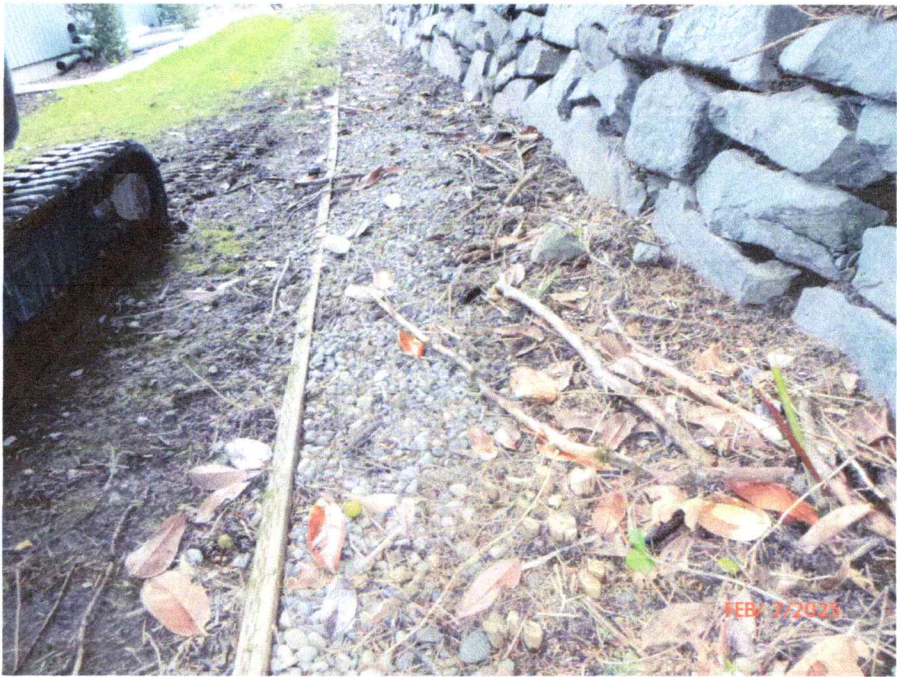
REAR YARD DOUBLE ROCKERY AND BASE "FRENCH DRAIN"
