RE: Permit No. 2505-049 Zhao Property

Regarding the application for construction of a garage and a primary suite addition to the existing single family residential structure, located at 4433 86th Avenue SE.

We have been requested to prepare a letter response to address your concerns pertaining to the general seismic design criteria for the subject site.

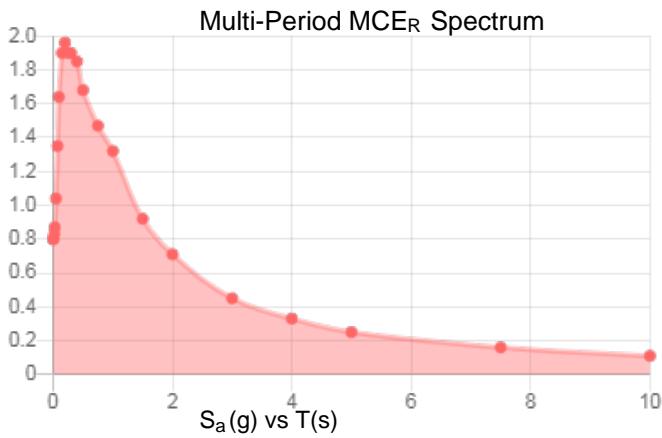
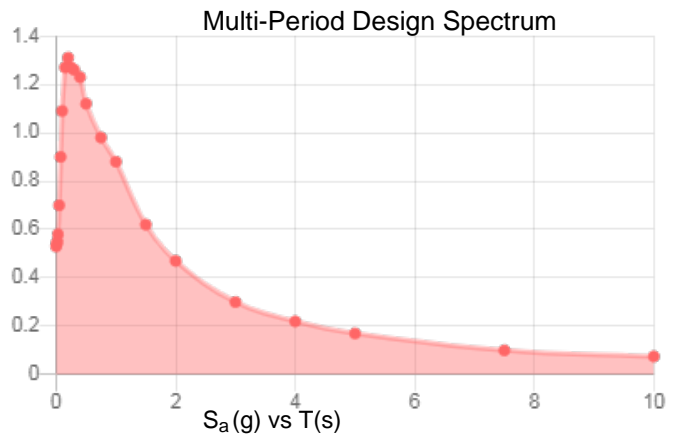
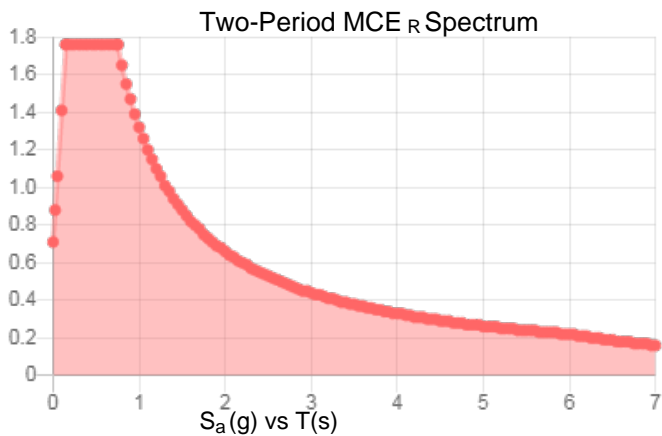
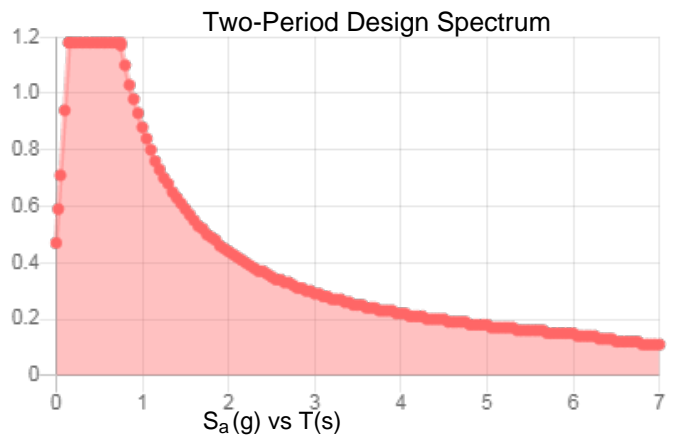
FIGURE 2

2. Seismic importance factor, $I_e = 1.0$ from Table 1.5-2 Importance Factors by Risk Category for Earthquake Loads. (see figure 1
3. Mapped spectral response acceleration parameters, $S_{s(g)} = 1.56$ and $S_{ms(g)} = 1.76$ from Table C22-3, ASCE/SEI 7-22. These values are for default site conditions assuming not needing an in-depth geotechnical boring program and lab testing of hardpan/glacial till subsurface conditions at less than 3 feet. (see figure 2

PGA _M :	0.73	T _L :	6
S _{MS} :	1.76	S _s :	1.59
S _{M1} :	1.32	S ₁ :	0.63
S _{DS} :	1.18	V _{S30} :	260
S _{D1} :	0.88

Seismic Design Category: D

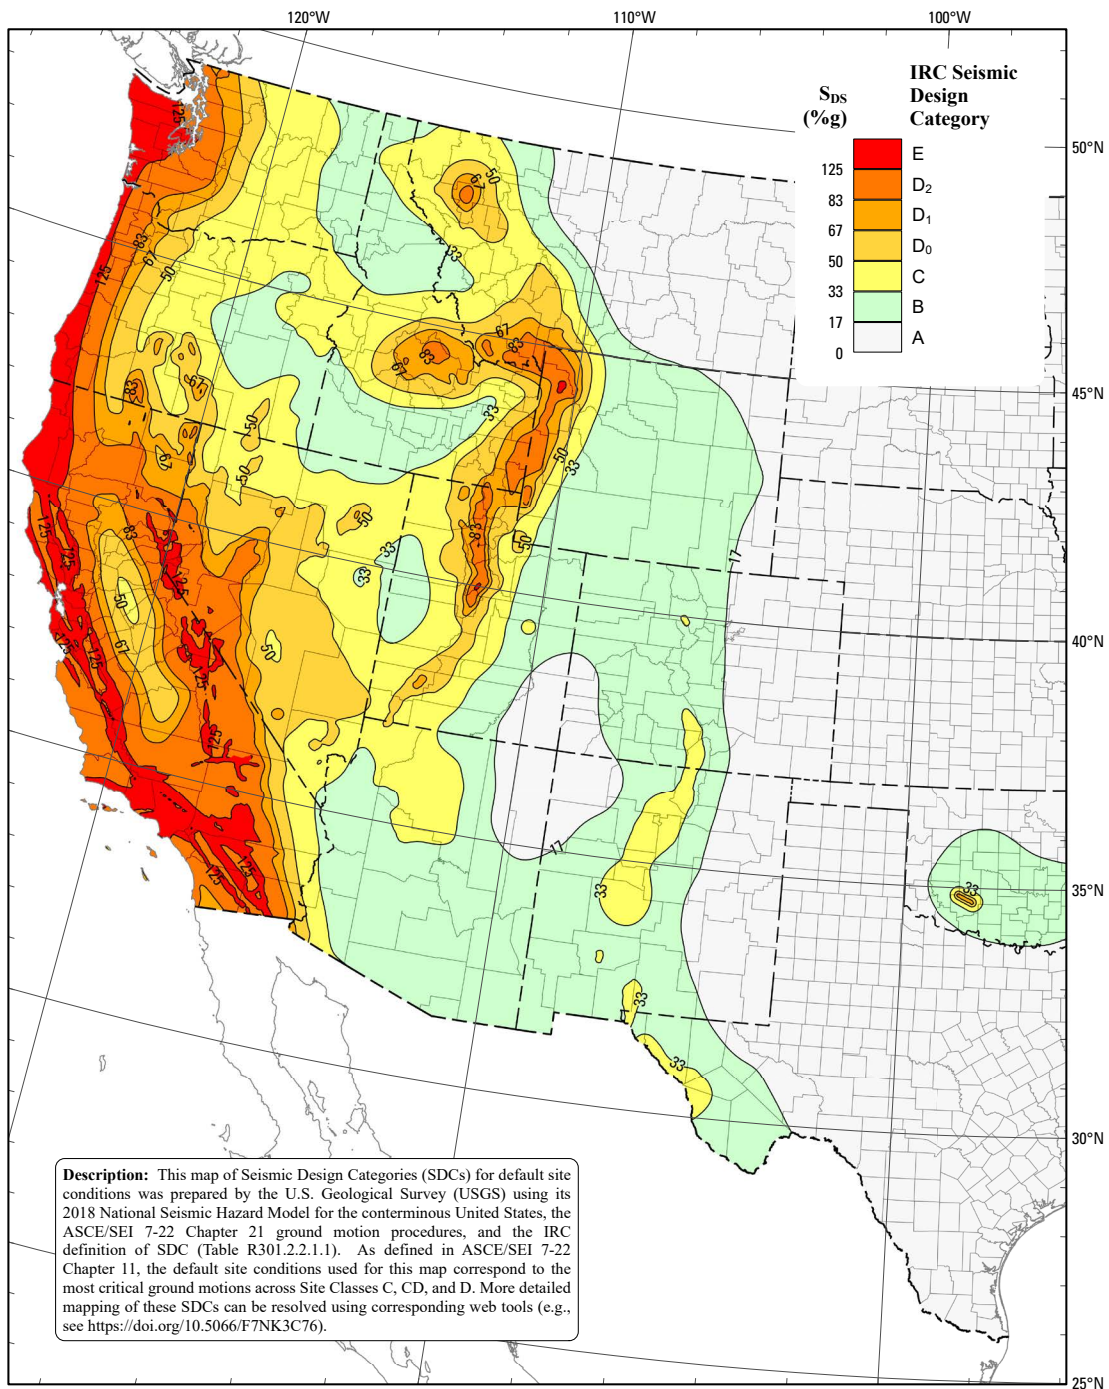
Figure 1. Seismic Design Category Map for 2024 IRC - Western U.S. (Color)

6. Seismic design category is D2 from both City of Mercer Island table and NEHRP/USGS color map.
7. Basic seismic force-resisting systems(s) Light frame wood construction with 5/8 "plywood panel construction or equal with Simpson Strong Tie Hold Downs at the garage opening on both sides of the garage door opening. Detailing requirements for contractor are found at ASCE 7 section 14.5 and specified.

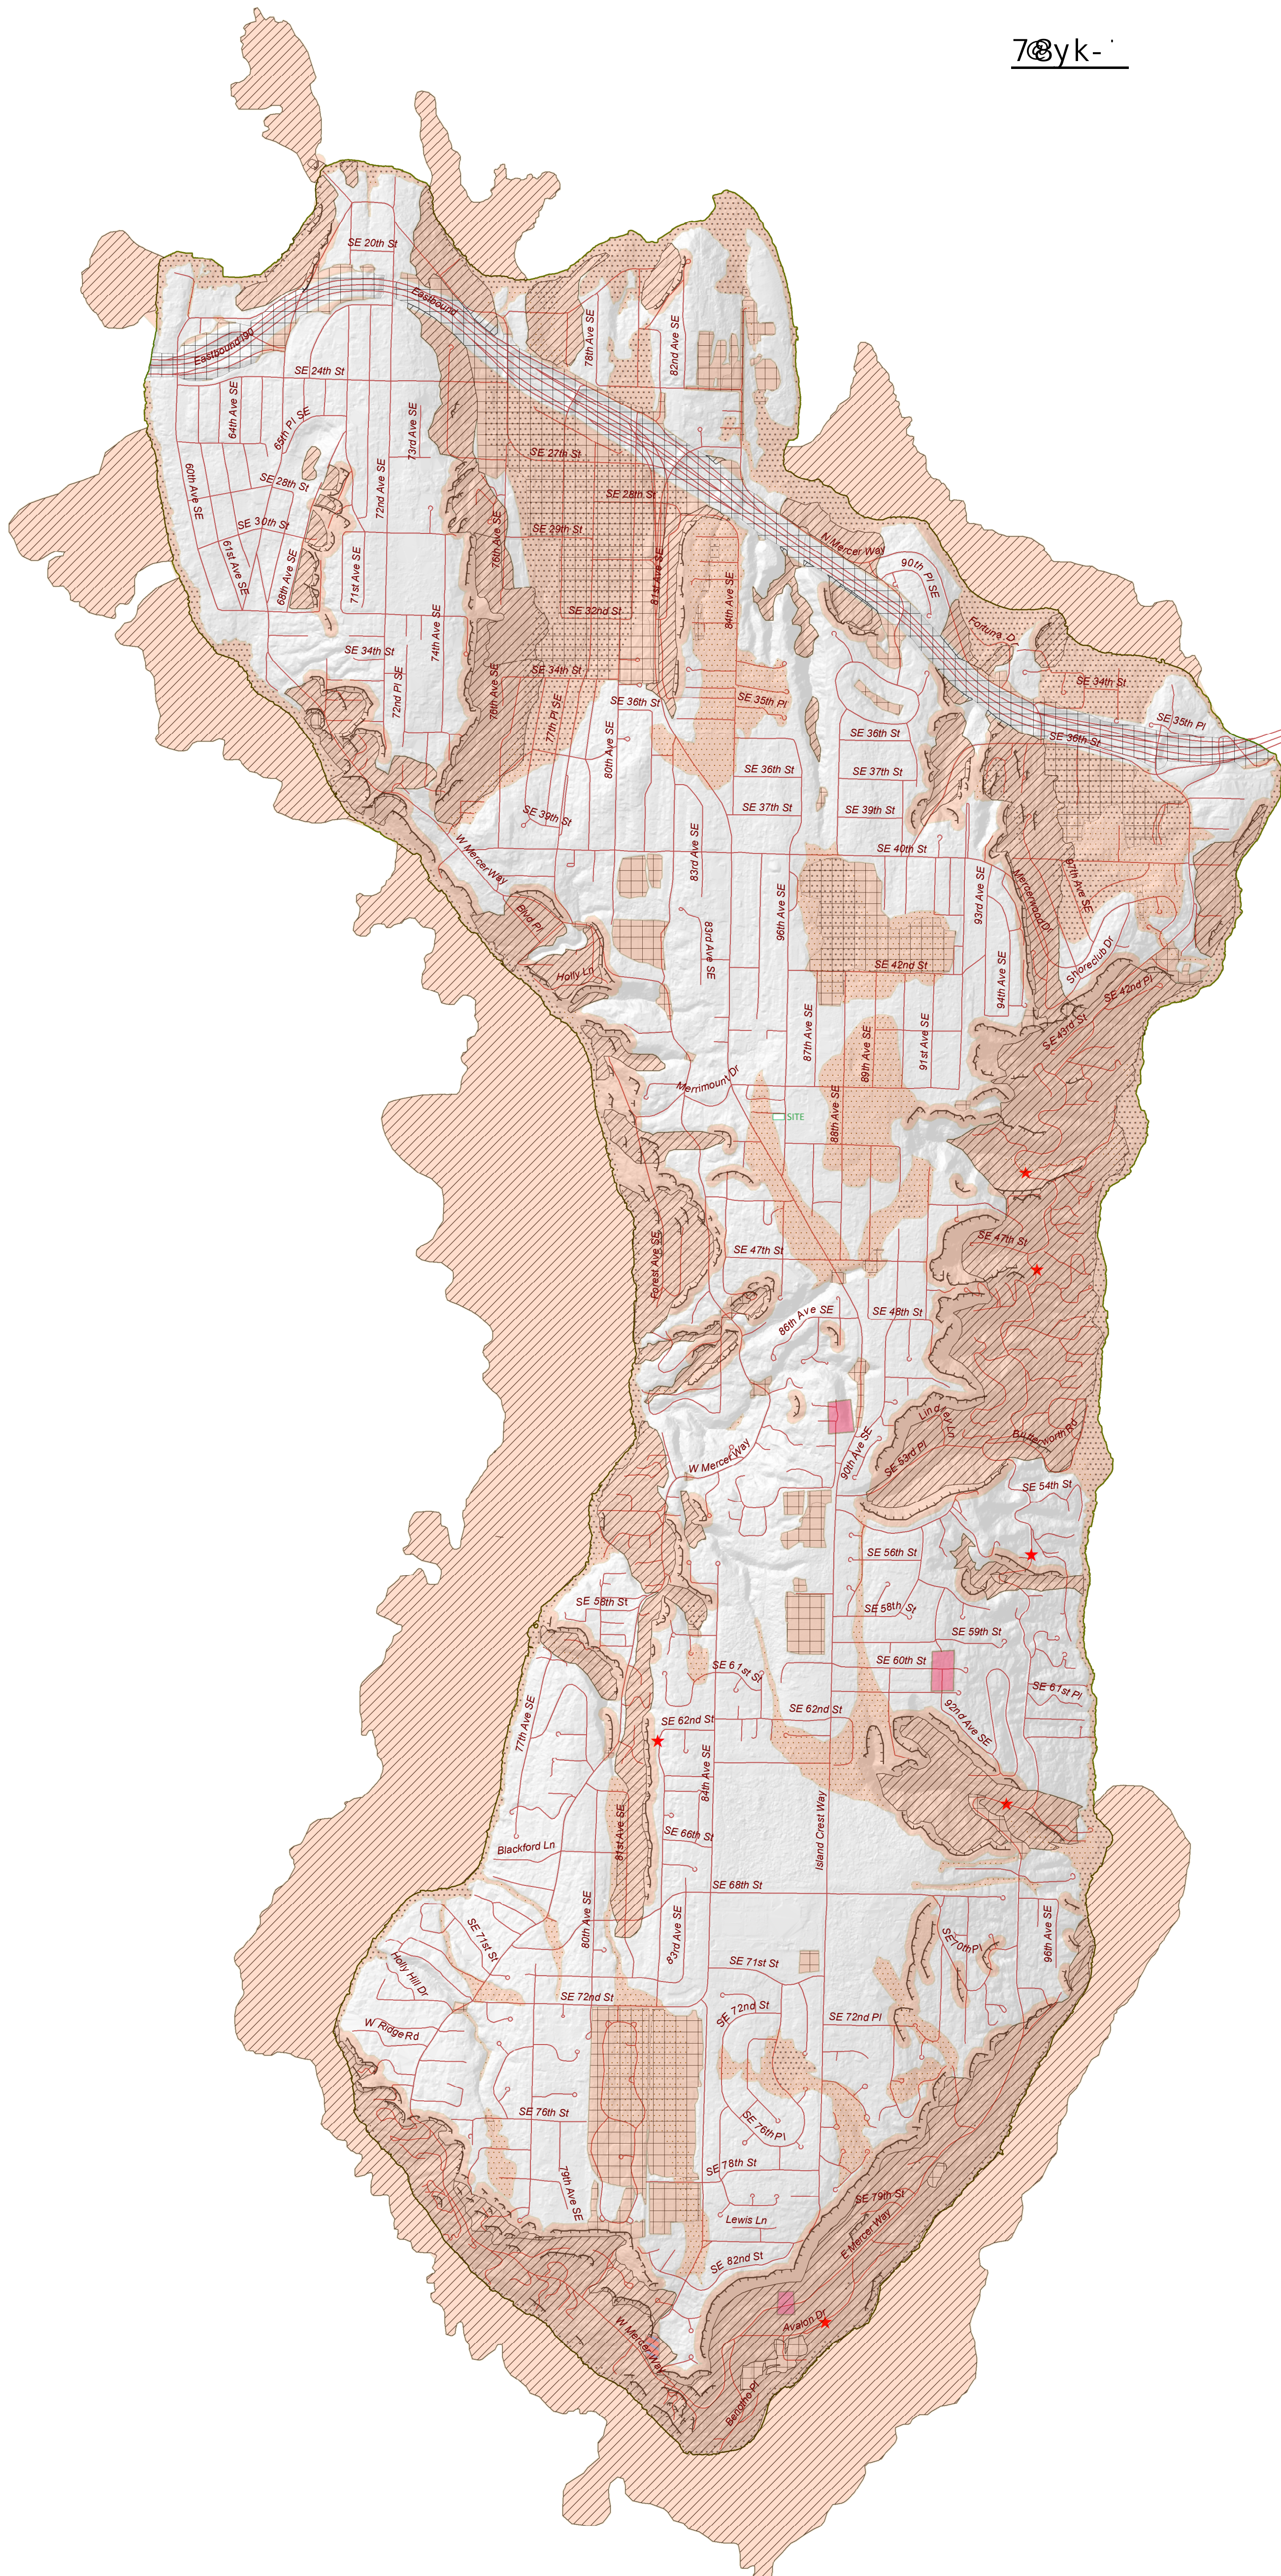
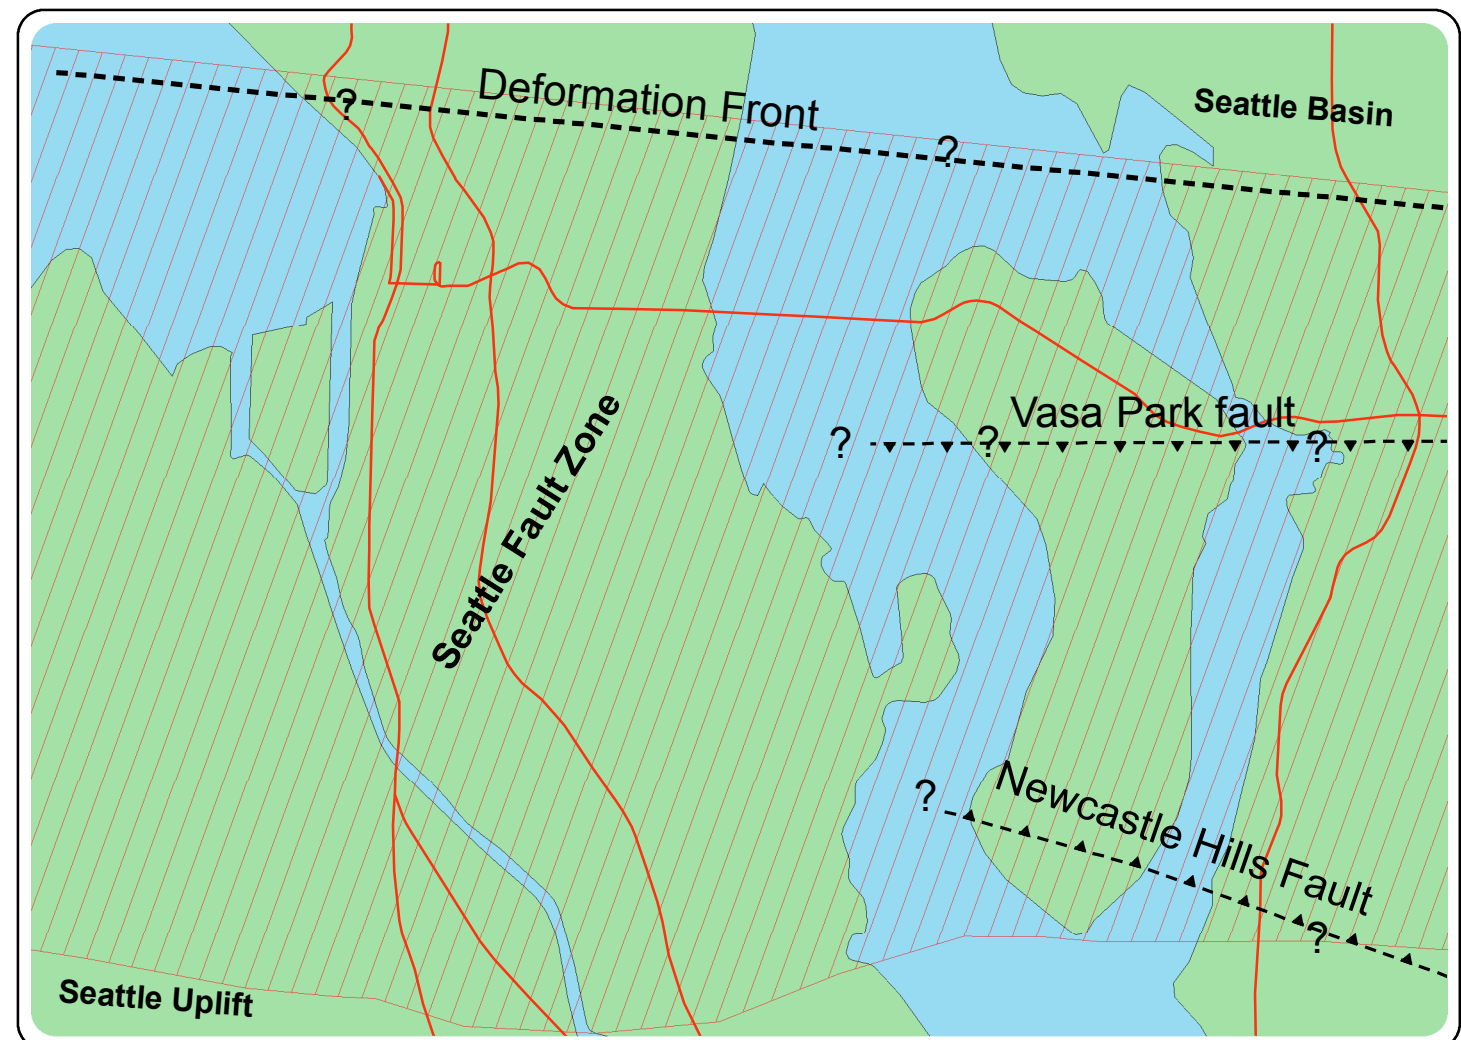
Below are the general two seismic maps that the City of Mercer Island has posted to their Critical Areas Mapping System and their GIS system. While the one map does depict a small portion of the site designated in pink or subject to seismic hazard, we believe that this is mis-mapped on the Cities GIS map based on the relatively flat nature of the lower or east end of the site and the fact that this area is underlain by hardpan or consolidated till layer on this site. The published geologic mapping of the site confirms that as does the mapping on other parcels to the east at least to the main City Right of Way to the east and the slope above the Island Crest Way, the primary N/S arterial East of SE 44th Place.

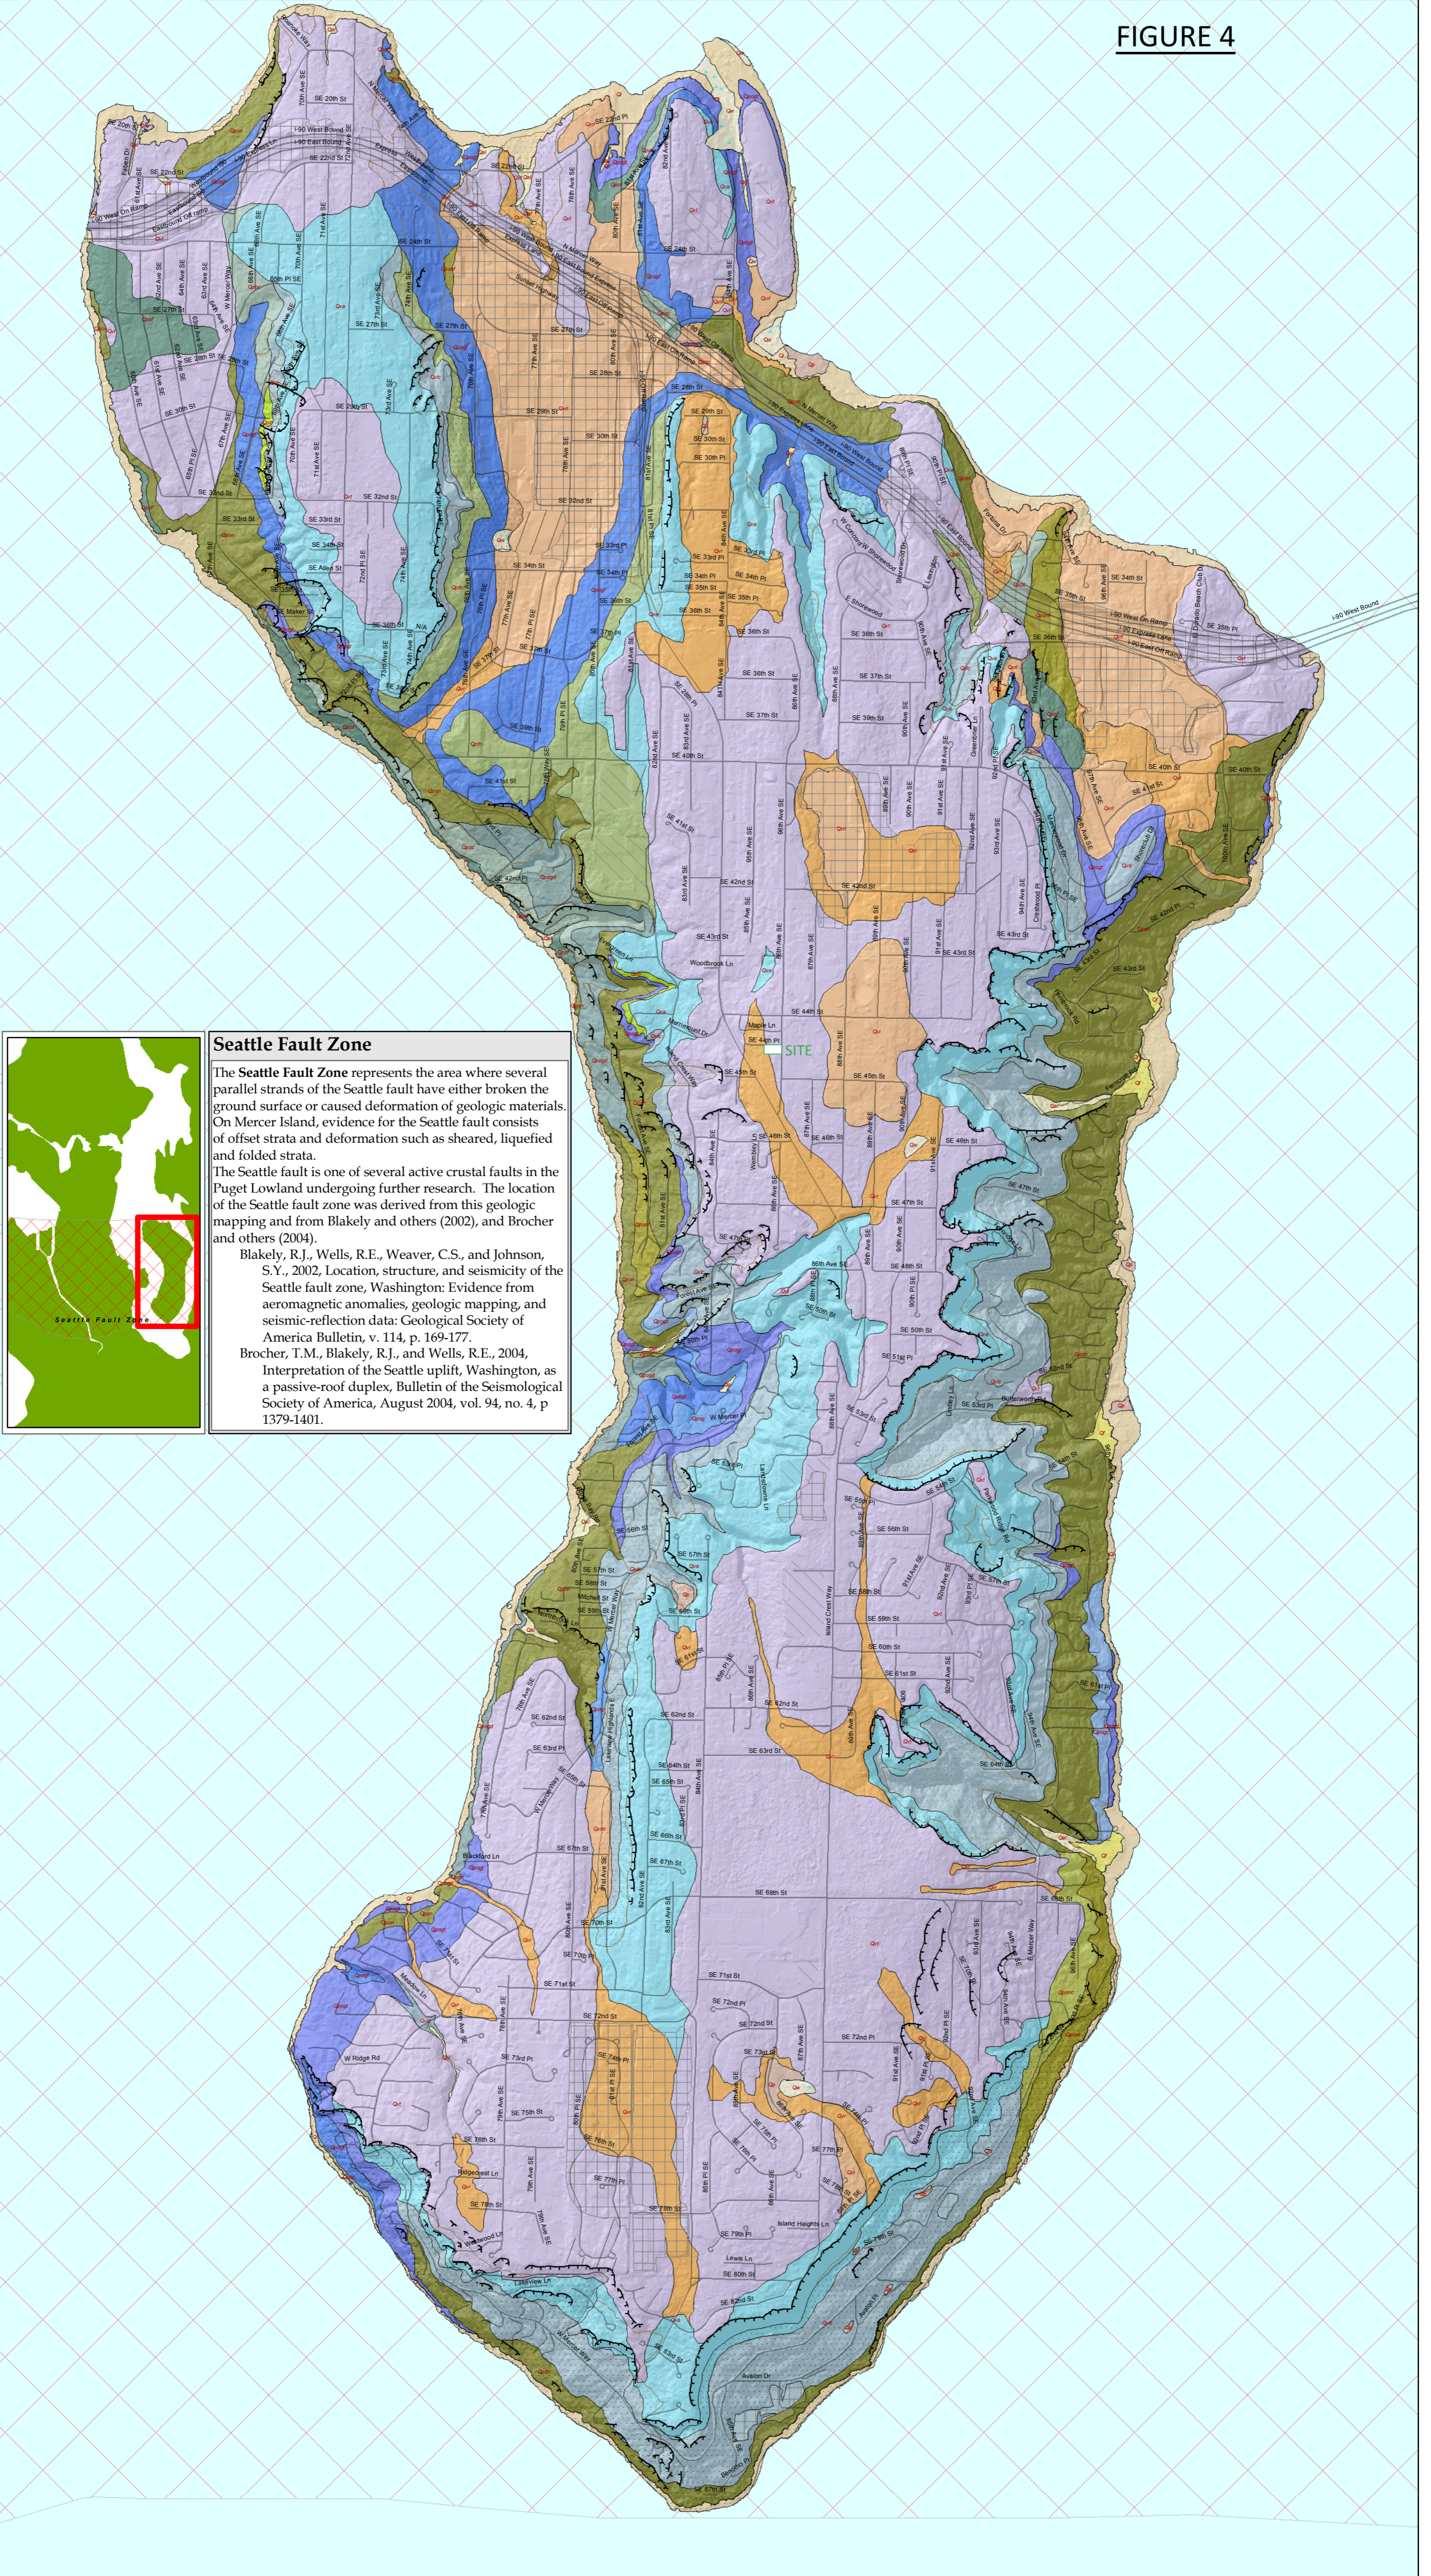
Also, the soils data and geologic mapping of the site is attached from Mercer Island GIS system with confirmed soils of till present as described. (see figure 4a)
