# Greenforest Incorporated

## Consulting Arborist

REFERENCE: Exceptional Tree Removal

SITE ADDRESS: 4024 85<sup>th</sup> Ave SE, Mercer Island WA

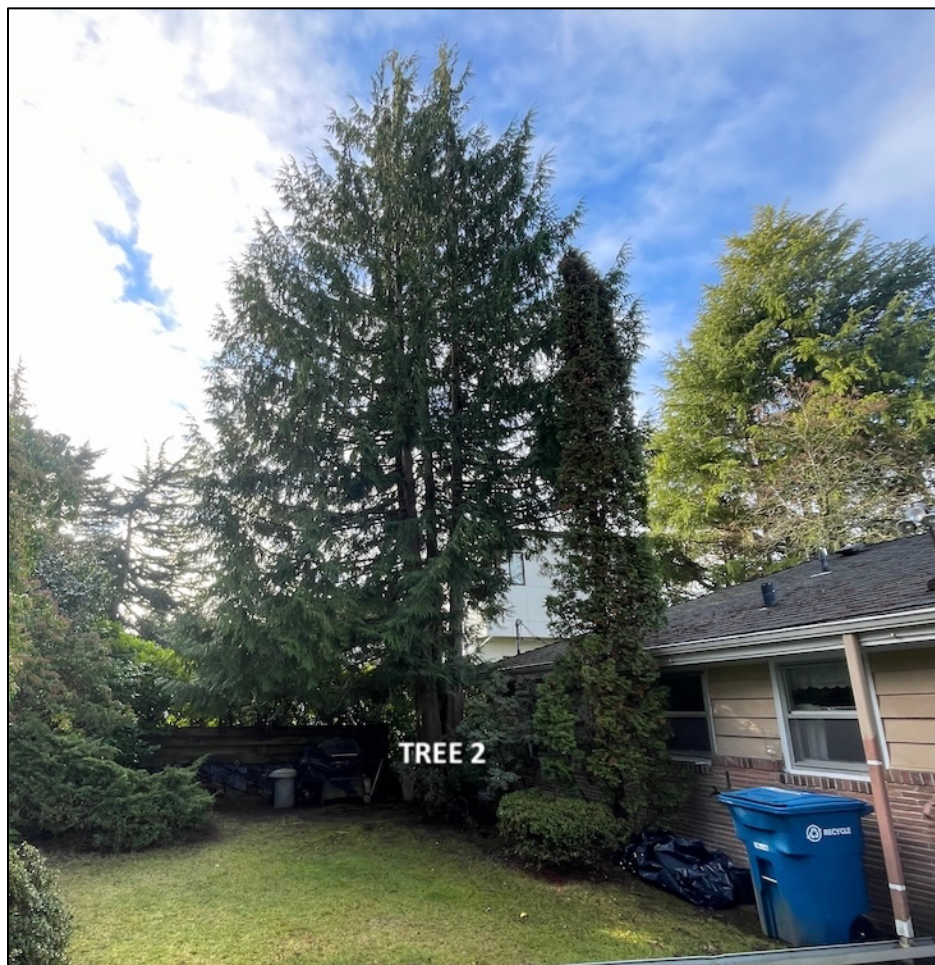
Tree 2 is a 35" DBH native Western red-cedar. Its current condition includes multiple leaders with included bark, in addition to the existing foundation preventing rootplate development. Though the bark inclusions can be mitigated with installation of dynamic support systems, the disruption of the rootplate caused by the removal of the existing foundation cannot. To avoid a high-risk scenario, the tree must be removed.

*The overall risk rating for this tree is **Extreme**.* The extreme-risk category applies in situations in which failure is *imminent* and there is a high likelihood of impacting the target, and the consequences of the failure are “severe”. The tree risk assessor should recommend mitigation measures be taken as soon as possible. In some cases, this may mean immediate restriction of access to the target zone area to avoid injury to people.

I recommend this tree be removed prior to or as the existing house is demolished.
