2505-068
4703 88th Ave SE
Mercer Island
TV inspection report.

To the attention of Ruji Ding, City of Mercer Island

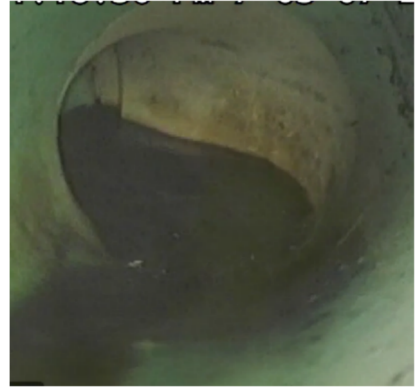
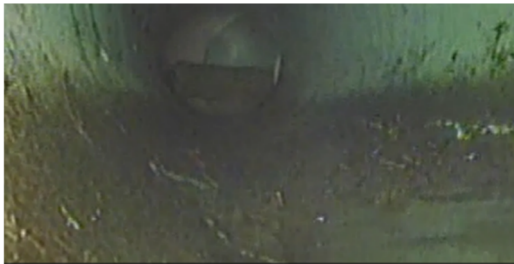
The video inspection from downspout 5 going downstream shows sediment and standing water in the 6" conveyance pipe. The pipe between downspout 6 and the two 90 degree bends downstream from there was holding water that appeared to be 1" – 2" deep (less than 1/3 of the pipe).

The retained water ends prior to the first of the two bends gradually, indicating that this portion of the pipe is sloping backward. There is also a fair amount of sediment at the bottom of the pipe along this section. The sediment should be removed and the pipe slope adjusted to provide positive drainage.

While the portion of the pipe that is not submerged may have capacity to convey the runoff from the project, the sedimentation in place indicates that it will continue to accumulate, eventually blocking the pipe in this location.

1. Flush system and remove rocks, sediment and other debris from the downstream catch basin.
2. Adjust the pipe slope at the north corner of the house to allow gravity flow at 2% slope.

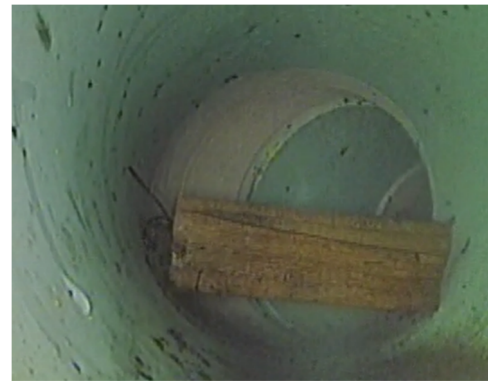
At the first of the two 90 degree bends in the north corner of the house, we observed a fairly small, but lodged wooden obstruction. The wooden obstruction should be removed.

We trust this analysis will provide the information needed to allow this project to proceed. While there were locations within the pipe that had retained rocks and sediment, a flush of the system should result in clearing those obstructions. Removal of the wooden obstruction can be accomplished while the slope of the reverse sloped pipe is being adjusted in that same corner.
