Corinne R. Hollister

Consulting Arborist Services

Reference: Partial Tree Inventory Report

Site Address: 5245 Forest Ave SE, Mercer Island 98040

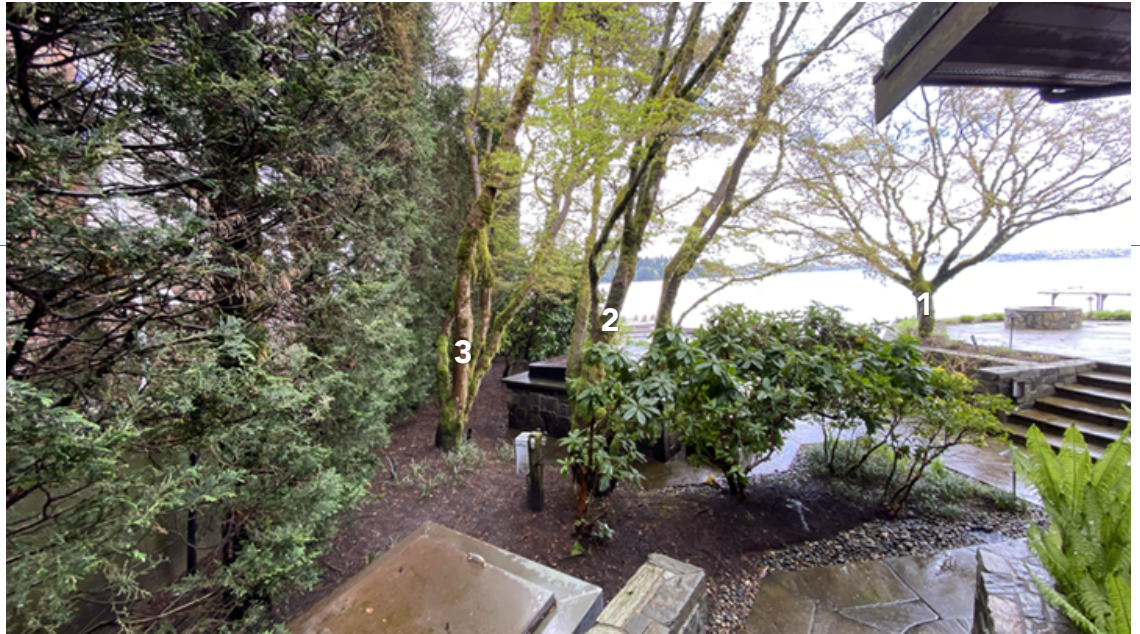
*Right: Looking west from the existing utility vault, Tree #1 is in the background, Trees #2 and #3 can be seen near the existing hot tub. The Leyland cypress hedge is on the left.*

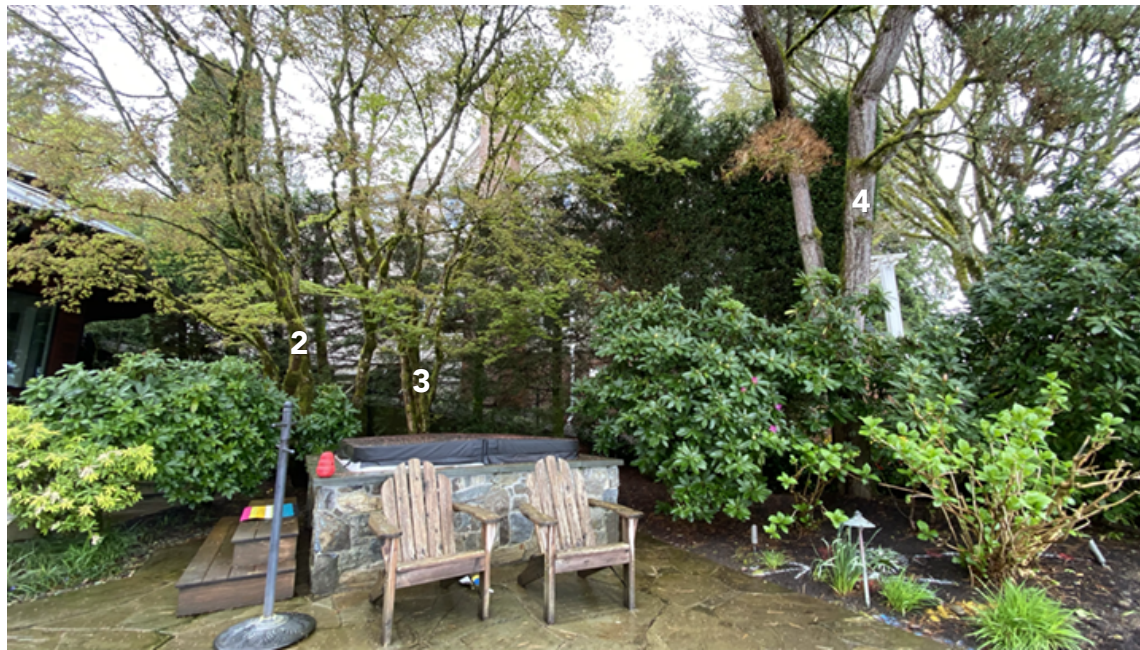
*Below: Looking south, (left to right) Trees #2, #3, #4 and the hedge behind.*
