Reference: Tree Inventory Report with Preliminary Tree Protection  
& Tree Replacement Recommendations

Date: June 26, 2025

Site Address: 6427 East Mercer Way, Mercer Island 98040

Parcel: 3024059151 (Lot C)

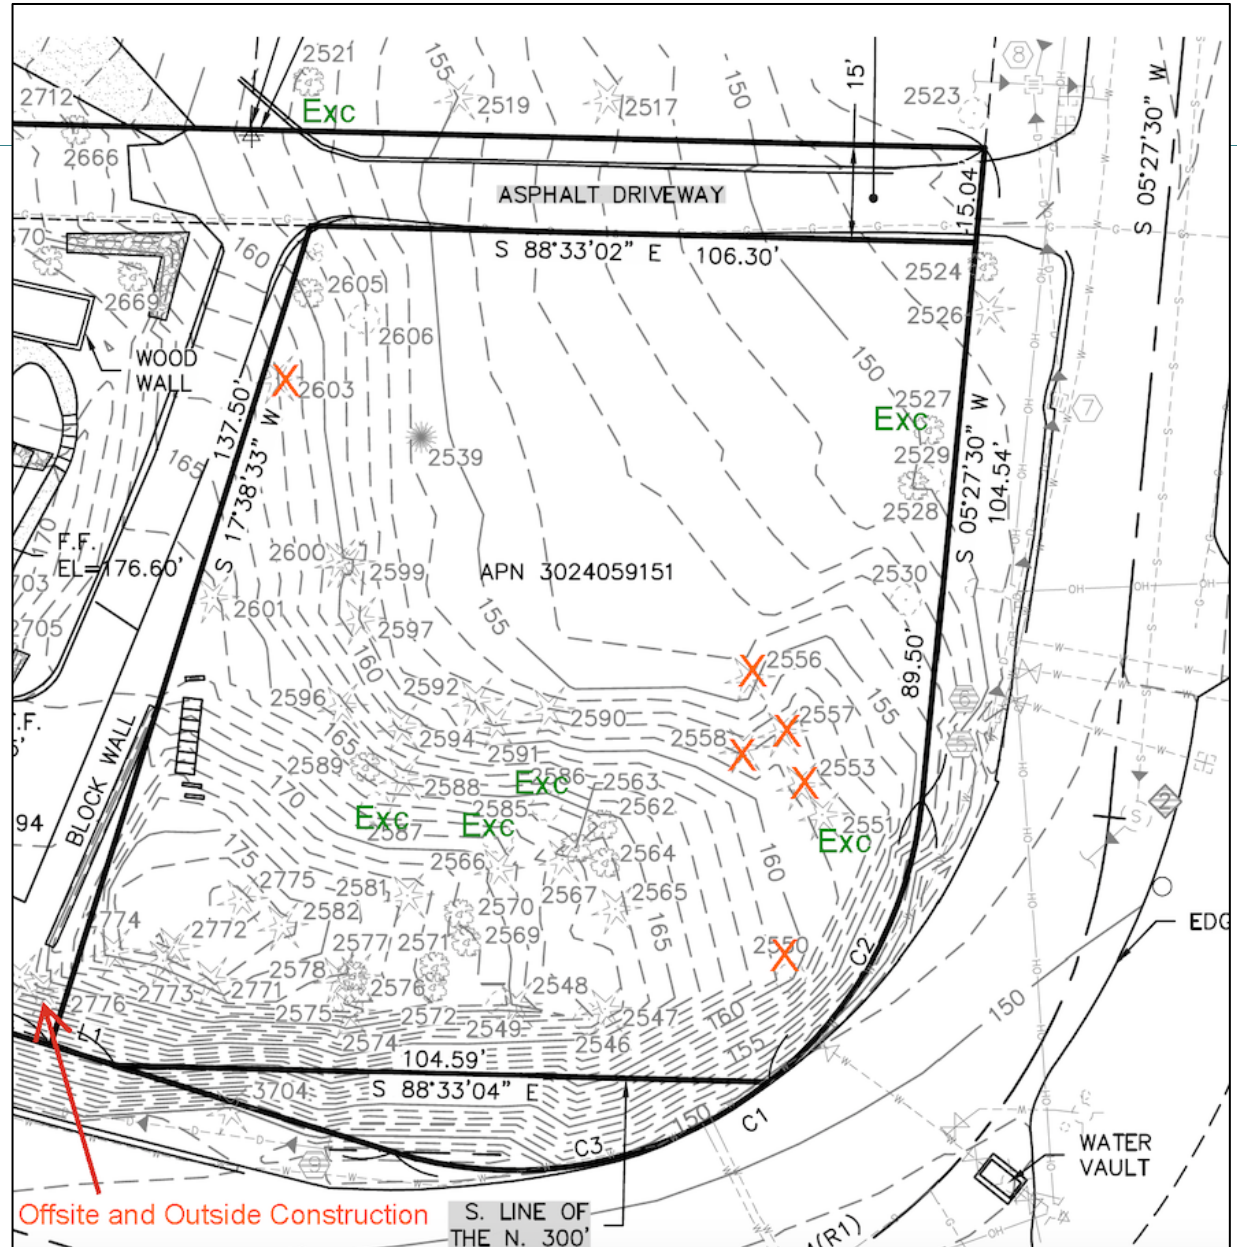
Attachment 4: Annotated Survey

X indicates trees have fallen or are no longer there.  
Exc. = exceptional tree

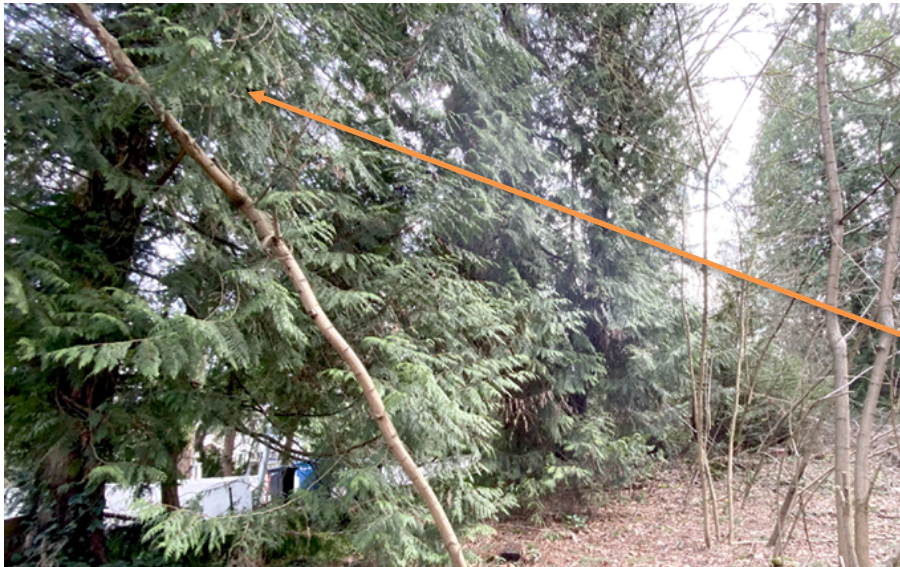
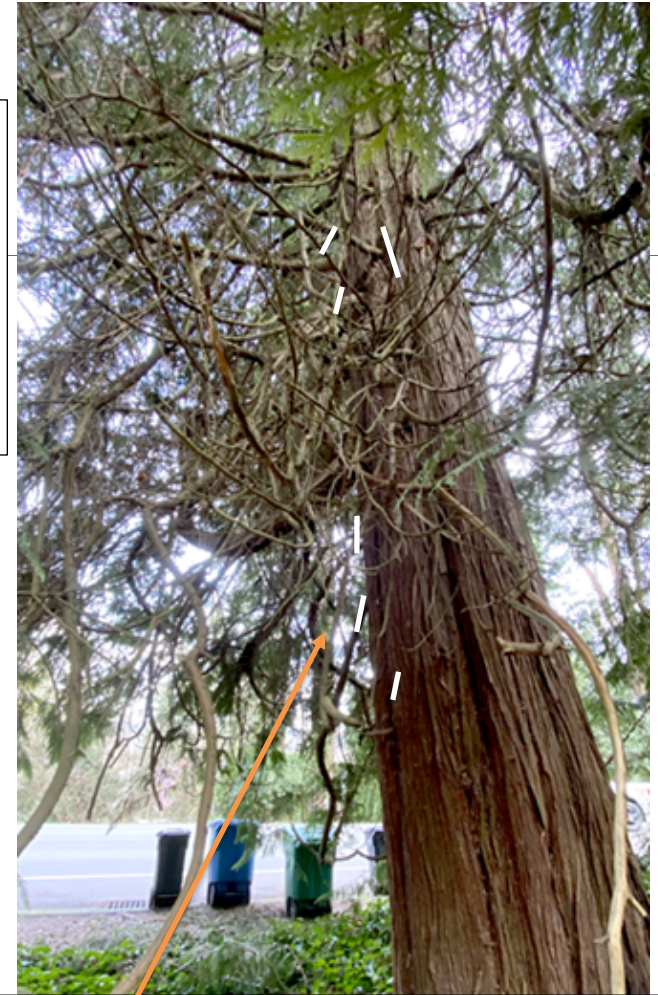
Exceptional Tree # 2527, 48.5-inch Western red cedar, 20-foot dripline:  
Objective – Clearance for construction of new home: four feet from the side and above the new home can easily be achieved by limbing up the SW corner of the tree’s canopy.

Method – Removal/thinning cuts of six or seven branches, approximately one to three inches in diameter growing west and southwest.

Clearance will be achieved by removal of six or seven branches. Some shearing may be required to achieve enough clearance for exterior and roof construction, reviewed and approved by the project arborist or city planner onsite.

No pruning is required on the north or east sides of the tree. The focus should be on the southwest corner, with some minor pruning on the west.
