**Arborist Report with Addendum on Pages 22-29 (9/8/25)
July 5th, 2024**

9412 SE 33rd St.
Mercer Island, Wa

Arborist notes for Sean OBrien at 9412 SE. 33rd St., Mercer Island Washington. Time of site visit: Wednesday, June 26, 2024. 11:30 AM.

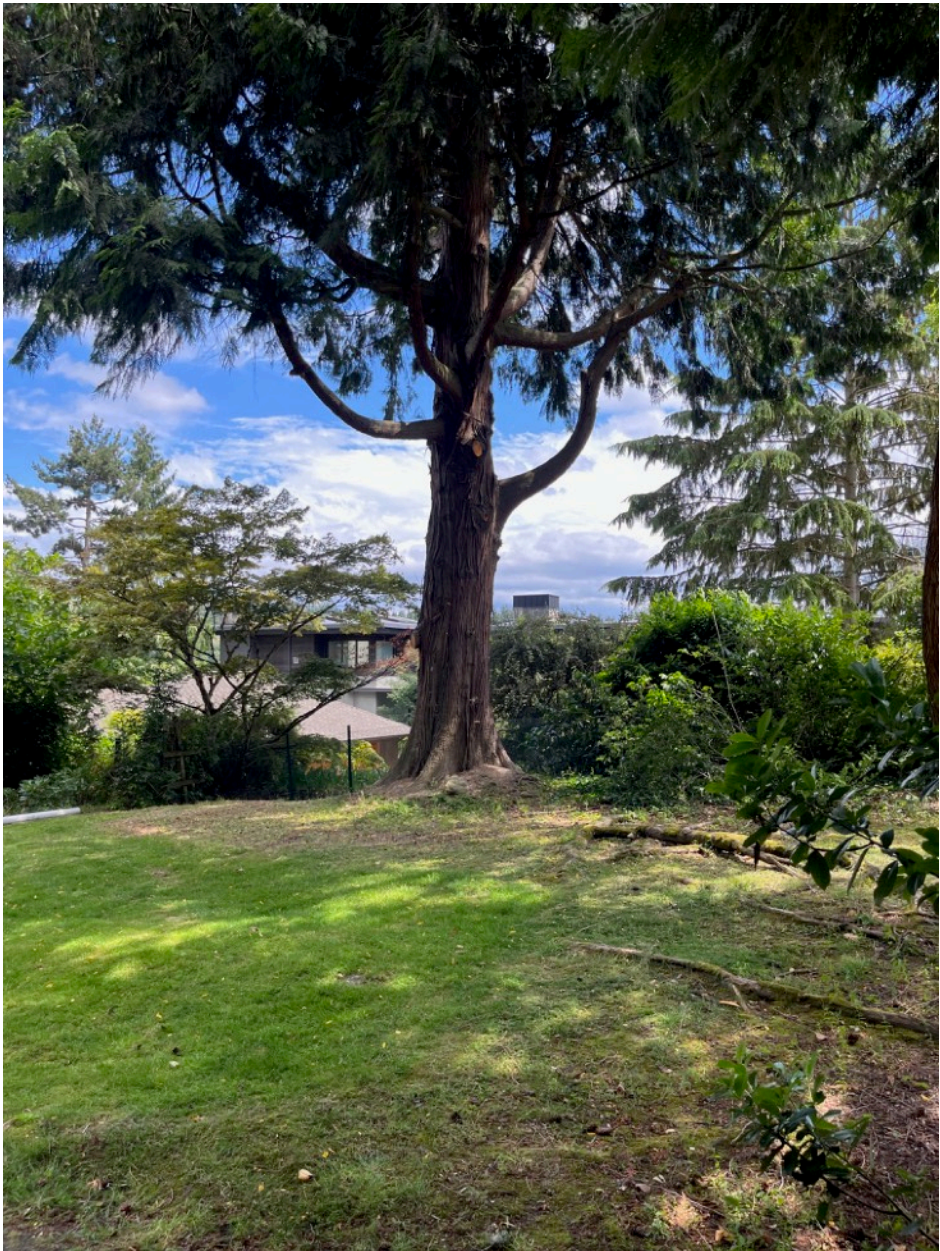
In the northeast corner of the site there is a western red cedar (*Thuja plicata*) with a diameter at standard height reading of 44 inches. This tree is easily big enough to have exceptional status in the city of Mercer Island. While the drip line radius for this tree is only 25 foot, there are obvious surface roots that extend beyond that radius. Surface rooting is clearly visible in between tree number one, which is the exceptional western red cedar, and tree number four which is another specimen of western red cedar that is multi-stemmed and smaller. It is difficult to tell which of the western red cedar trees is producing some of the surface rooting in this area. The client has informed me that the intention is to extend the footprint of the single-family residence at this address toward the north. The client will need to avoid the entire tree protection zone of tree number one. It does appear to me as though there is ample room to extend the footprint of the home toward the north while still protecting tree number one.

Looking NW at Tree 1

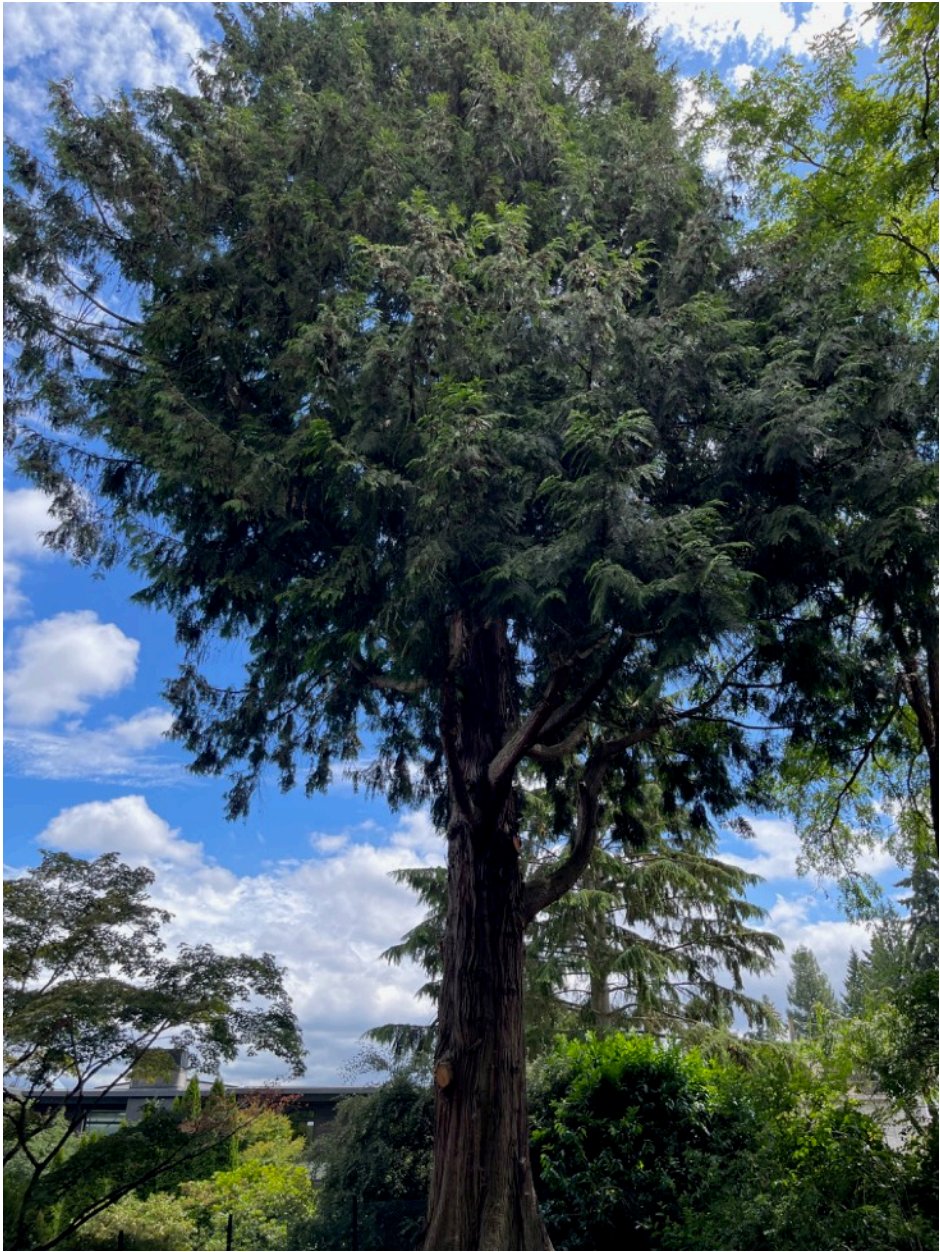
Looking north at Tree 1

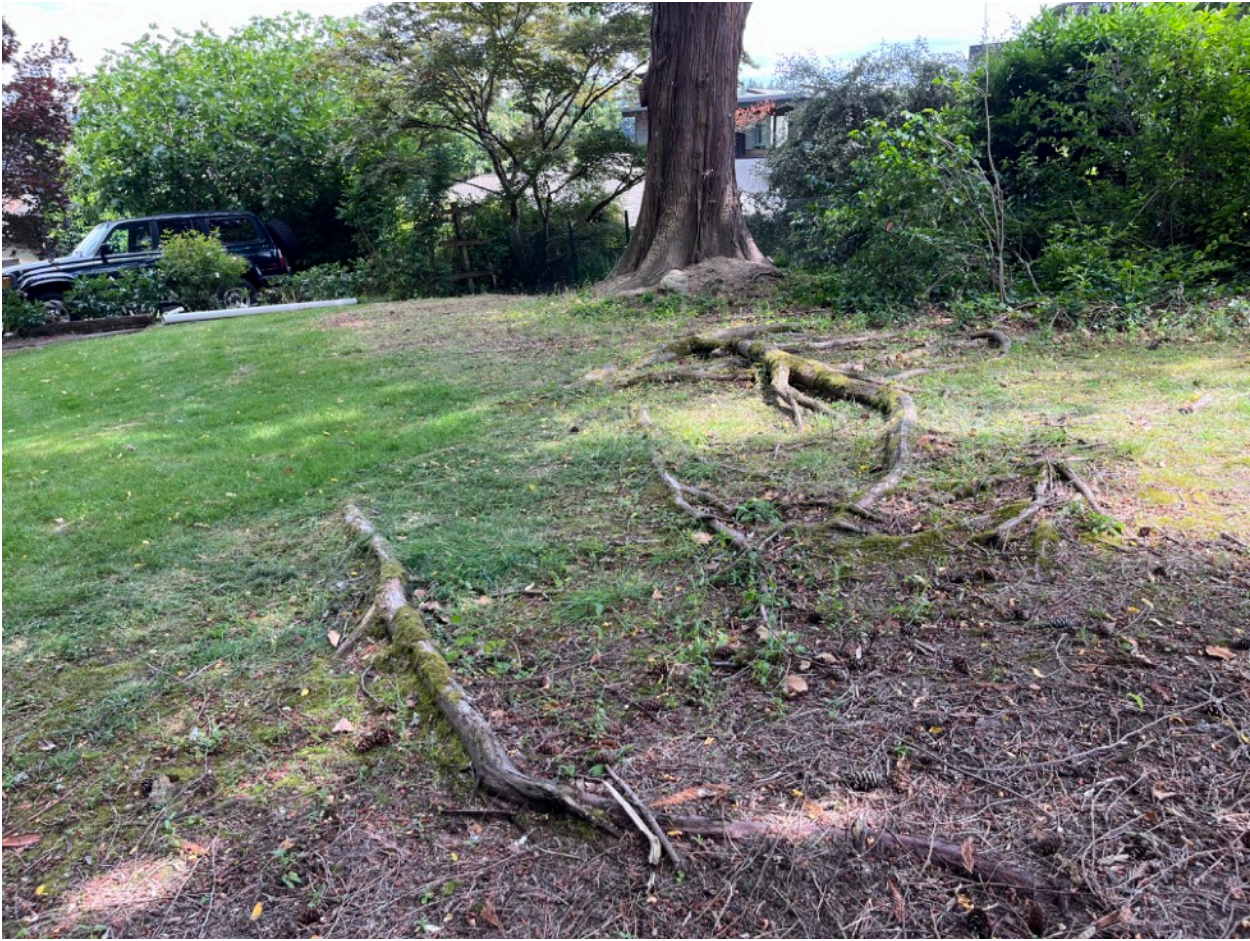
Surface rooting SE of Tree 1

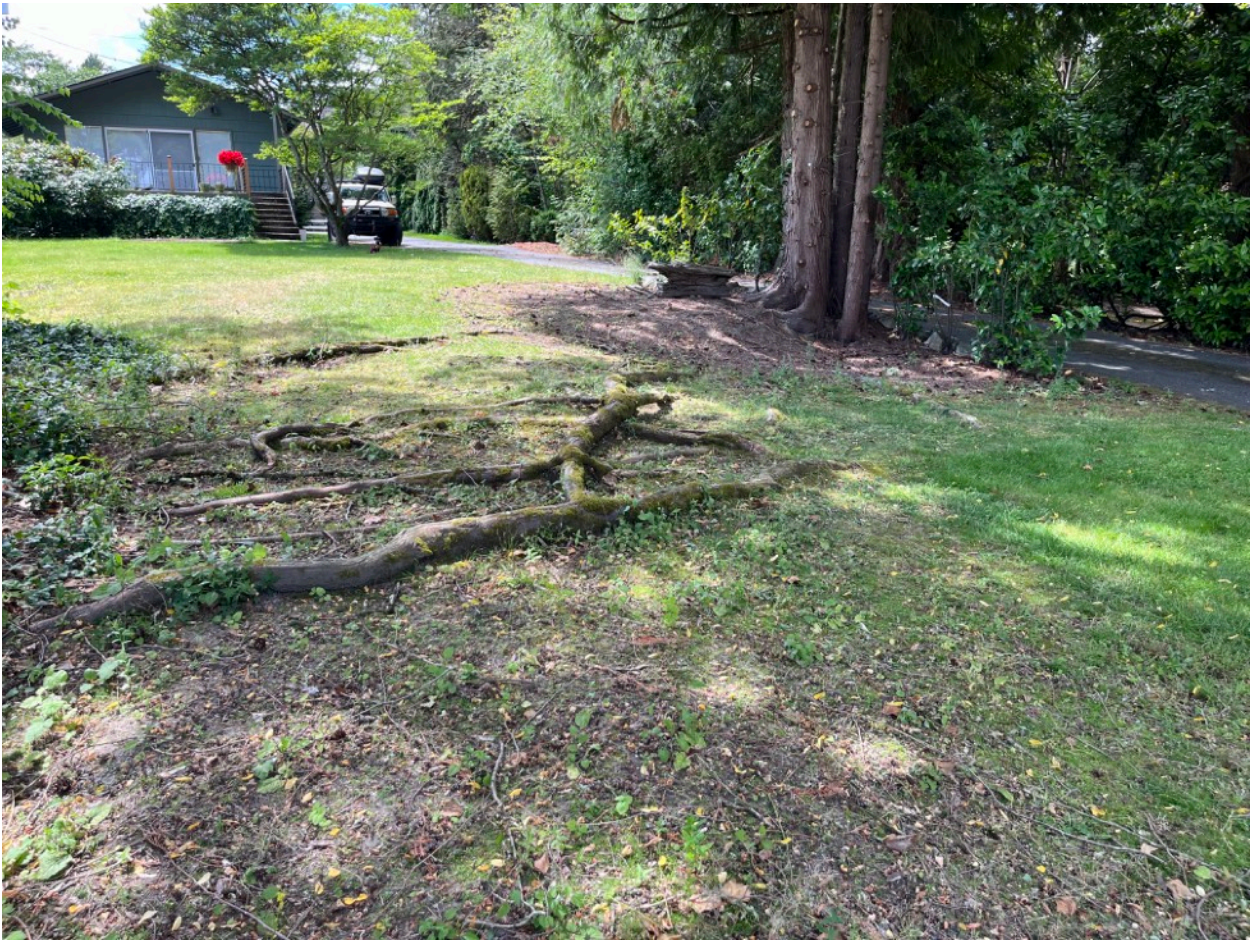
Trees two and three are fairly young black locust (*Robinia pseudoacacia*) trees that are in good condition.

Looking SE at Tree 2

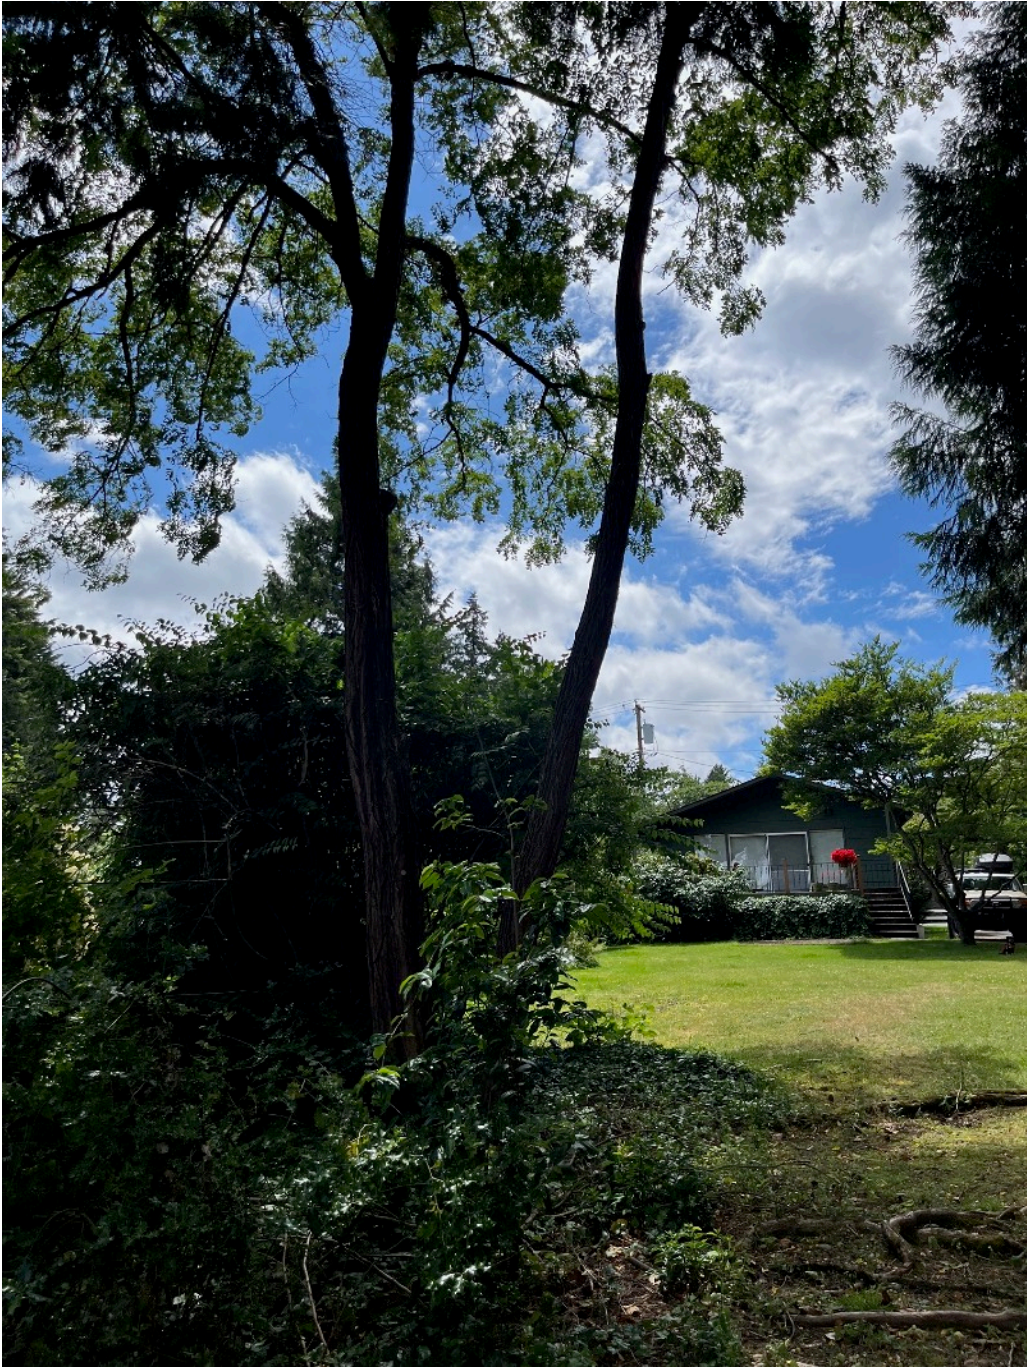
Looking east at Trees 2 and 3

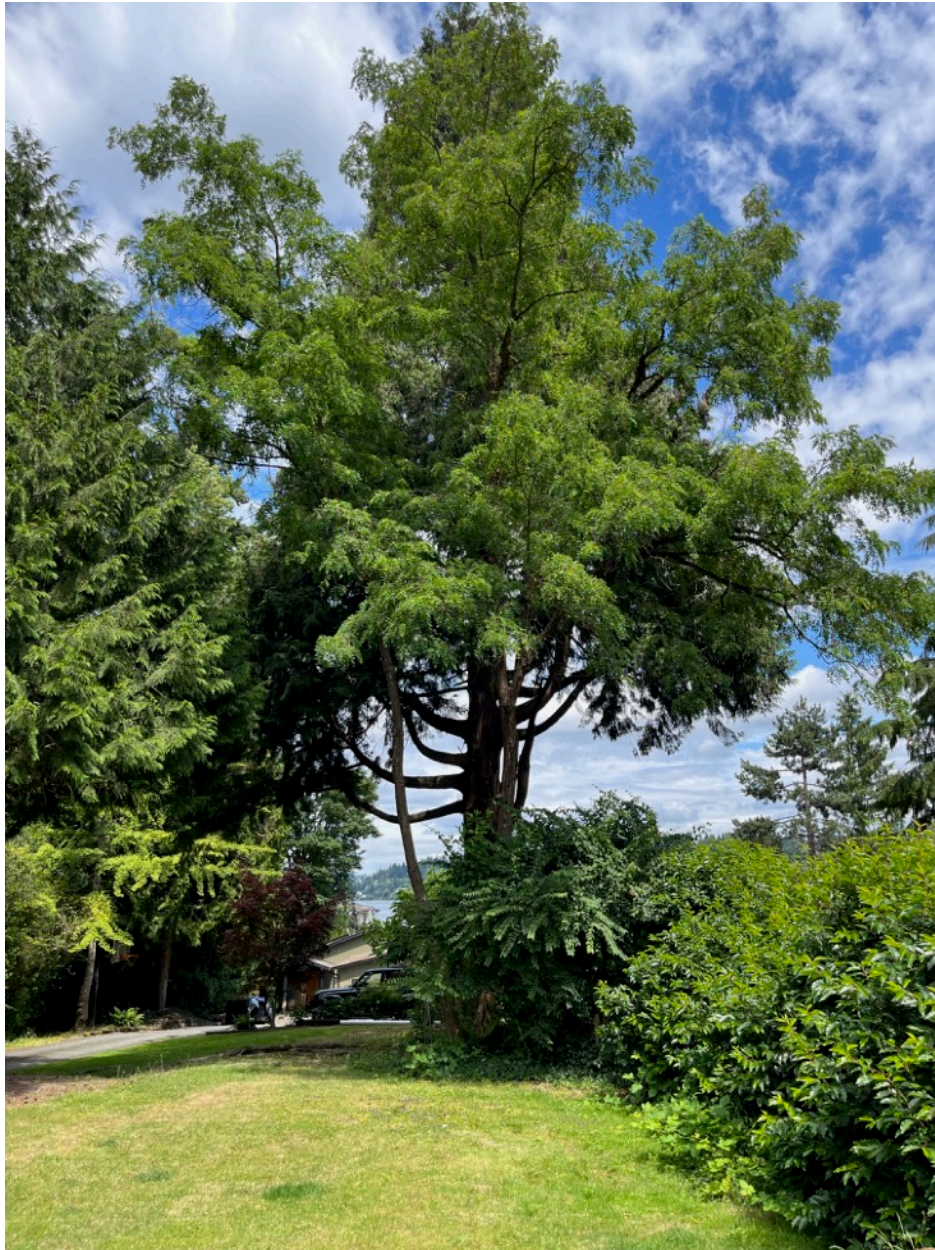
Looking west at Trees 1,2 and 3

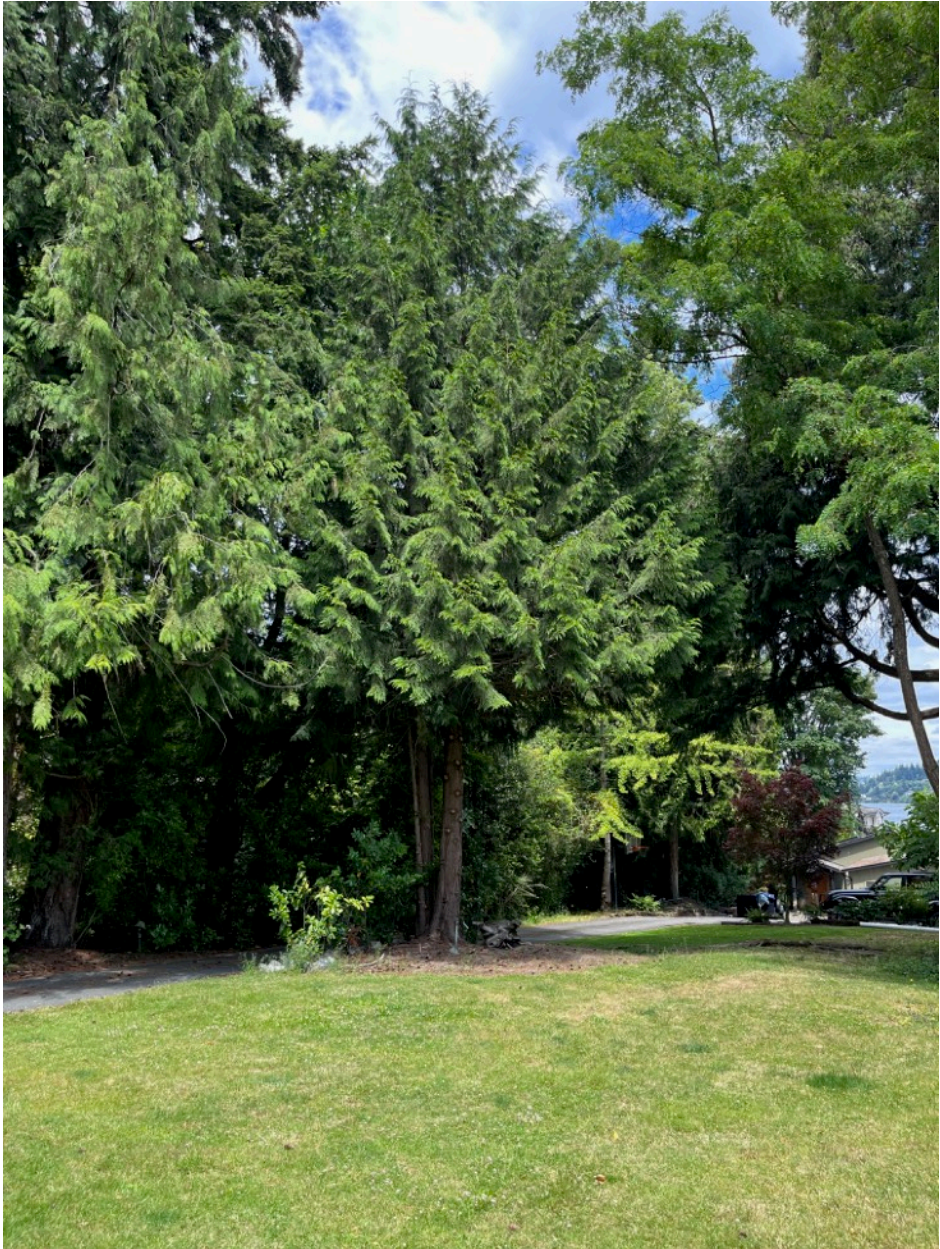
Tree number four is a multi-stemmed western red cedar that is in good condition.

Looking SW at Tree 4

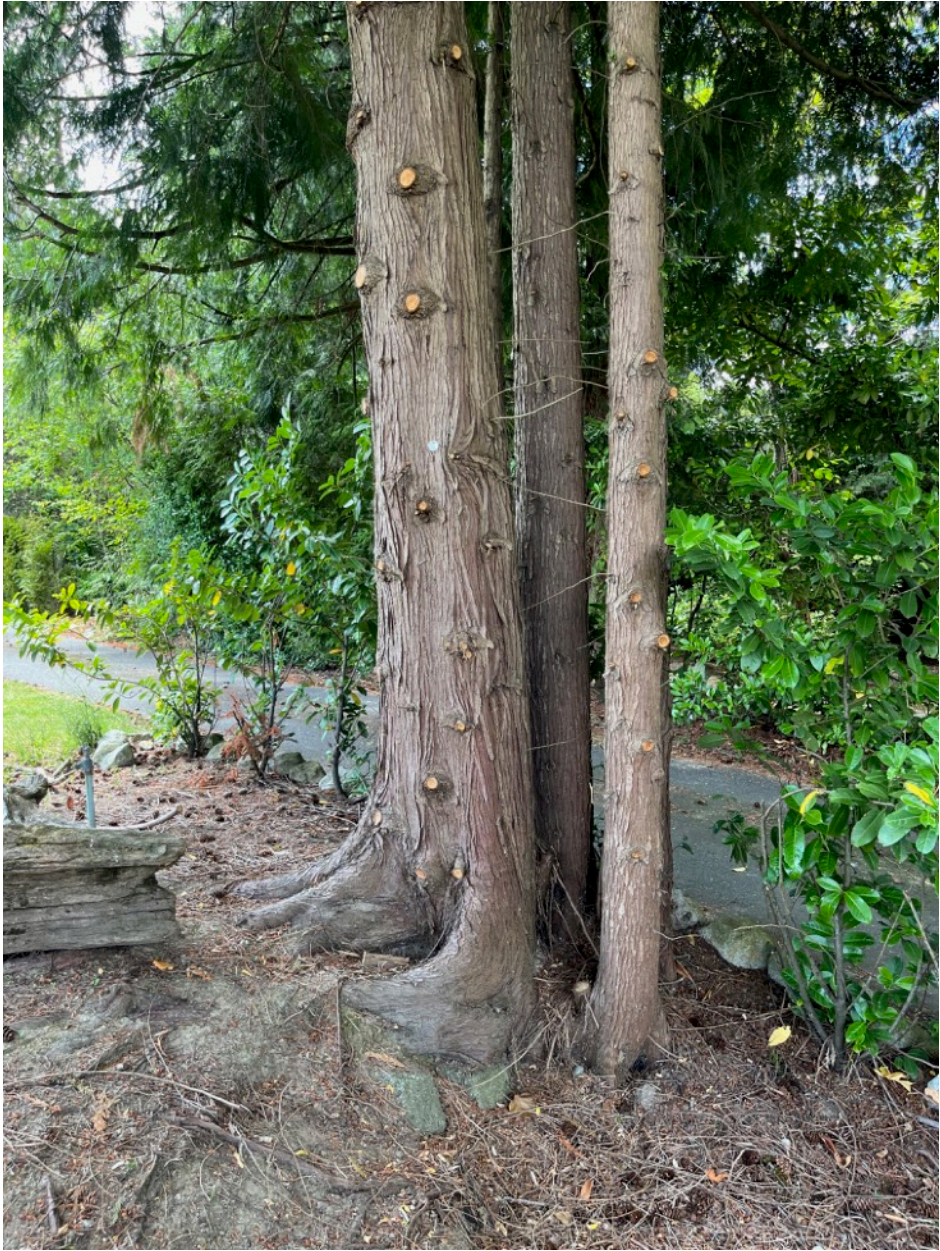
Trunk of Tree 4

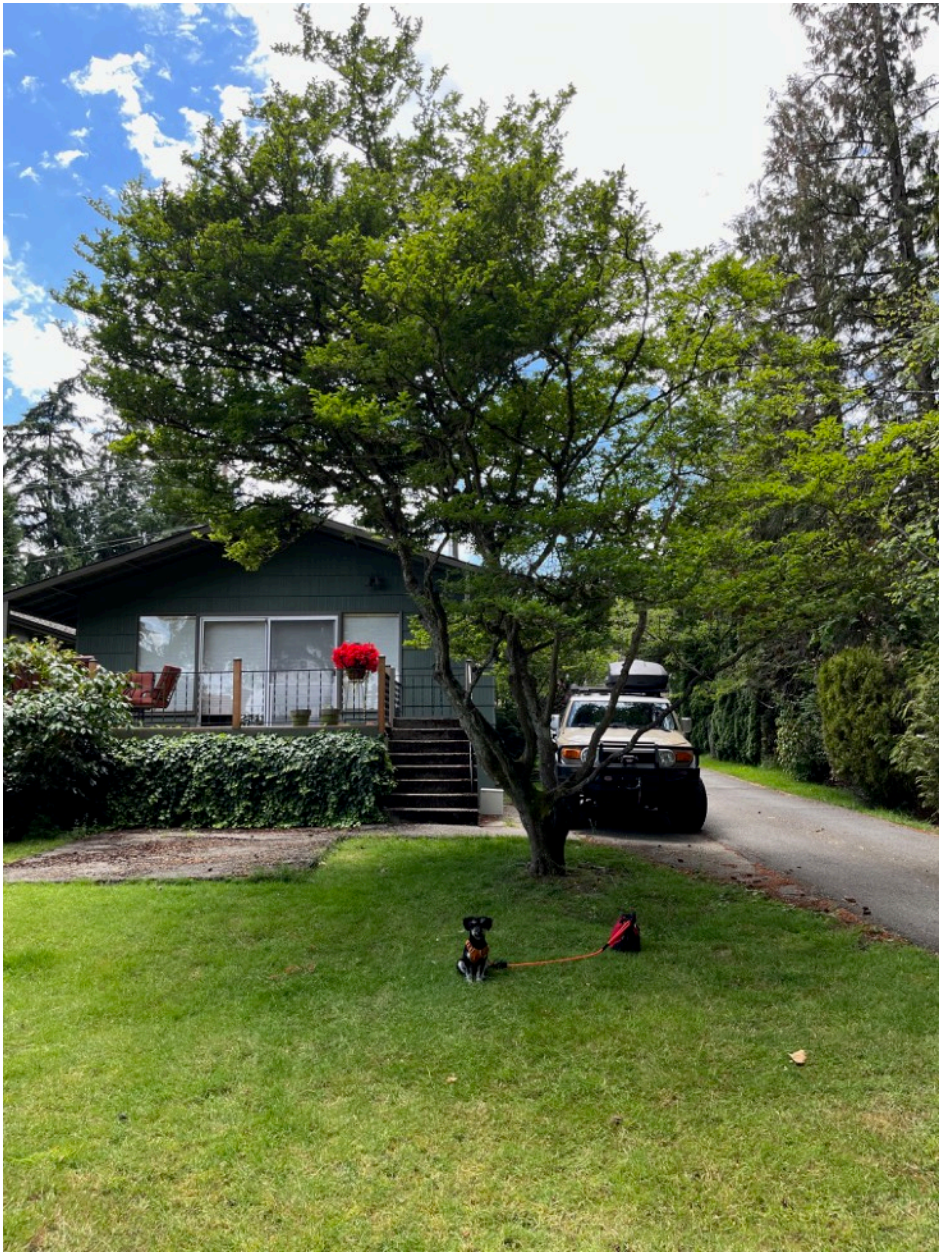
Located to the north of the northwest corner of the existing single-family residence at this address is a Japanese snowdrop tree (*Styrax japonica*) that is in nice condition. It is possible that this tree will need to be removed for the sake of developing the site. Because this tree is not large enough to be considered exceptional in the city of Mercer Island, it should not pose any significant challenges to development. I will be listing this tree as being scheduled to be removed on the spreadsheet and will indicate that it is going to be removed on the required Mercer Island the tree retention worksheet.

Looking east at Tree 5

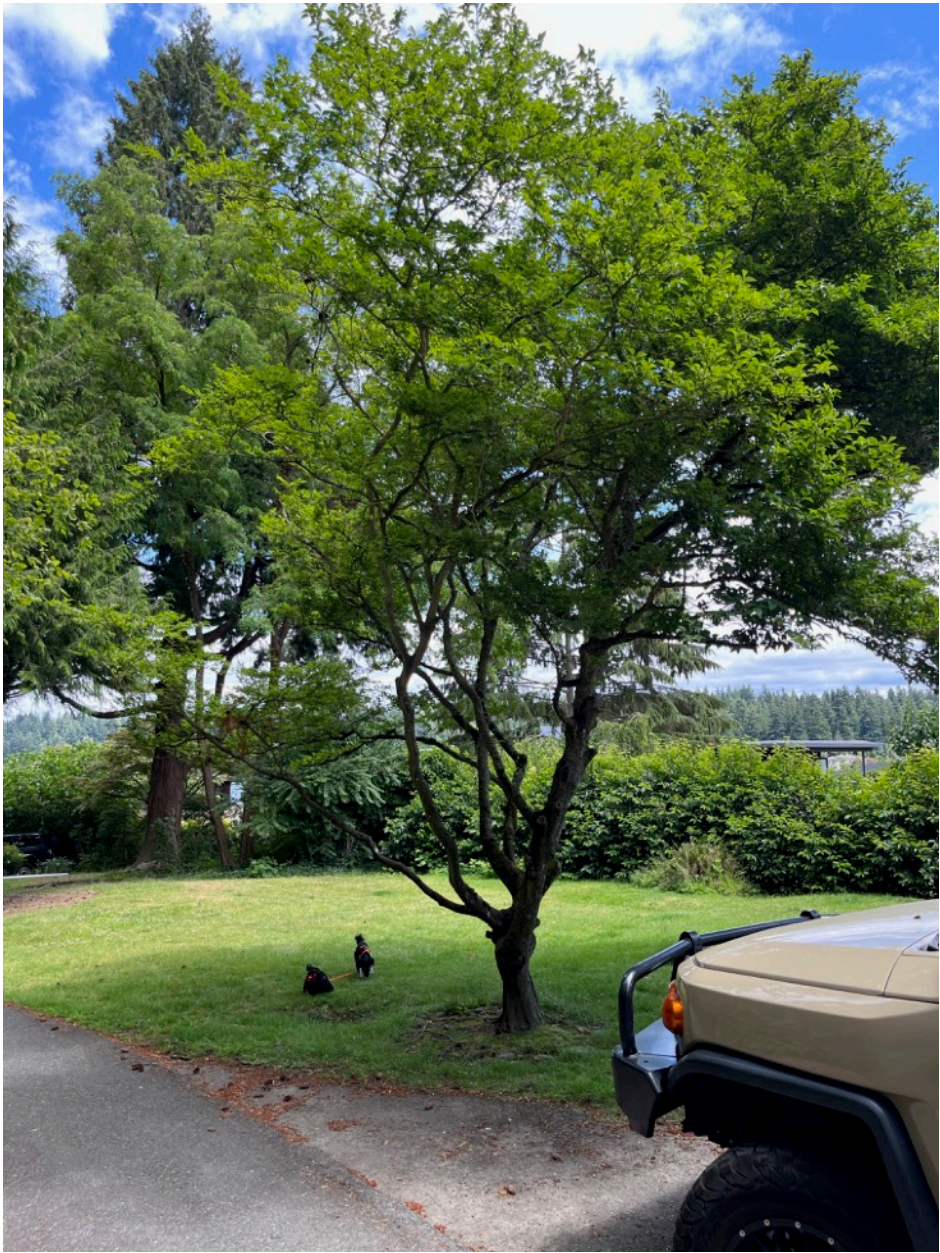
Looking NW at Tree 5

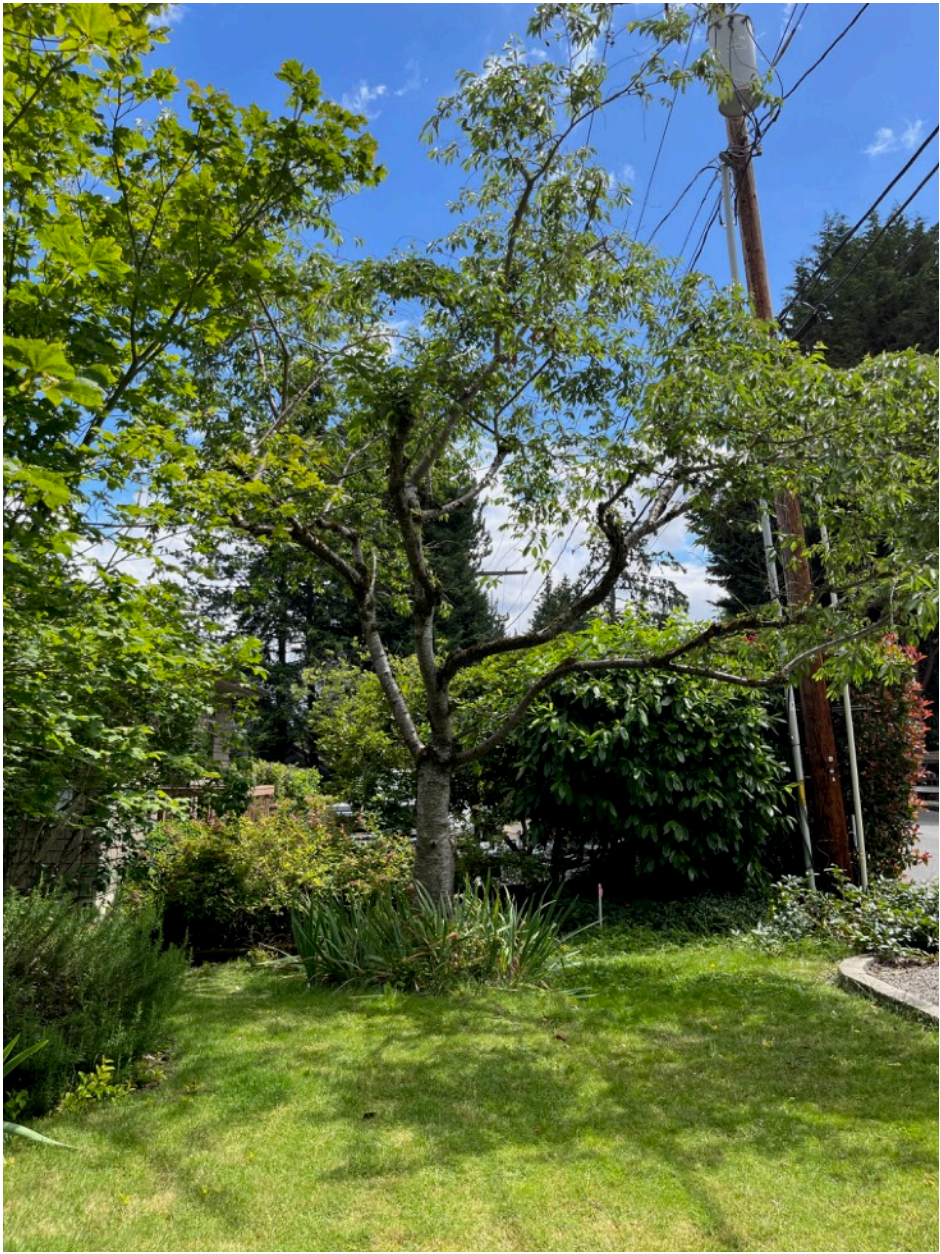
Tree number six is a flowering cherry (*Prunus serrulata*) that is located due south of the southeast corner of the existing single-family residence. This is a fairly young tree that is not large enough to be considered exceptional in the city of Mercer Island. The drip line radius for this tree was averaged from several cardinal points. The client may want to remove this tree to facilitate development and I will list it as a removal on the spreadsheet and the worksheet.

Looking north at Tree 6

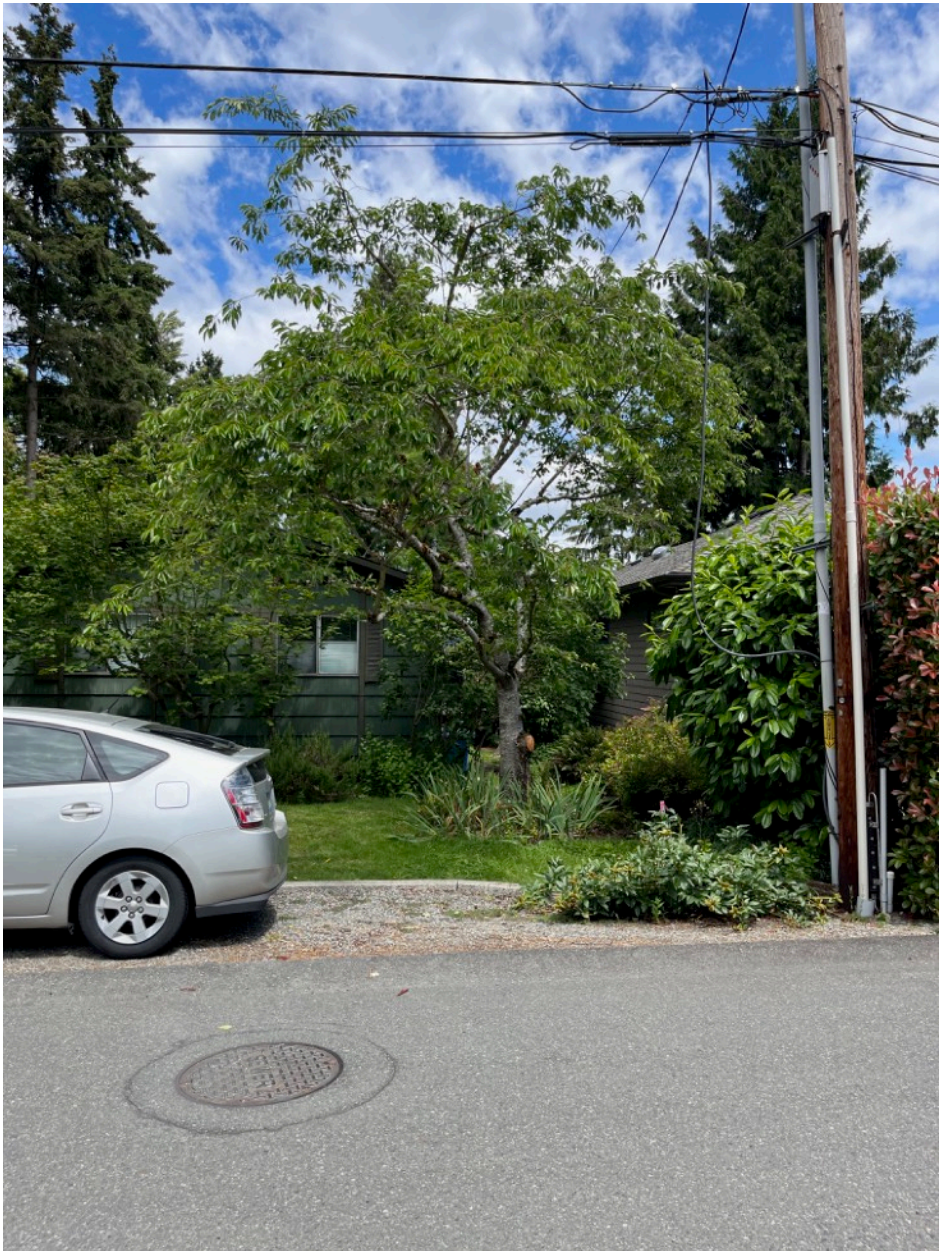
Looking west at Tree 6

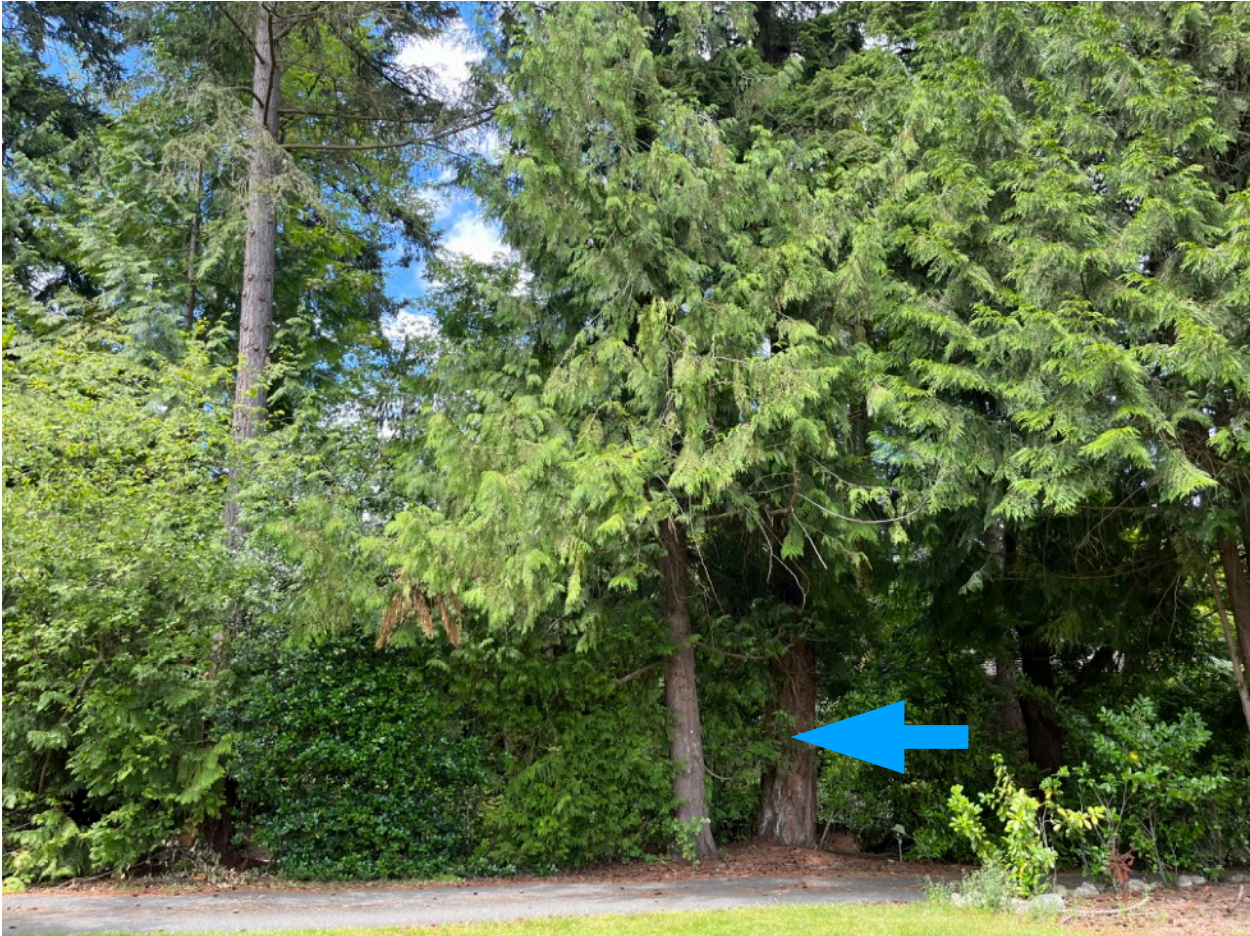
**Looking south at the trees along the driveway
Arrow pointing at Tree 8 (exceptional)**

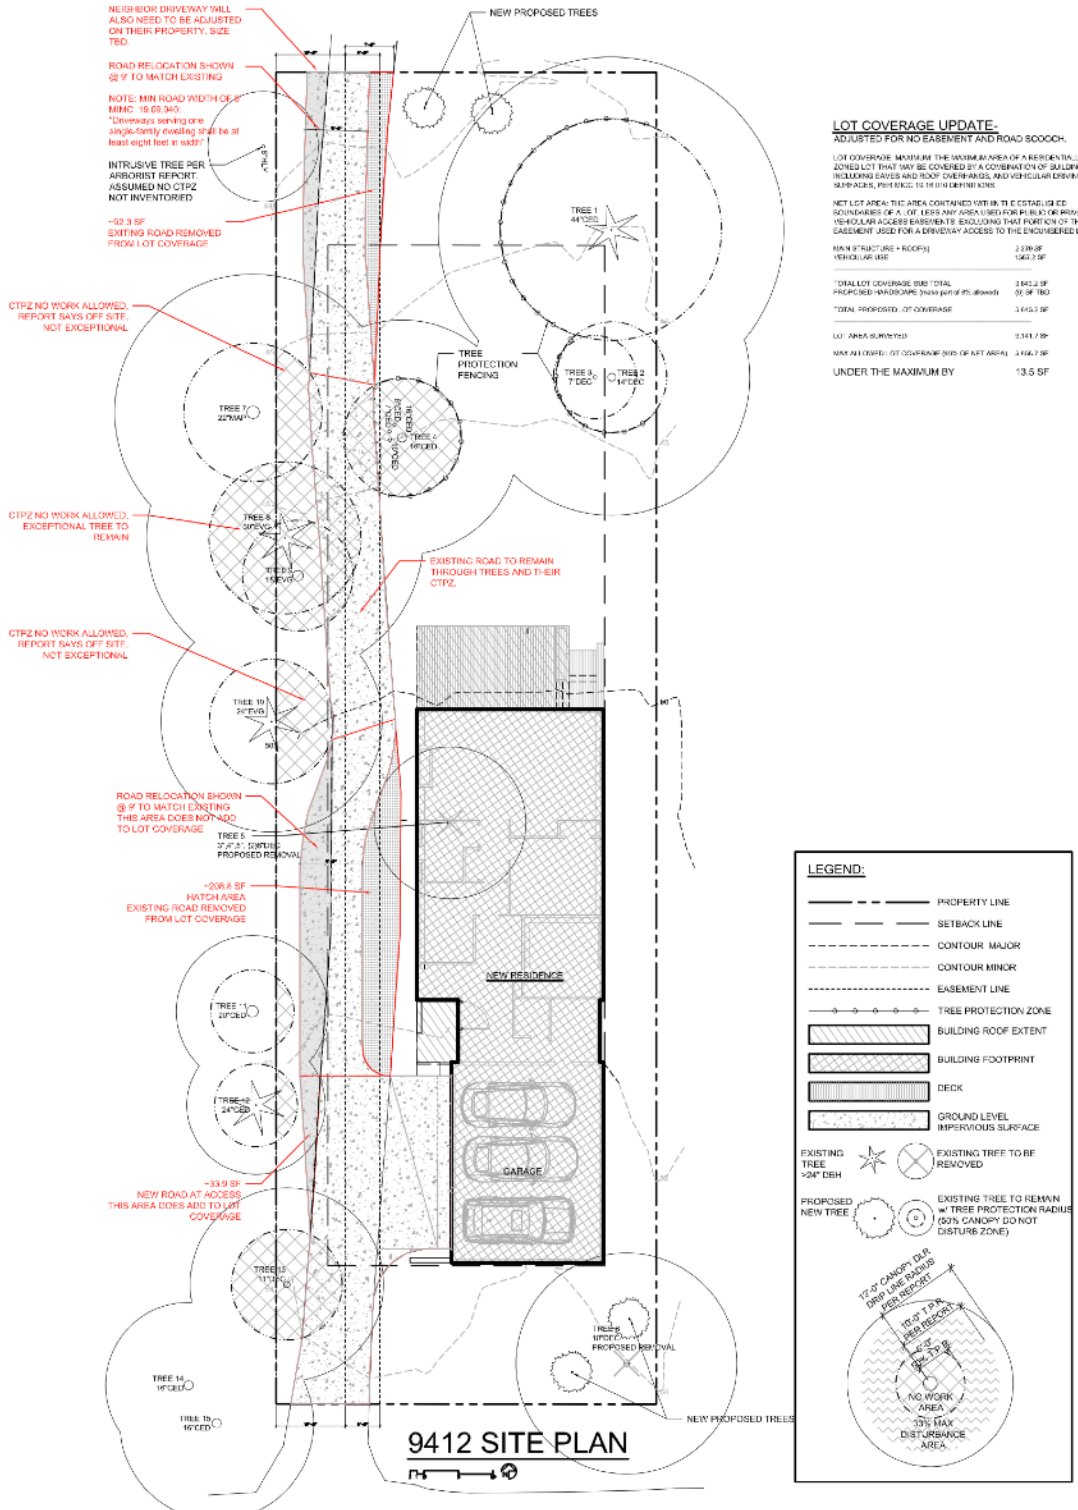
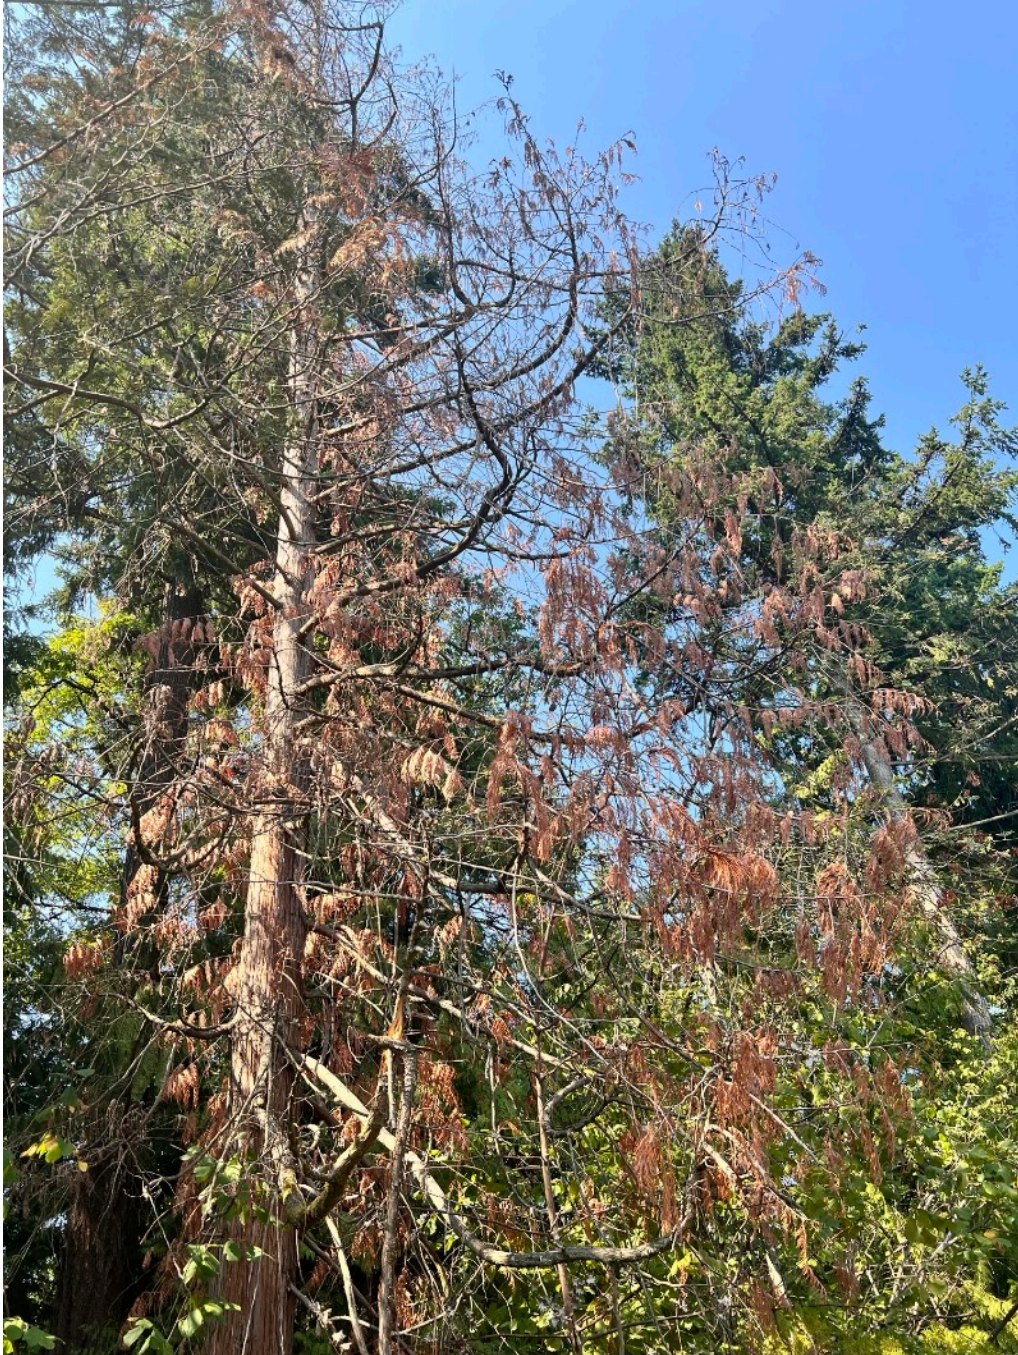
Most current map of the proposed new driveway configuration

- North of Tree #12, shifting the driveway eastward before curving slightly back to the west and reconnecting with the existing alignment.
- These adjustments avoid the inner TPZs of all trees identified for retention.
- The proposed disturbances remain below **35% of the outer TPZ area**, consistent with industry standards for acceptable impacts.

It is my opinion that the proposed driveway modifications will **not adversely affect the health or stability** of any trees on the subject site, nor of trees on the adjacent western property.

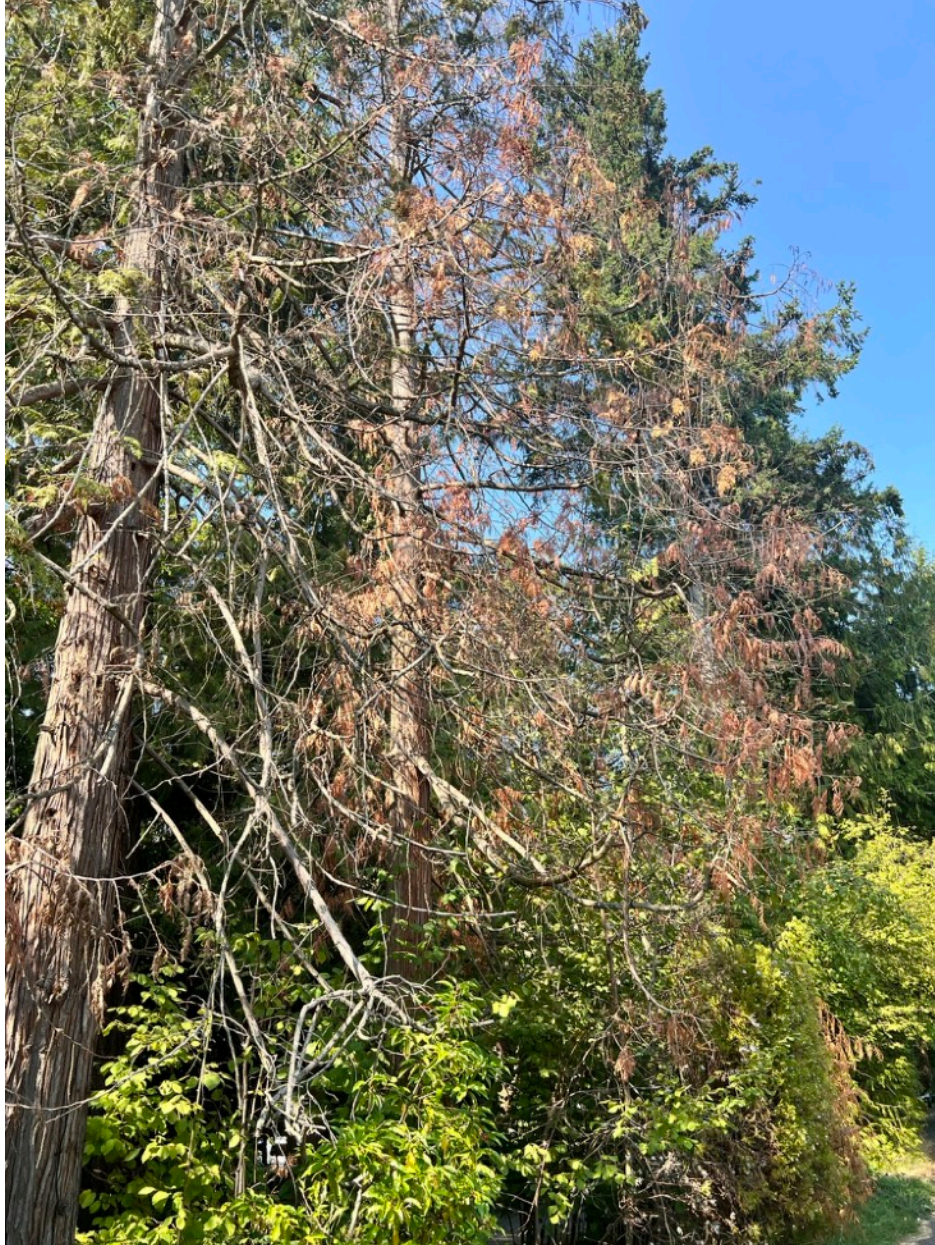
- During the original inventory, both Trees #11 and #12 were assigned a **condition rating of 4** due to sparse canopies and visible stress.
- At that time, both retained some green foliage.
- The client has since reported a steep decline in both trees, and recent photographs (taken September 4, 2025) confirm complete browning and desiccation of foliage, with only minor green tips visible.

While I have not re-inspected these trees in person, the symptoms strongly suggest acute decline, potentially caused by a cambium-boring insect such as a bark beetle.

Tree 11
Photo shared from the client, take 9/4/25

- Both trees should be **removed promptly**, with all material taken off-site to prevent potential insect migration.
- The optimal season for removal is **winter**, when beetles are dormant.
- Their decline appears unrelated to the driveway modifications.

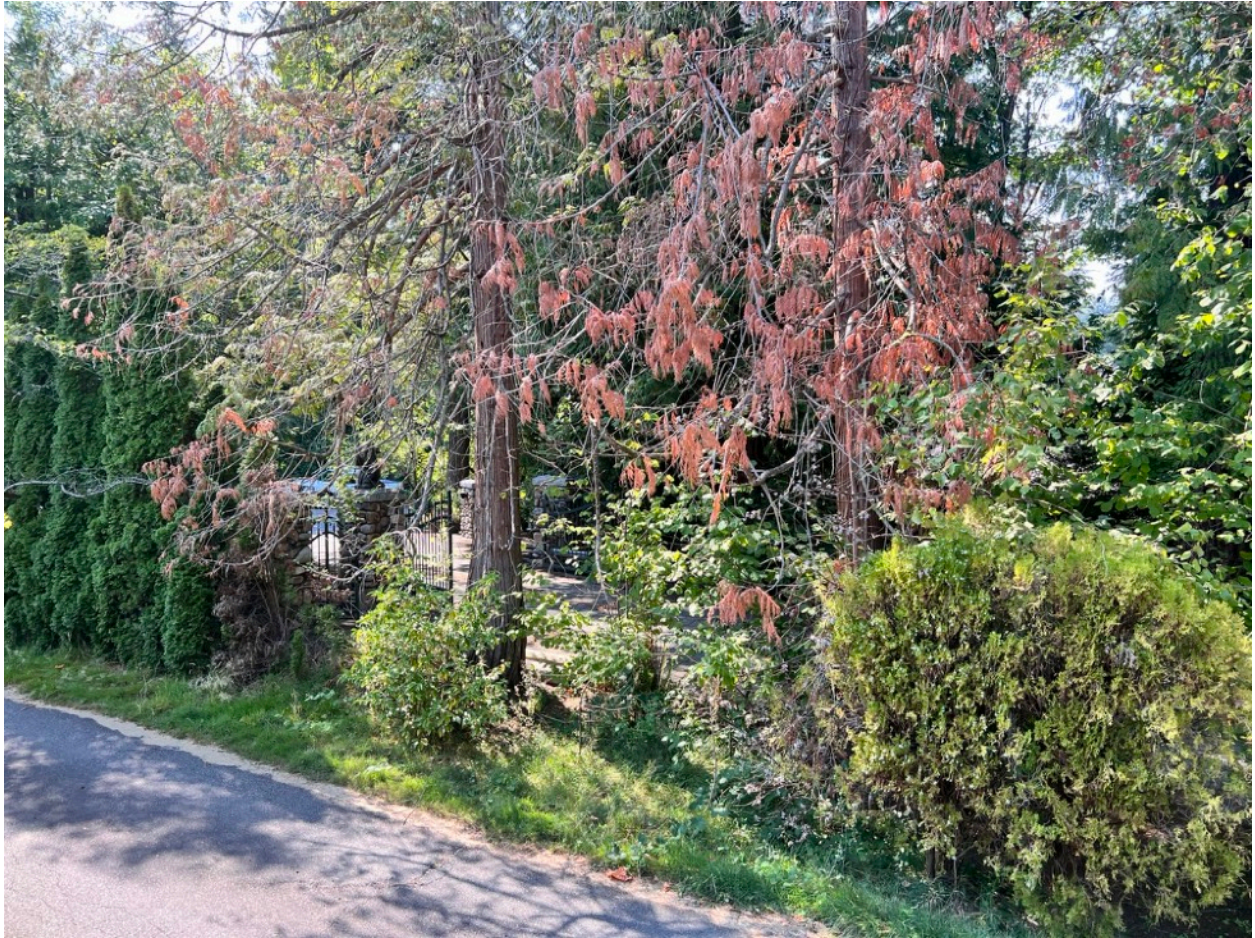
Tree 11 (right) and 12 (left)
Photo shared from the client, take 9/4/25
