## Arborist Report

To: SRS Architecture c/o Bryan Samuel  
Site: 8621 SE 63rd St, Mercer Island, WA 98040  
Re: Tree Inventory and Assessment  
Date: May 12, 2025  
Project Arborist: Julian Garcia  
ISA Certified Arborist PN-9969A  
Reviewed By: Connor McDermott-Grossman  
ISA Certified Arborist PN-8704A  
ISA Qualified Tree Risk Assessor  
Referenced Documents: Site Survey (Terrane dated 12.17.2024)  
Conceptual Design Plans ("Mercer Modern", SRS dated 01.31.2025)  
Attached: Table of Trees  
Tree Site Map

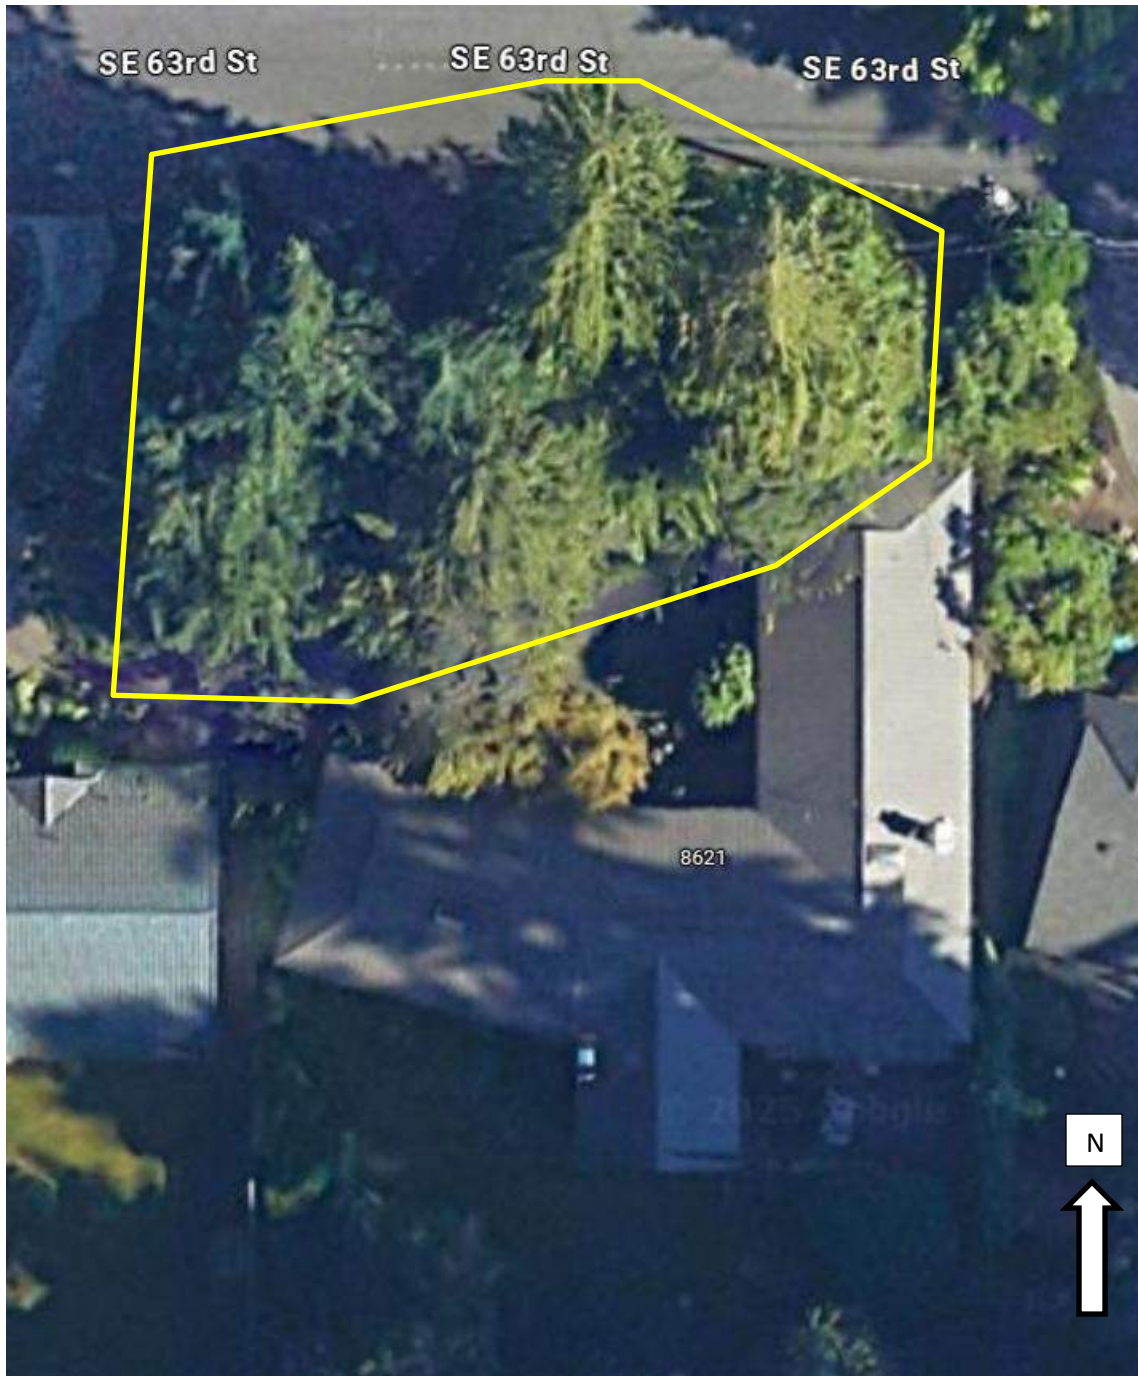
One tree grove consisting of eight trees with diameters of 10 inches or greater was observed (see Appendix C). The trees within this grove are considered exceptional trees and should be prioritized for retention pursuant to MICC 19.10.060.A.2(b).

**Figure 1.** Tree grove located north of existing house (Google Maps accessed on 02.20.2025)

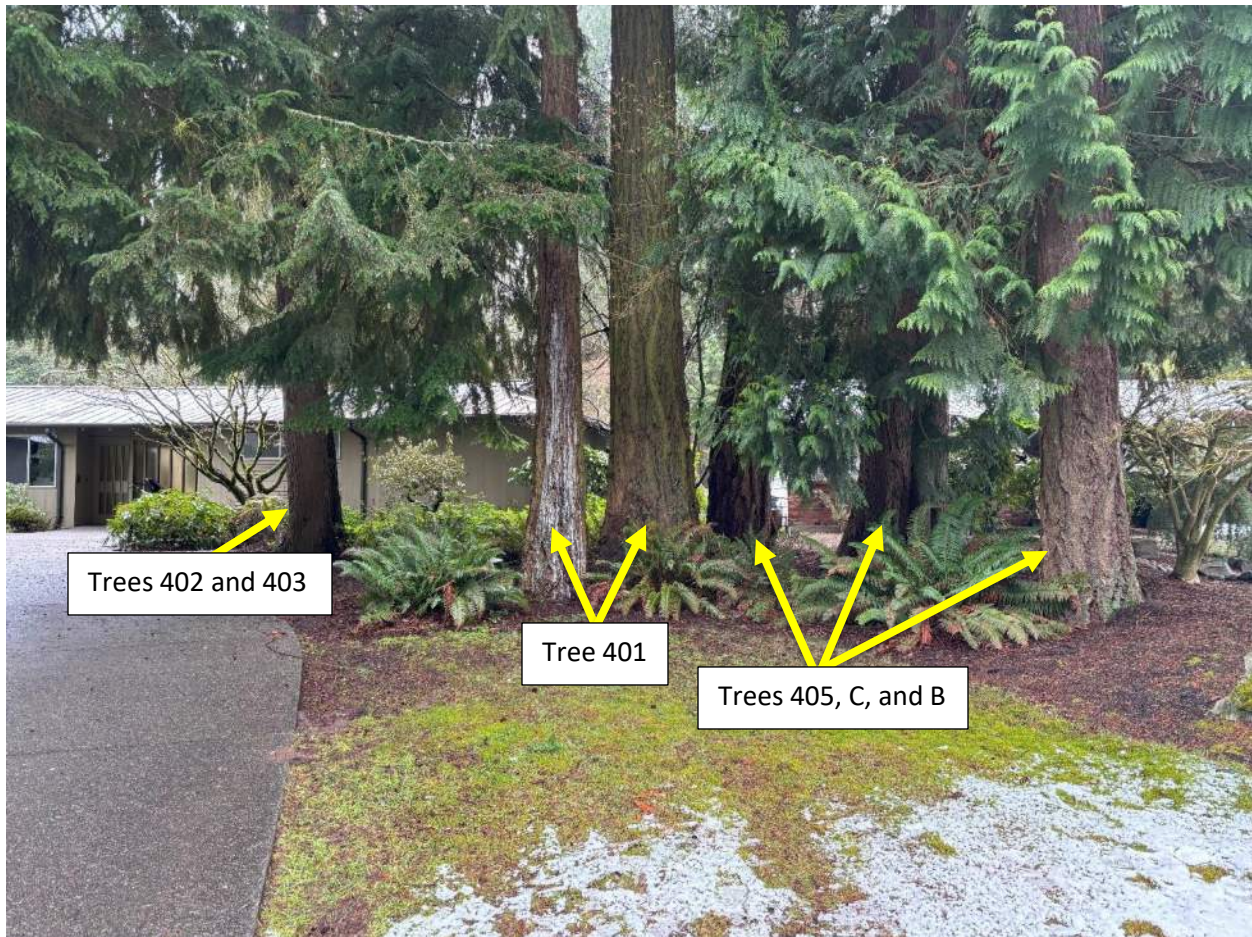
**Photograph 1.** As seen from the north, trees 402 and 403, to be removed, and trees 401, 405, B, and C, to be retained along the new driveway to the garage extension. Retained trees should be protected together as a group with tree protection fencing.

Trees 401, 405, 406, B, and C are located adjacent to the existing driveway and may be impacted by the proposed driveway connecting to the new garage.<sup>1</sup> I recommend that tree protection fencing be installed at the edges of the existing driveway and moved to outside the RLODs once the driveway is demolished. These five trees may be protected with fencing as a group including the landscaping beds and lawns included in their RLODs (see Appendix D).

The existing driveway should be kept in place for as long as possible and should be demolished carefully to avoid damaging tree roots that extend beneath the existing slabs. Construction equipment should work from closest to the house backwards, always operating on paved surfaces. Other acceptable methods of soil protection include applying 3/4-inch plywood over 4-6 inches of wood chip mulch or use of AlturnaMats® (see Appendix G). No regrading should take place, and I recommend having an arborist on-site to monitor driveway demolition since it is within the MLODs of trees 401, 408, and 409.

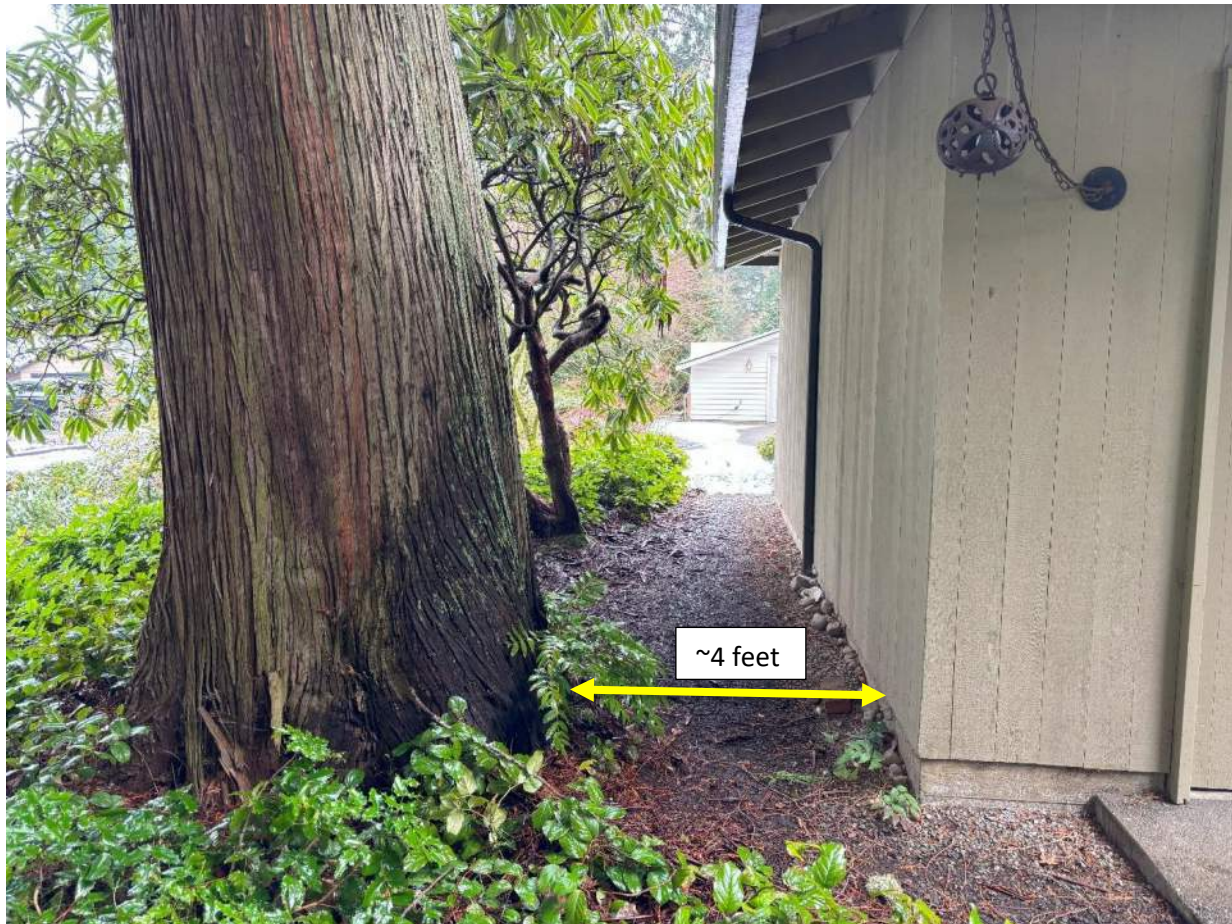
Trees 408 and 409 are two healthy exceptional western redcedars located just north/northwest of the existing garage in the eastern section of the house. Both had full canopies and sound structural conditions and are excellent candidates for retention. The base of tree 409 is approximately four feet from the existing garage's foundation (see Appendix D ).

**Photograph 2.** Tree 408, shown above, is proposed for retention and is located approximately four feet from the existing garage's foundation. In order to retain, no disturbance should occur within its MLOD as western redcedars are particularly vulnerable to excavation and compaction.

Trees 408 and 409 are located northwest and north, respectively, of the existing garage. In my professional experience western redcedars are particularly vulnerable to excavation and compaction. I recommend that tree protection fencing be installed outside the RLODs and at the edges of the existing driveway. If the existing driveway is to be used for construction access, I recommend that it remains in

place during initial phases of the project and demolished later in the project. This will help to reduce overall compaction and damage to any potential surface roots.

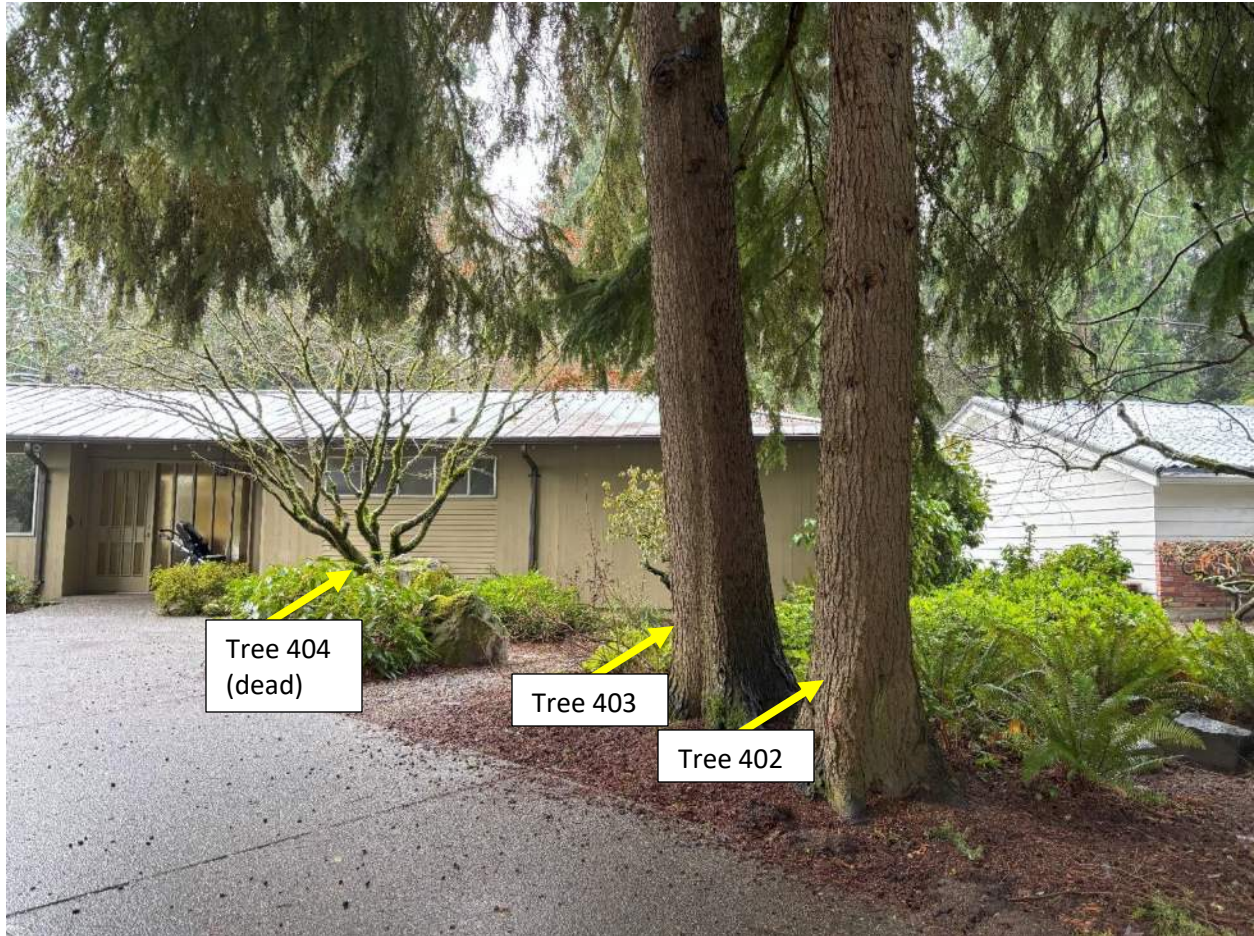
Trees 402 and 403 are two healthy exceptional western hemlocks that are proposed for removal. They are located just west of the existing driveway and north of the house. I believe it would be difficult to retain the trees due to the proposed locations of the new driveway and garage extension, which would be within feet of their trunks. Tree 404 is a fairly healthy regulated Japanese maple that is located within the footprint of the new garage and will thus need to be removed.

**Photograph 3.** As seen from the north, trees to be removed due to their conflict with the footprint of the garage extension and new driveway.

The stumps of trees 402 and 403 should be ground or be cut to grade and left to decay because they are within the MLOD of tree 401. This will avoid collateral damage to adjacent root systems of retained trees caused by pulling the stump out with an excavator. If the stumps must be removed entirely for the new driveway, then alternative methods such as stump grinding, severing with a flat front bucket, or hydro-excavation and cutting the roots should be used to expose and sever roots before the stumps are removed (see Appendix G .

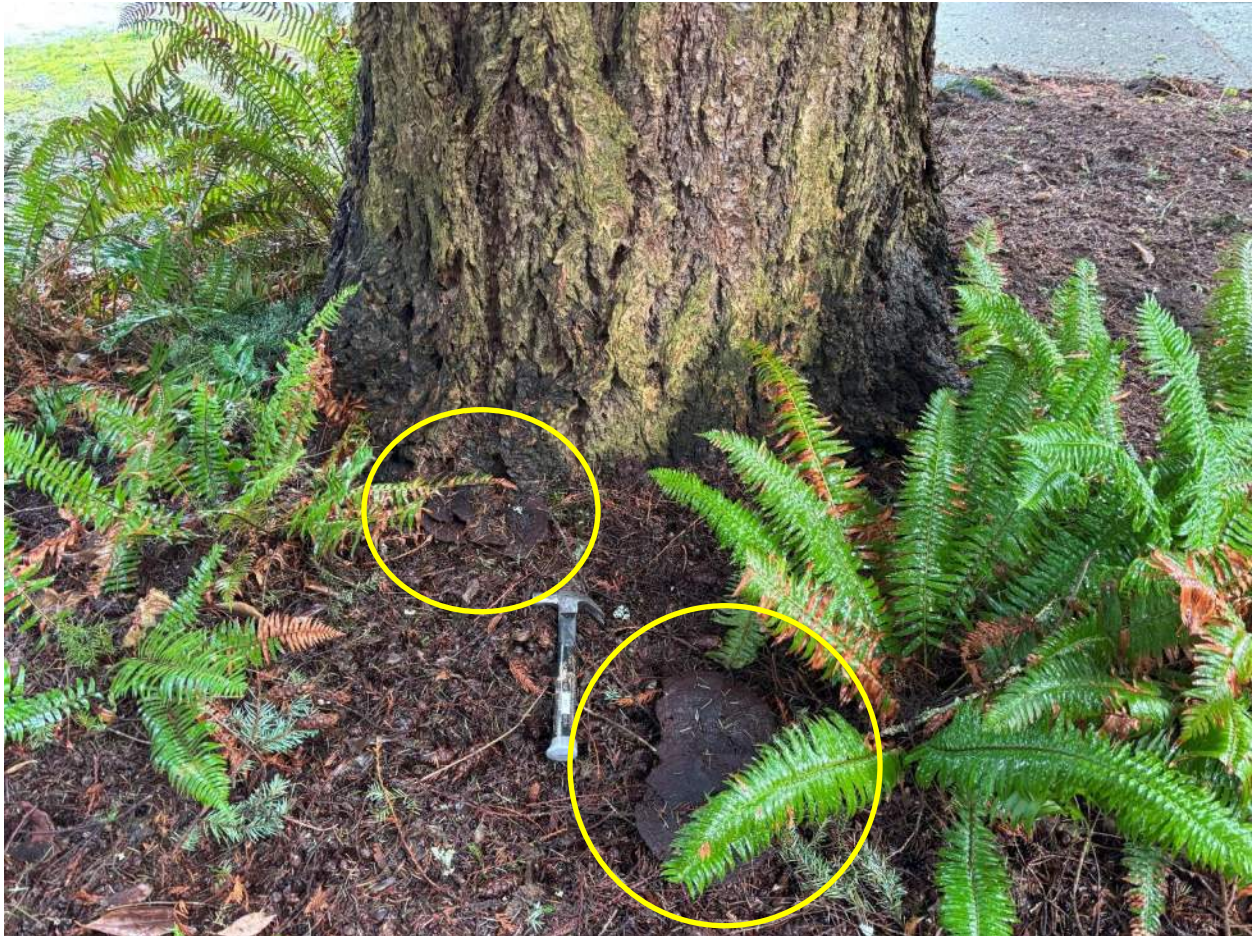
Trees 401 and 405 are two Douglas-firs in good health condition located near the northwestern property line and located within the existing tree grove. I observed two dyer's polypore (*Phaeolus schweinitzii*) fruiting bodies near the base of tree 401. Dyer's polypore is a wood decay fungi that can impact the structure of the wood (see Appendix D ). I recommend conducting an advanced assessment using a microresistance drill to determine the extent of decay.

**Photograph 4.** *P. schweinitzii* fruiting bodies, circled above, observed south/southwest of the base of tree 401. If the tree is retained, I recommend an advanced assessment by microresistance drill to test for sound wood.
