Addendum

To: SRS Architecture
Site: 86212 SE 63rd St, Mercer Island, WA 98040
Re: Tree Inventory and Assessment
Date: May 5, 2025
Project Arborists: Julian Garcia
ISA Certified Arborist PN-9969A

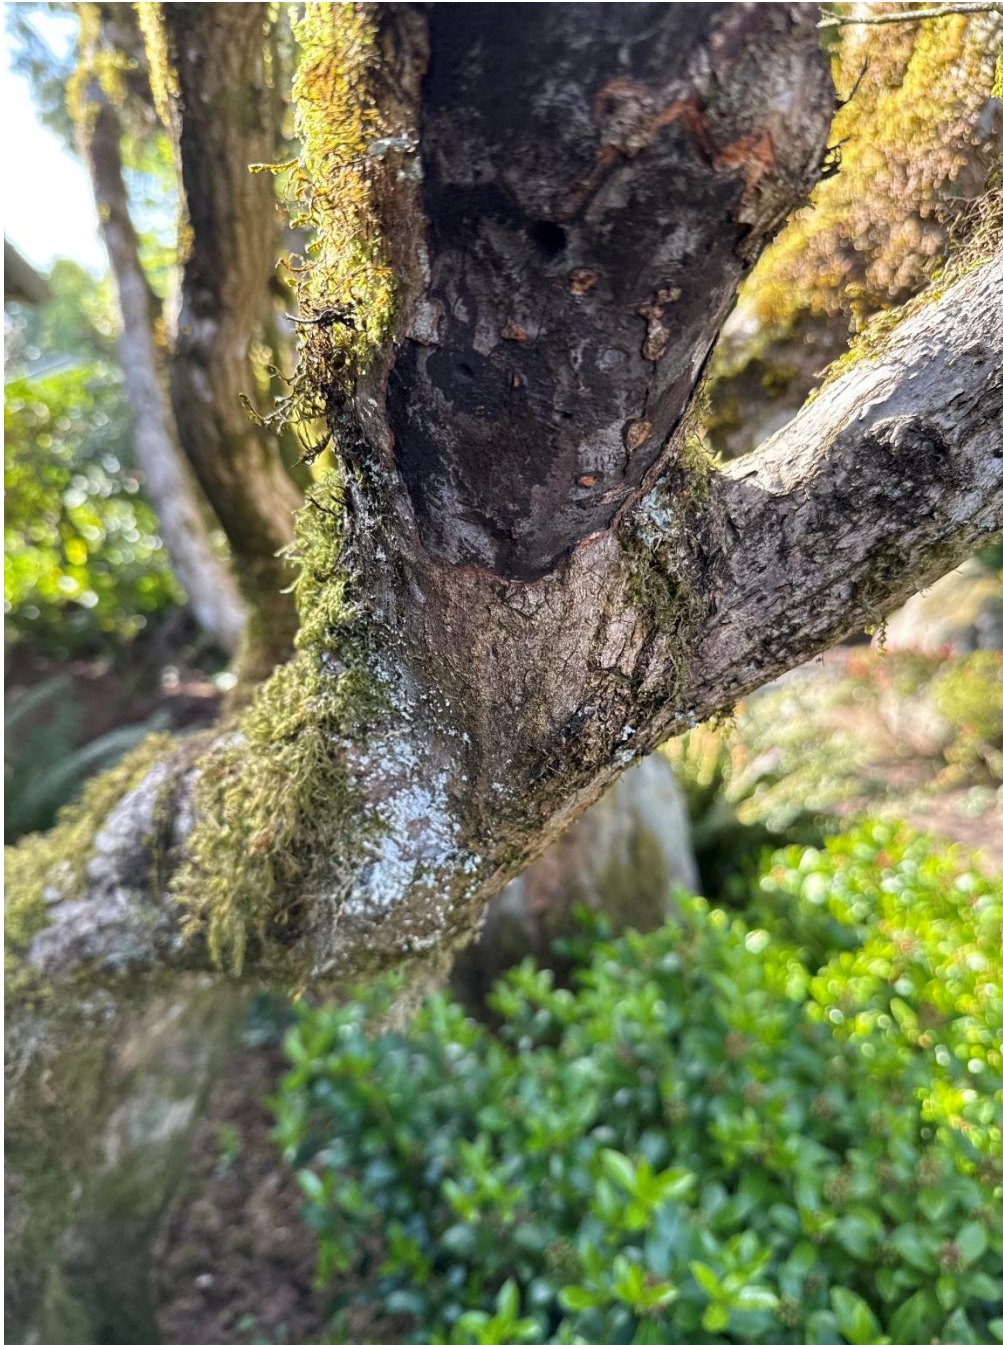
This addendum to the arborist report dated February 28, 2025 addresses that tree 404 (*Acer palmatum*) is dead. No new live leaf buds sprouted this spring and the client confirmed that it died utilizing a scratch test on the trunk's bark and breaking smaller twigs (see photos below).

Photo 1. A view of tree 404 showing decay and dieback on the trunk.

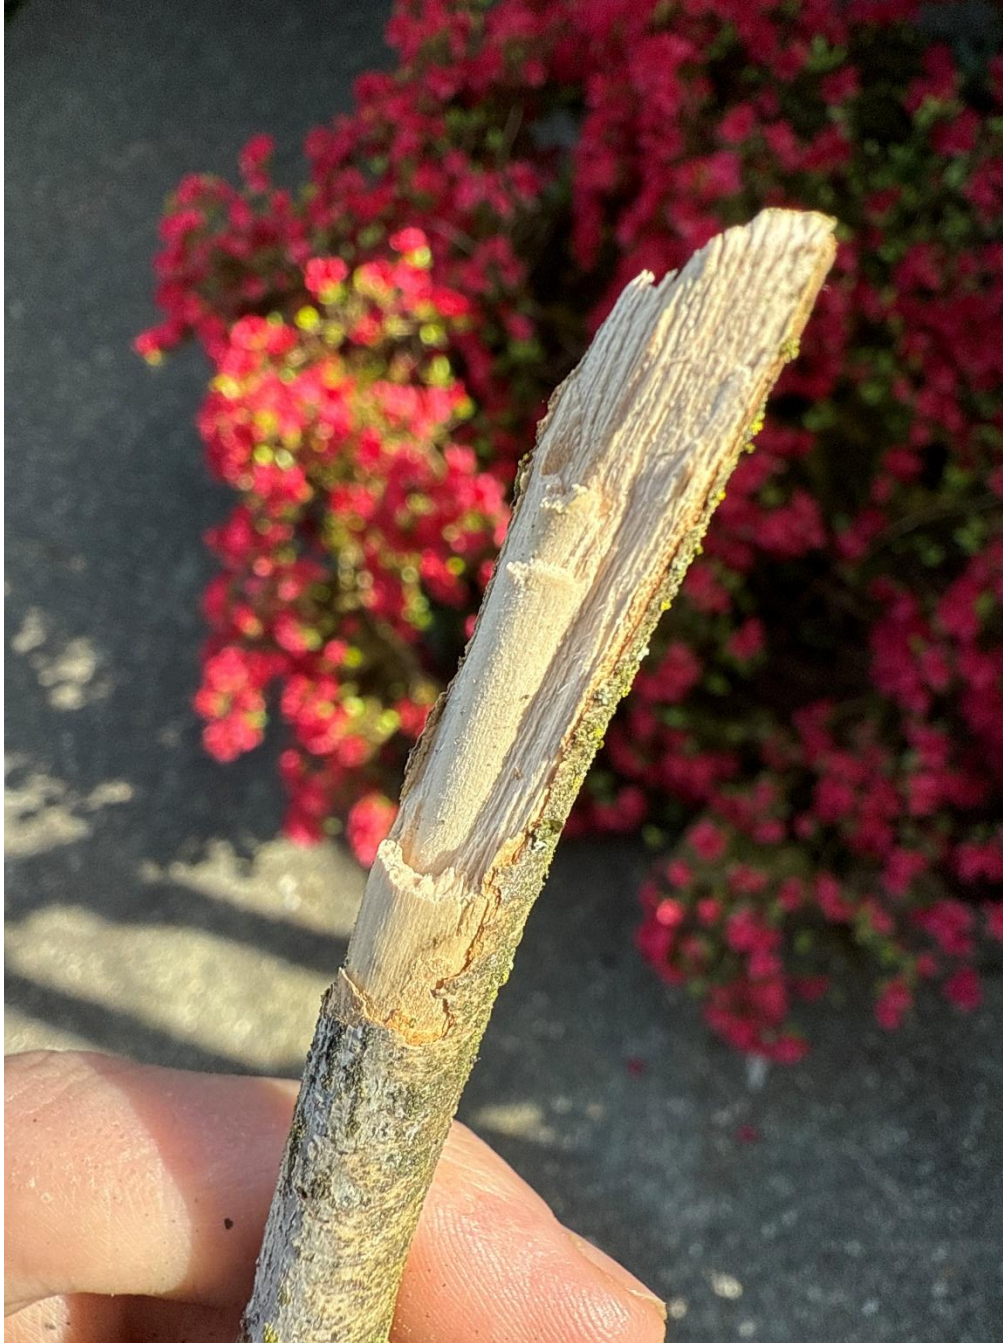
Photo 2. A twig broken off tree 404 with no live cambium layer present.

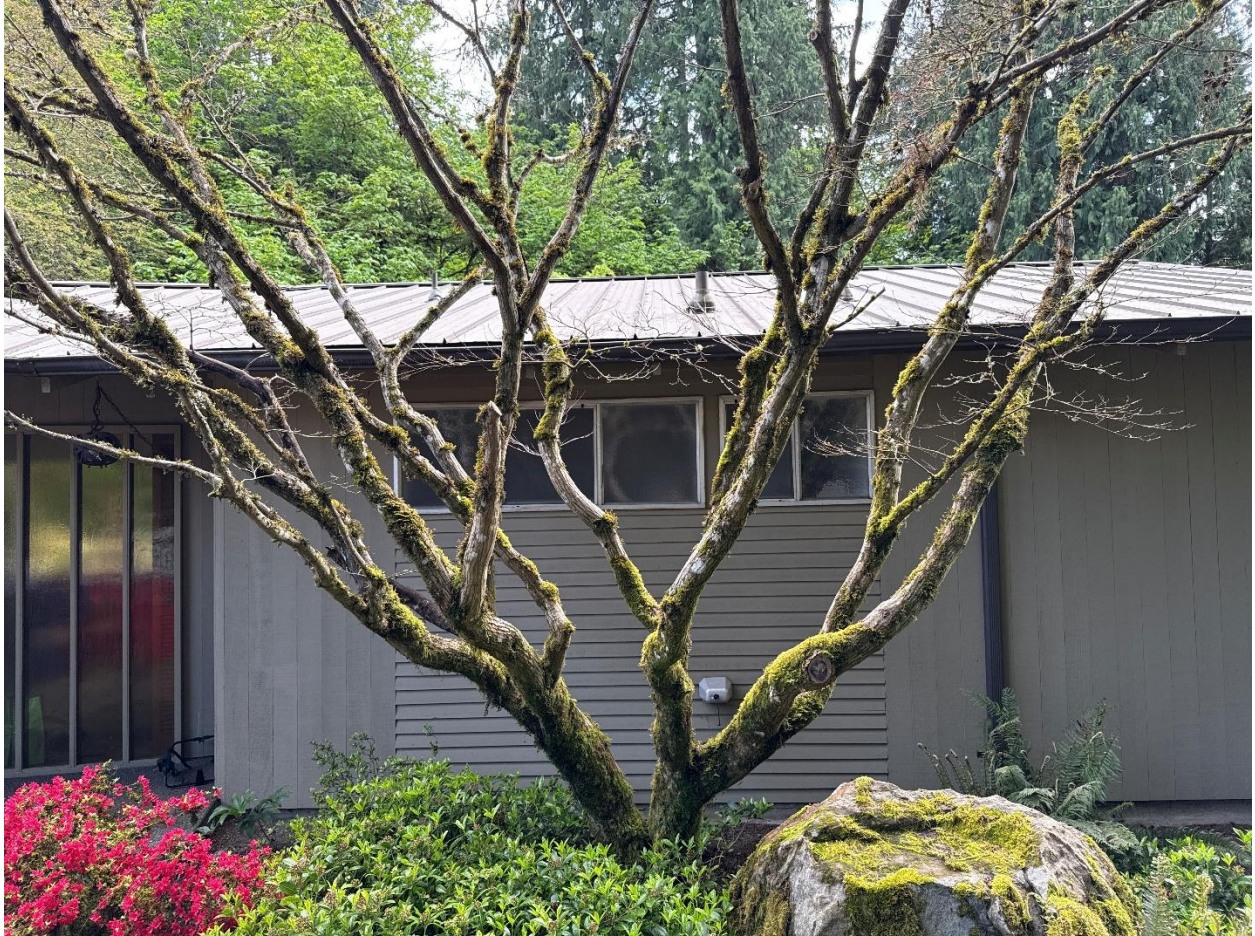
Photo 3. Tree 404 with no living canopy in April 2025.
