David Yusen
Mercer Island project

Pre-construction Arborist Report

Address: 3246 72nd PI SE, Mercer Island, WA

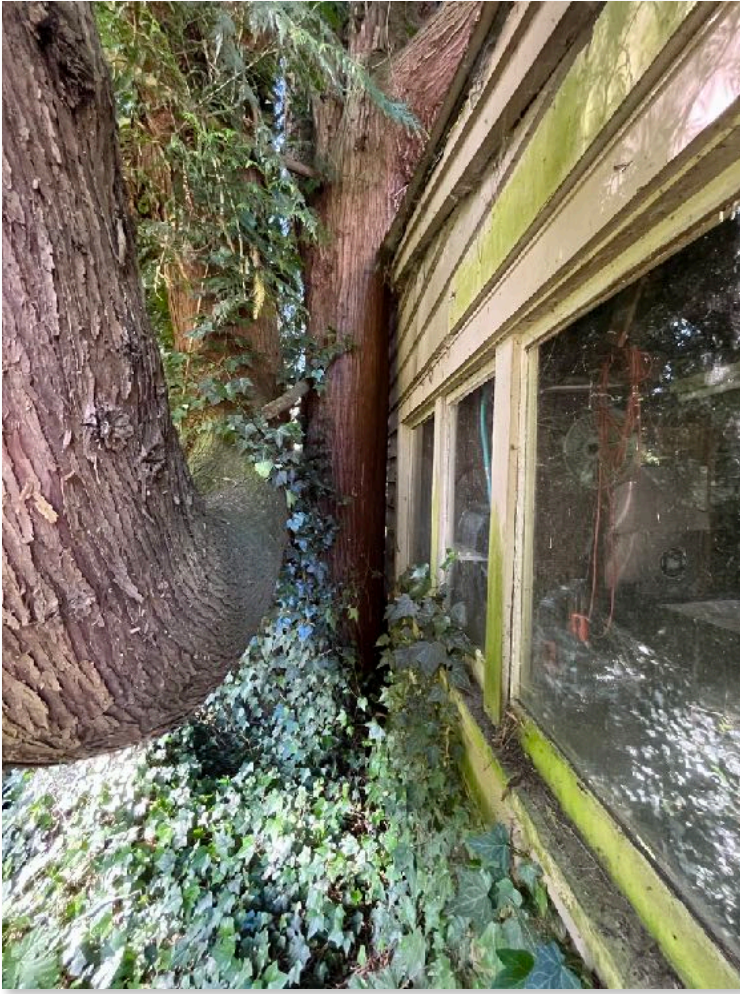
Right: Lilac (in front of garage) is not regulated and can be removed. Below: Cedar 5067 seen behind the garage could be designated a hazard tree due to the fact that it touches the structure of the garage. Remove.

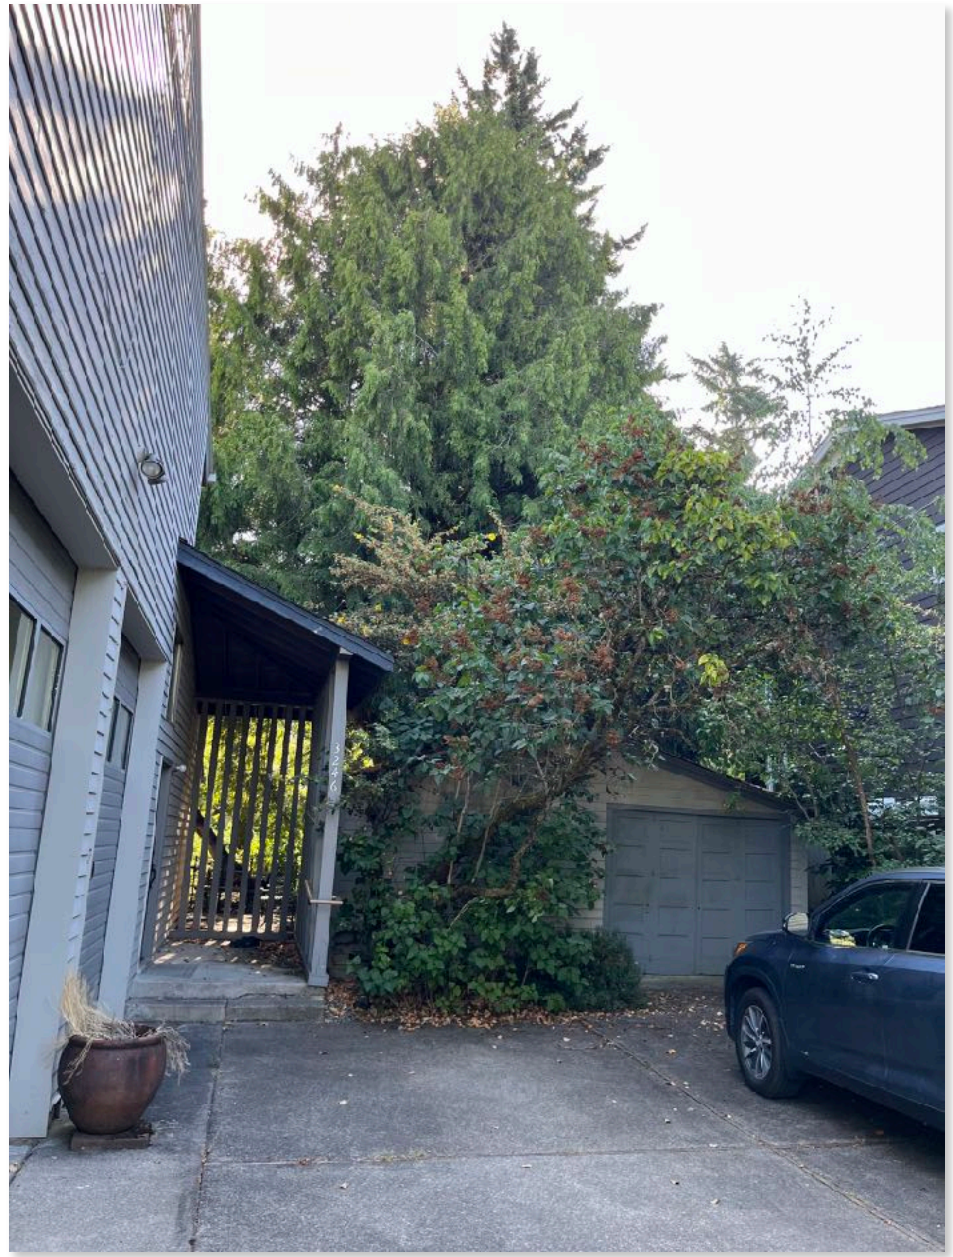
- **Tree #5067** – Western Red Cedar (landmark): This tree is located behind and in contact with the garage. It was previously topped and has large, sweeping branches resembling a pitchfork form. If removal is preferred, it can be considered a hazard tree due to proximity to the existing garage. A tree risk assessment will be required and we can provide that for you.

2 Exceptional = 5067, 5085 = 12 planted trees required.

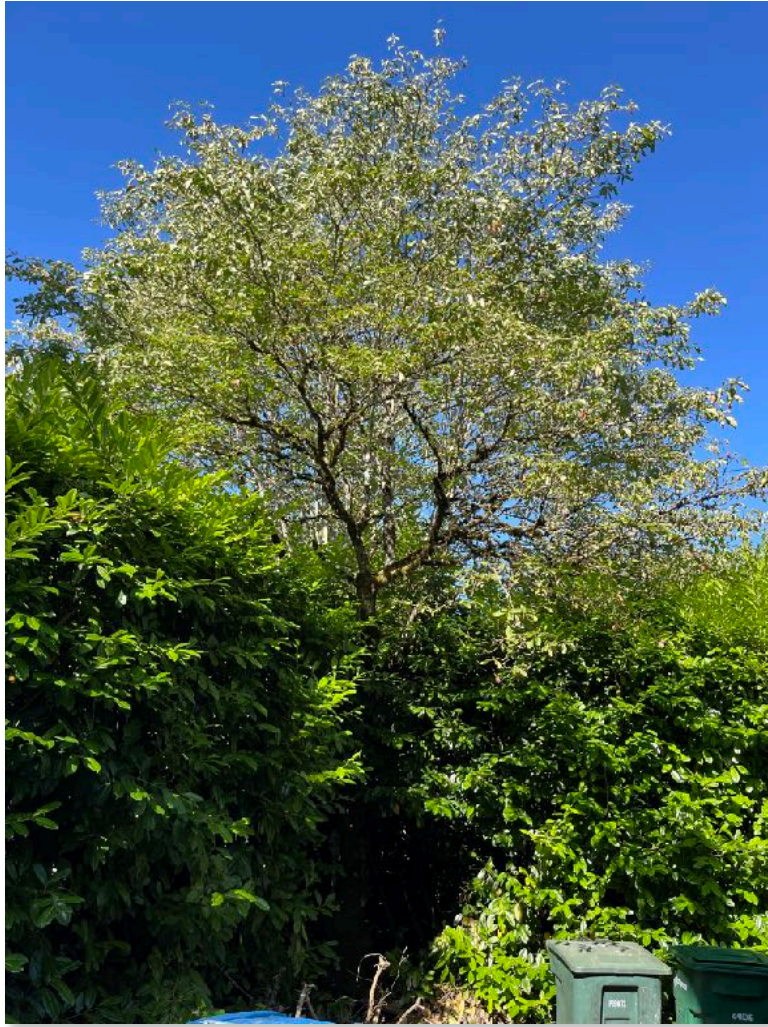
- Tree #5066 – Black Hawthorn (right side of driveway): In good condition. This native species should be retained if possible. While this tree is 6-10"

Right: Hawthorn 5066. Retain.

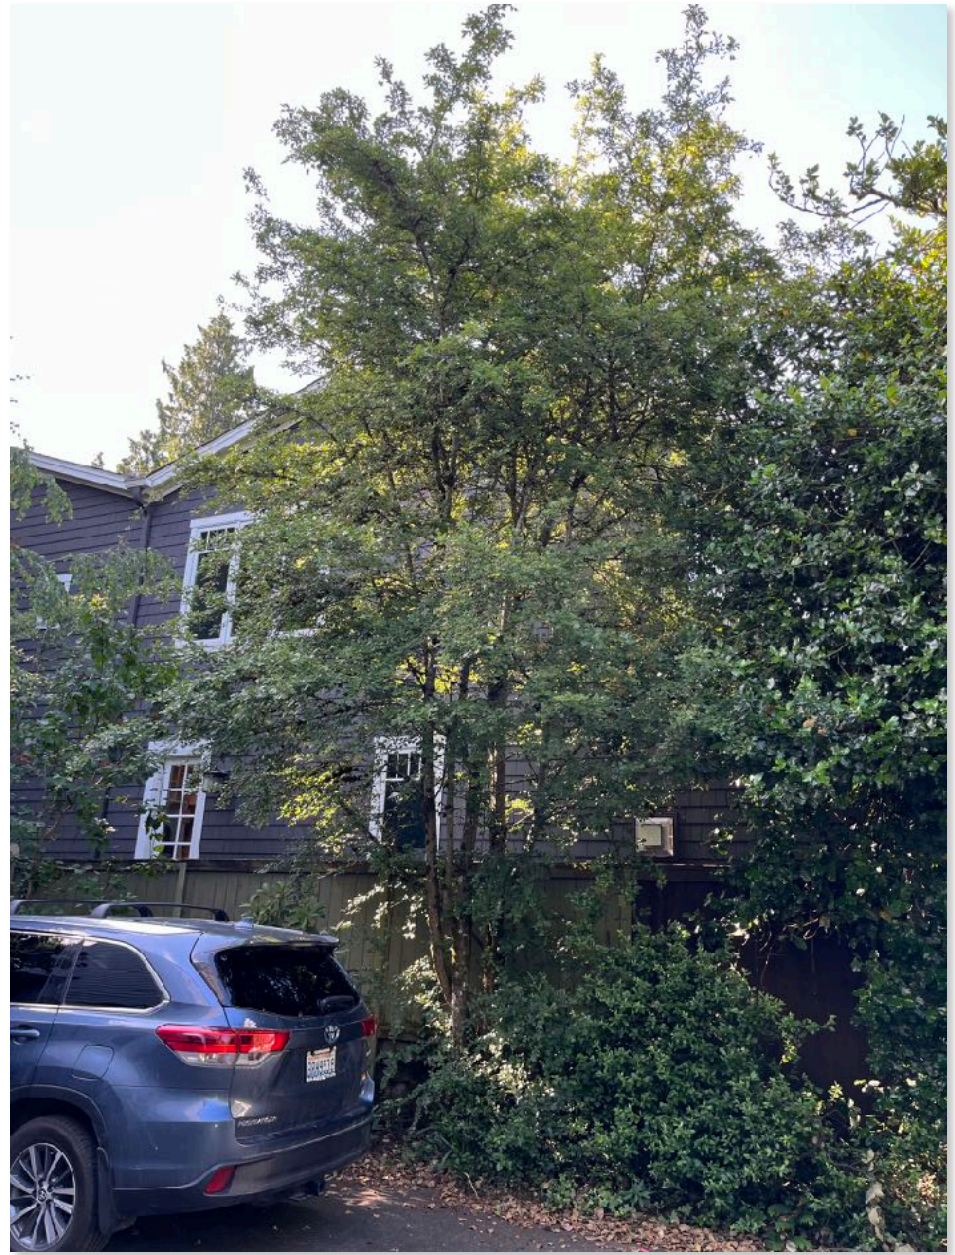
Below: Dogwood 5085 surrounded by laurel hedge. Remove.

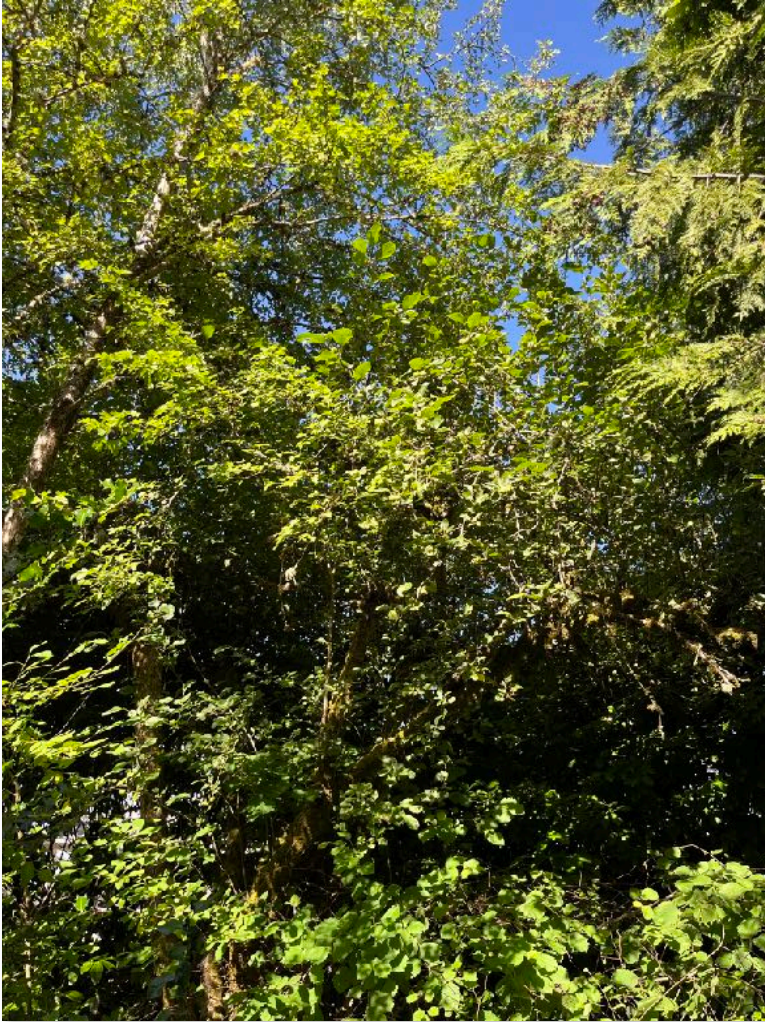
Right: Hawthorn 5084. Retain.
Below: Crabapple 5083. Retain.

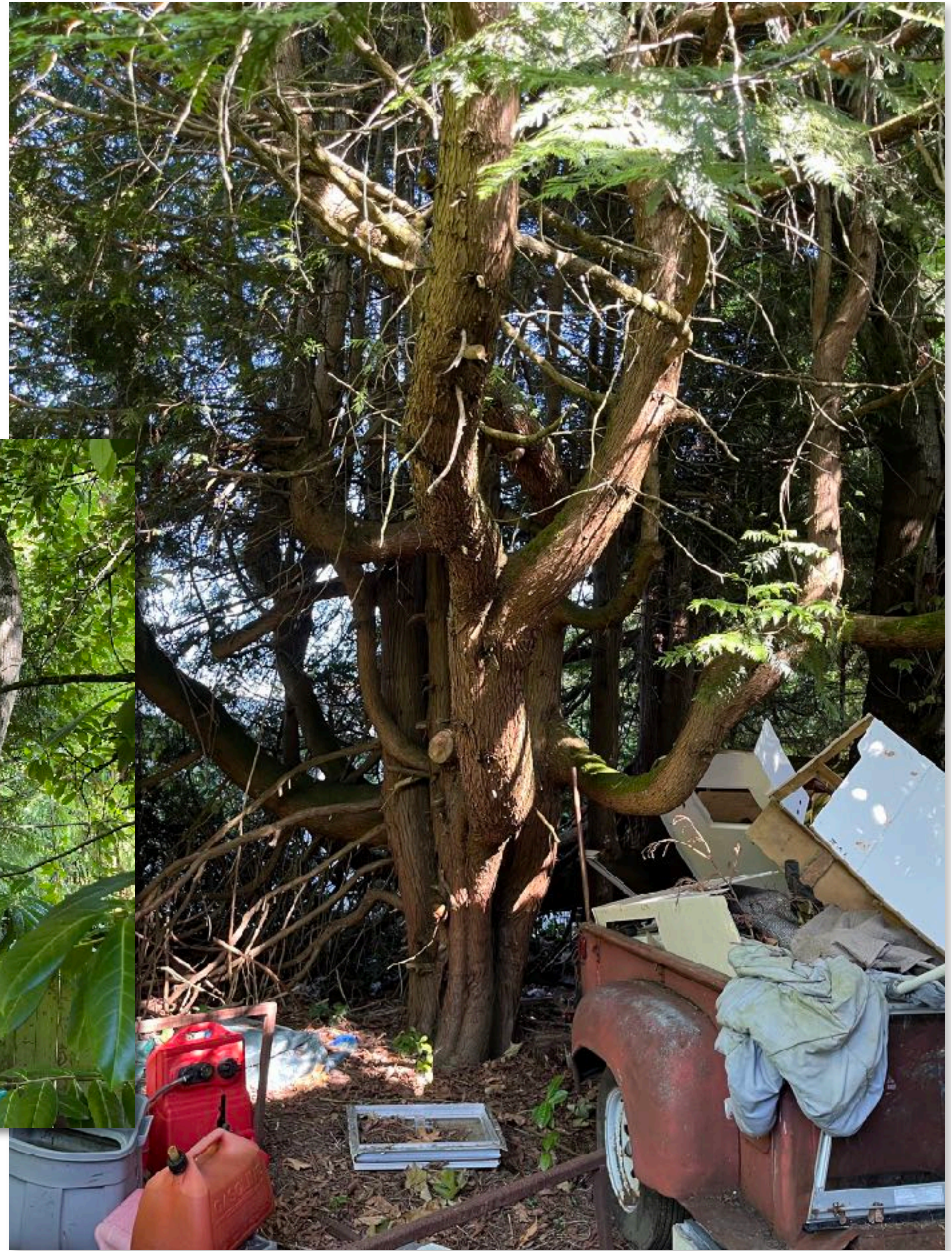
- Tree #5081 – Big leaf Maple: Appears healthy with a single trunk but unusual lower branching that should be monitored.
- **Trees #5079, 80, 82** – Western Red Cedar (multi-stemmed): Forms a pitchfork structure at ~4-7 feet and appear to have been topped multiple times. The trees have **poor structure** and are impacted by **overhead utility lines** at ~15 feet. **All trees in this corner have been topped**, except the maple.

Right: Cedar 5082 has been topped. Retain
Below: Cedar and maple group in NW corner 5079-5082 Retain.

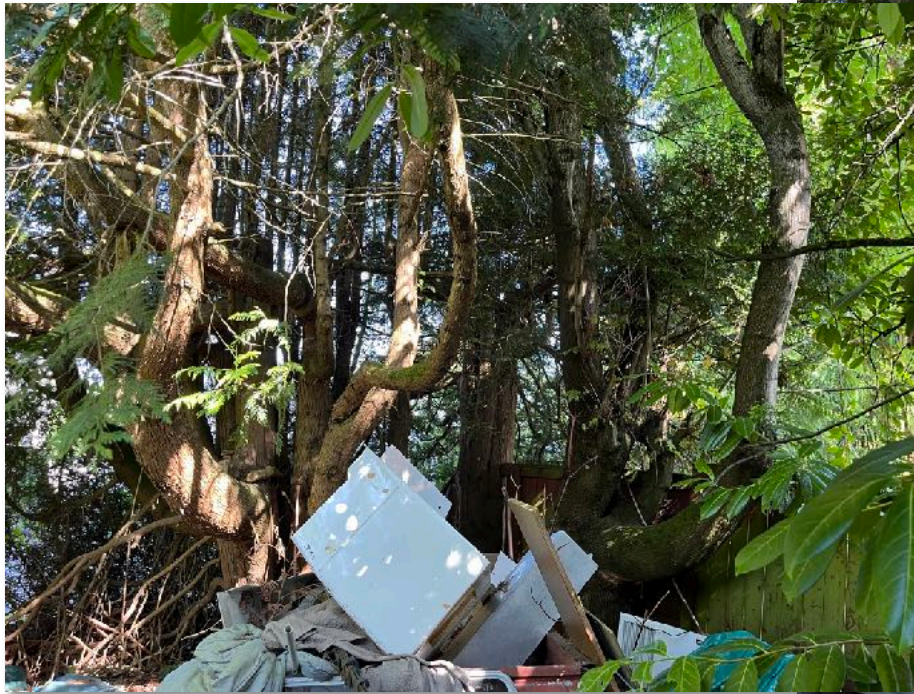
Northwest Corner trees (adjacent to the street): This area contains **four trees 5079-5082**, three of which are western red cedars with poor structure, and one is a big leaf maple with fair structure.

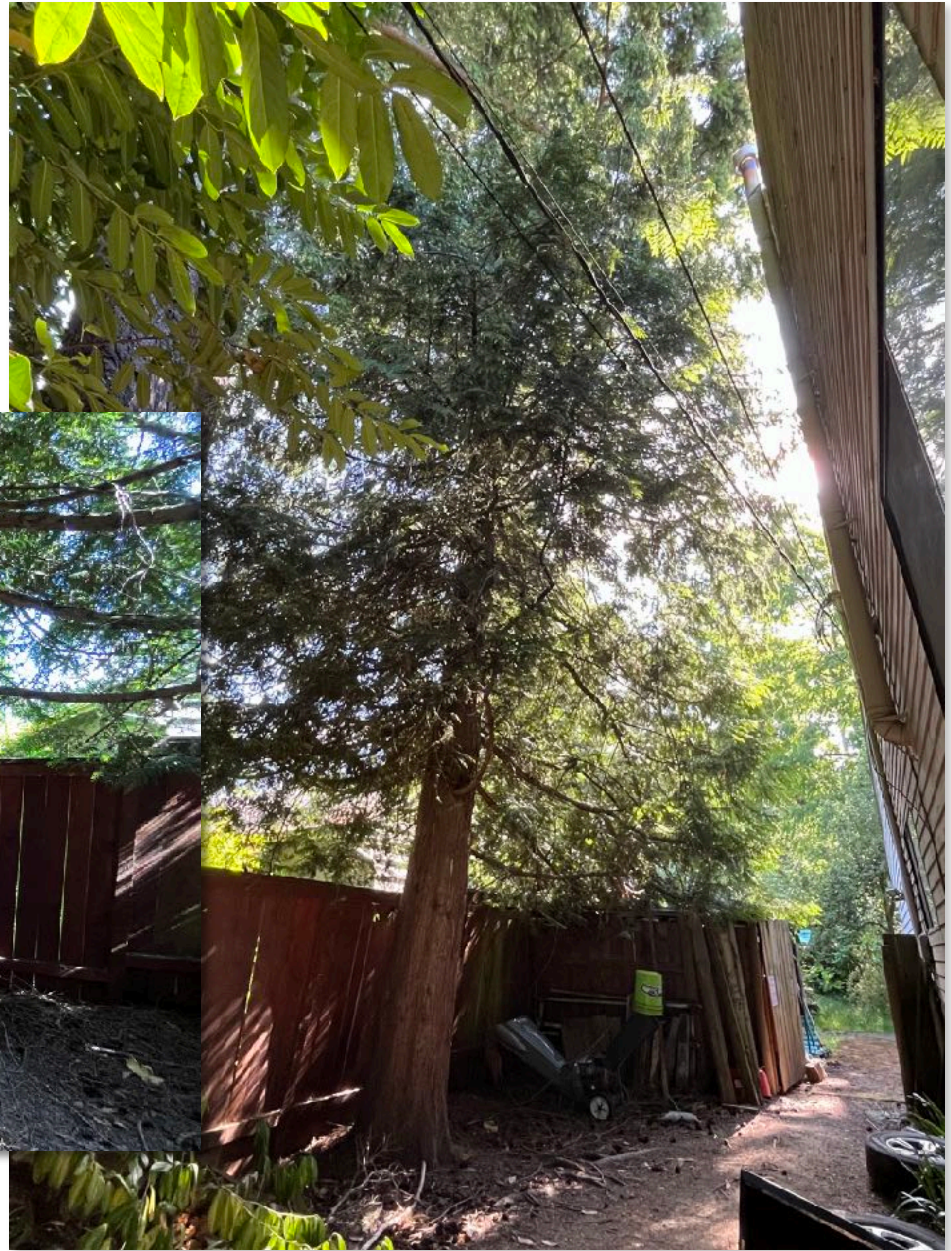
- Tree #5077 – Western Red Cedar: In good condition and located near the fence line, close to two Douglas fir trees.

Right: Cedar 5077. Retain.
Below: Douglas fir 5078 and cedar 5077 trunks. Adjacent tree A is behind the fence. Retain.

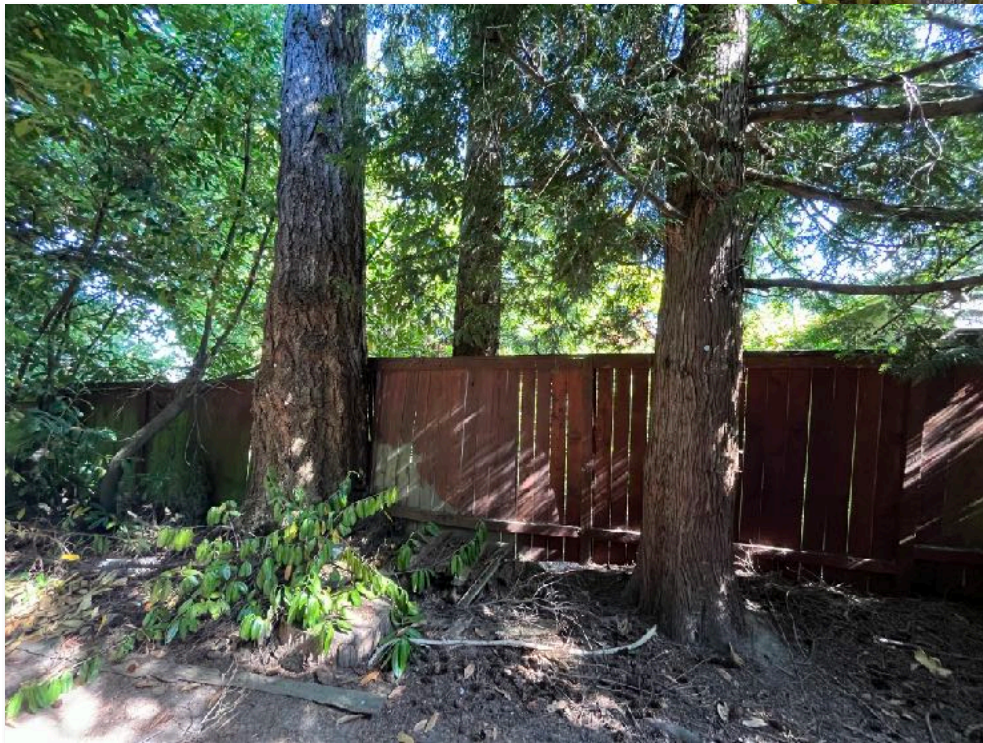
- Tree #5078 – Douglas Fir (landmark): In good condition and adjacent to an off-site Douglas fir. No visible health or structural concerns.
- Tree #5083 – ROW. Crabapple: In fair condition and would benefit from structural pruning.
- Tree #5084 – Black Hawthorn: In good condition and should be considered for retention.
- Tree #5085 – Western Dogwood: Exhibits signs of chlorosis, wilt, and water sprouting, yet the canopy remains full. Leaf and soil assessment are recommended to diagnose disease or nutrient deficiency.
- Tree #5086 (previously tree C) – Willow was initially thought to be offsite but determined to be an onsite tree during the survey. This tree was not tagged.

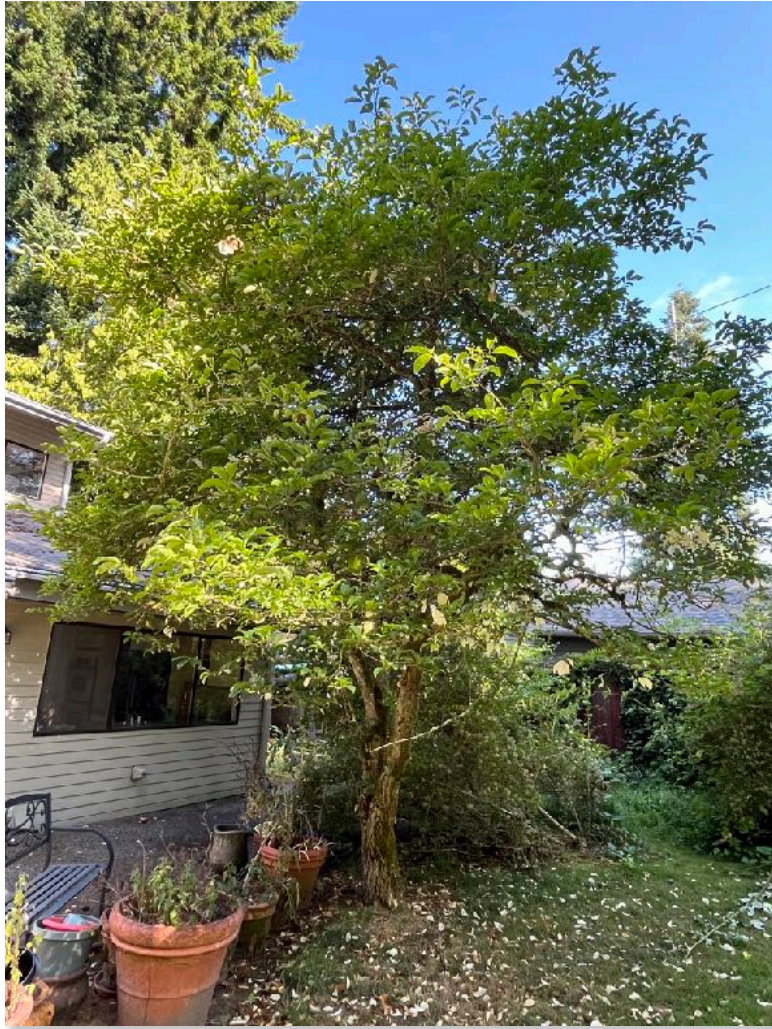
Right: Pear tree 5076. Remove

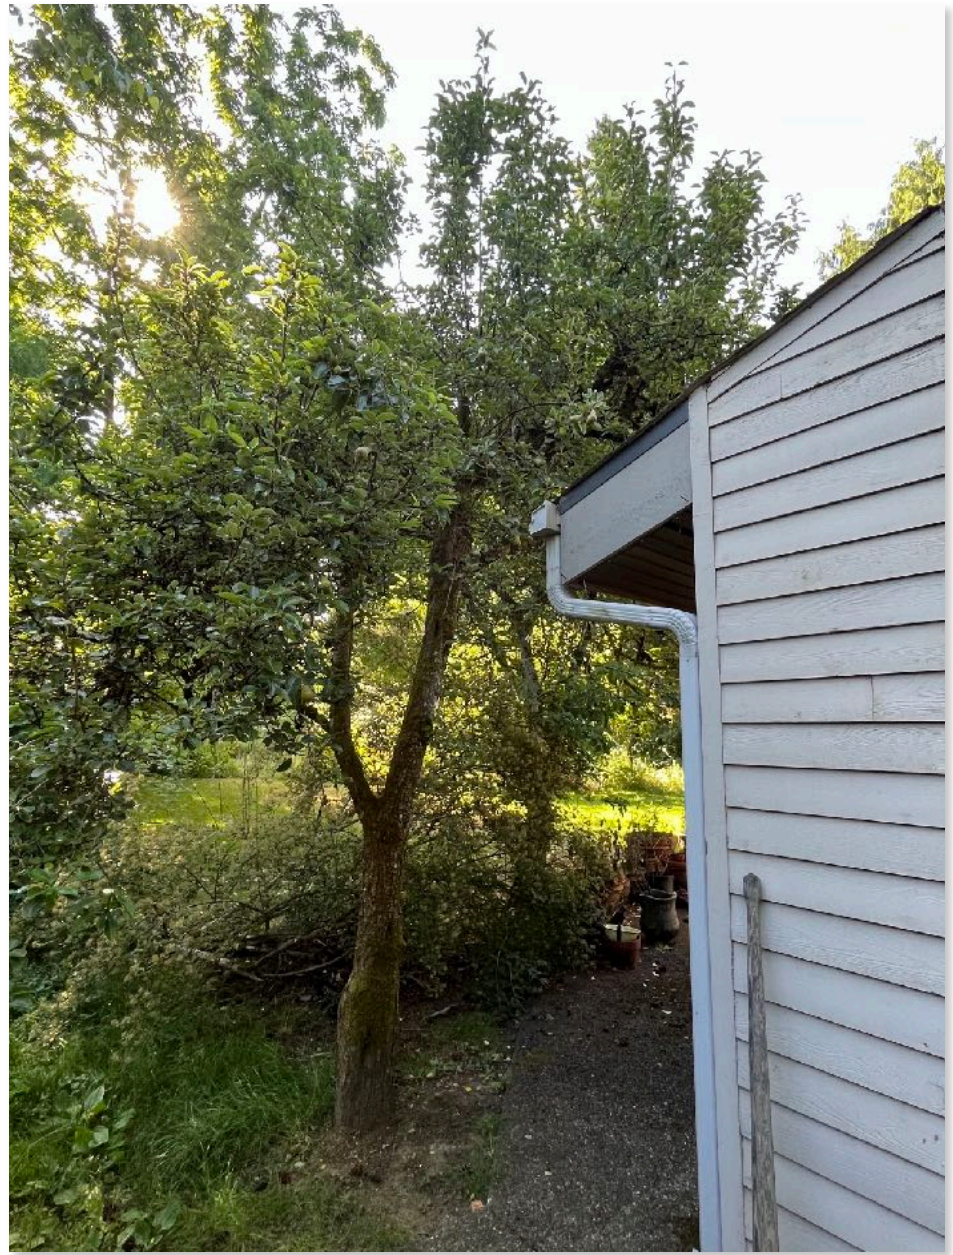
Below: Euonymus 5075 has a tree form. Remove

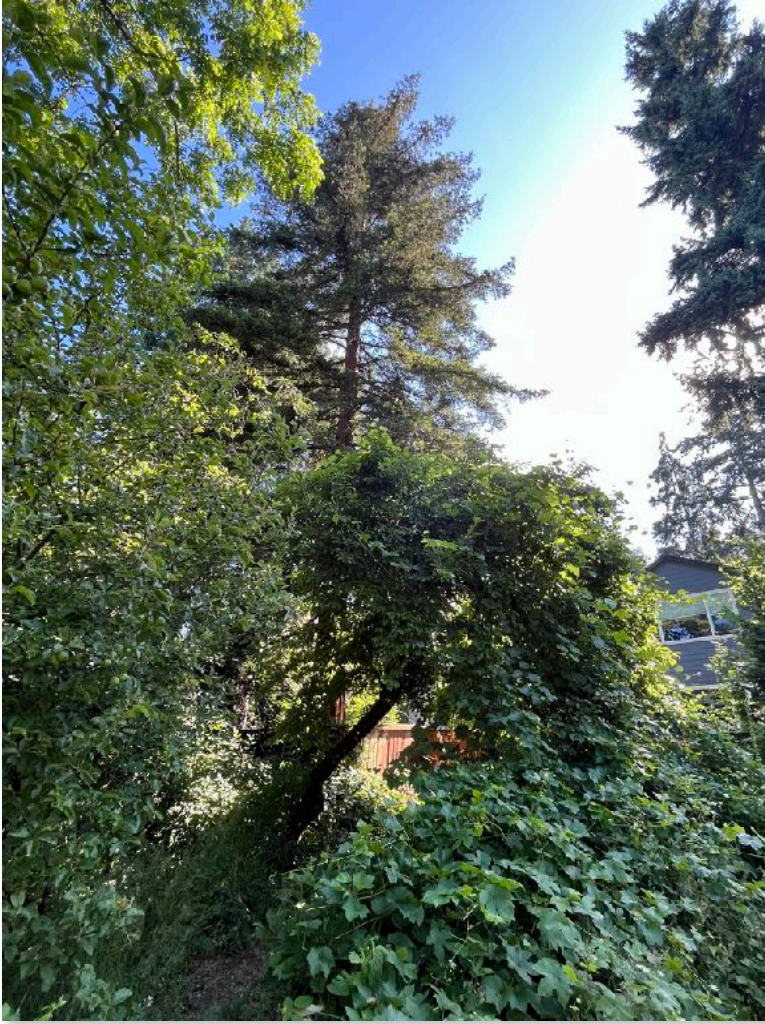
Right: Walnut 5074

- Tree #5074 – Walnut: In good health with generally sound structure. However, at ~20 feet there is a co-dominant stem junction with stems diverging in two directions. Cabling may be needed in the future; arborist inspection recommended in 5 years if retained.

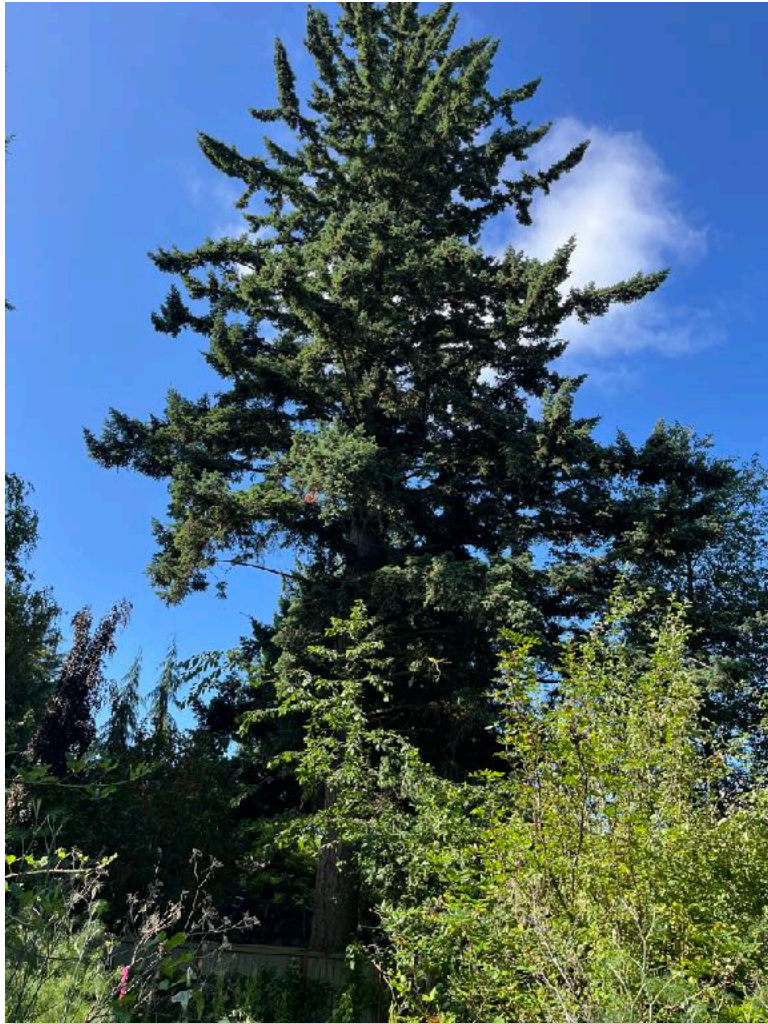
Right: Adjacent tree C willow is right against the fence.
Below: Adjacent tree D is a large Douglas fir close to the fence.

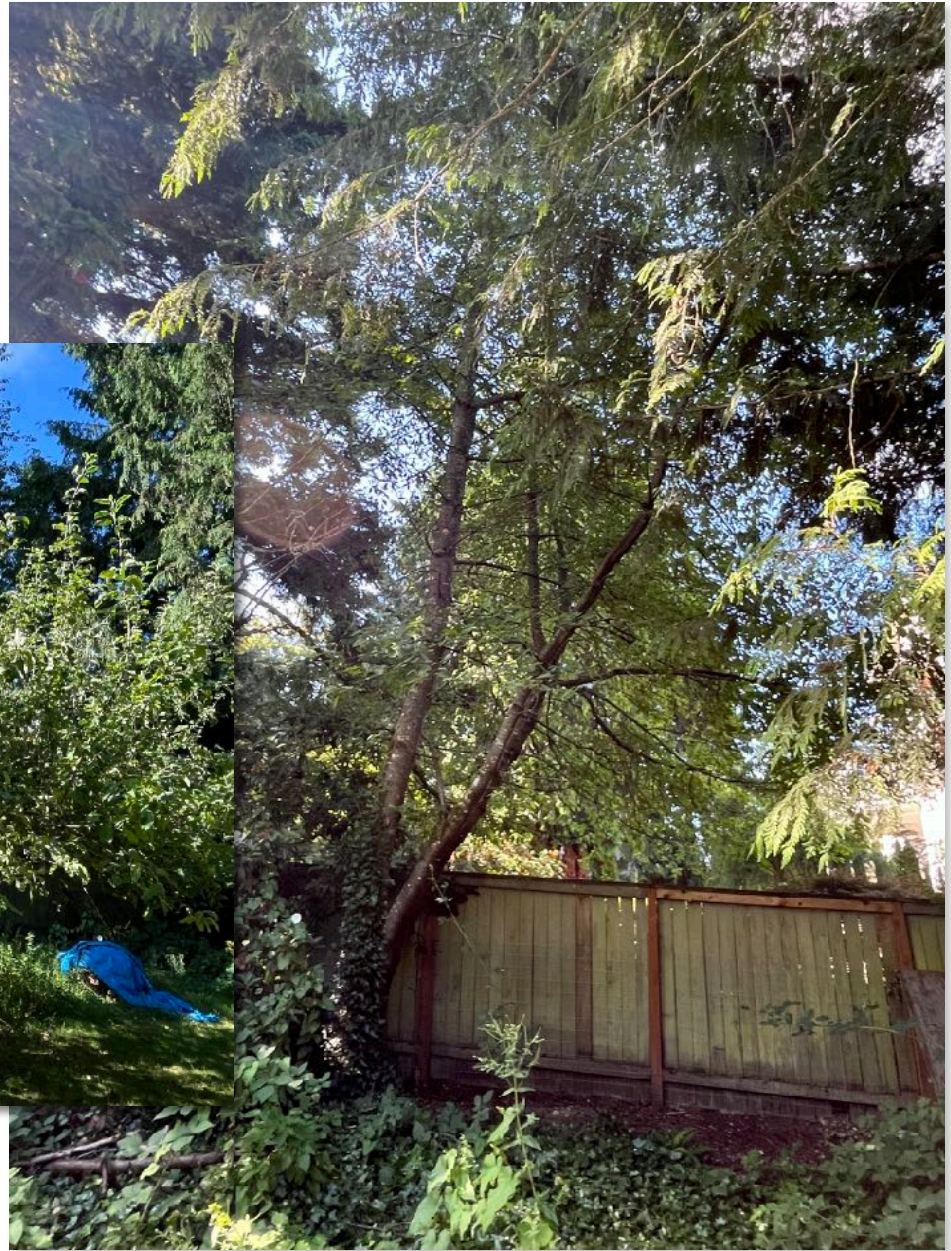
- Tree #5069 – Bitter Cherry: Multi-stemmed at ~4 feet with three stems forming a steep-angled junction. This structure can become unstable over time, but there is no current sign of weakness. One or more secondary stems could be removed or cabled in the future.

Right: Bitter cherry 5069
Below: Apple 5071

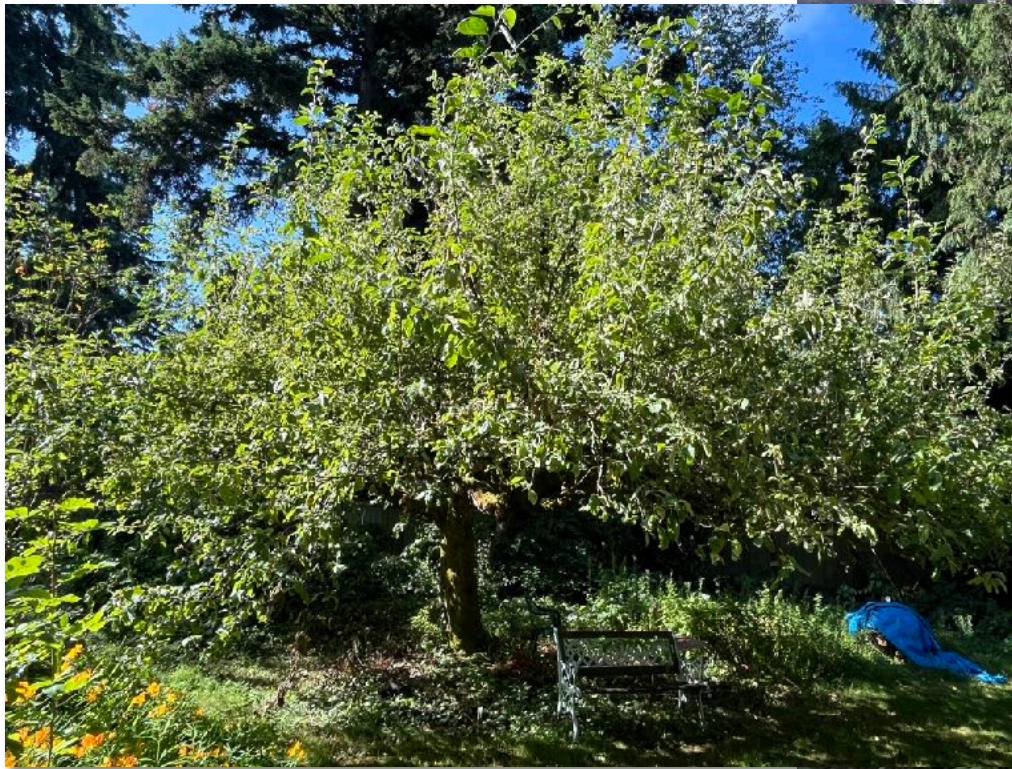
- **Tree #5070** – Cherry: Completely dead, with no visible foliage. Reduction to wildlife snag or removal is recommended.
- **Tree #5071** – Apple Tree: Very mature with a hollow trunk, but otherwise appears healthy and structurally stable at this time. Monitor every 2-3 years for decline.

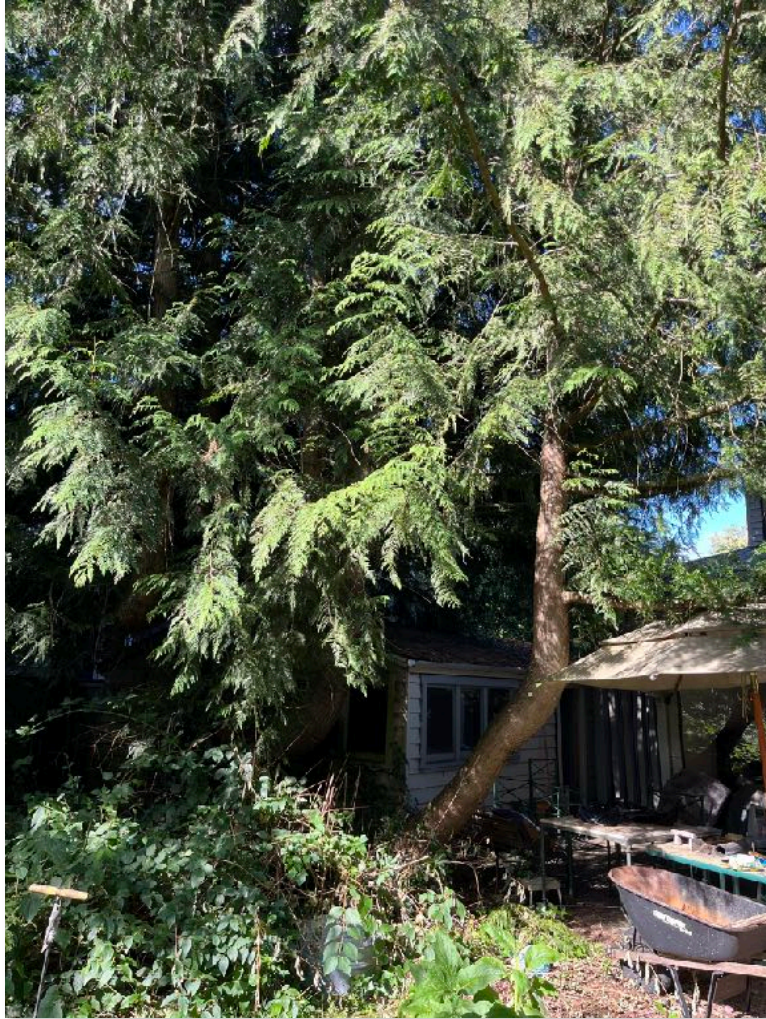
Right: Cedar 5068 and 5067 (far right)

- **Tree #5068** – Western Red Cedar: Nearby cedar with a sweeping lower stem that becomes vertical at about 7 feet. Its canopy is mostly one-sided due to suppression by Tree 5067.
