LAYTON TREE CONSULTING, LLC

Trees & Construction Memo

Re: 5320 Butterworth RD - Tree #33 and #35 Retention Issues - Updated

ARBORIST REPORT

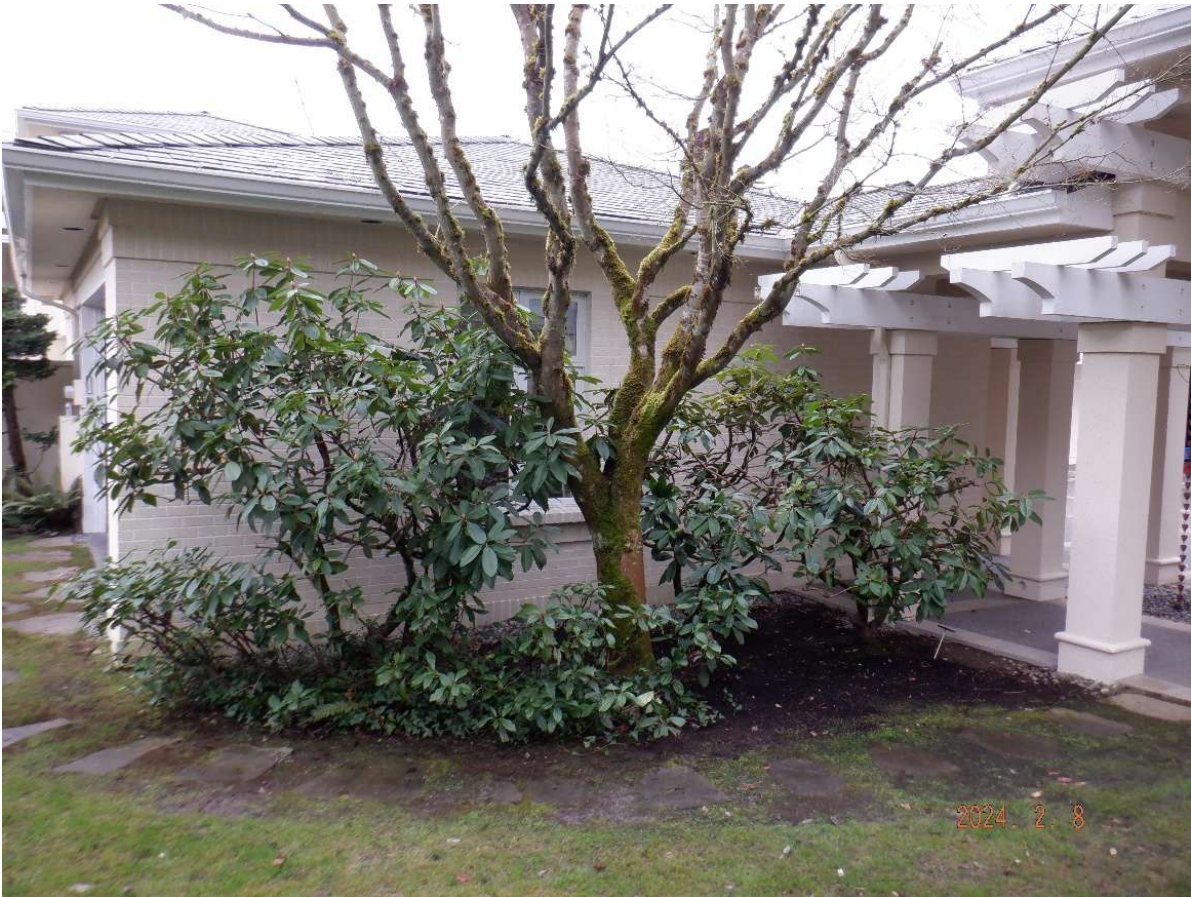
Tree #33 (the 'Exceptional' 12-inch Japanese maple) does not meet the criteria outlined under MICC 19.10.060(A)(3) a, b or c and will need to be retained. The proposed driveway has been redesigned or slightly modified to afford this tree more space for successful retention. See the attached exhibit. Although the tree will be impacted by the new driveway, the proposed impact or anticipated root loss would not be expected to threaten long-term health per MICC 19.10.080 - Tree protection standards B. This is a small, young specimen in good condition. It is only 22-feet in height. See picture below.

The tree protection fencing shall be positioned at the edge of the proposed new driveway and 2-feet off of the existing garage wall to allow for demolition, per the attached exhibit. There will not be any roots beneath the existing garage concrete foundation. The existing stone steps or pavers shall be removed by hand-labor only from within the tree protection area. Once removed, cover the ground within the entire protection area with a +/- 4-inch layer of wood/bark chip mulch.

To prepare the subbase for the new driveway, excavate as little material or topsoil as possible. Any roots that are damaged during work beyond the protection area shall be properly pruned at the new driveway edge. The damaged root shall be pruned clean at sound tissue. Sound tissue is where the root is undamaged and the bark is completely intact. This will help roots to seal off potential decay and allow them to sprout new growth. Consider installing a root barrier at the new driveway edge to deflect root growth downward and prevent future damage. Disturbed

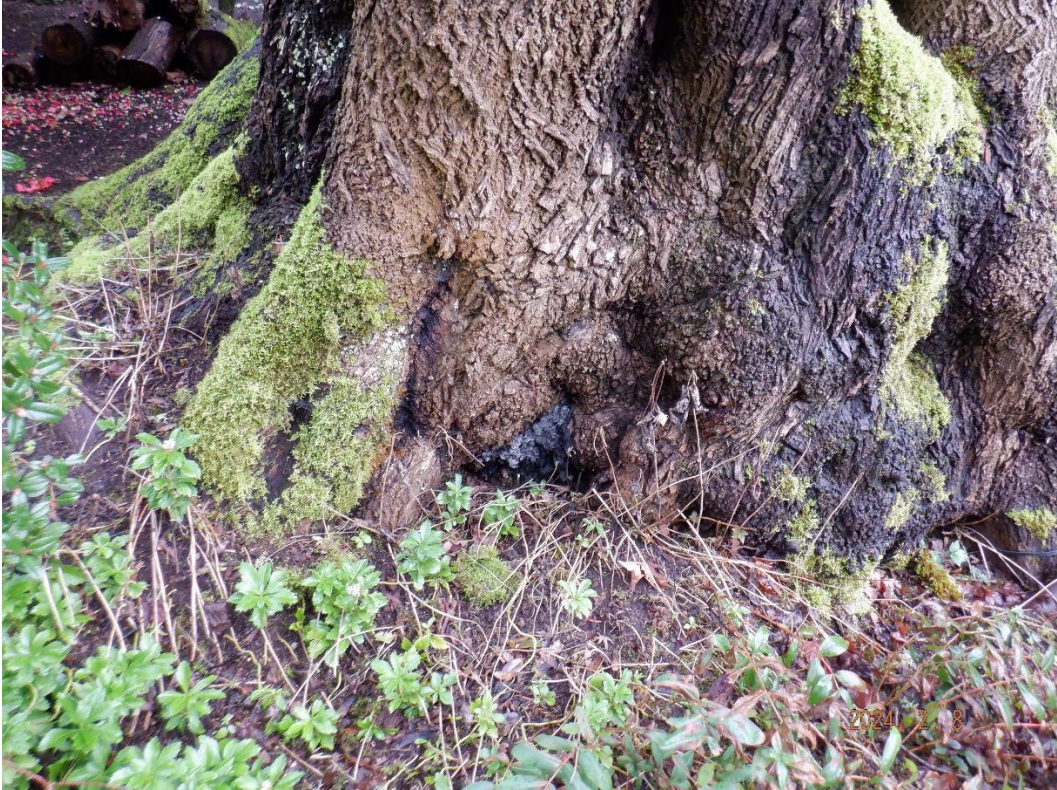
Five of the subject trees were found to be in a ‘poor’ condition. Tree #3 is a mature native bigleaf maple at the front of the property. It has an advanced soft rot infection, *Kretzschmaria deusta*. This is evident by multiple fruiting bodies of the fungus observed on the root crown and lower trunk. See pictures

below. These appear as black crusty nodules resembling dried tar. Tree #18, another mature bigleaf maple also has an advanced infection. There is risk of complete trunk failure for both of these.

Base of Tree #3, advanced soft rot infection

Trees #3, #15 and #18 have significant defects and pose an elevated risk. These trees are recommended for removal as part of this project.

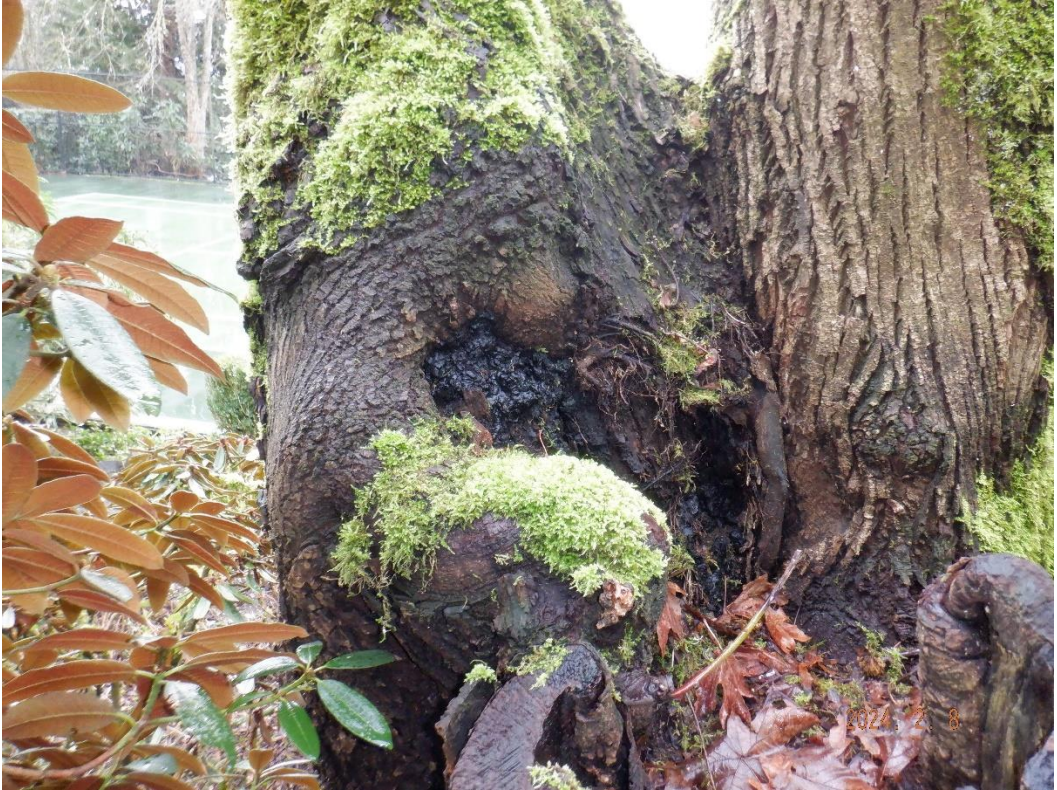
Base of Tree #3, advanced soft rot infection
