Arborist Report

- Inventory of trees throughout parcel and who's crowns overhang the subject parcel for proposed DADU construction.
- Assessment of trees adjacent to proposed area of disturbance for the effects of disturbance.
- Tree retention and protection plan.

7901 SE 65th St.
Mercer Island, WA 98040
Parcel #5452800600

9am/1-6-2025

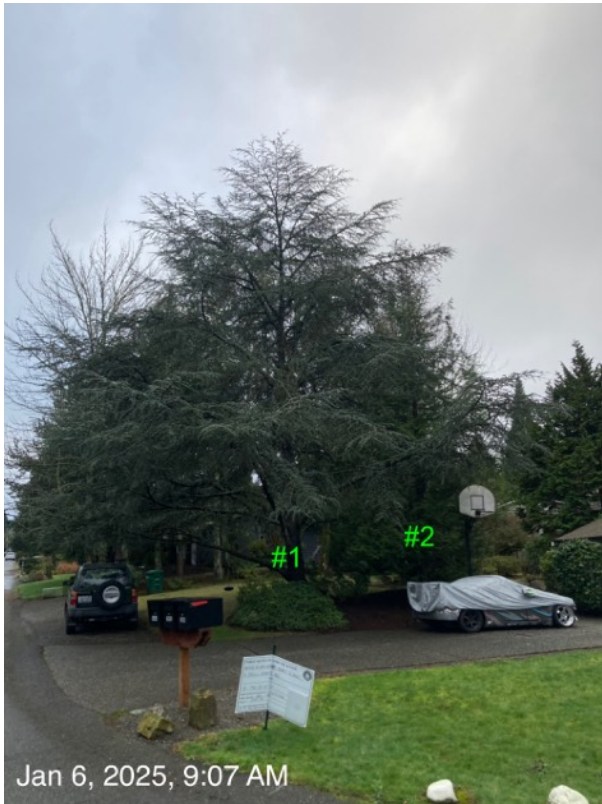
Trees #1 and #2 noted as healthy and vigorous. Roots limited by drive on S side. Adjacent to work area and access point. Tree protection fencing recommended.

- Tree protection measures including tree protection fencing are recommended for retained trees adjacent to and who's crowns overhang the development site and its access point. Fencing shall be maintained for the duration of the project.

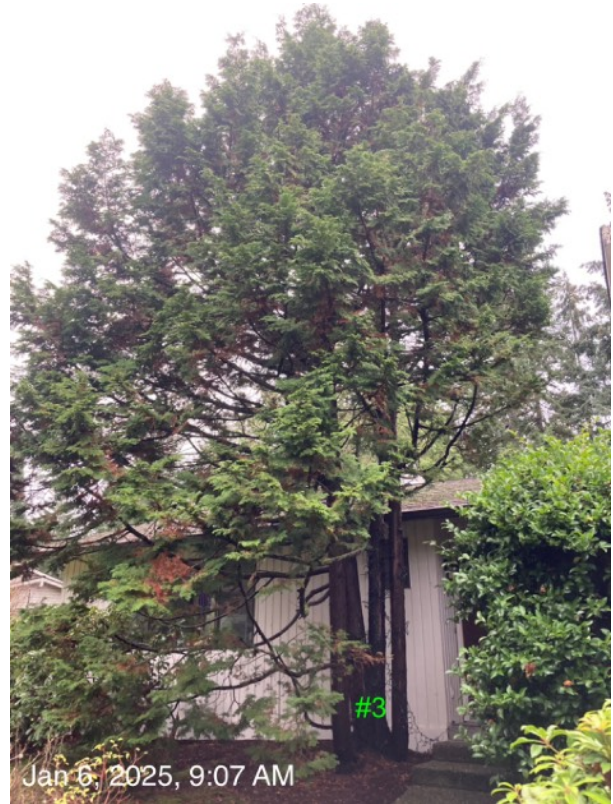
Tree #3 noted as healthy and vigorous. Adjacent to work area. Tree protection fencing recommended.

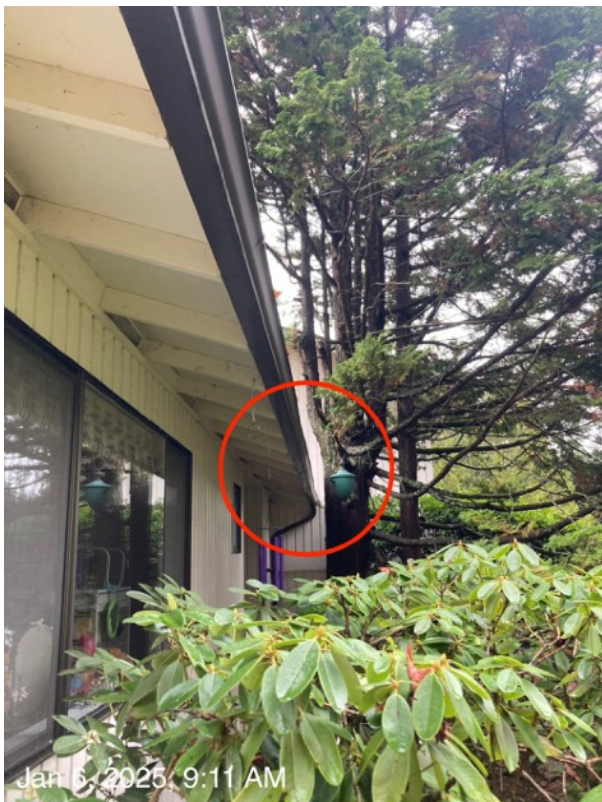
Tree #3 in extreme proximity with home.

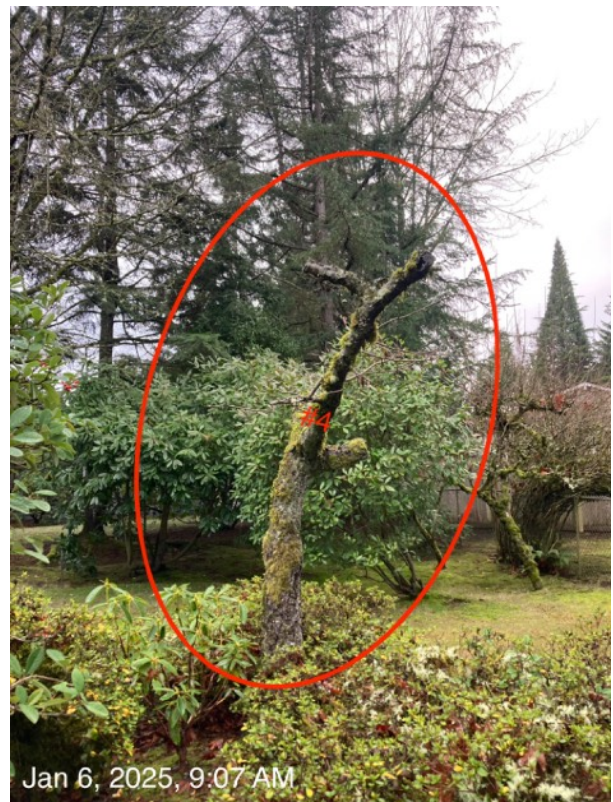
Tree #4 found to be 100% necrotic.

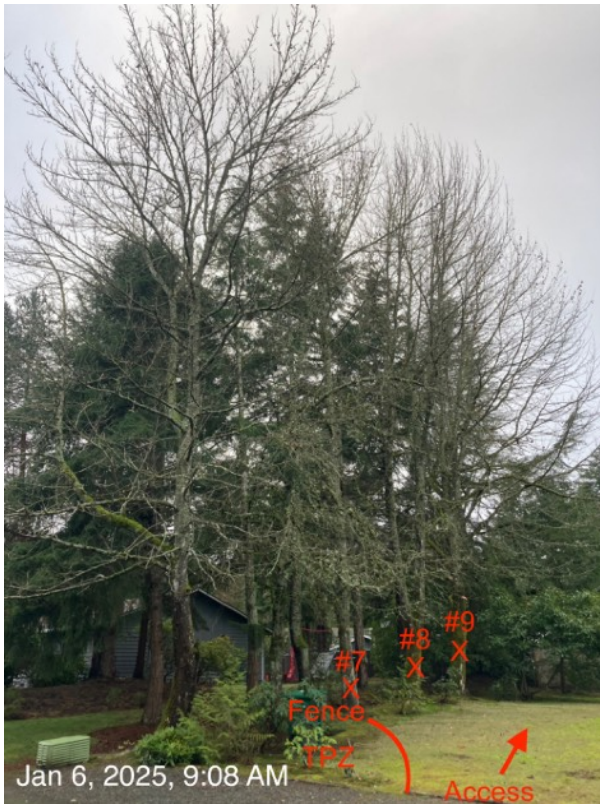
Trees #7, #8 and #9 to be removed due to root disturbance for development. Tree protection fencing recommended for trees #5 and #6.

- 2:1 replacement ratio for trees #7-#9.
- 1:1 replacement ratio for trees #16-#18.

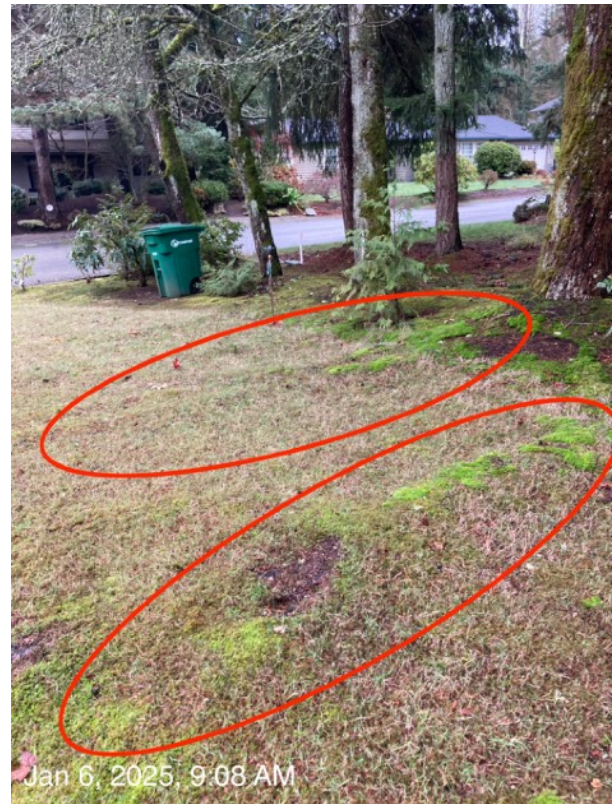
Shallow roots of tree #7, adjacent to disturbance indicate significant root cutting for proposed development. Removal is recommended.

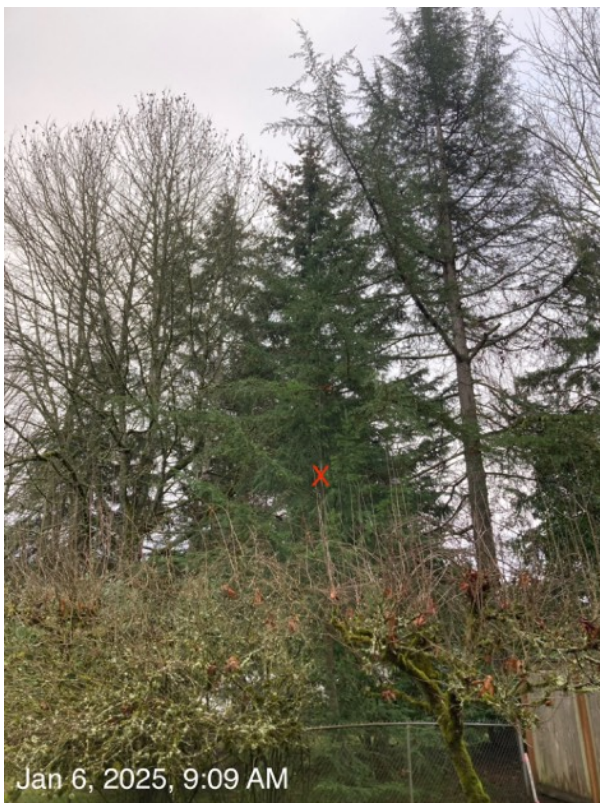
Tree #16 to be removed due to significant disruption to critical root zone.

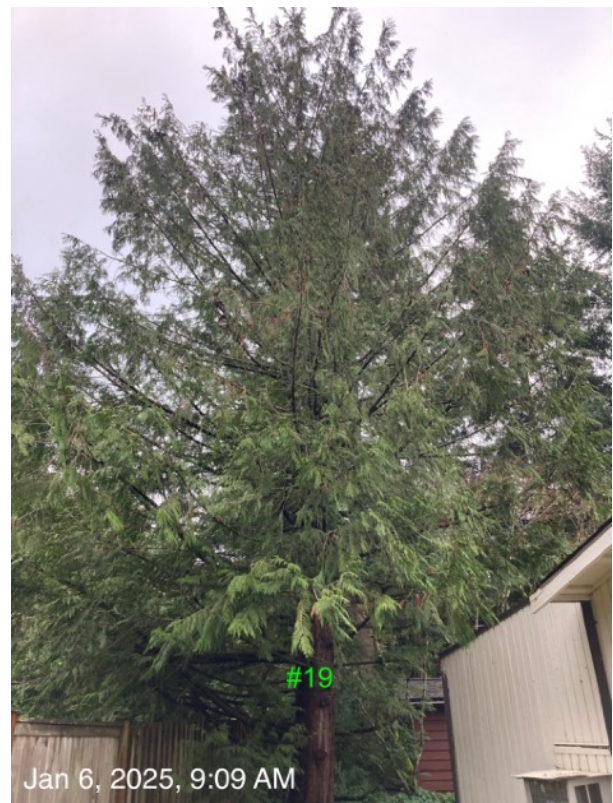
Tree #19 noted as exceptional with co-dominate trunks. Co-dominate attachment point noted as sound at time of inventory.

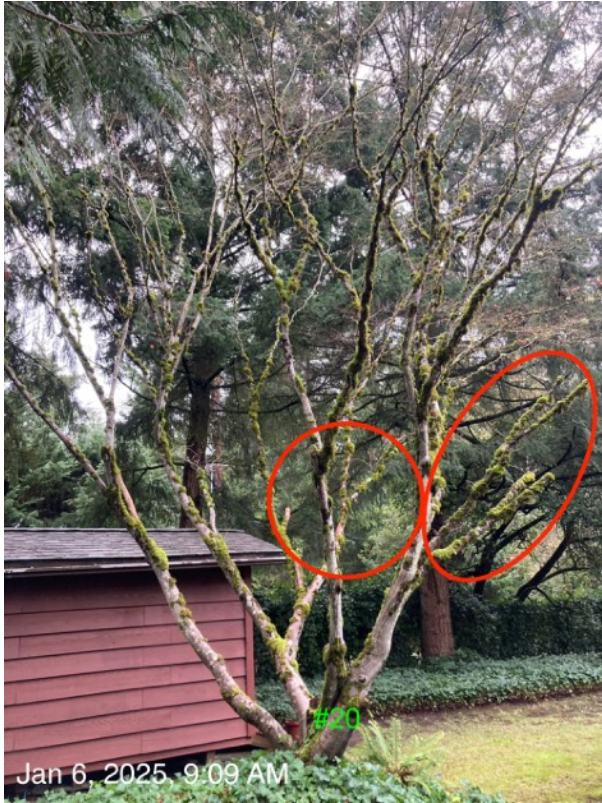
Significant deadwood in tree #20 indicates possible decline.

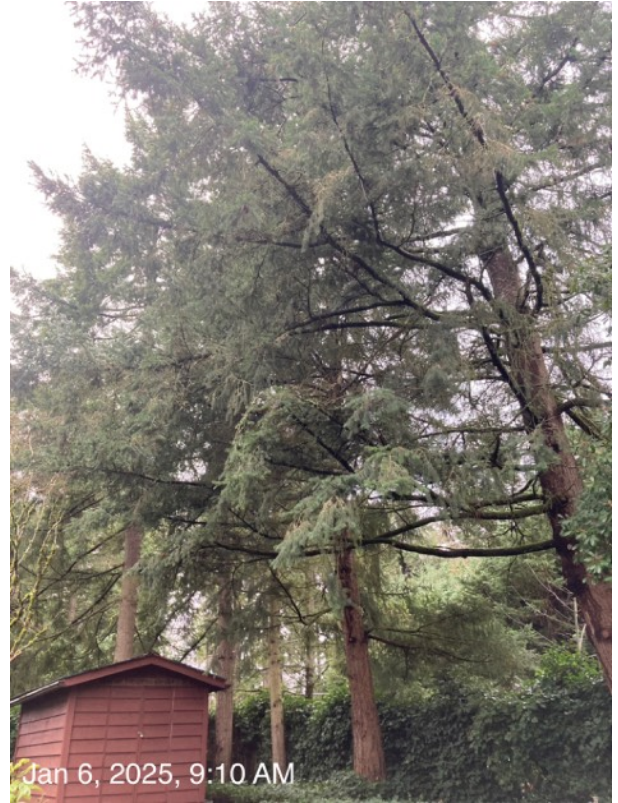
Trees #21-#25 noted as healthy and vigorous. Shed foundation damage noted caused by soil displacement from root growth.

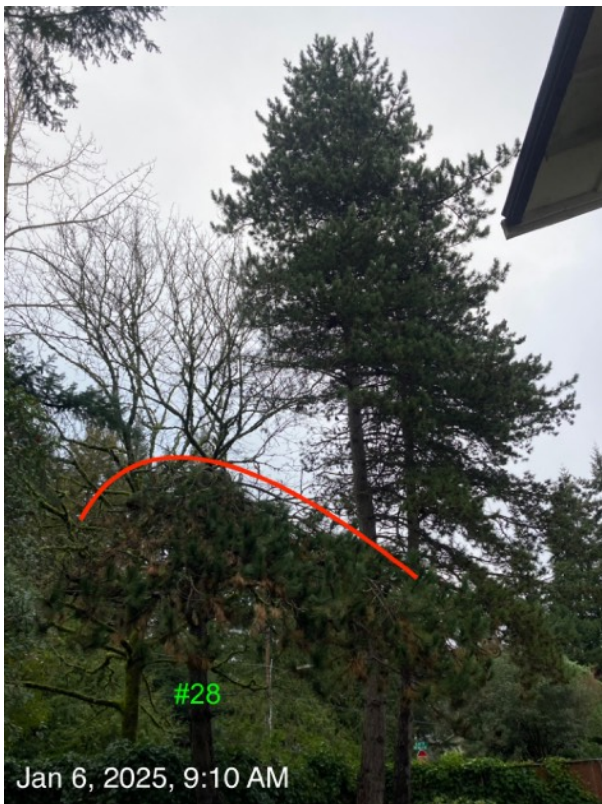
Tree #28 noted as previously topped or storm damaged. Trees #28 and #30 noted as healthy and vigorous with somewhat matted crowns.

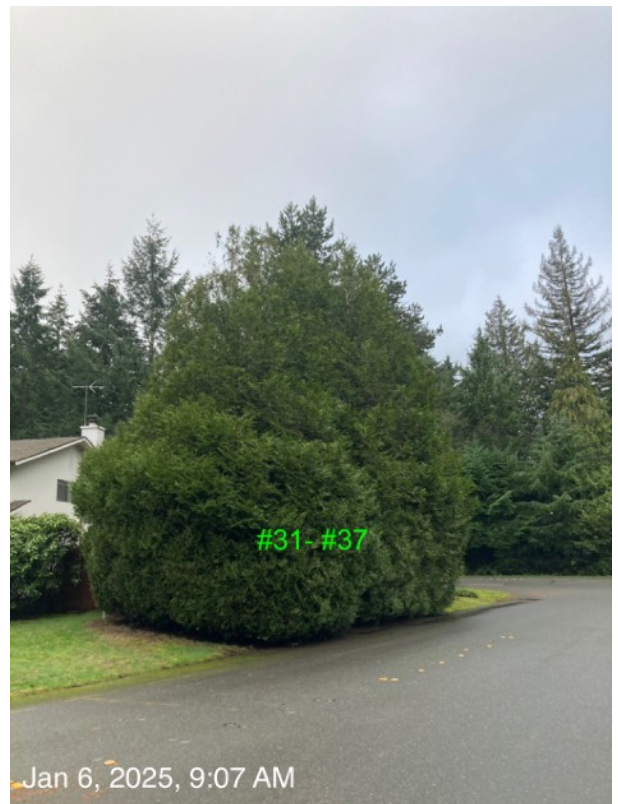
Trees #31-#37 grown in formal hedgerow.

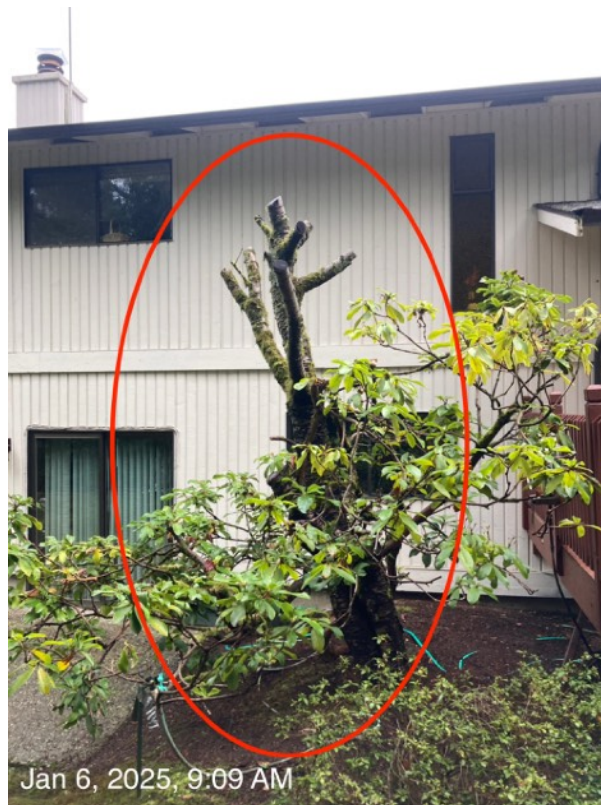
Tree #38 noted as 100% necrotic
