Long Residence

Downstream Analysis Report

Mercer Island Permit No.: 2508-232

October 17, 2025

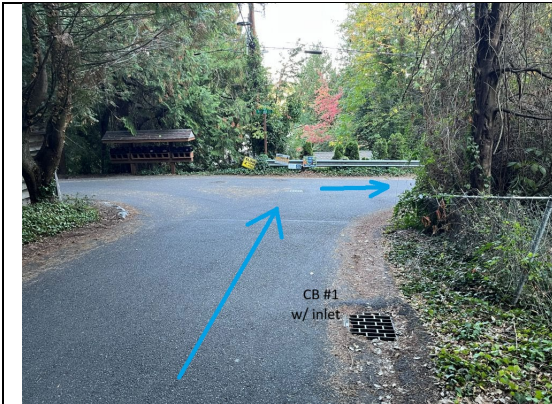
Picture 1

Traveling along SE 69th St, facing east towards 96th Ave SE. The subject is to the right of the CB #1. CB #1 shown (Per City of Mercer Island GIS SD-CB-40a-64, Type I), receives flows from the west and directs them east approximately 22 ft.

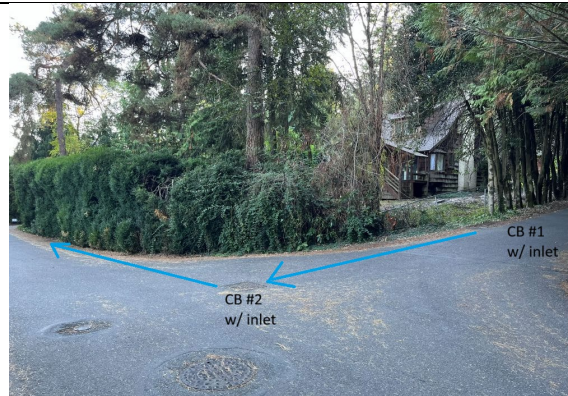
Picture 2

At the intersection of SE 69th St and 96th Ave SE, facing southwest from the east side of 96th Ave SE. CB #2 shown (Per City of Mercer Island GIS SD-CB-40a-34, Type I), receives flows from the west (CB #1) and directs them south approximately 59 ft.

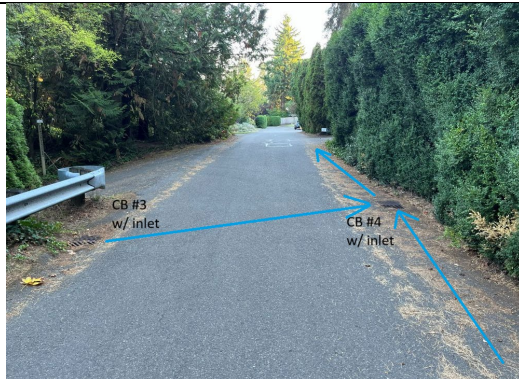
Picture 3

Traveling along 96th Ave SE facing south. CB #3 shown (Per City of Mercer Island GIS SD-CB-40a-40, Type I), collects road runoff and is routed 14 ft to CB #4. CB #4 shown (Per City of Mercer Island GIS SD-CB-40a-41, Type I), receives flows from the east (CB #3), and from the north (CB #2), and directs them south approximately 65 ft.

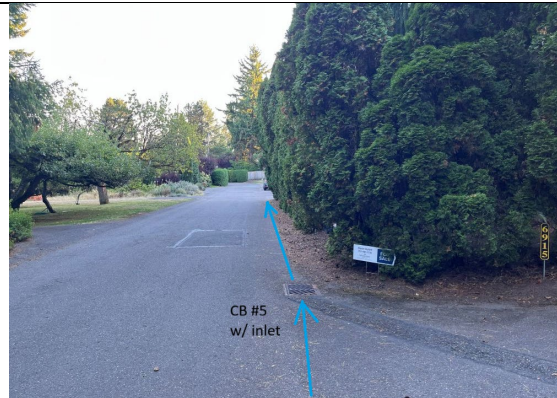
Picture 4

Traveling along 96th Ave SE facing south. CB #5 shown (Per City of Mercer Island GIS CB SD-CB-40a-19, Type II) receives flows from the north (CB #4) and directs them south approximately 63 ft.

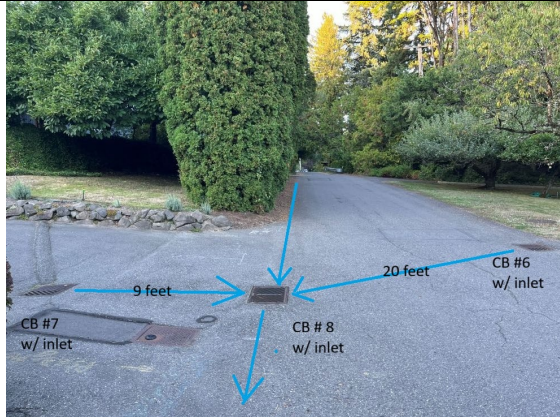
Picture 5

Traveling along 96th Ave SE facing north. CB #8 shown (Per City of Mercer Island GIS SD-CB-40a-20, Type I) receives flows from the north (CB #5), from the west (CB #7 shown, Per City of Mercer Island GIS SD-CB-40a-21, Type I), and from the east (CB #6 shown, Per City of Mercer Island GIS SD-CB-40a-43, Type I) directs them to the south approximately 41 ft.

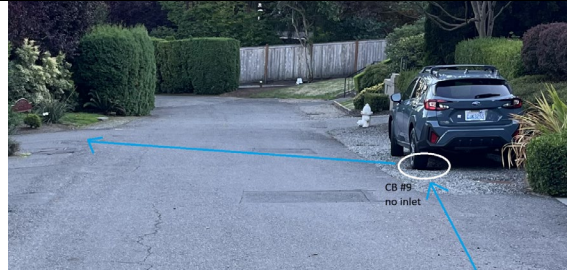
Picture 6

Traveling along 96th Ave SE facing south. CB #9 shown (Per City of Mercer Island GIS SD-CB-40a-65, Type II / Manhole), receives flows from the north (CB #8) and directs them to the southeast approximately 32 ft.

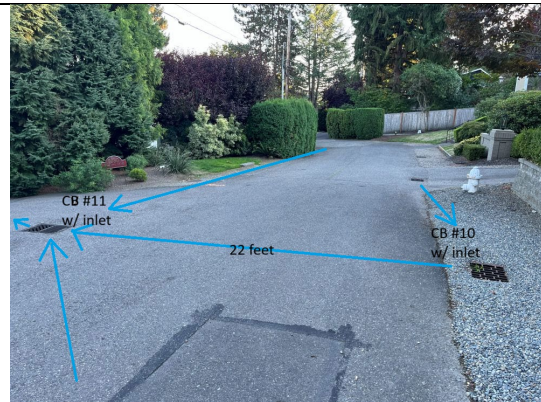
Picture 7

Traveling along 96th Ave SE facing north. CB #11 shown (Per City of Mercer Island GIS SD-CB-40a-23, Type I) receives flows from the northwest (CB #9), from the east (CB #10 shown, Per City of Mercer Island GIS SD-CB-40a-22, Type I), and from the south (CB not shown, Per City of Mercer Island GIS SD-CB-40a-18, Type I) and directs them east along the private drive approximately 137 ft.

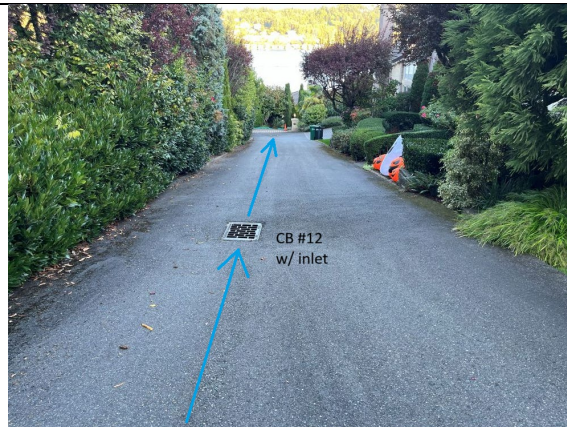
Picture 8

Traveling along the private drive off of 96th Ave SE (across from 6921 96th Ave SE), facing east. CB #12 shown (Per City of Mercer Island GIS SD-CB-40a-24, Type I), receives flows from the west (CB #11) and directs them to the east approximately 36 ft.

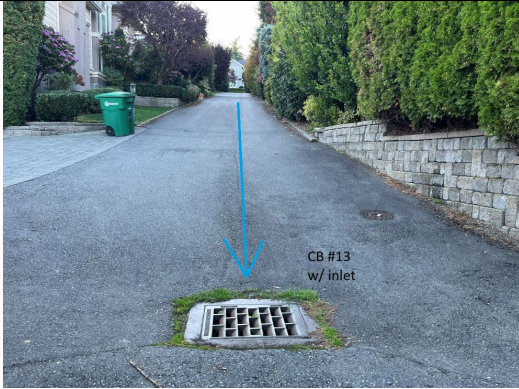
Picture 9

Traveling along the private drive off of 96th Ave SE (across from 6921 96th Ave SE), facing west. CB #13 shown (Per City of Mercer Island SD-CB-40a-25, Type II / Manhole), receives flows from the west and directs them east approximately 150 ft through two other CBs to a discharge point directly into Lake Washington.

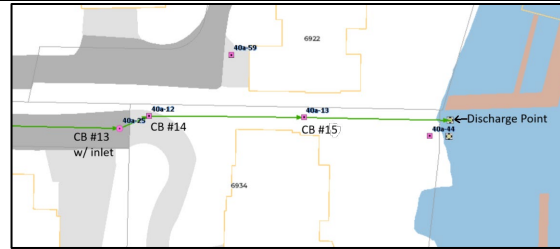
Picture 10

CB #13 flows northeast 15 ft to CB #14 (Per City of Mercer Island GIS SD-CB-40a-12, Type: unknown), 70ft east to CB #15 (Per City of Mercer Island GIS SD-CB-40a-13, Type: unknown), and then 65 ft east to the discharge point into Lake Washington.

Downstream of CB #13 to the discharge location are connected by 12” concrete pipe. CB #14 and #15 and the discharge point were not visually inspected due to private property restrictions.

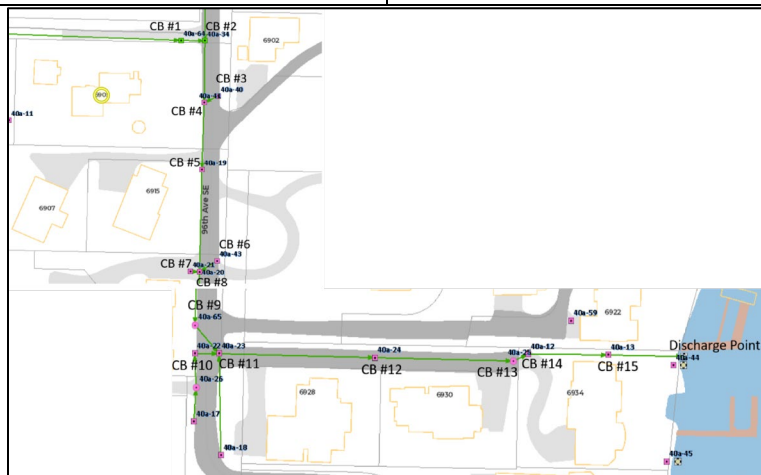
Picture 11

Aerial View of ¼ Mile Downstream Stormwater Infrastructure Network
(Per City of Mercer Island GIS).
