TO: Artoush Construction
SITE: 3427 72nd Place SE, Mercer Island 98040 parcel #130030-1391
RE: Tree Protection Plan
DATE: August 4, 2025
PROJECT ARBORIST: Scott Selby, ASCA Registered Consulting Arborist #749, ISA Board Certified Master Arborist #PN-1775B, ISA Qualified Tree Risk Assessor

Artoush Construction Remodel: 3427 72nd Place SE, Mercer Island 98040 Parcel #130030-1391

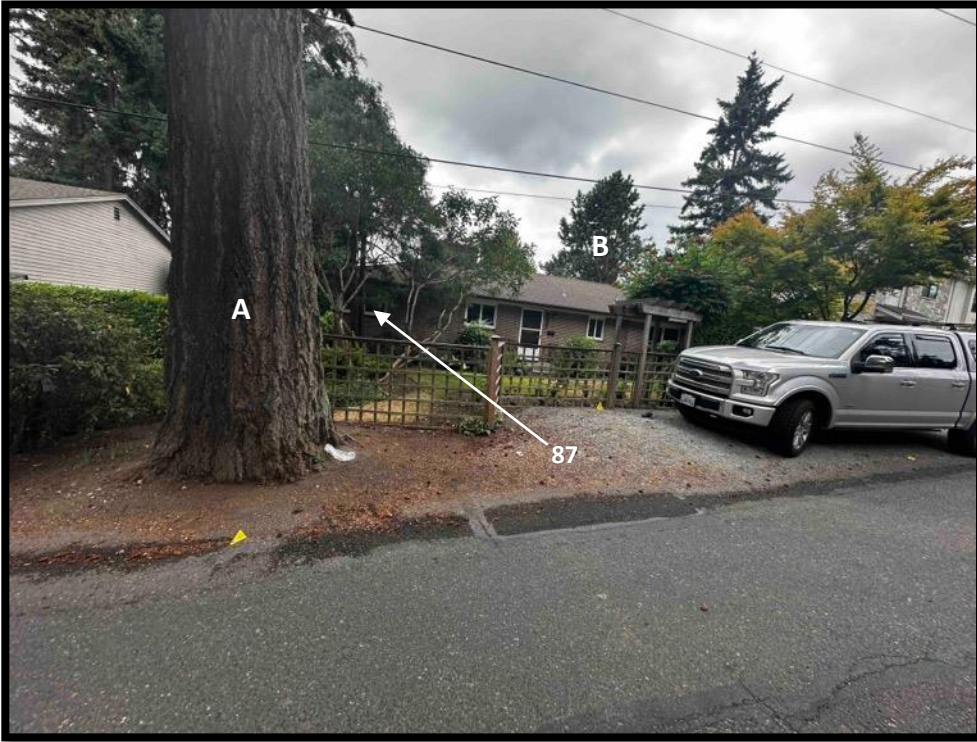
Photo 1. Image facing west from street showing ROW tree A, on-site tree 87, and off-site tree B.

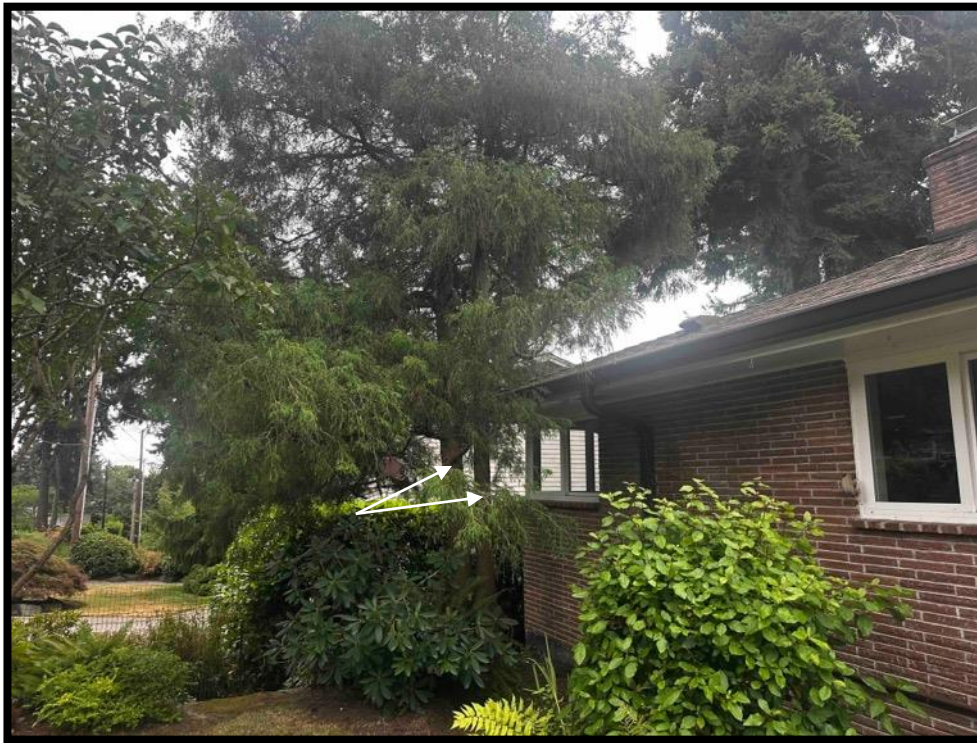
Photo 2. Tree #87 at front left of house (two-stem).

The only on-site regulated tree is proposed for removal due to conflict with the project as designed. Tree replacement is required pursuant to MICC 19.10.070. The replacement ratio for trees 10 inches up to 24 inches DSH is 2:1. Two trees will be planted to replace the removed 11.4-inch tree.

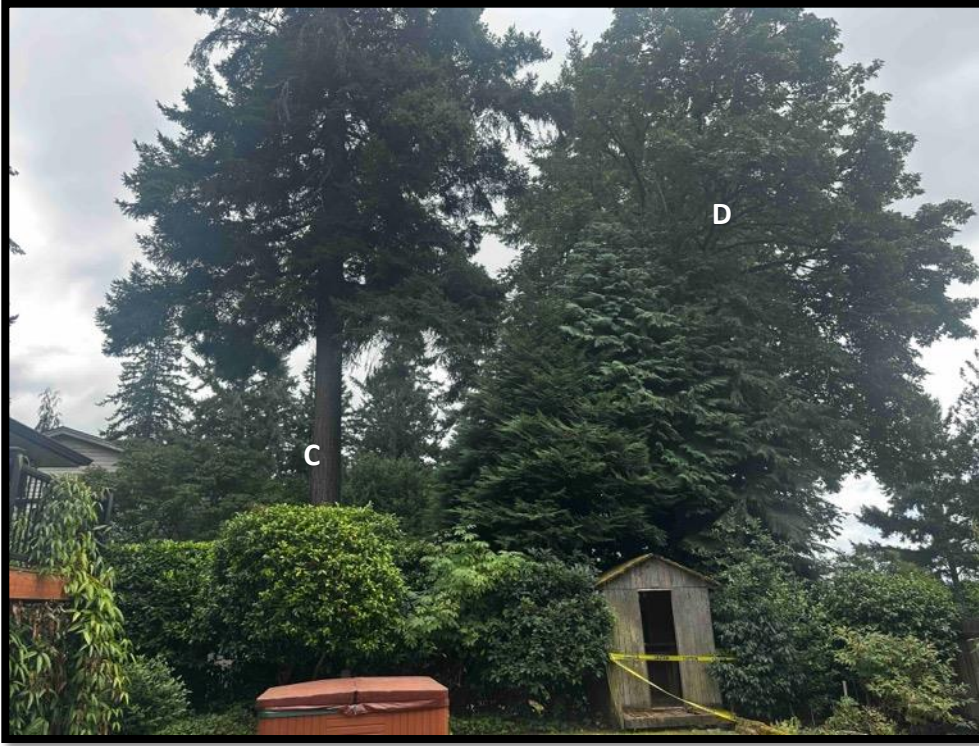
Photo 3. Image of off-site trees C (Douglas-fir) and D (maple).

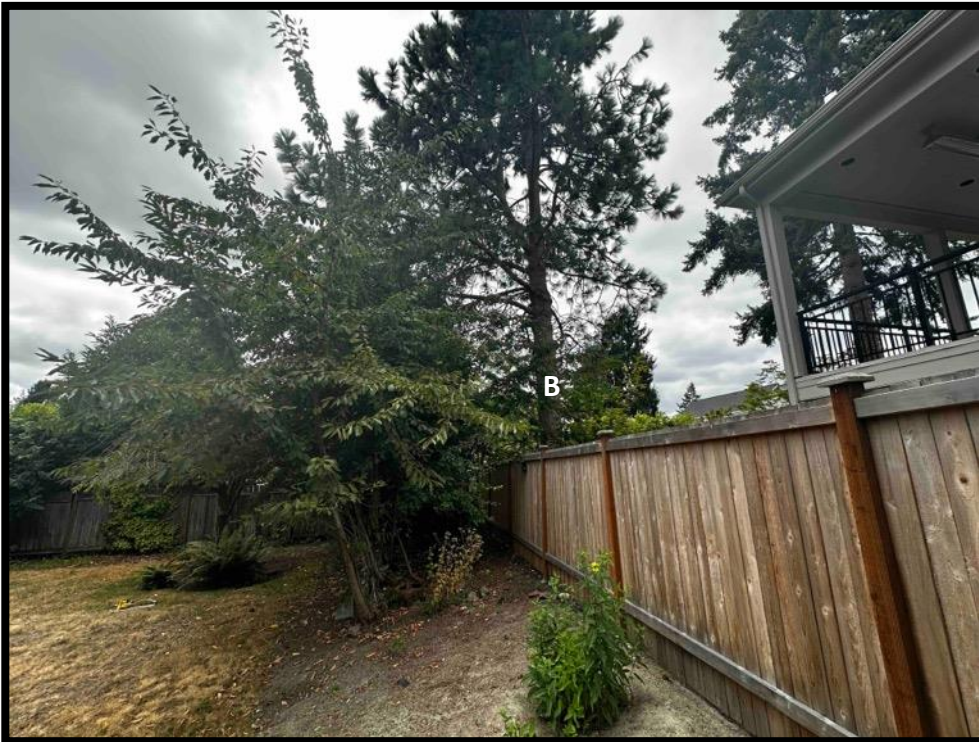
Photo 4. Off-site tree B (pine).
