## DOWNSTREAM ANALYSIS REPORT

RKK Project  
3419 72<sup>nd</sup> Place SE  
Mercer Island, WA 98040

Tax Map #130030-1381  
February 19, 2023

CES #2036

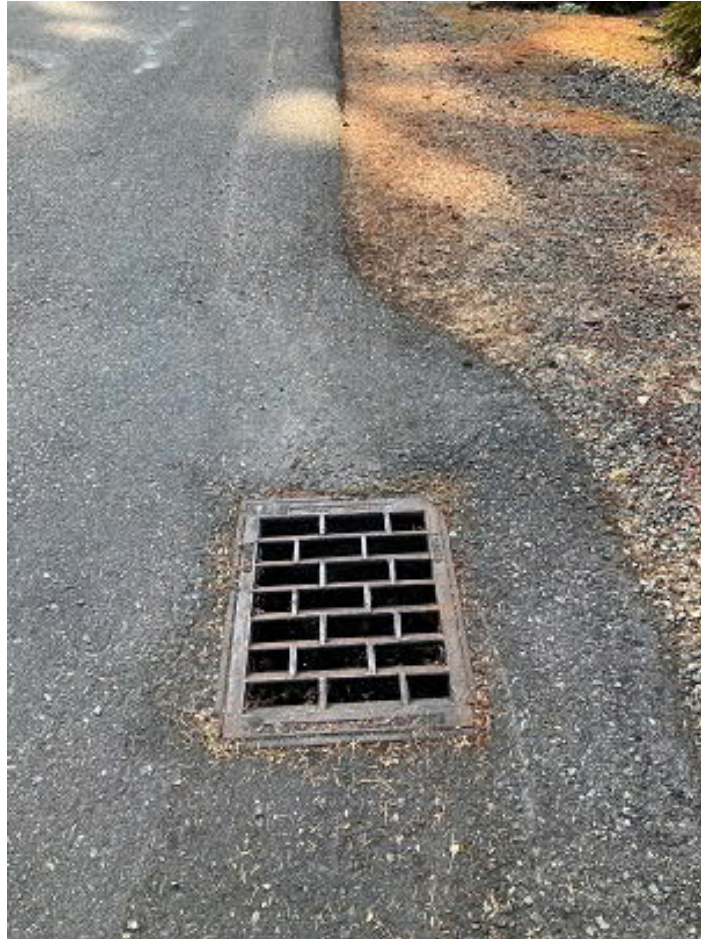
Picture 1:  
ROW in front of 3443 72<sup>nd</sup> Place SE  
Storm will extend south from project site to this catch basin.

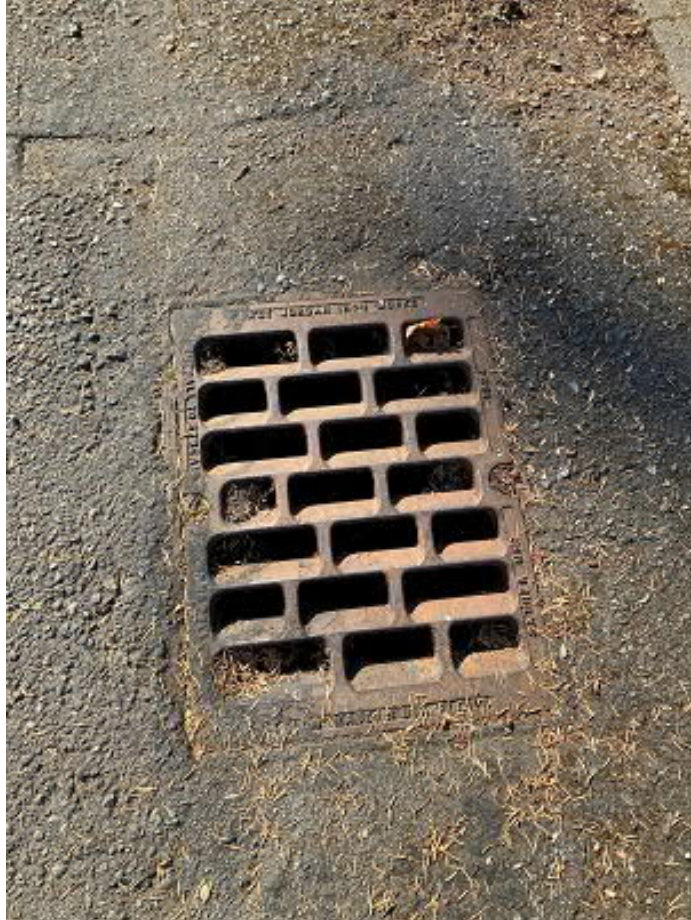
Picture 2  
ROW in front of 3449 72<sup>nd</sup> Place SE  
8" DI pipe discharging toward the south leads to this catch basin.

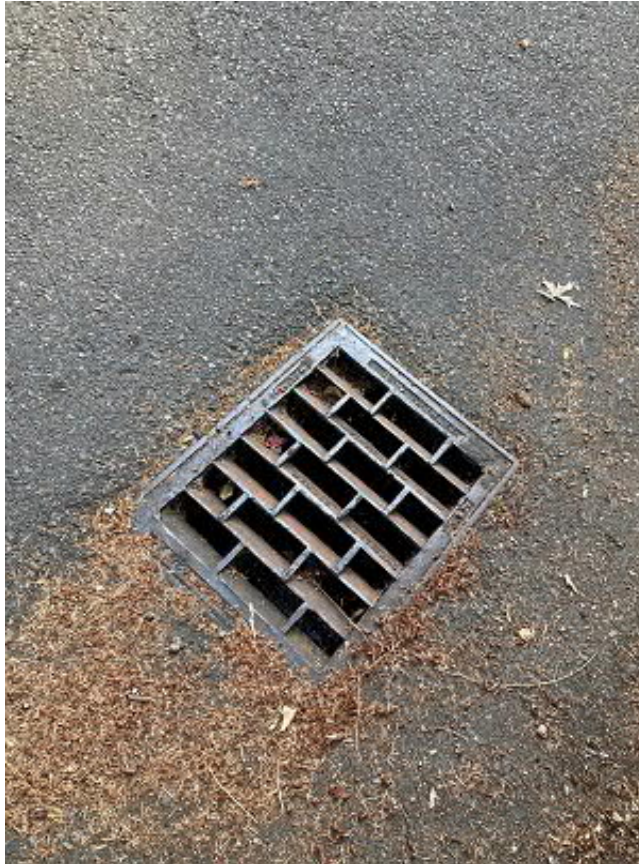
Picture 3

ROW at intersection of 72<sup>nd</sup> Pl SE and SE 36<sup>th</sup> Street  
From here water turns the corner into SE 36<sup>th</sup> Street.

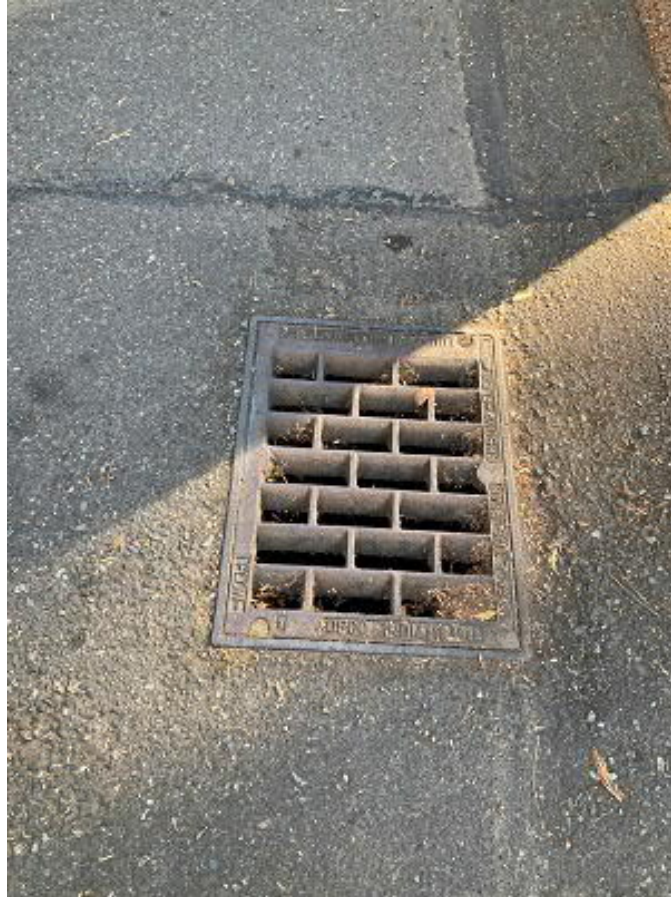
Picture 4  
ROW in front of 7225 SE 36<sup>th</sup> Street  
Another catch basin in line, this one under SE 36<sup>th</sup> Street.

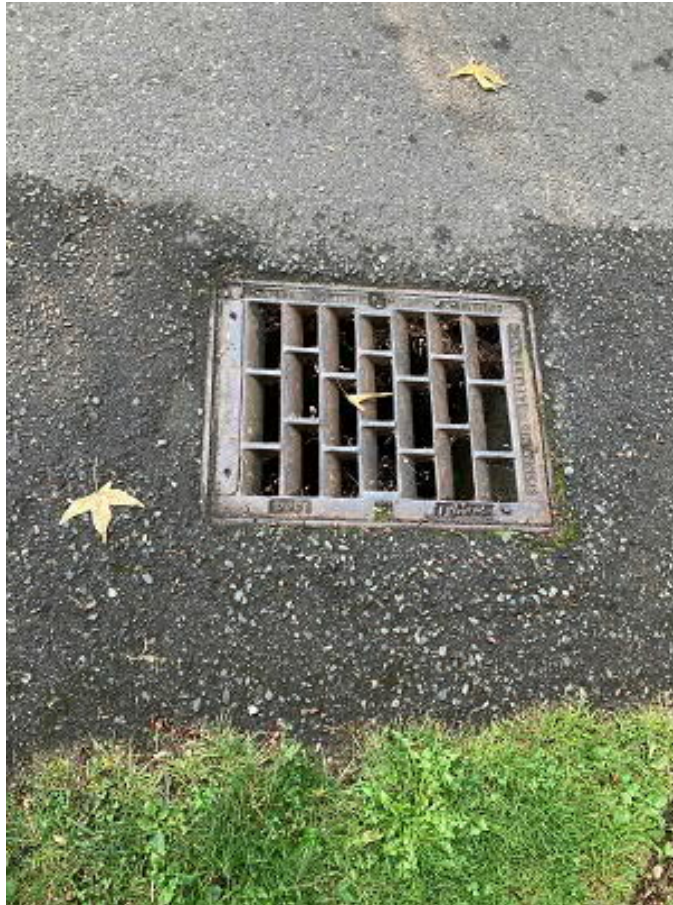
Picture 5  
ROW in front of 3449 SE 36<sup>th</sup> Street  
From this catch basin, water turns toward the south.

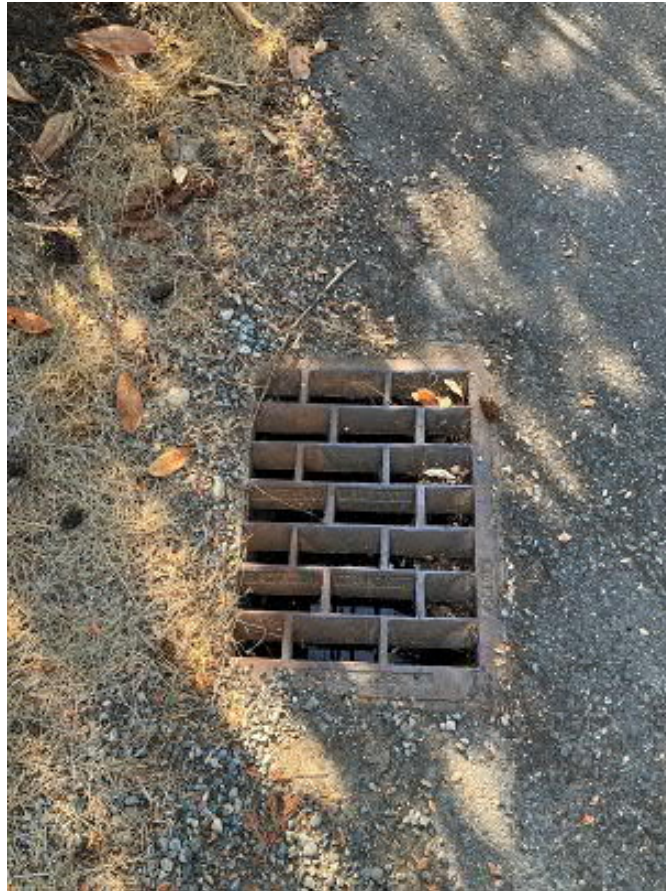
Picture 6  
ROW in front of 7337 SE 36<sup>th</sup> Street  
Water discharges toward the south in this 12" concrete pipe.  
CBs are on the east side of the street on this block.

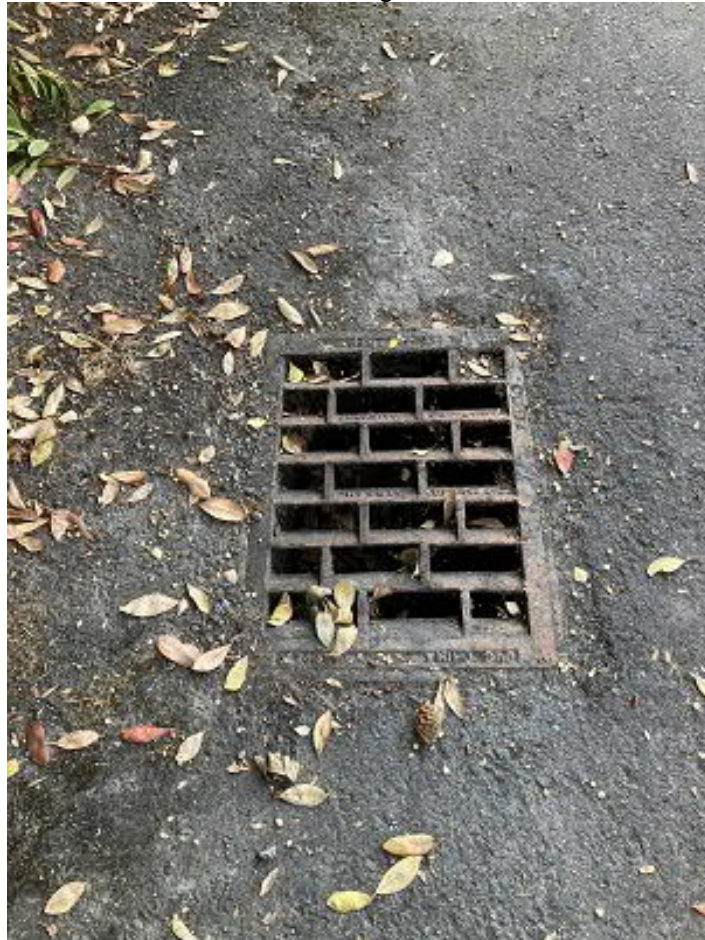
Picture 8  
ROW in front of 3616 73<sup>rd</sup> Avenue SE (south)  
Still flowing south

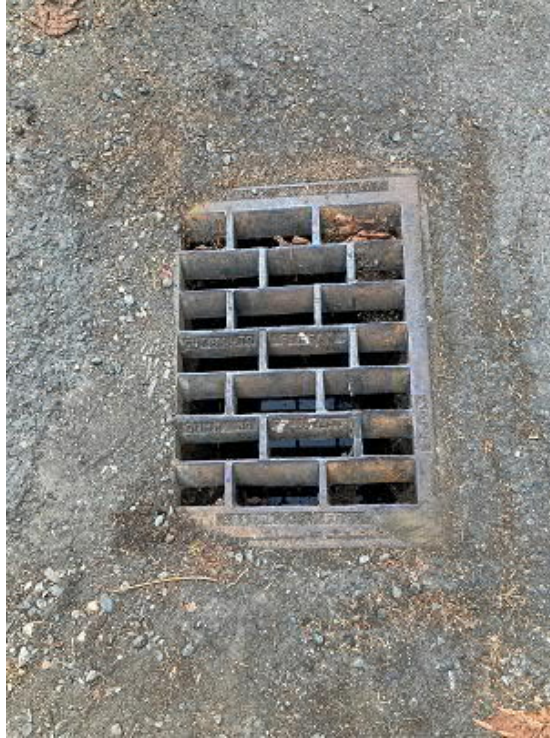
Picture 12  
ROW in front of 3650 73<sup>rd</sup> Avenue SE  
storm direction is due south

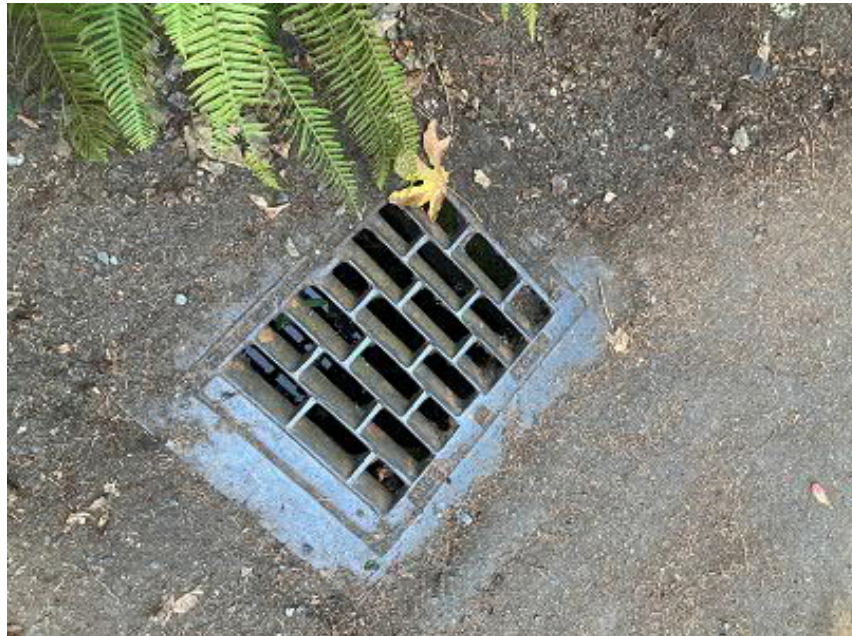
Picture 13  
ROW at the NE corner of 73<sup>rd</sup> Avenue SE and SE 38<sup>th</sup> Street  
At this CB the storm drain makes a turn east under the SE 38<sup>th</sup> Street ROW

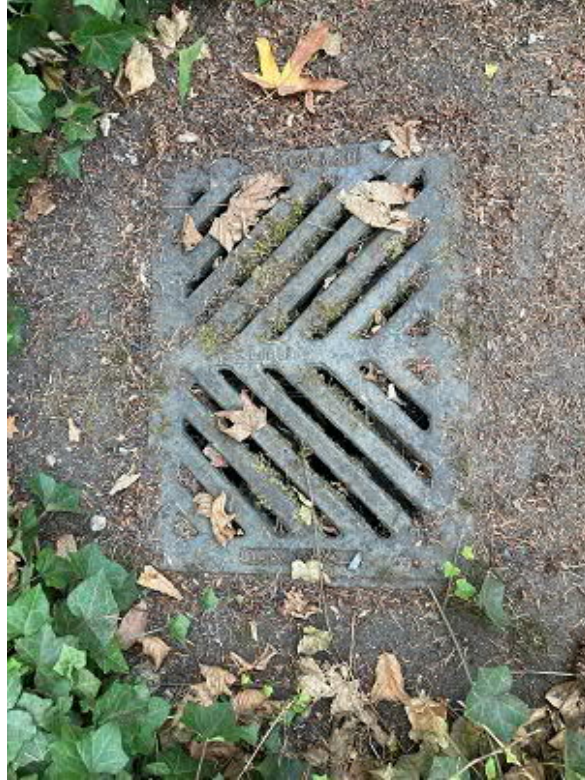
Picture 14  
ROW at the sw corner of 73<sup>rd</sup> Avenue SE and SE 38<sup>th</sup> Street  
runoff heading east

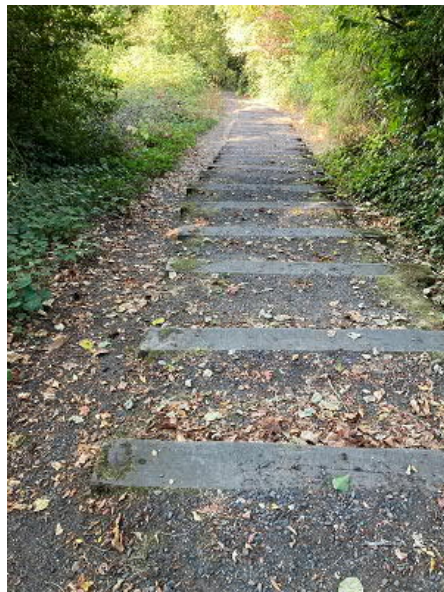
Picture 15:  
SE 38<sup>th</sup> Street ROW  
Engineer could not locate the two catch basins in this area.

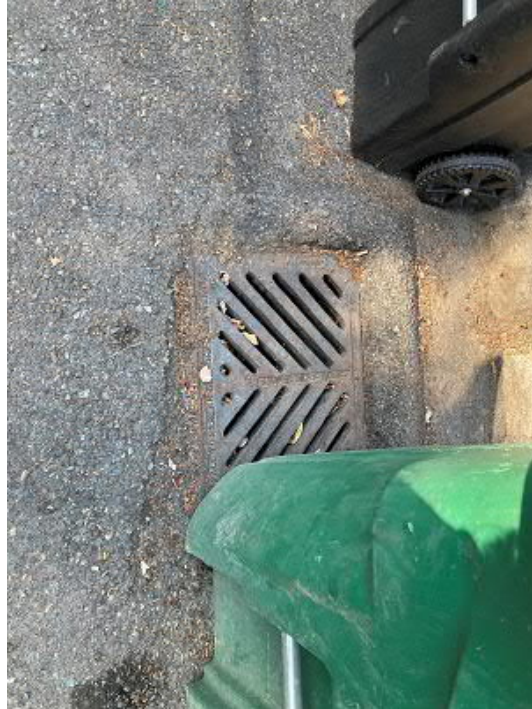
Picture 18  
ROW in front of 3698 72<sup>nd</sup> Place SE  
From this catch basin water heads toward the west.

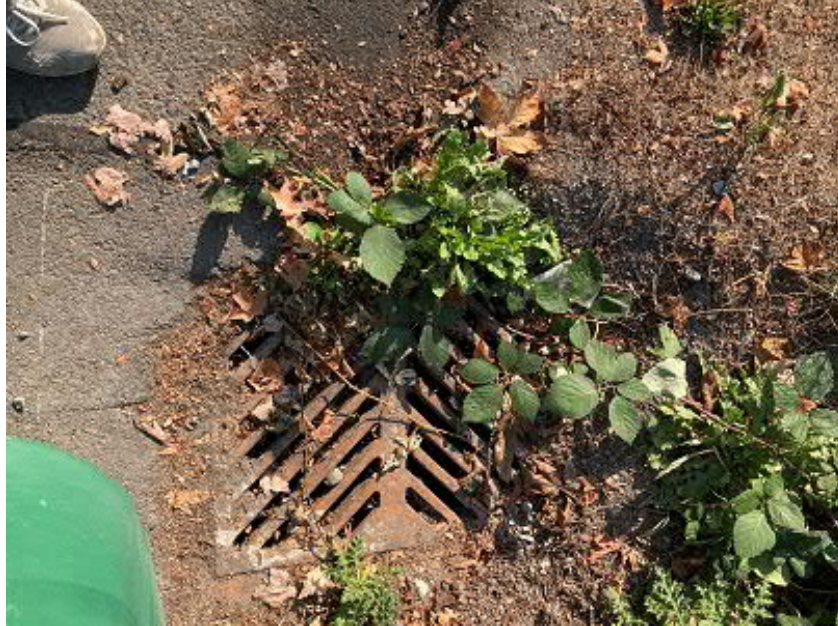
Picture 20

ROW at the NW corner of 72<sup>nd</sup> Place SE and W. Mercer Way  
From this catch basin water heads turns northwest onto W. Mercer Way

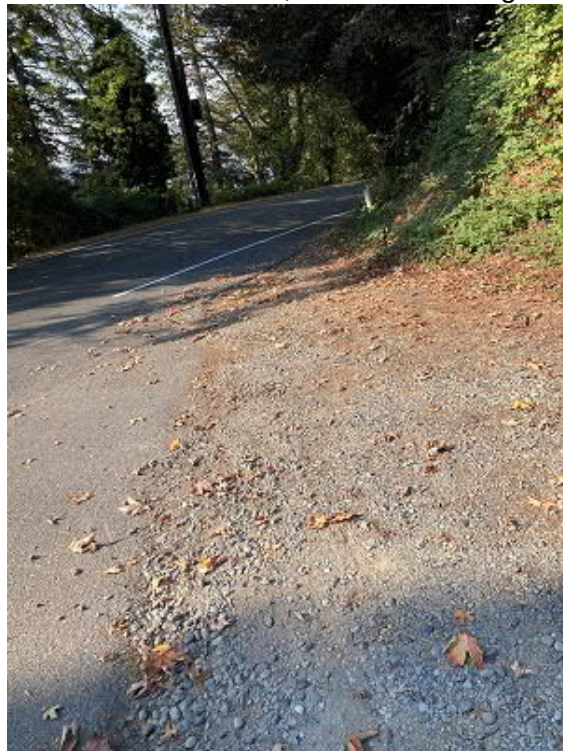
Picture 21

looking nw along West Mercer Way at 72<sup>nd</sup> Place SE  
runoff leaves the CB at Picture 20, and heads along W. Mercer Way.
