**LIMITED GEOTECHNICAL REPORT
COSON RESIDENCE
7709 W. MERCER WAY
MERCER ISLAND, WASHINGTON**

January 14, 2002

Subject: Limited Geotechnical Report
Coson Residence
7709 W. Mercer Way
Mercer Island, Washington

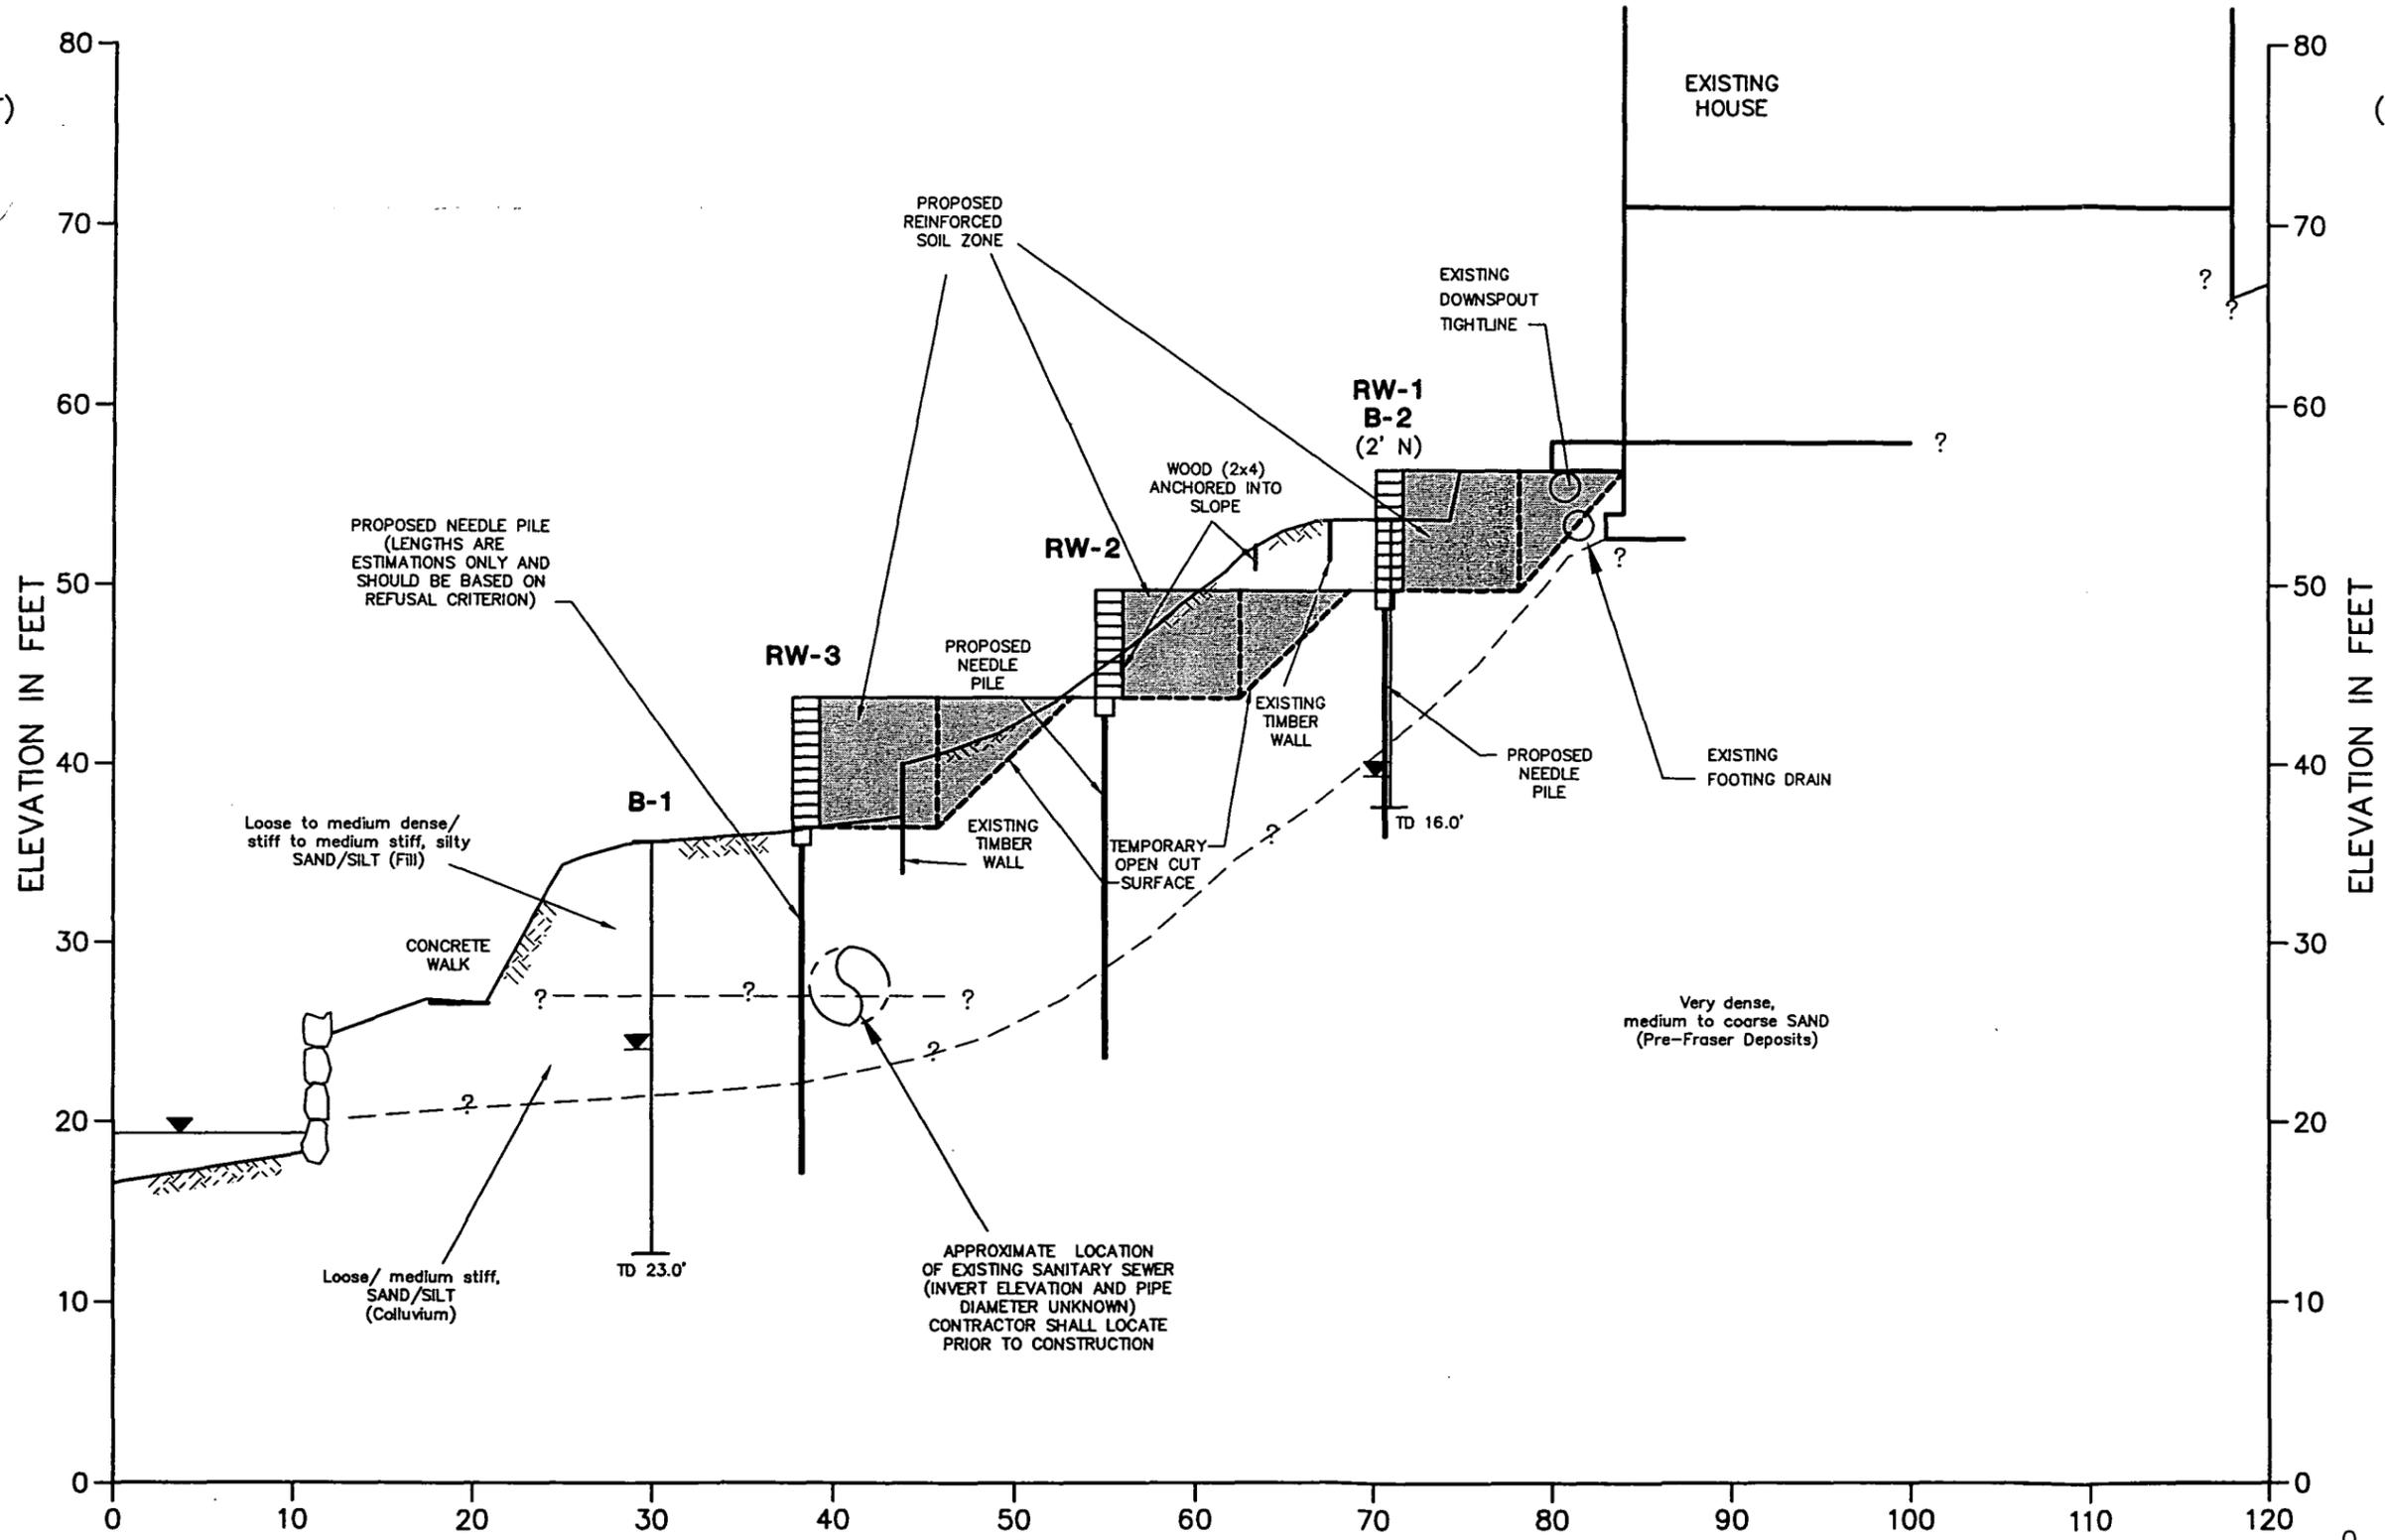
FIGURE
3

The enclosed exploration logs provide a detailed description of the soil strata encountered in our subsurface explorations. The enclosed *Cross-Section A-A'* (Figure 3) illustrates our stratigraphic interpretations at a selected location across the project site.
